# Navajo Abandoned Uranium Mine

## Site Screen Report

### **Ryan No. 2 AUM Site**

**January 2011**

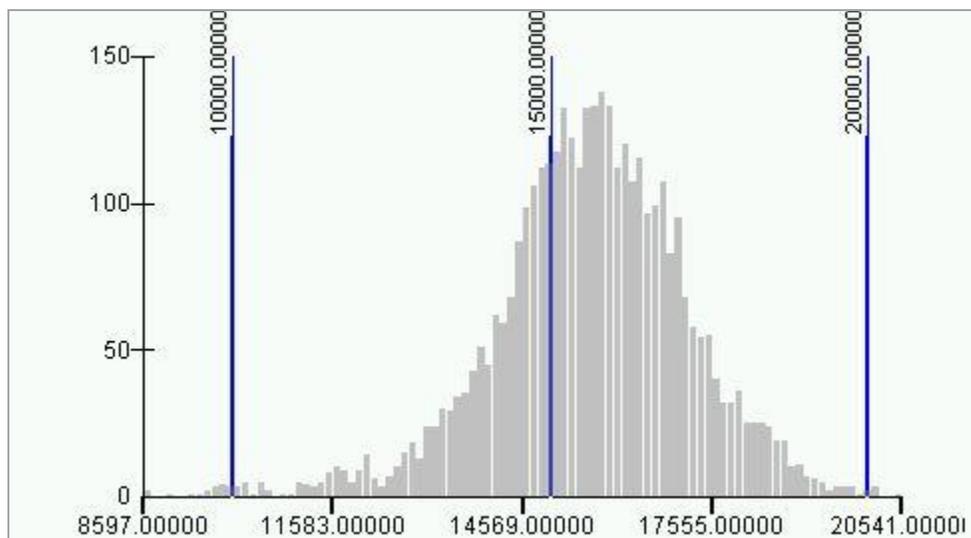
The following chart and statistics were generated by ESRI ArcGIS 9.3.1, and show the general distribution of the site gamma radiation measurements. The horizontal X axis represents the gamma radiation reading levels in cpm (lowest levels to the left). The vertical Y axis represents the frequency of each gamma radiation level.

Count:	3721
Minimum:	8597.00000
Maximum:	20541.00000
Sum:	58144437.00000
Mean:	15626.02446
Median:	15692.00000
Standard Deviation:	1548.56216

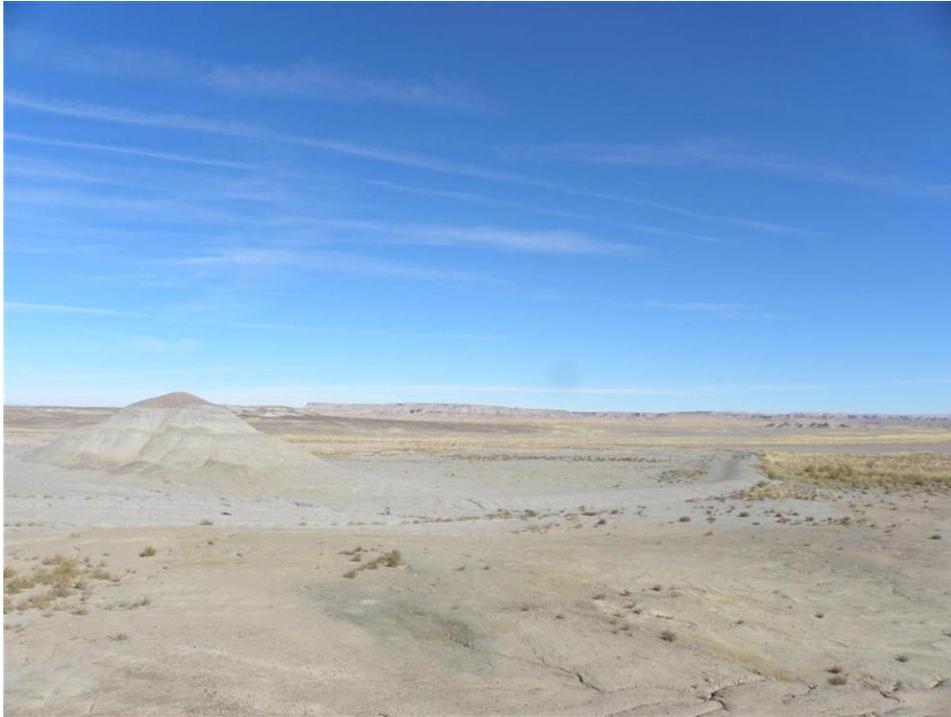
Photo 3. Ryan No. 2 mine site, reclamation area

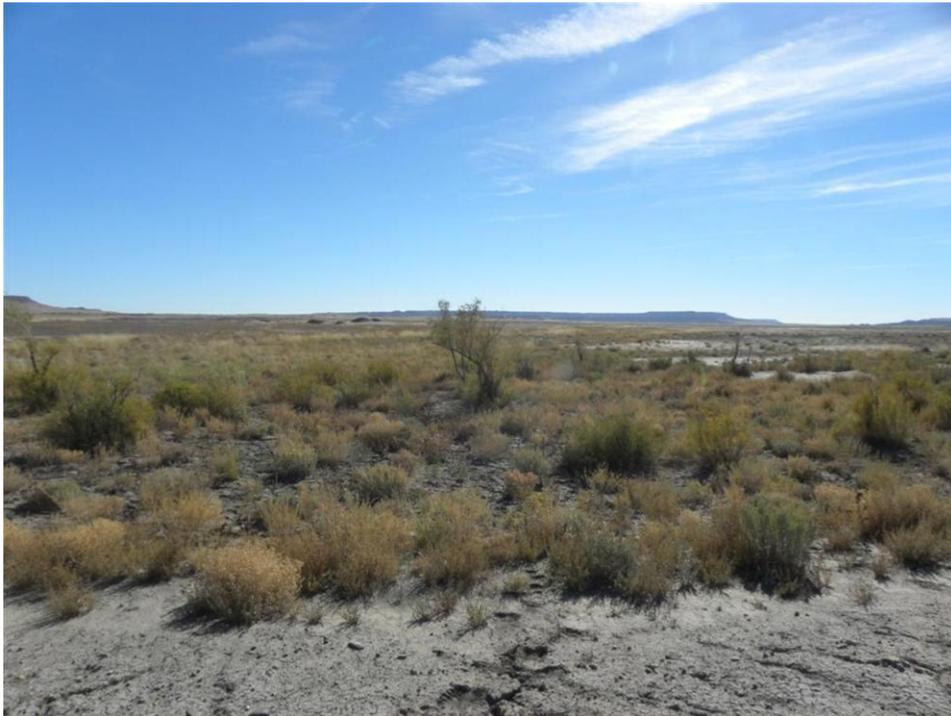
Photo 4. Ryan No. 2 mine site, former pond area

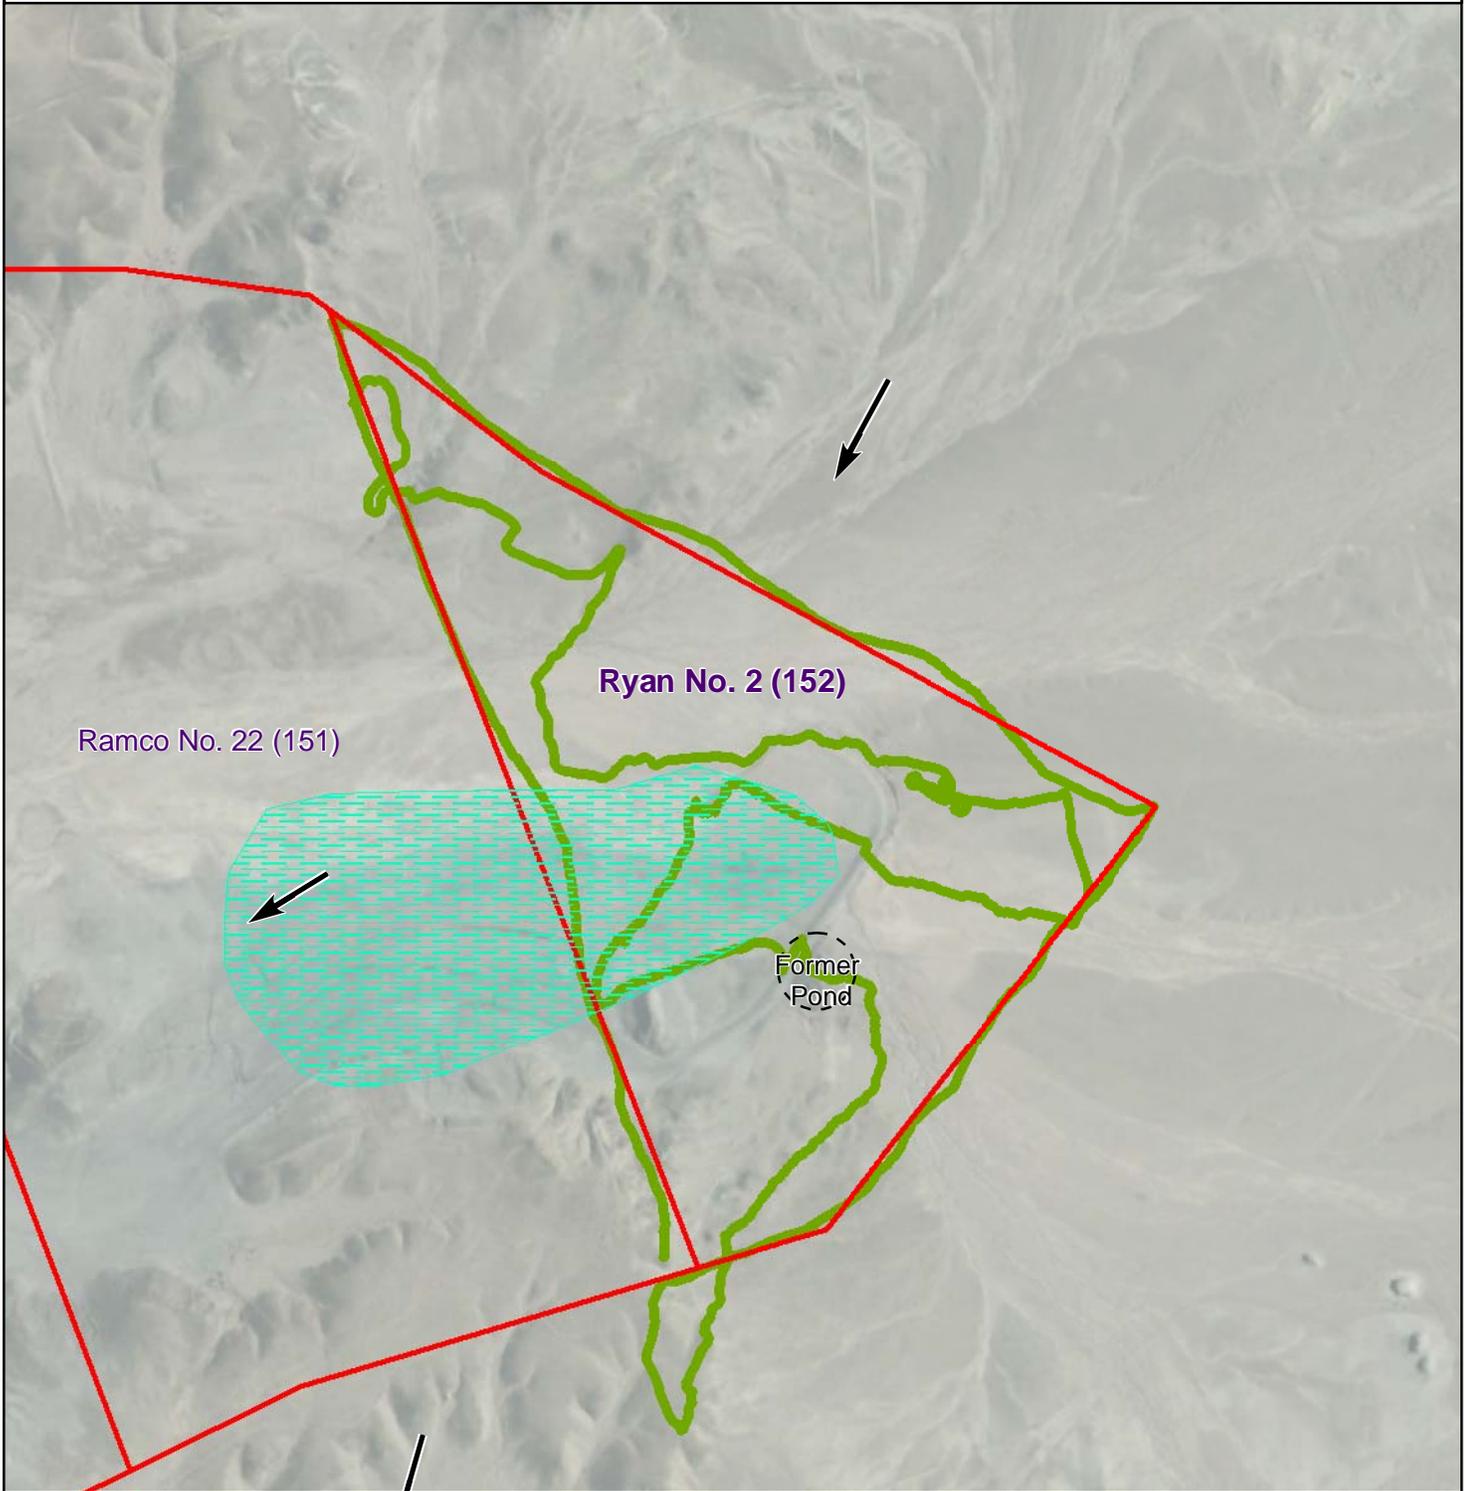
A total of 3,721 gamma radiation measurements were collected from the mine site, ranging from 8,597 cpm to 20,541 cpm. The measurements collected at the berm area were found at a background levels. The measurements are represented in Figures 1 and 2.

**Figure 1 - Gamma Radiation Measurements, Above Two Times Background  
 Ryan No. 2 (152)  
 Coalmine Mesa Chapter, Navajo Nation**

Gamma survey conducted 11/2010  
 Measured as counts per minute (cpm)

Average background 11,885 cpm

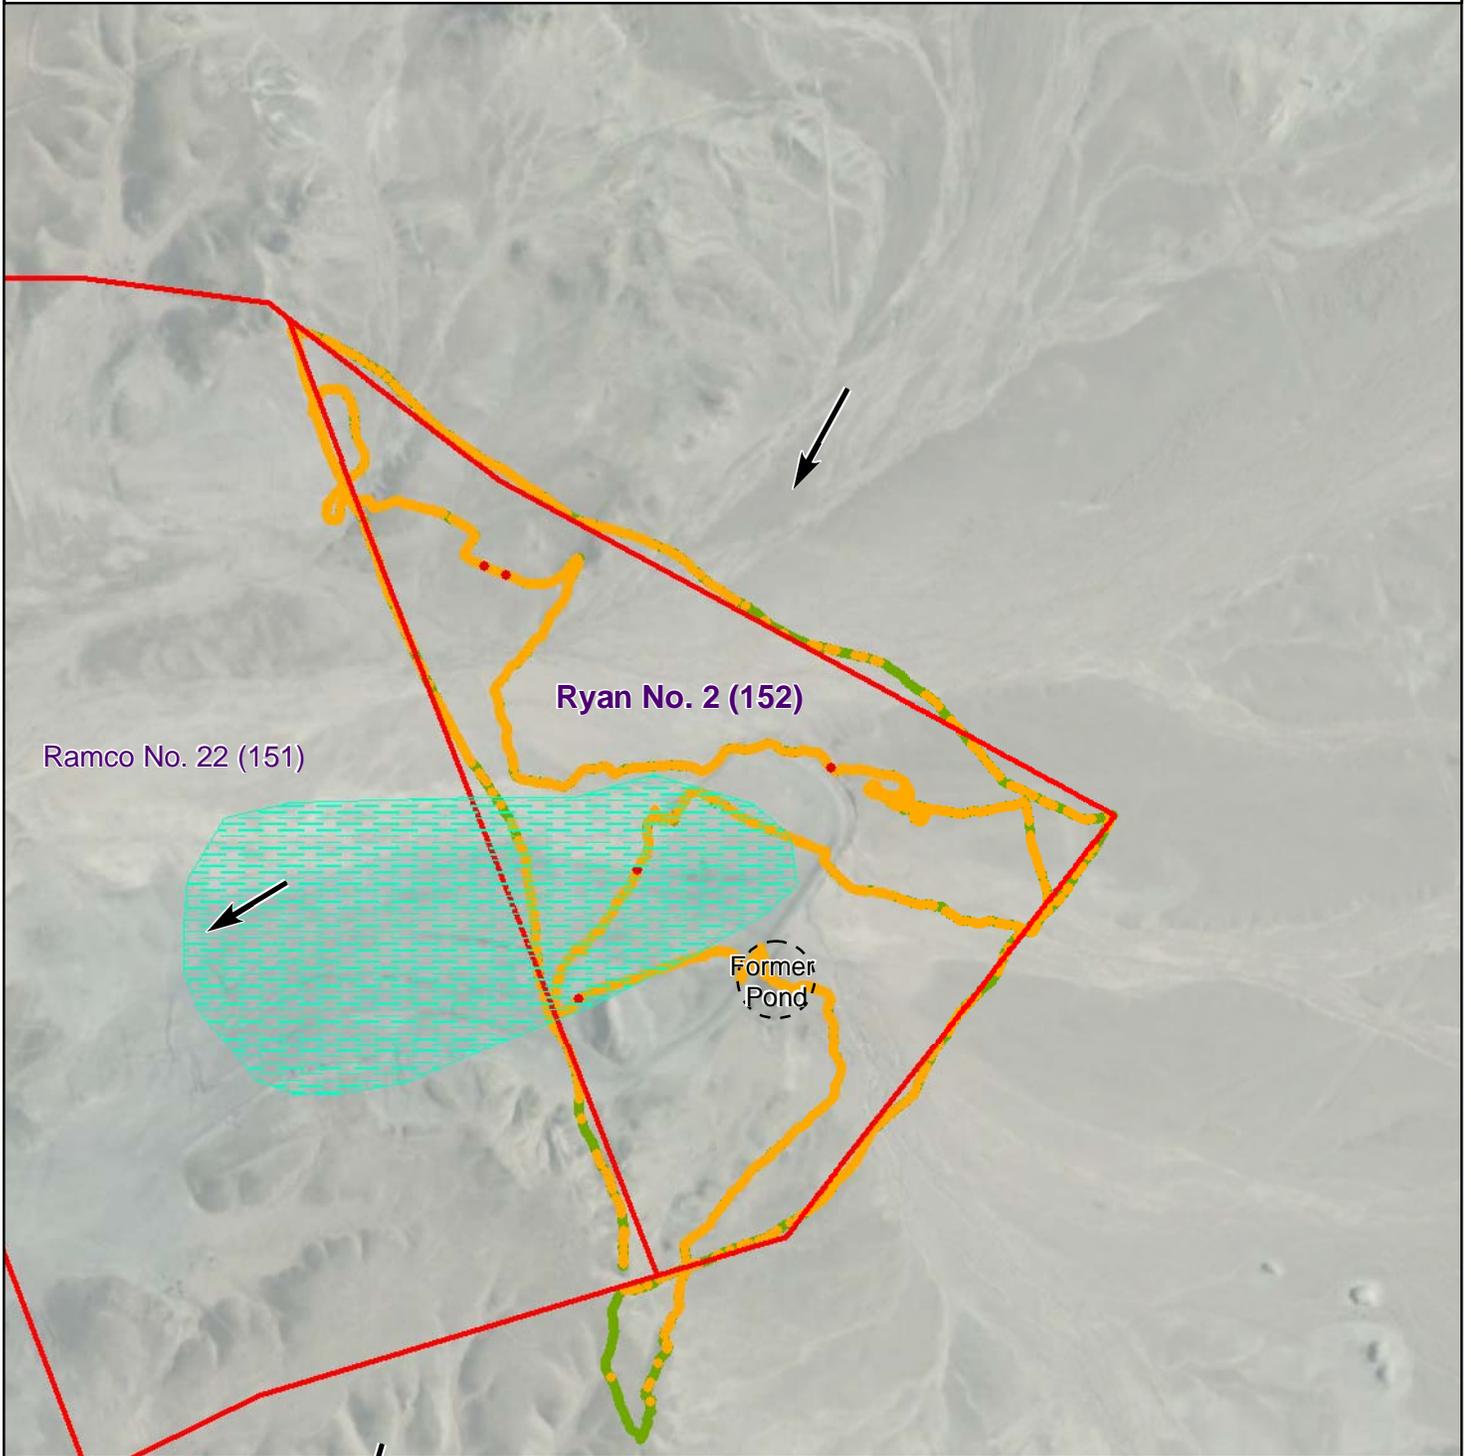
**Figure 2 - Gamma Radiation Measurements  
Ryan No. 2 (152)  
Coalmine Mesa Chapter, Navajo Nation**

**Gamma survey conducted 11/2010  
Measured as counts per minute (cpm)**

**Average background 11,885 cpm**
