Navajo Abandoned Uranium Mine

Site Screen Report

Charles Huskon No. 4 AUM Site

January 2011

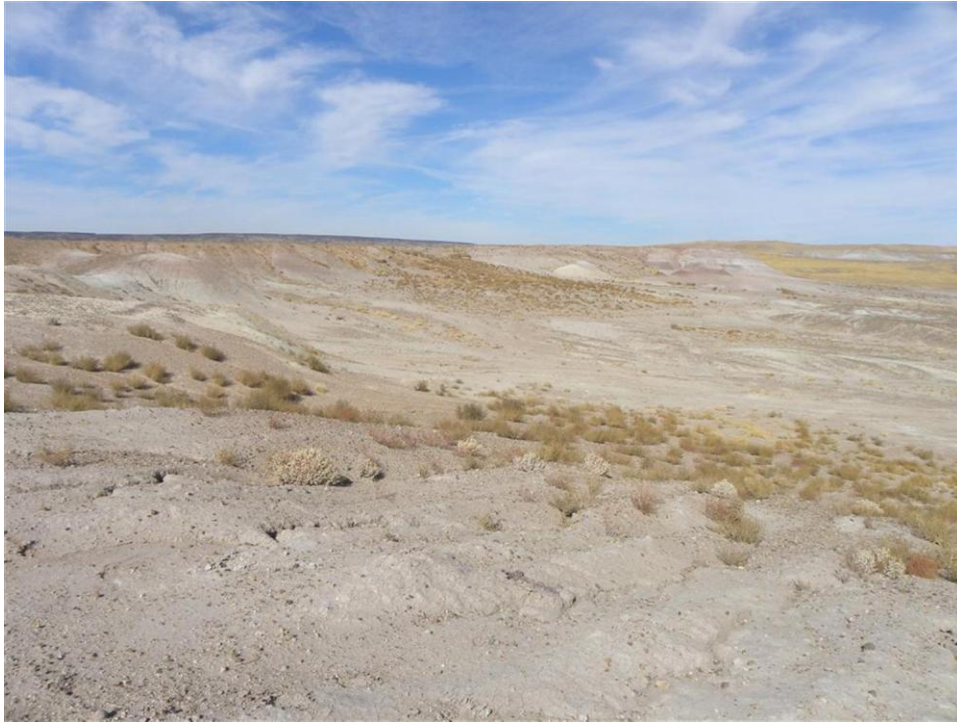
Photo 1. Charles Huskon No. 4 mine site

Possible centralized reclamation cap

Yes (possible centralized reclamation cap)
