Navajo Abandoned Uranium Mine

Site Screen Report

Julius Chee No. 4 AUM Site

Navajo AUM Western Region

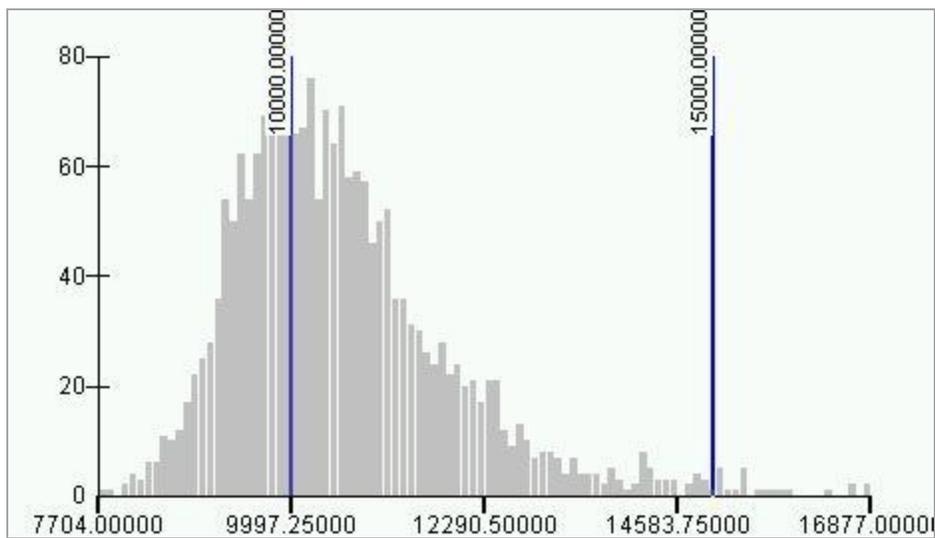
The following chart and statistics were generated by ESRI ArcGIS 9.3.1, and show the general distribution of the site gamma radiation measurements. The horizontal X axis represents the gamma radiation reading levels in cpm (lowest levels to the left). The vertical Y axis represents the frequency of each gamma radiation level.

Count:	2063
Minimum:	7704.00000
Maximum:	16877.00000
Sum:	21866539.00000
Mean:	10599.38875
Median:	10380.00000
Standard Deviation:	1312.29074

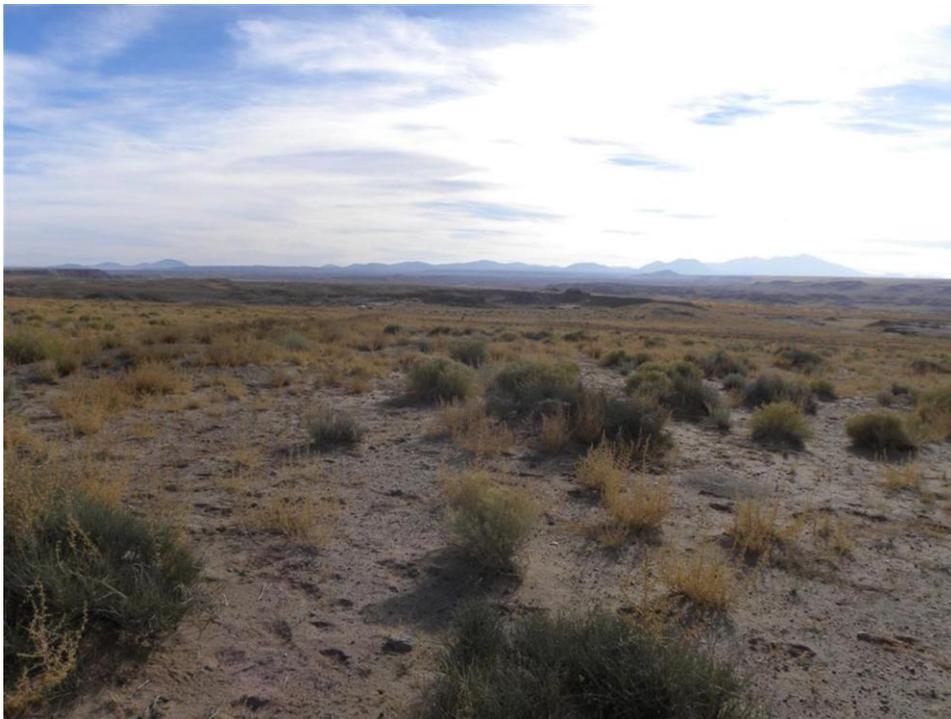
Photo 2. Julius Chee No. 4 mine site, berm area

Series of reclamation berms, over area identified on old topo maps as "tailings", berms cover the corner area between sites 159, 549, 550, and 1041

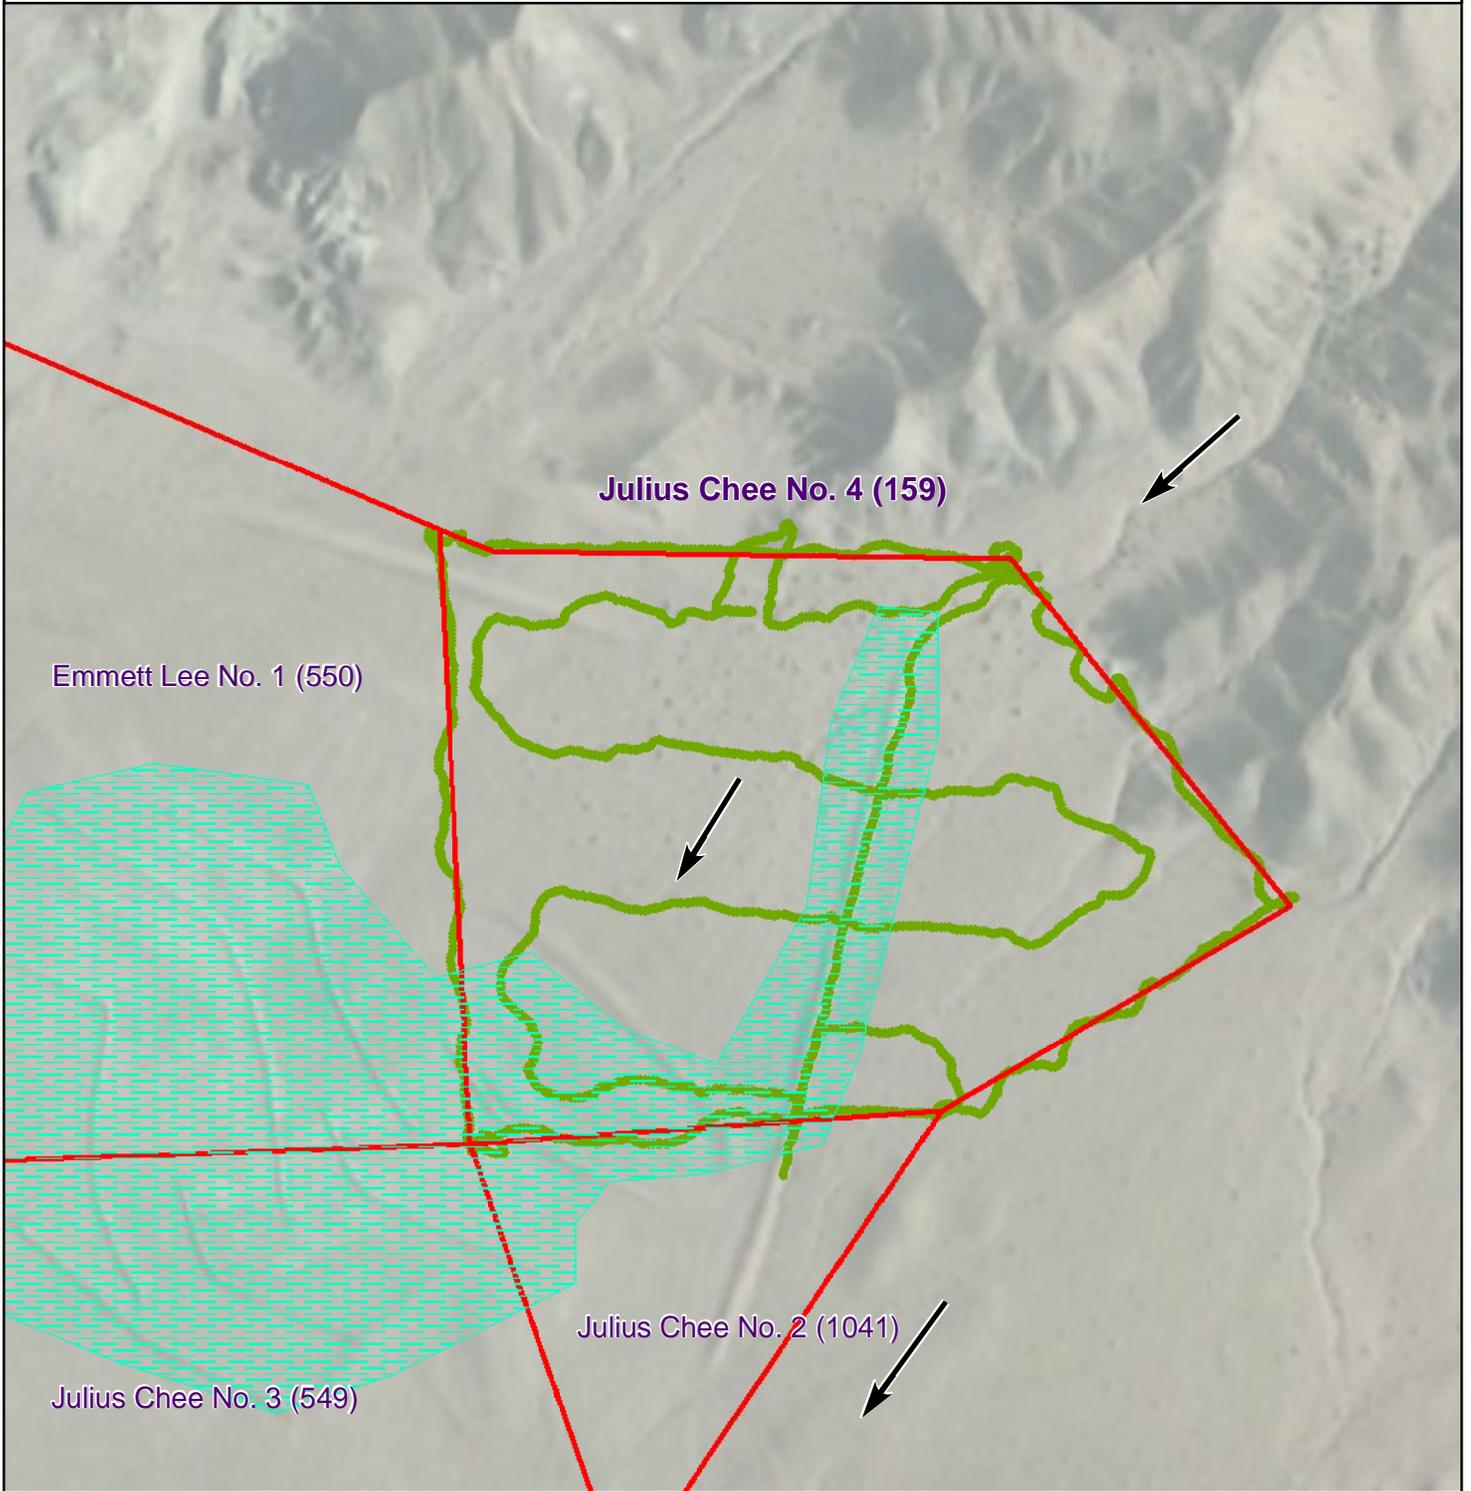
**Figure 1 - Gamma Radiation Measurements, Above Two Times Background
 Julius Chee No. 4 (159)
 Coalmine Mesa Chapter, Navajo Nation**

A total of 2,063 gamma radiation measurements were collected from the mine site, ranging from 7,704 cpm to 16,877 cpm. The measurements are represented in Figures 1 and 2.

Gamma survey conducted 11/2010
 Measured as counts per minute (cpm)

Average background 9,641 cpm

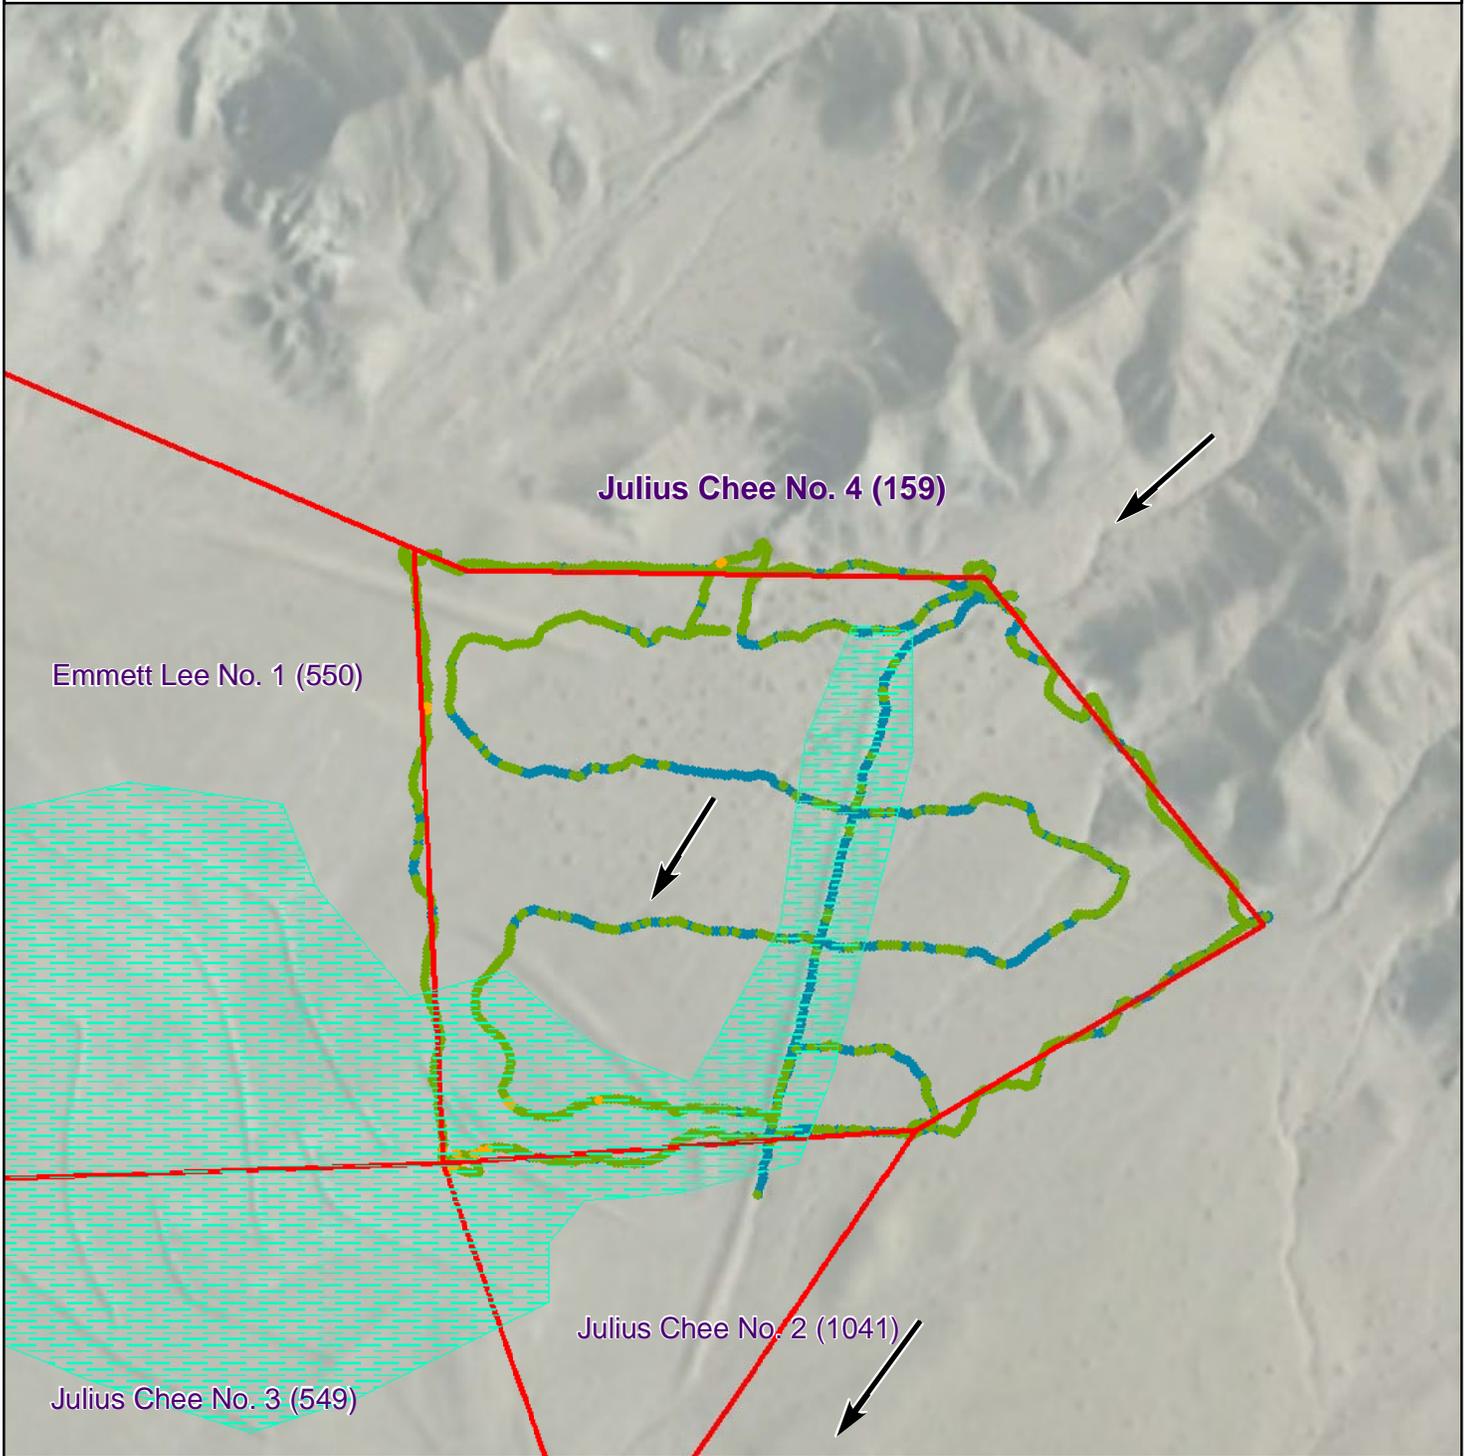
**Figure 2 - Gamma Radiation Measurements
Julius Chee No. 4 (159)
Coalmine Mesa Chapter, Navajo Nation**

**Gamma survey conducted 11/2010
Measured as counts per minute (cpm)**

Average background 9,641 cpm
