Navajo Abandoned Uranium Mine

Site Screen Report

Mine Name: Montezuma No. 2
Mine IDs: 163, 165, 166

August 2011

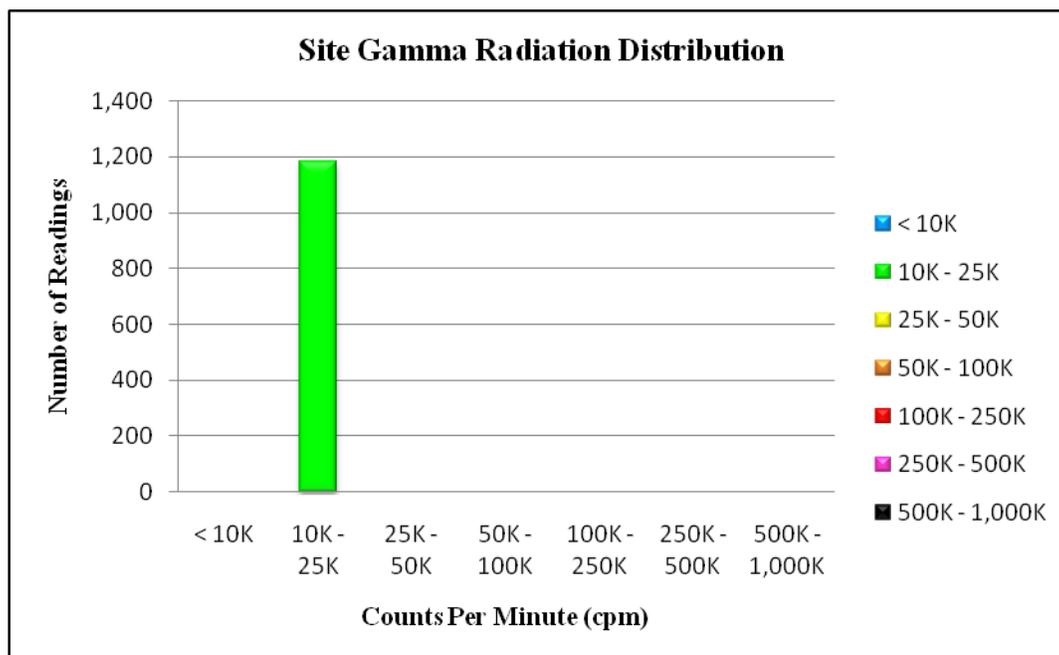
A total of 1,184 gamma radiation measurements were collected from the mine site, ranging from 10,843 cpm to 24,311 cpm. Measurements collected in the vicinity of the reclamation areas were found at a maximum level of approximately 25,000 cpm. The measurements are represented in Figures 1, 2, 3 and 4.

Site Gamma Radiation Statistics	
Number of Readings	1,184
Minimum (cpm)	10,843
Maximum (cpm)	24,311
Mean (cpm)	15,430
Median (cpm)	15,306
Standard Deviation	1,680

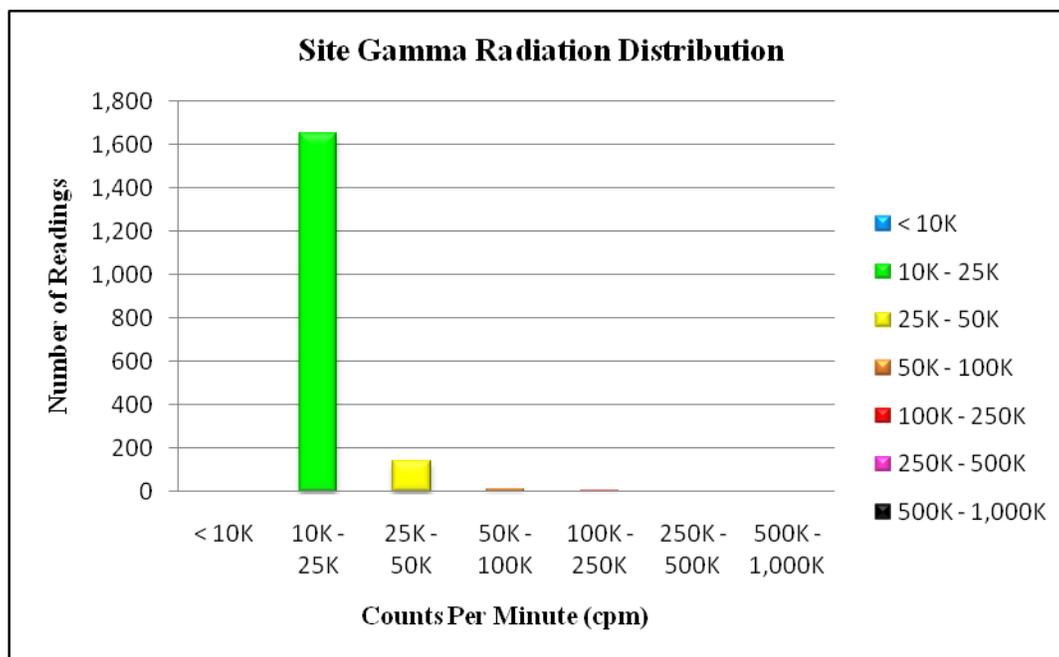
A total of 1,804 gamma radiation measurements were collected from the mine site, ranging from 14,505 cpm to 100,368 cpm. Measurements collected in the vicinity of the waste rock were found at a maximum level of approximately 50,000 cpm, and the reclamation areas of approximately 35,000 cpm. The measurements are represented in Figures 1, 2, 3, and 4.

Site Gamma Radiation Statistics	
Number of Readings	1,804
Minimum (cpm)	14,505
Maximum (cpm)	100,368
Mean (cpm)	20,211
Median (cpm)	18,809
Standard Deviation	6,040

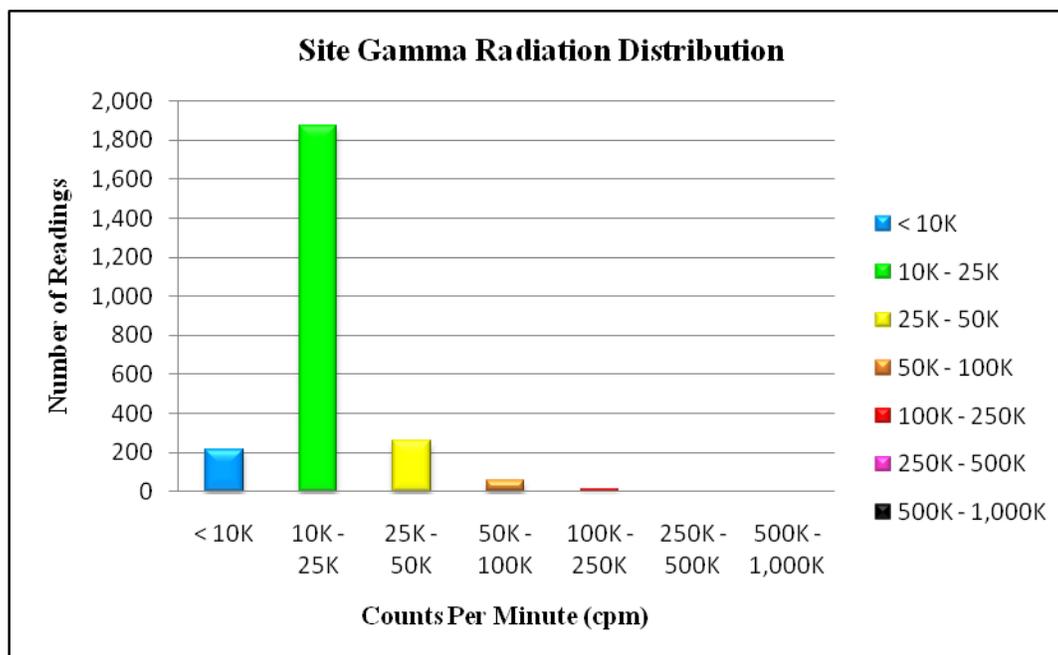
A total of 2,415 gamma radiation measurements were collected from the mine site, ranging from 7,762 cpm to 151,759 cpm. Measurements collected in the vicinity of the reclamation areas were found at a maximum level of approximately 150,000 cpm. The measurements are represented in Figures 1, 2, 5, and 6.

Site Gamma Radiation Statistics	
Number of Readings	2,415
Minimum (cpm)	7,762
Maximum (cpm)	151,759
Mean (cpm)	18,450
Median (cpm)	15,688
Standard Deviation	13,077

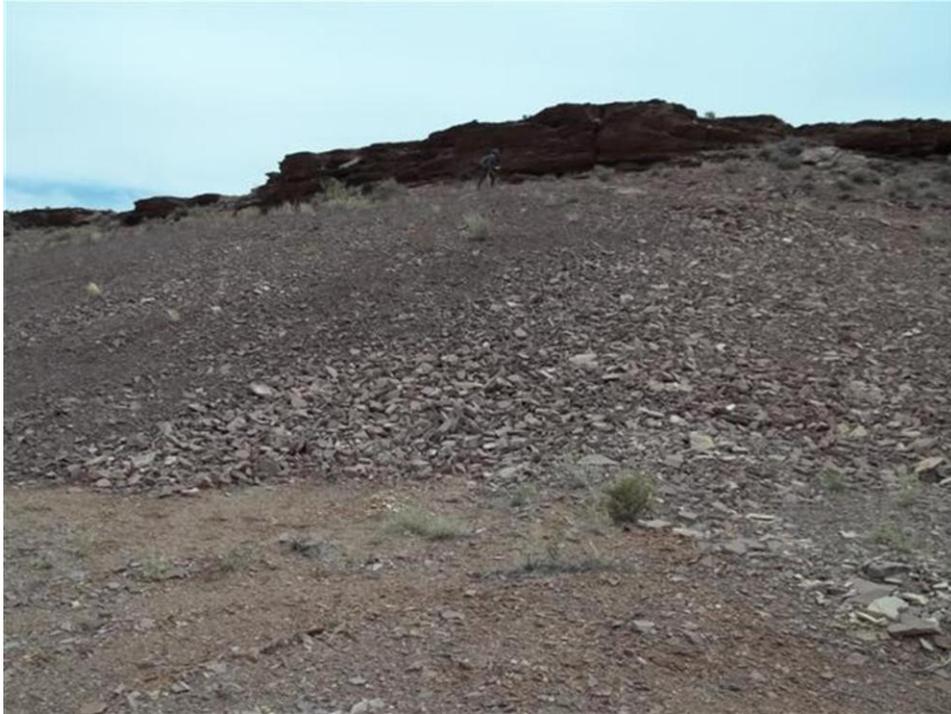
Reclamation cap, 100' x 150' x 5', rocky red-brown rocks, down slope

Photo 2: Mine Site #163; Reclamation area

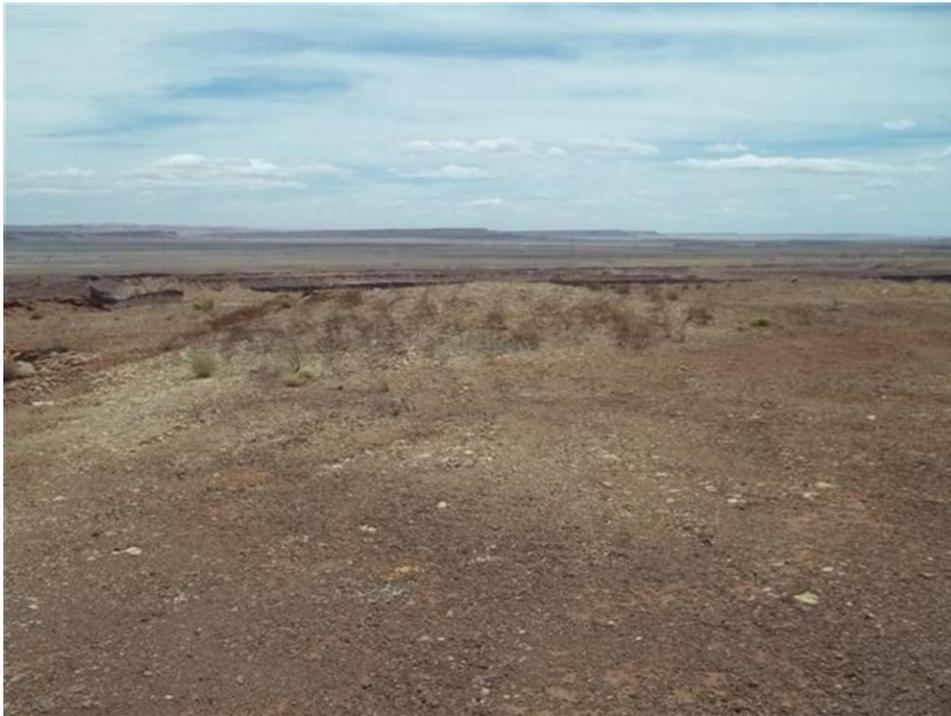
Reclamation cap, 70'x40'x5', light brown small rock fragments

Photo 4: Mine Site #165; Reclamation area

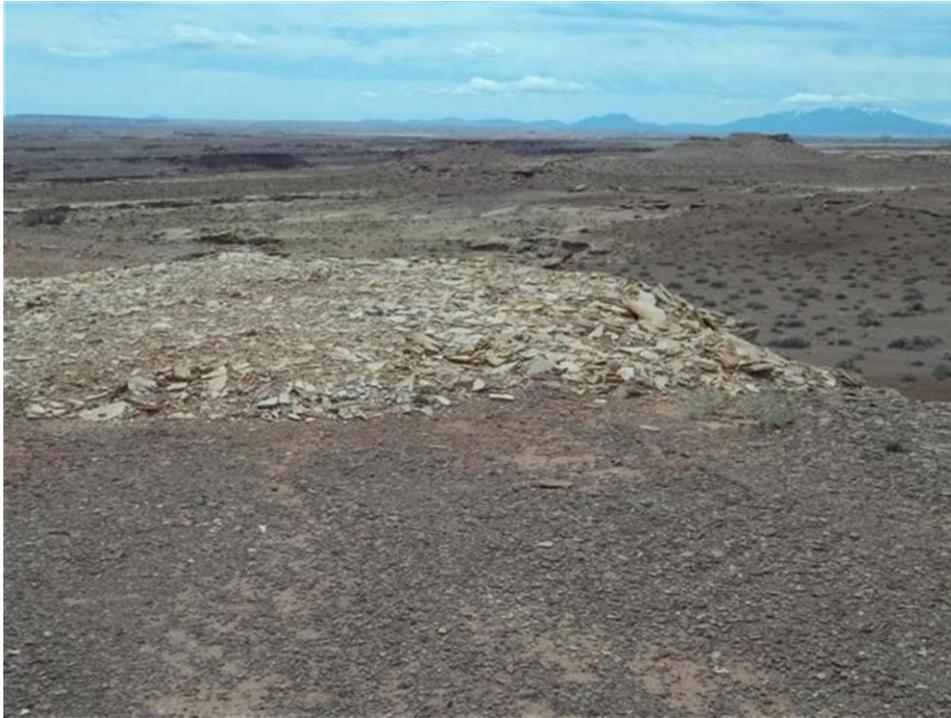
2 waste rock piles: Pile 1 - 15'dia x 1.5'h, light brown rock fragments; Pile 2 - 40' x 30' x 1', near ledge

Photo 5: Mine Site #165; Waste rock

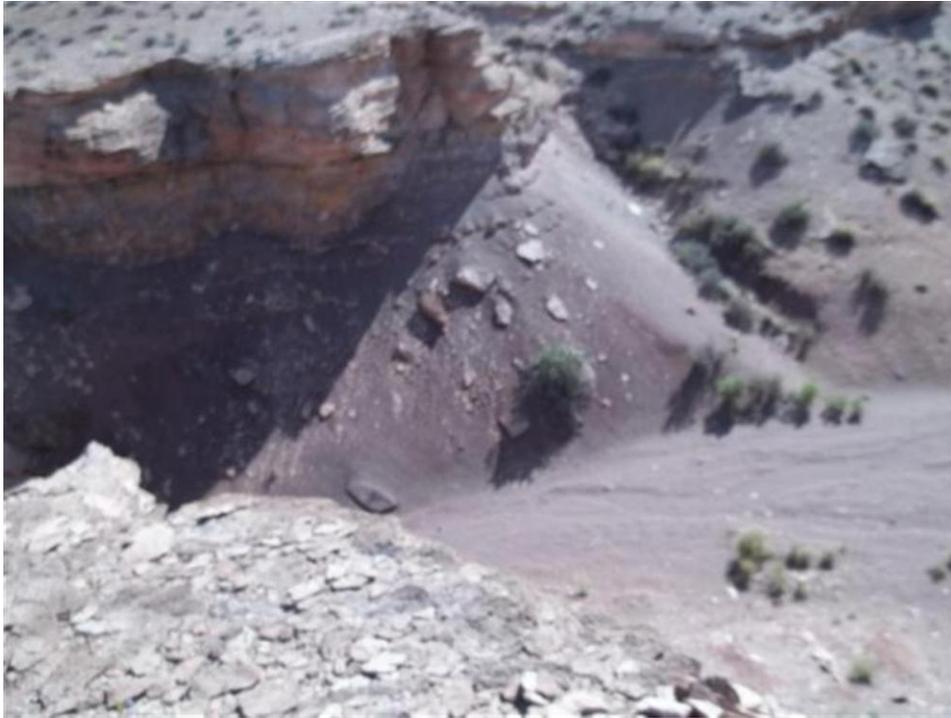
Photo 7: Mine Site #166; Drainage

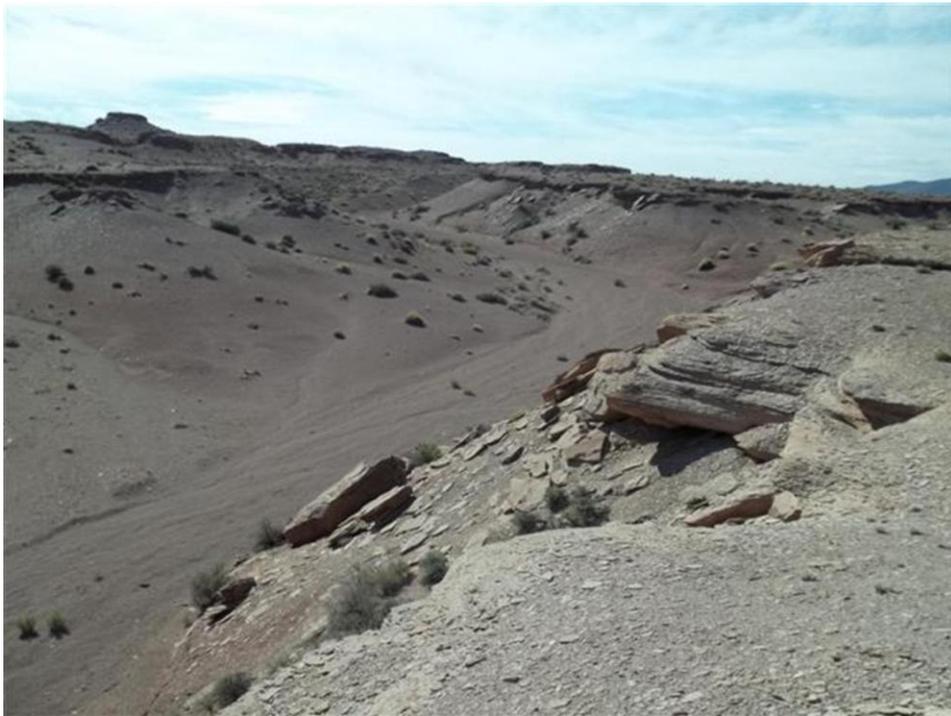
Photo 8: Mine Site #166; Drainage

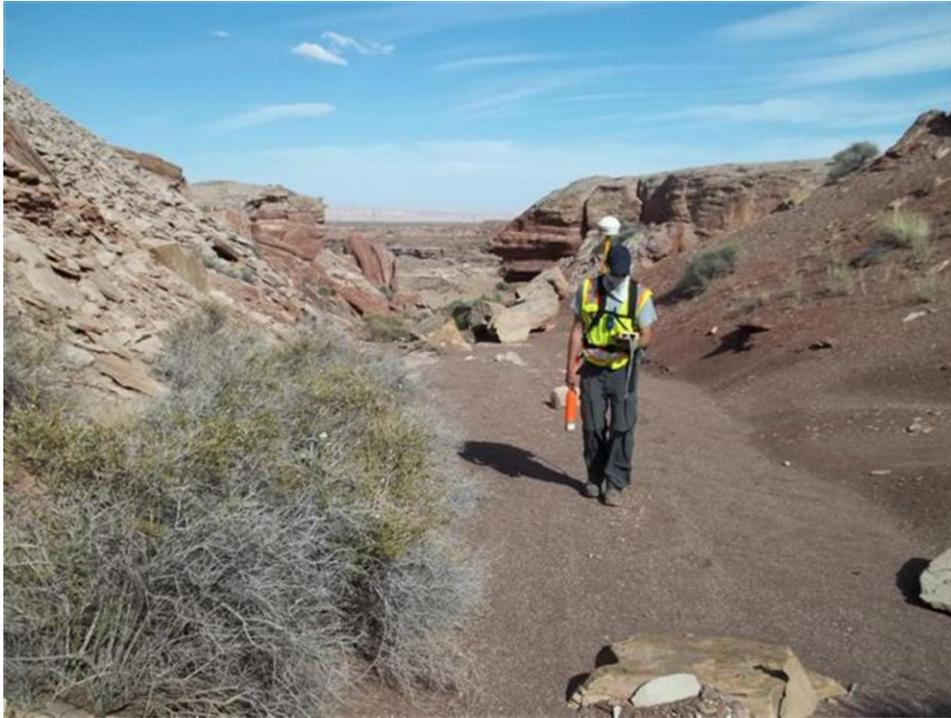
Photo 9: Mine Site #166; Drainage

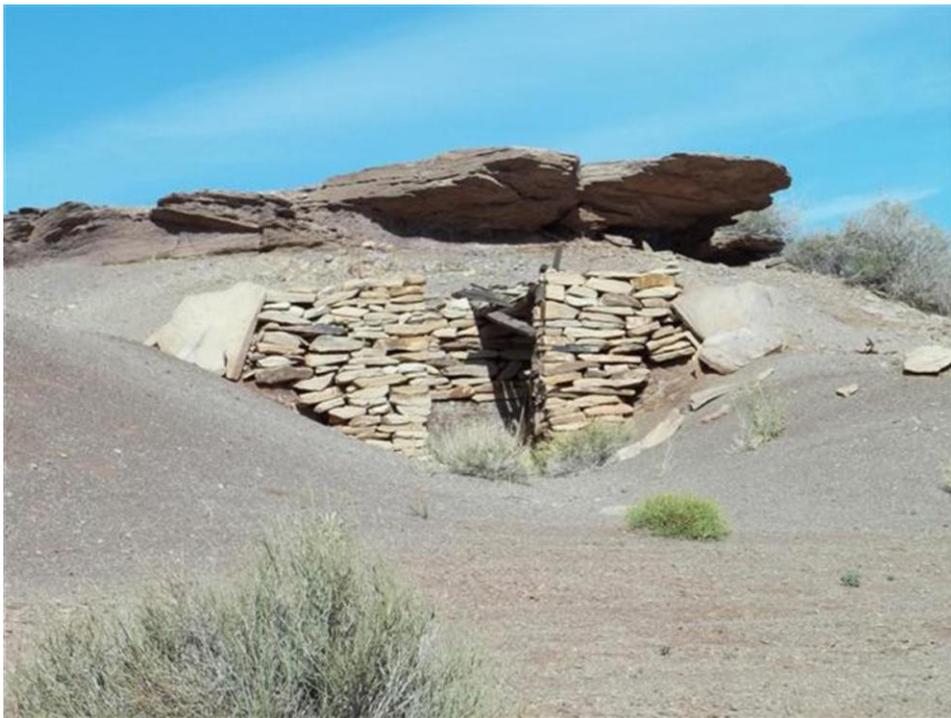
0 to 200 feet: No residential structures were observed, but a collapsed stone Hogan was located on site #66

Photo 10: Mine Site #166; Hogan in southwest part of site

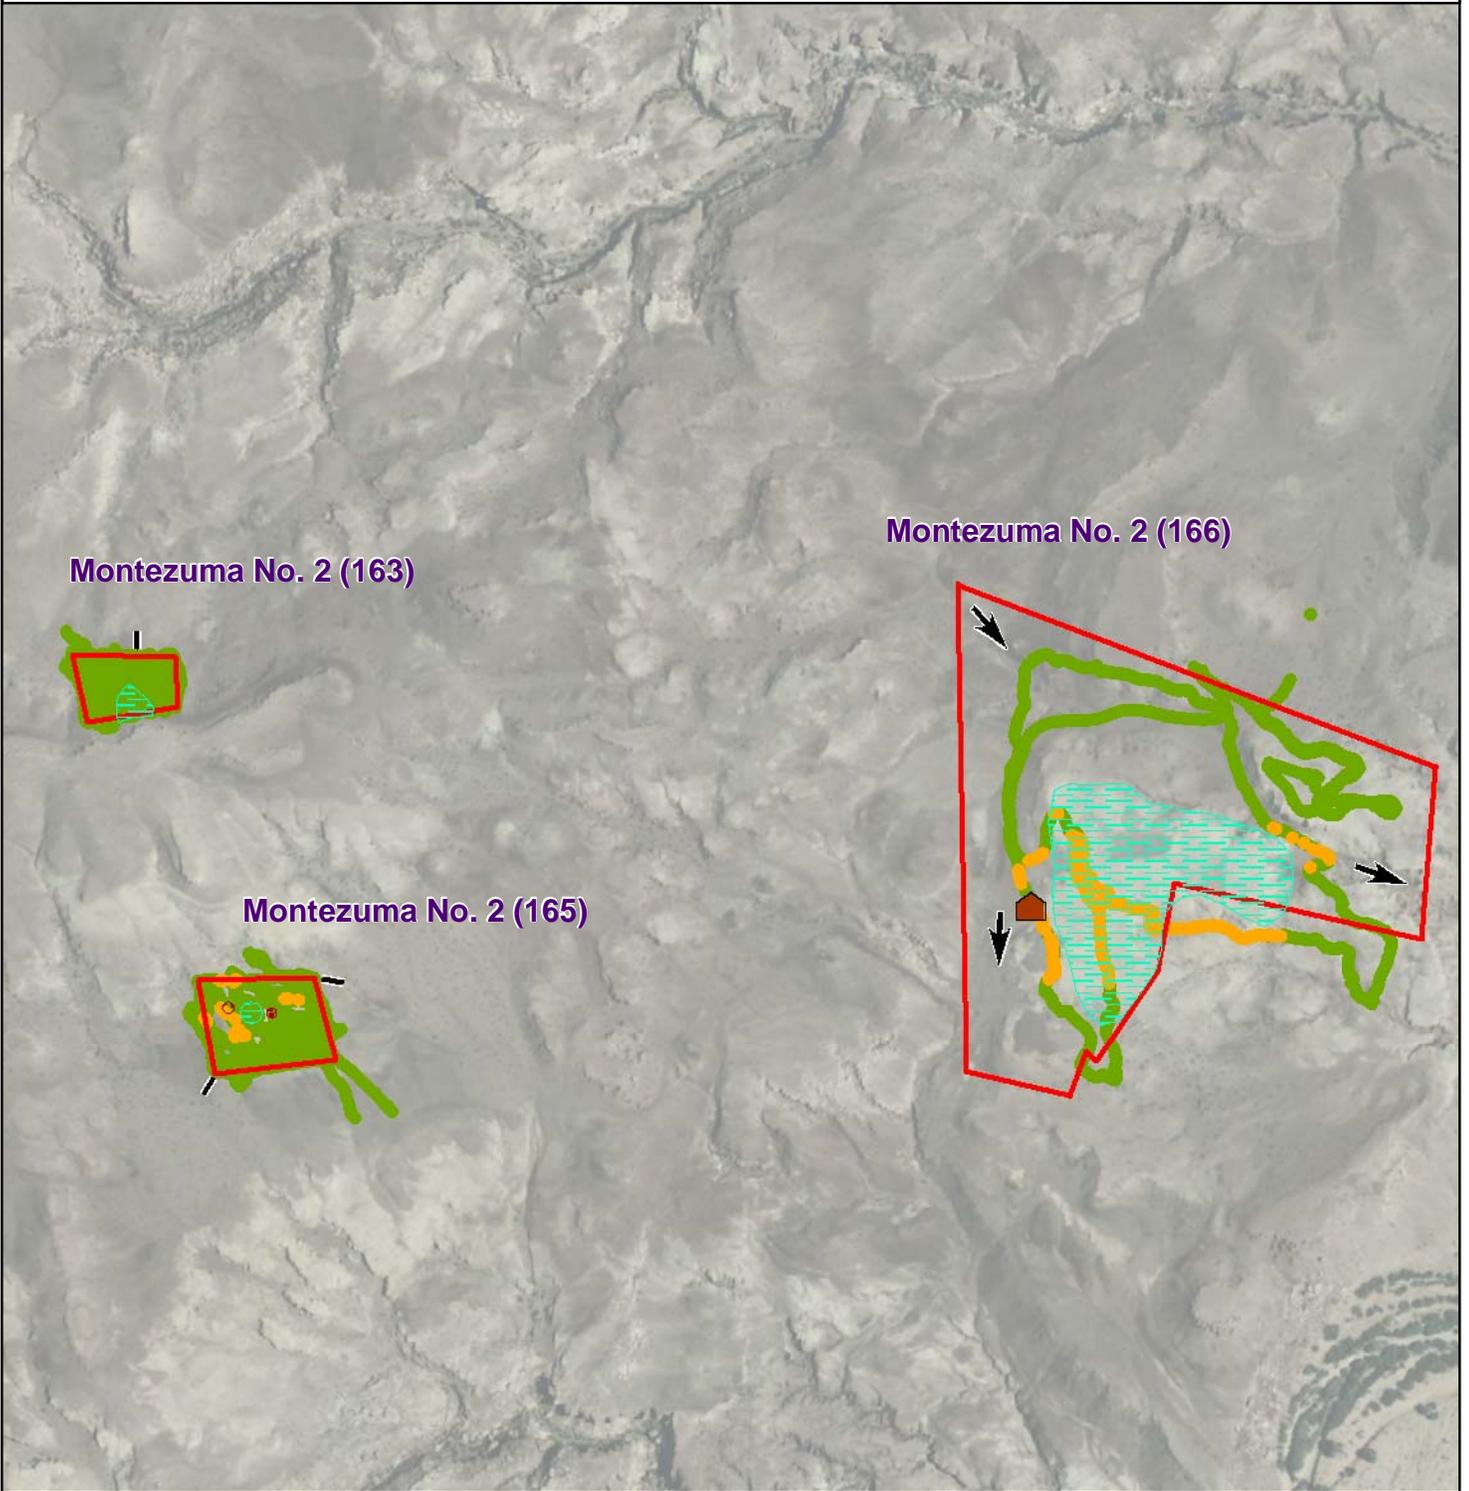
**Figure 1 - Gamma Radiation Measurements, Above Two Times Background
 Montezuma No. 2 (163, 165, 166)
 Bodaway / Gap Chapter, Navajo Nation**

Average background 14,449 cpm

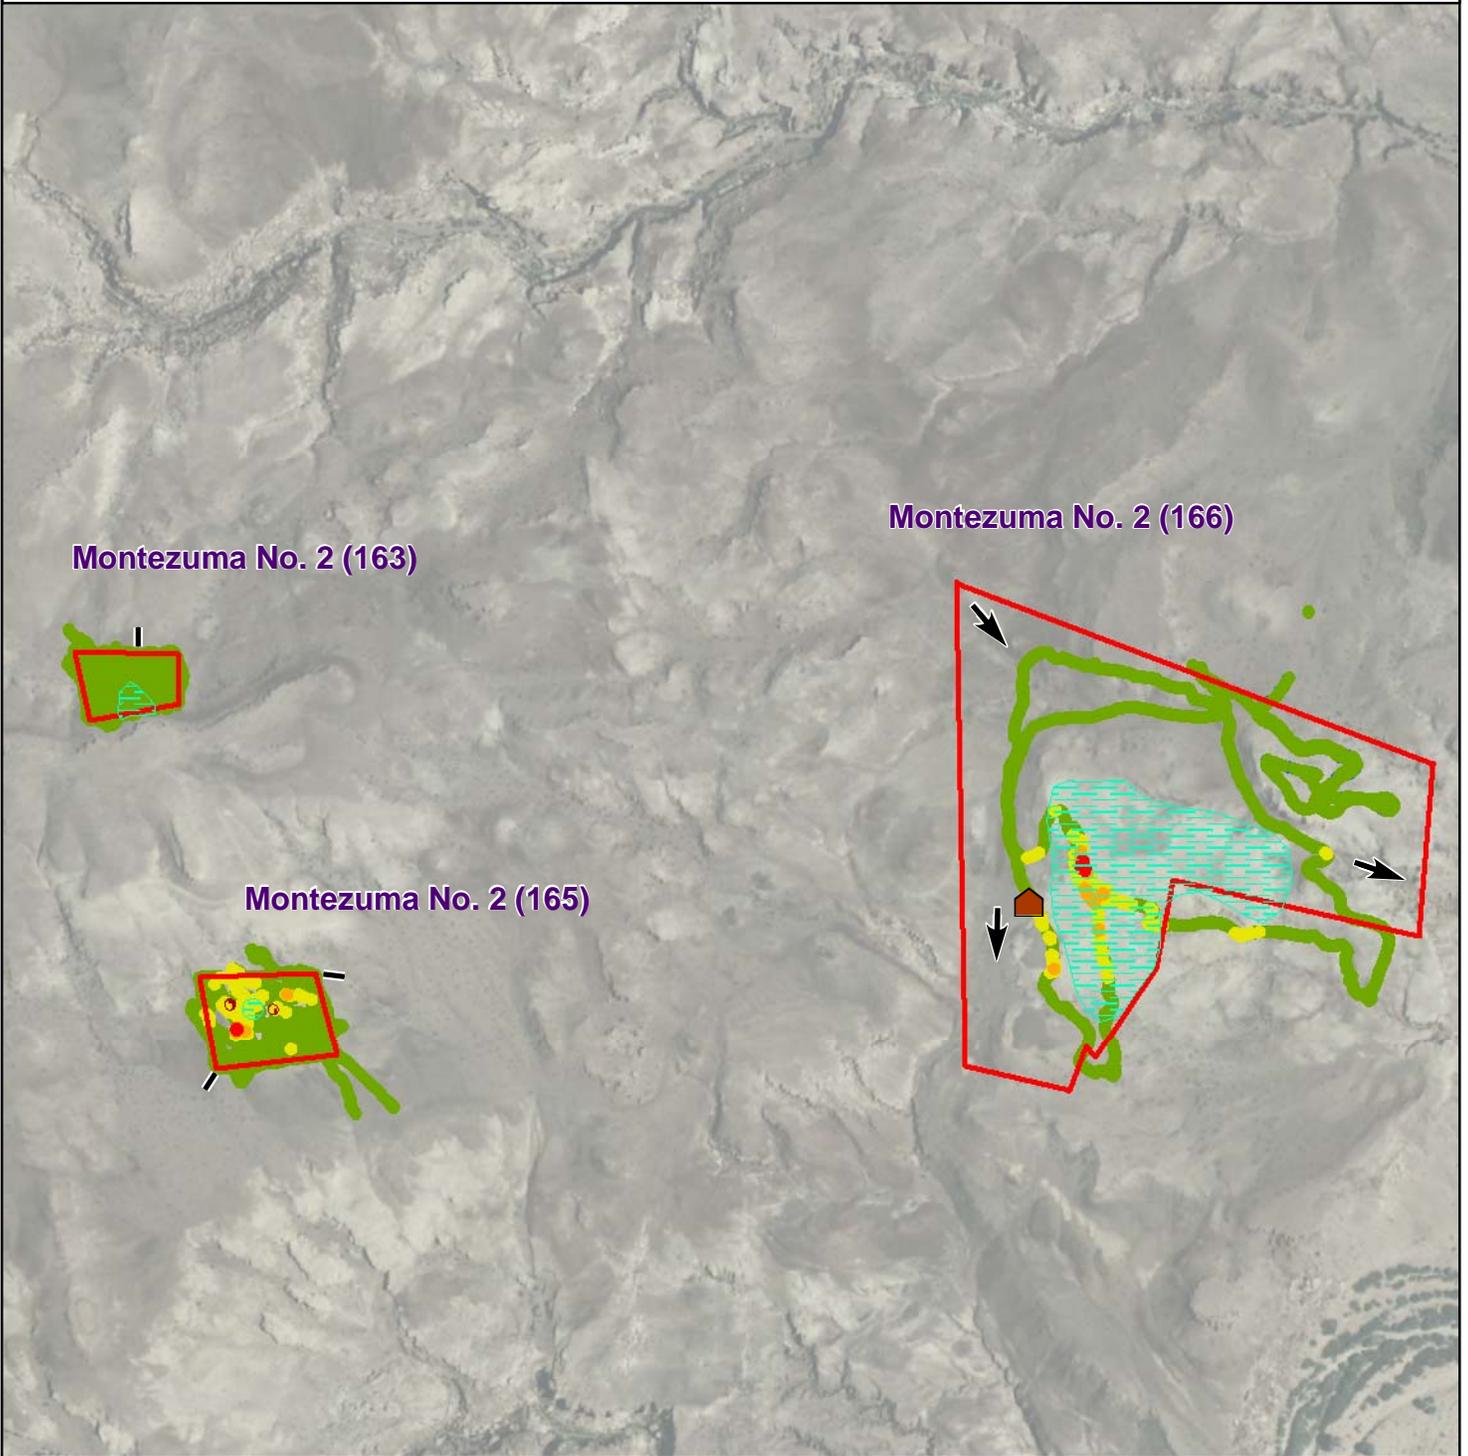
**Figure 2 - Gamma Radiation Measurements
Montezuma No. 2 (163, 165, 166)
Bodayay / Gap Chapter, Navajo Nation**

Measured as counts per minute (cpm) Average background 14,449 cpm

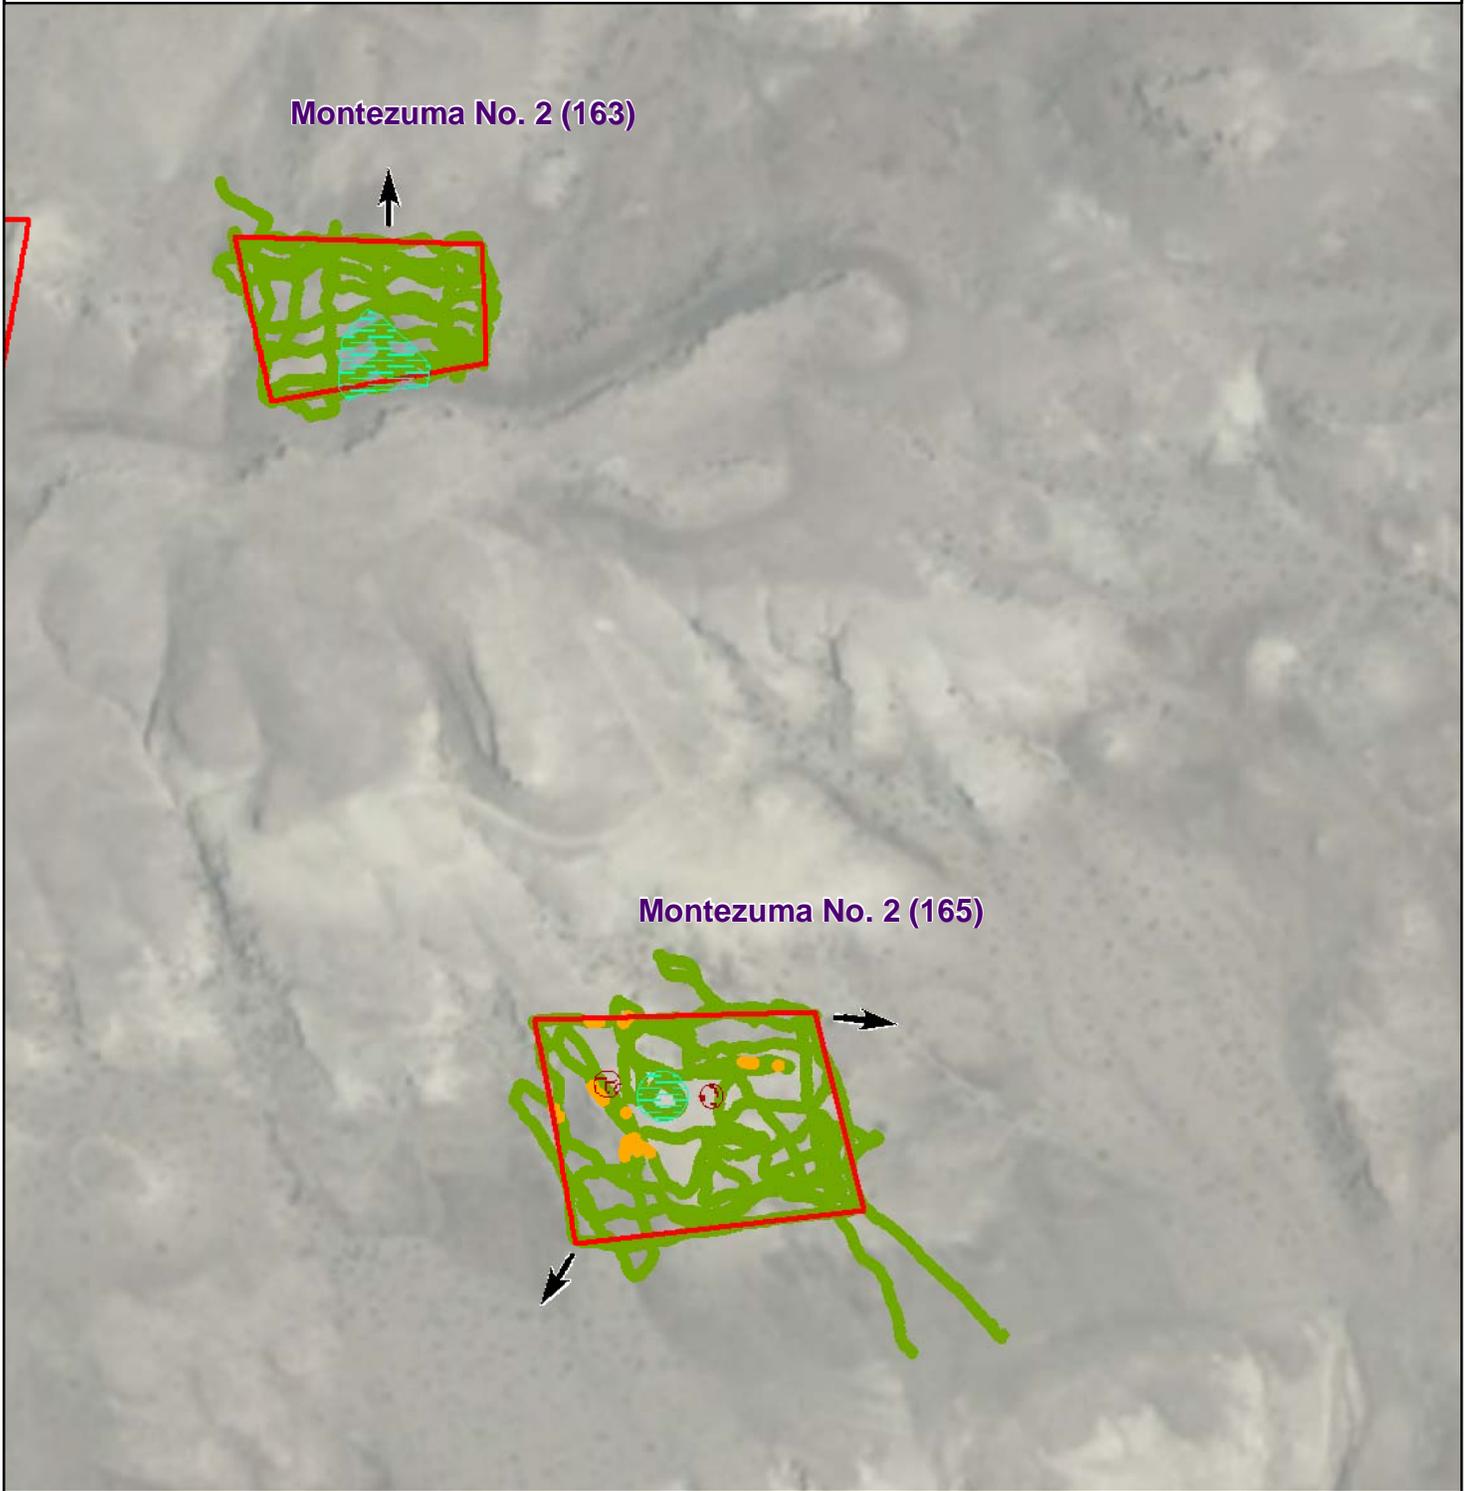
**Figure 3 - Gamma Radiation Measurements, Above Two Times Background
Montezuma No. 2 (163, 165)
Bodaway / Gap Chapter, Navajo Nation**

Average background 16,301 cpm

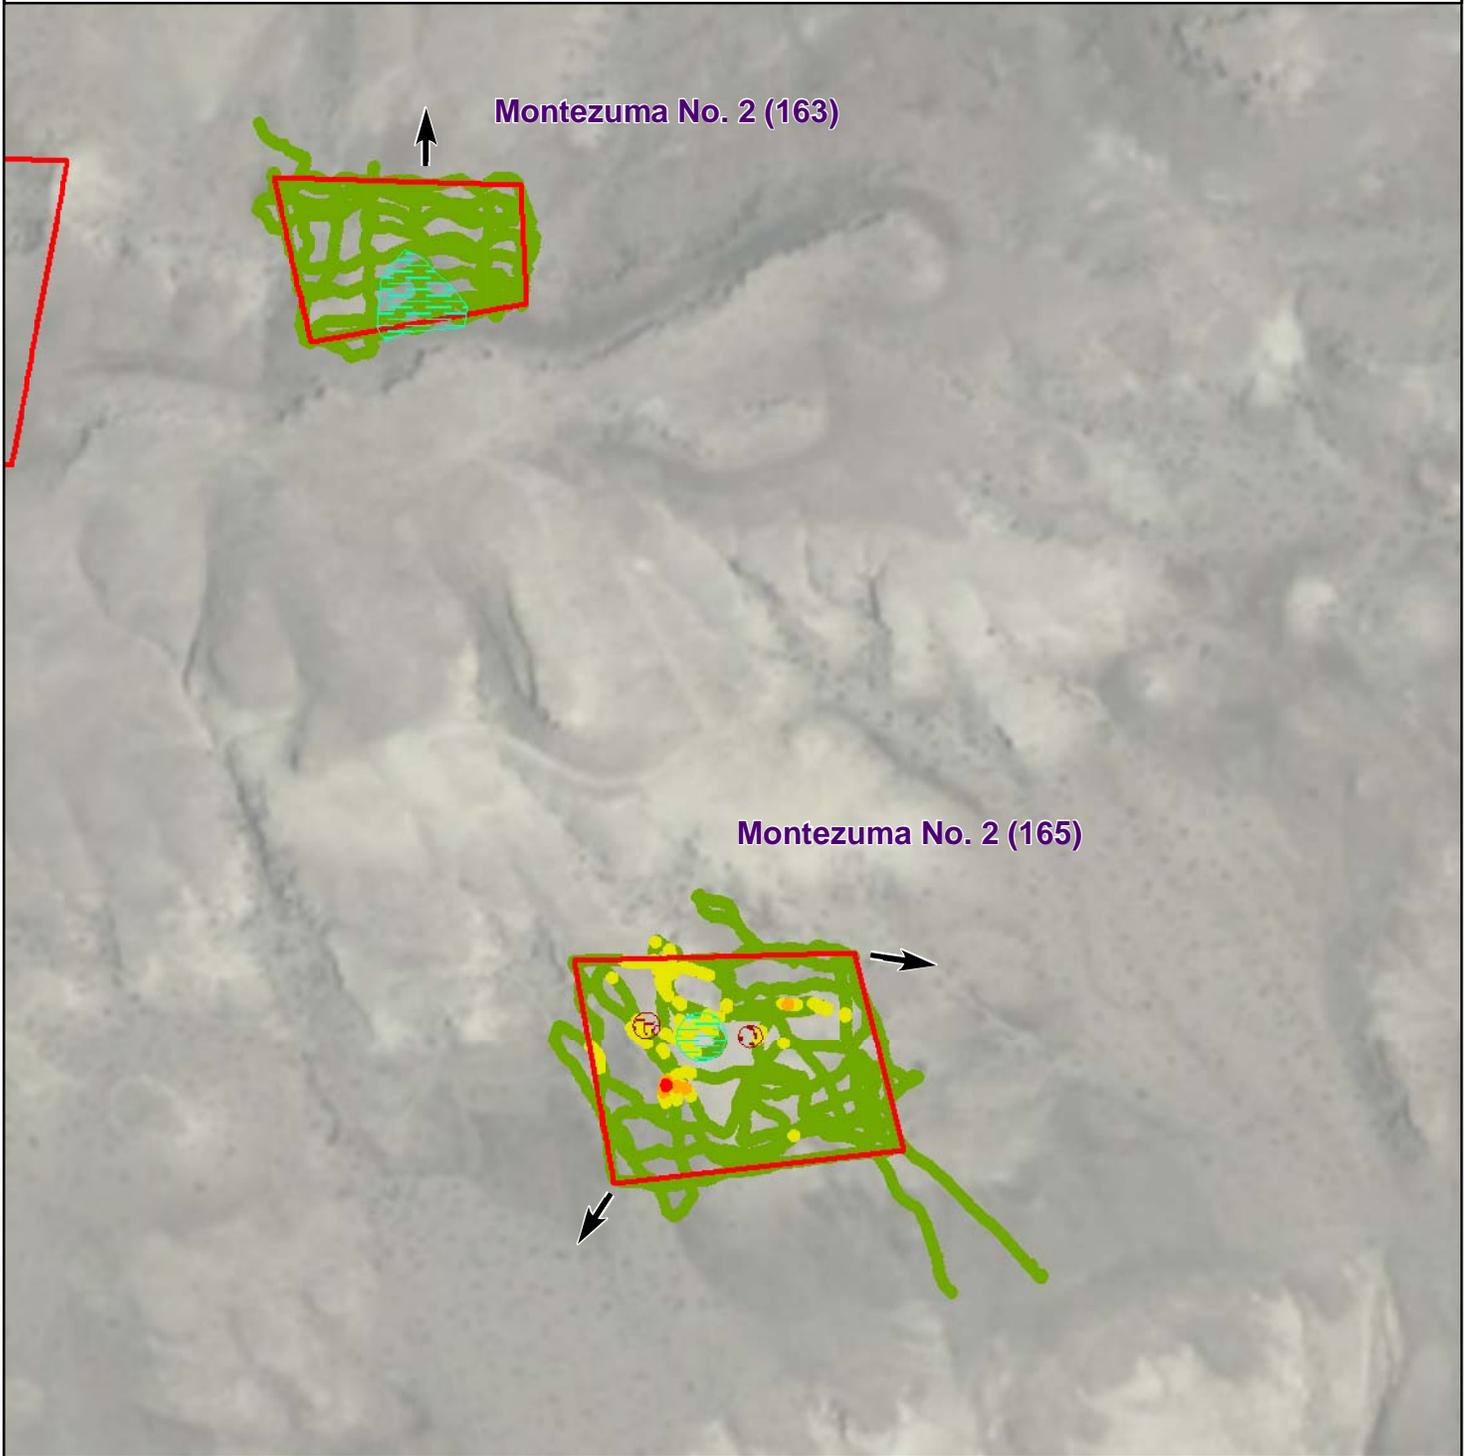
**Figure 4 - Gamma Radiation Measurements
Montezuma No. 2 (163, 165)
Bodaway / Gap Chapter, Navajo Nation**

Measured as counts per minute (cpm) Average background 16,301 cpm

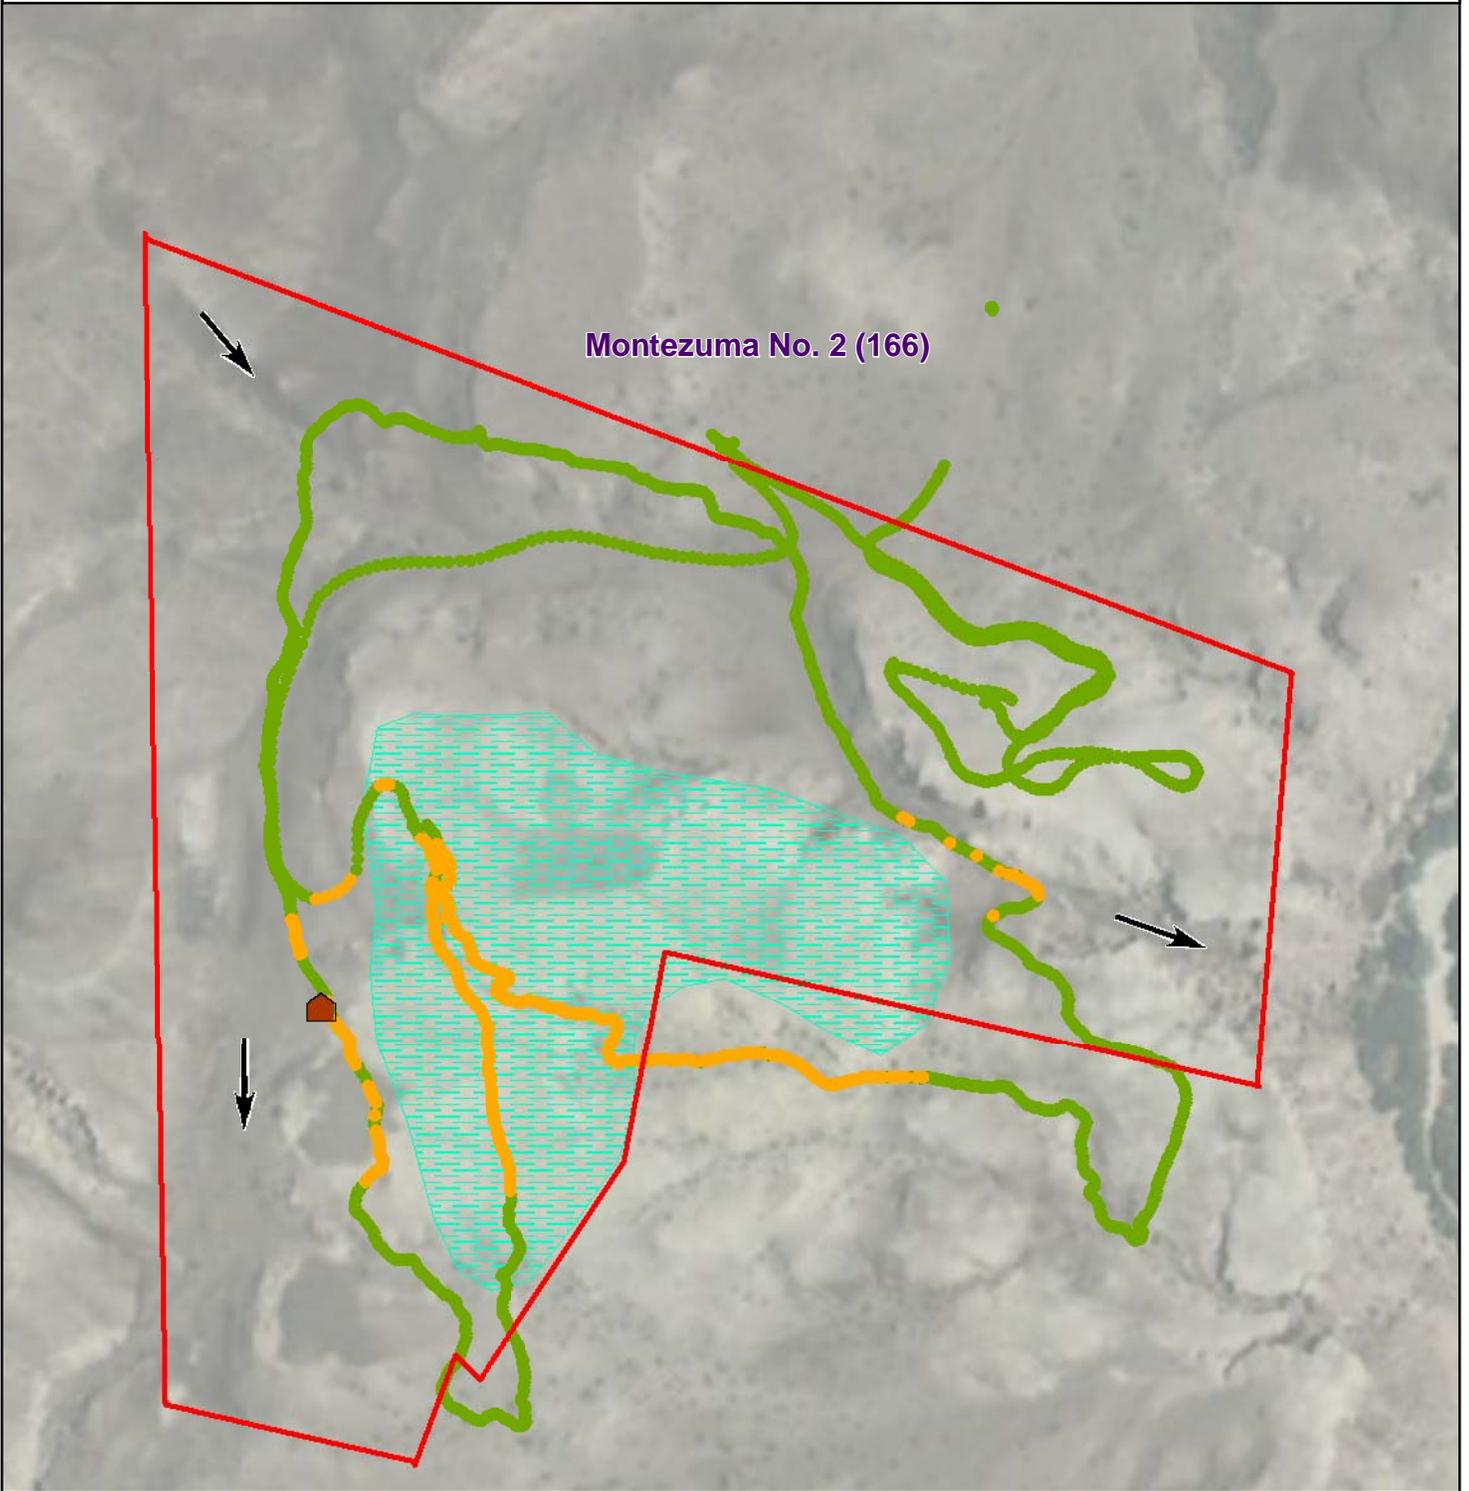
**Figure 5 - Gamma Radiation Measurements, Above Two Times Background
 Montezuma No. 2 (166)
 Bodaway / Gap Chapter, Navajo Nation**

Average background 10,746 cpm

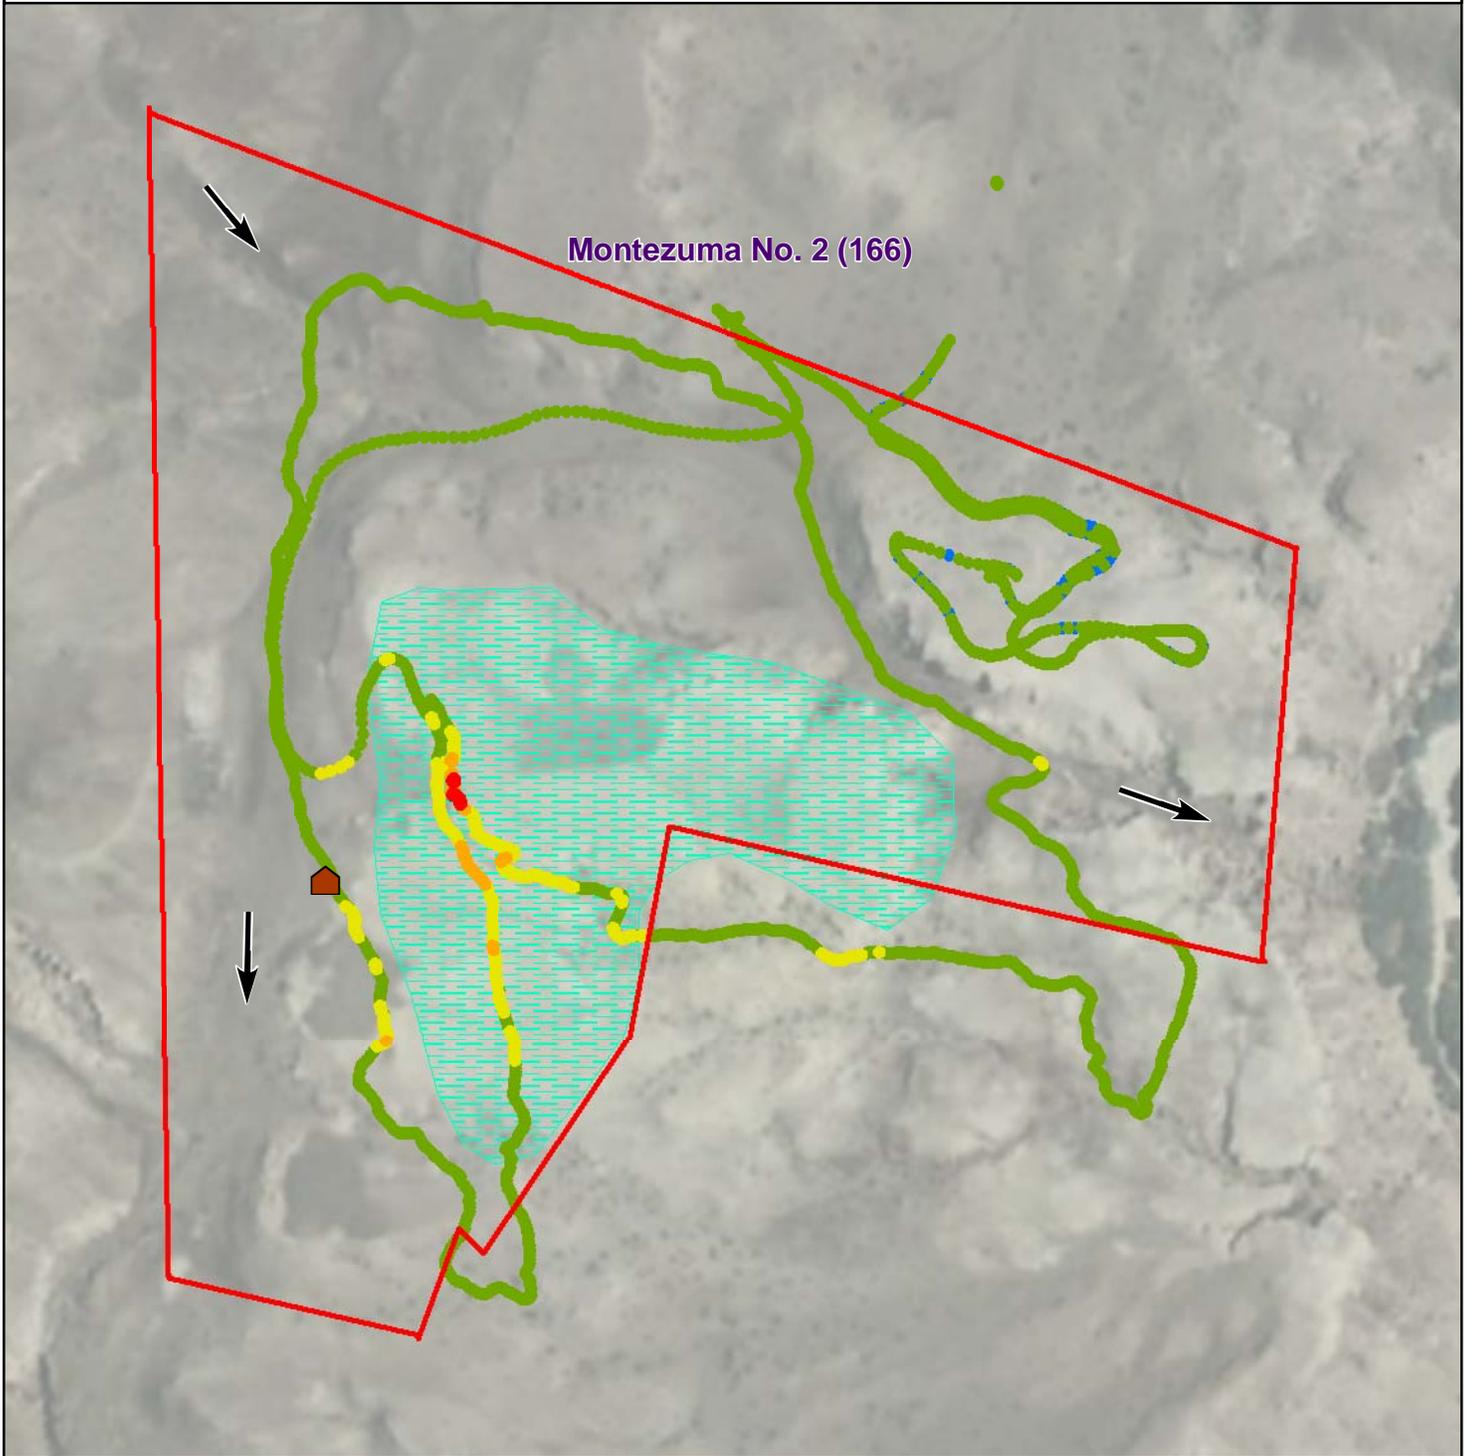
**Figure 6 - Gamma Radiation Measurements
Montezuma No. 2 (166)
Bodaway / Gap Chapter, Navajo Nation**

Measured as counts per minute (cpm) Average background 10,746 cpm
