# **Navajo Abandoned Uranium Mine**

## **Site Screen Report**

### **Charles Huskon No. 8 AUM Site**

**January 2011**

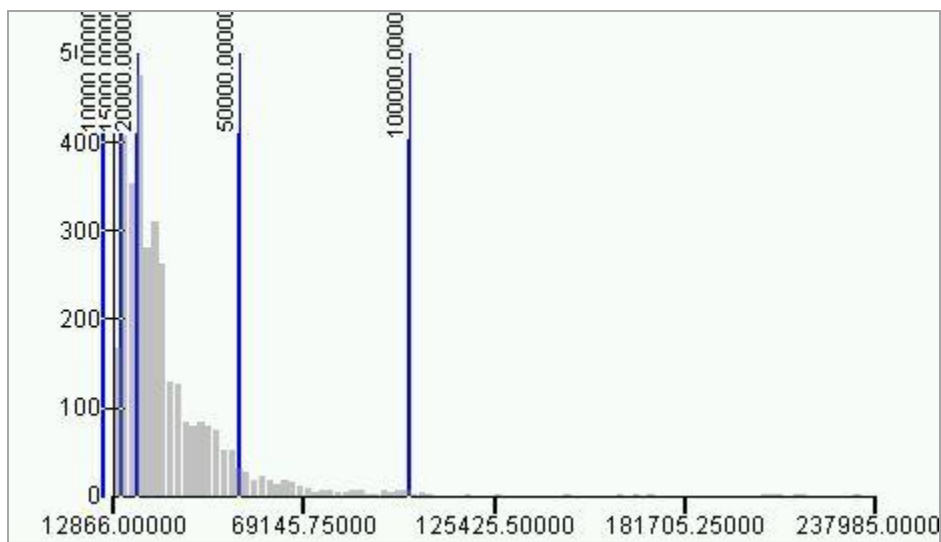
The following chart and statistics were generated by ESRI ArcGIS 9.3.1, and show the general distribution of the site gamma radiation measurements. The horizontal X axis represents the gamma radiation reading levels in cpm (lowest levels to the left). The vertical Y axis represents the frequency of each gamma radiation level.

Count:	3315
Minimum:	12866.00000
Maximum:	237985.00000
Sum:	100131366.00000
Mean:	30205.54027
Median:	23922.00000
Standard Deviation:	22478.62095

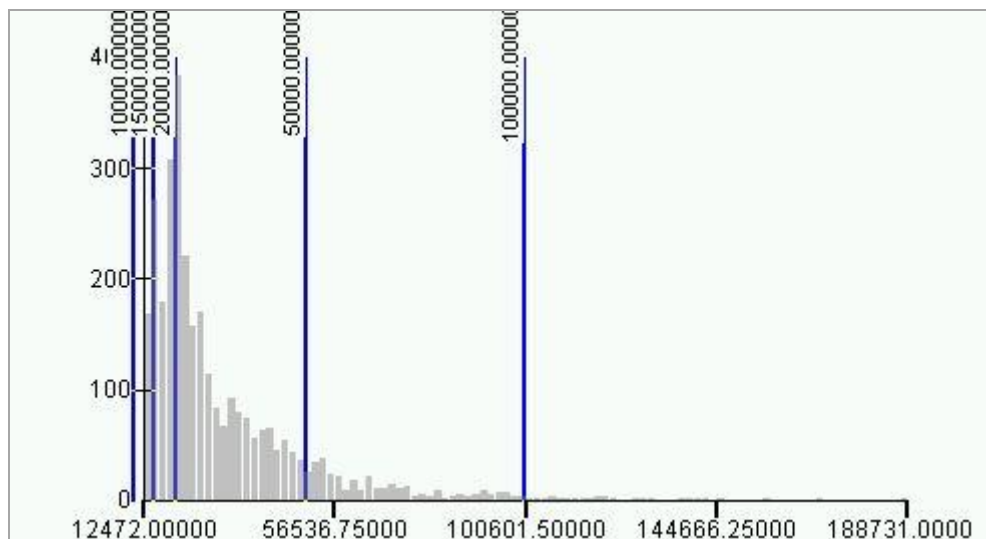
The following chart and statistics were generated by ESRI ArcGIS 9.3.1, and show the general distribution of the site gamma radiation measurements. The horizontal X axis represents the gamma radiation reading levels in cpm (lowest levels to the left). The vertical Y axis represents the frequency of each gamma radiation level.

Count:	3101
Minimum:	12472.00000
Maximum:	188731.00000
Sum:	93794260.00000
Mean:	30246.45598
Median:	23331.00000
Standard Deviation:	18879.81613

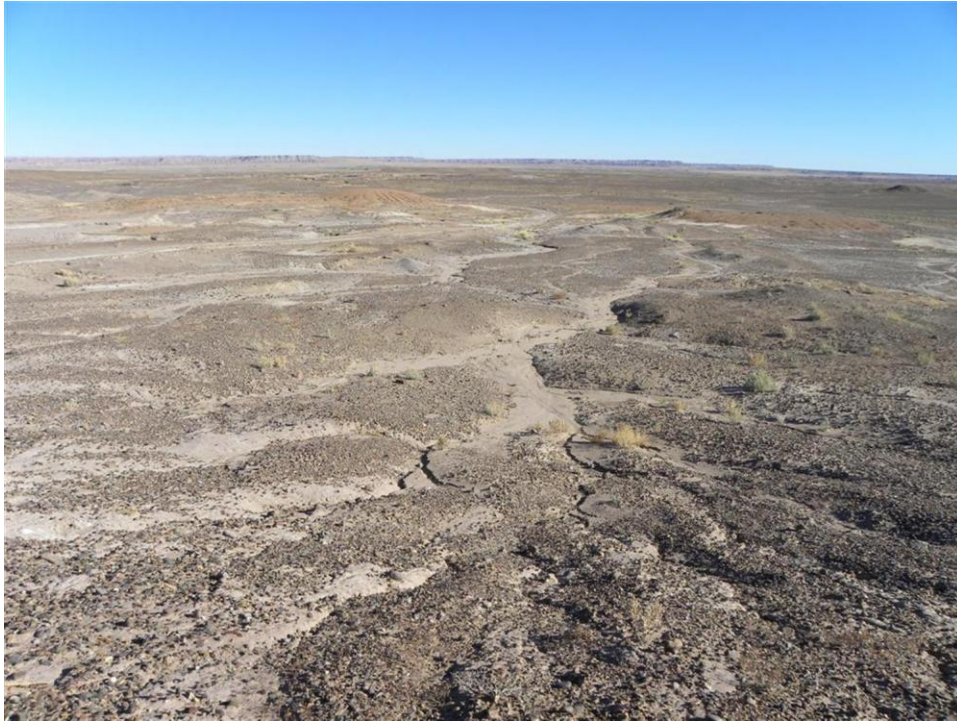
Photo 1. Charles Huskon No. 8, Site #167

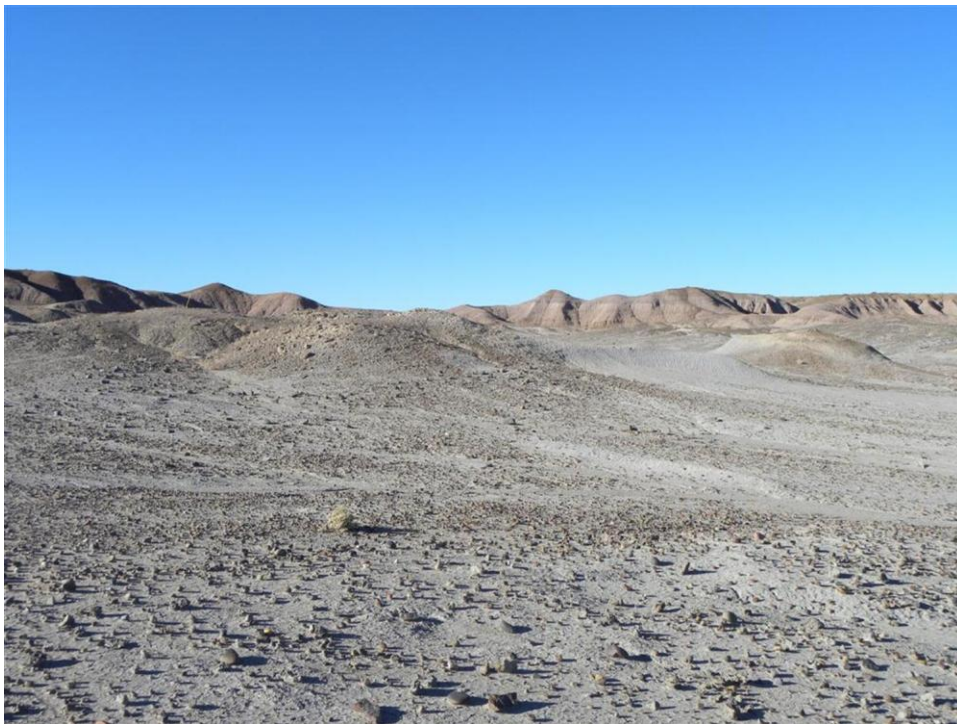
3 reclamation caps: 250' x 100 x 15' mound, red-brown sandy clay; 100' x 80' x 2' high mound, red-brown sandy clay; 450' x 150' x 20' mound, red-brown clay

Photo 2. Charles Huskon No. 8, Site #167, reclamation area

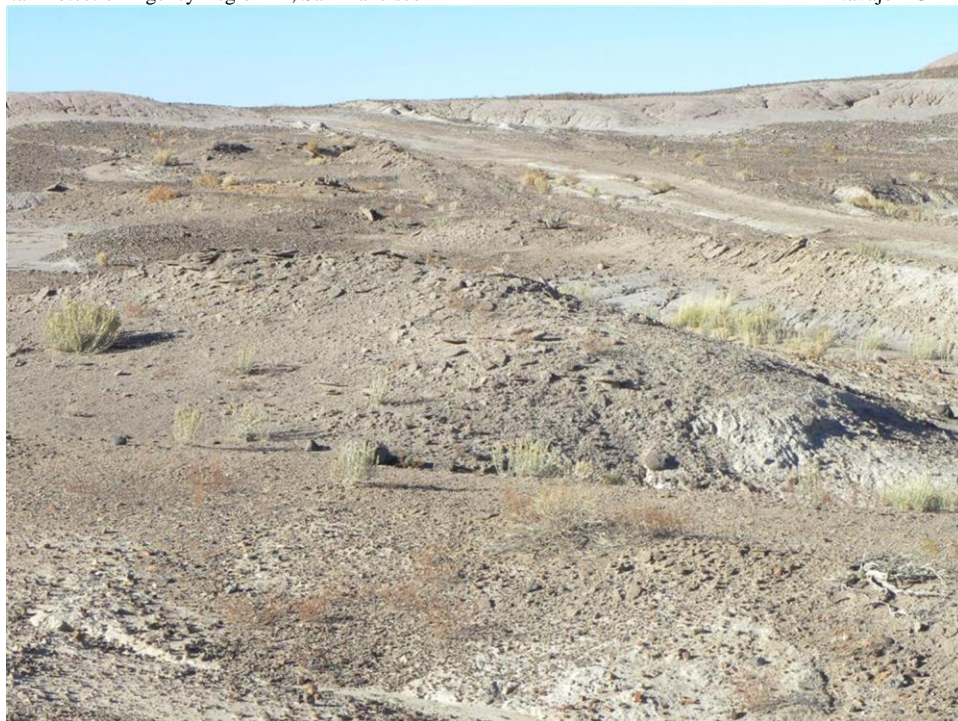
3 waste piles: 1 - 50' x 30' x 7' grey mound; 2 - 7' diameter x 2.5' high grey mound with rock markers; 3 - 25' x 10' x 12' grey/tan mound at bottom of drainage beneath caps; N edge of reclamation cap exposed grey rock

Photo 3. Charles Huskon No. 8, Site #167, waste pile

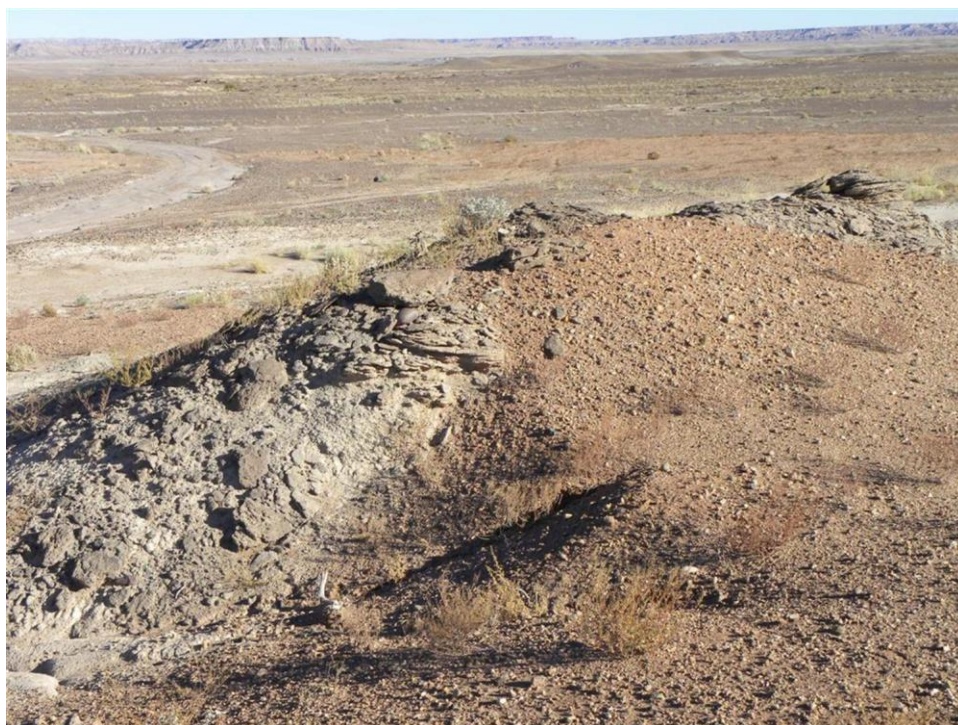
Photo 4. Charles Huskon No. 8, Site #167, waste pile

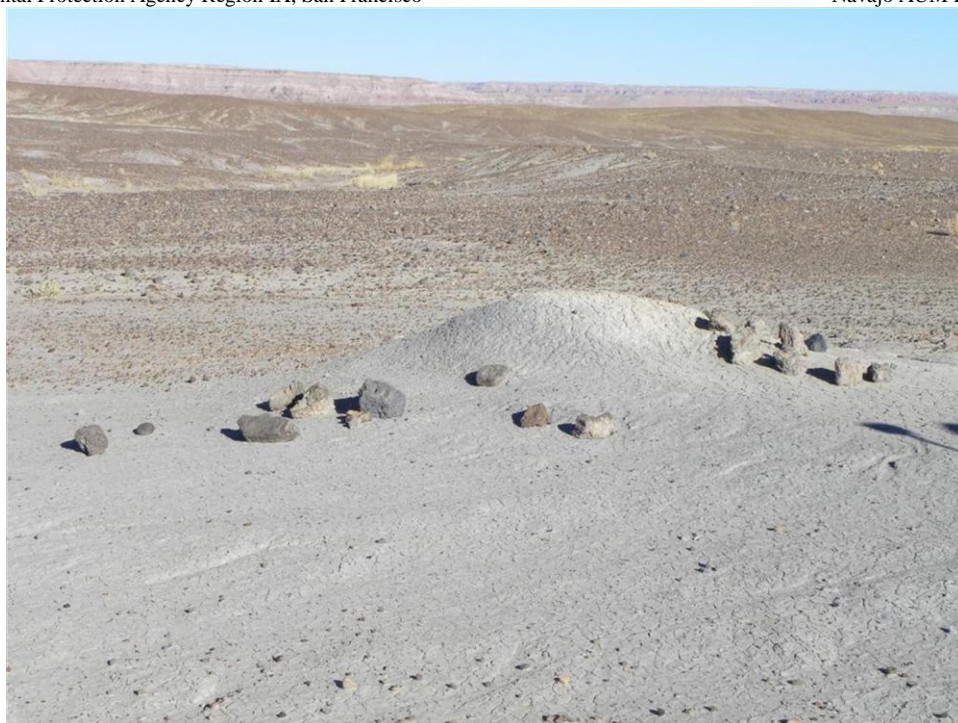
Photo 5. Charles Huskon No. 8, Site #167, mound

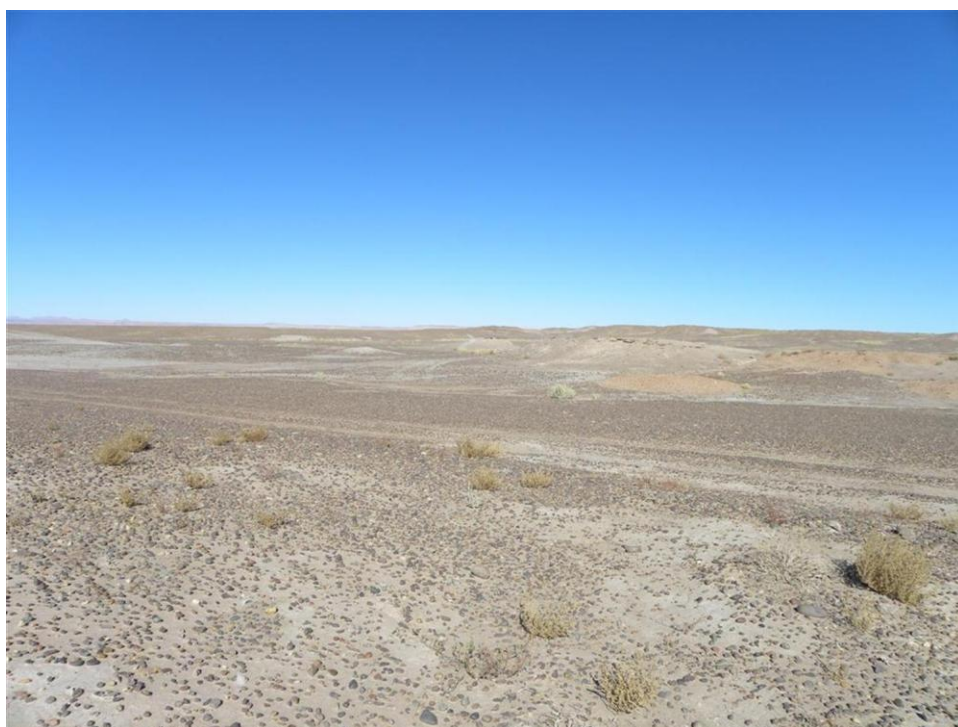
Photo 6. Charles Huskon No. 8, Site #168

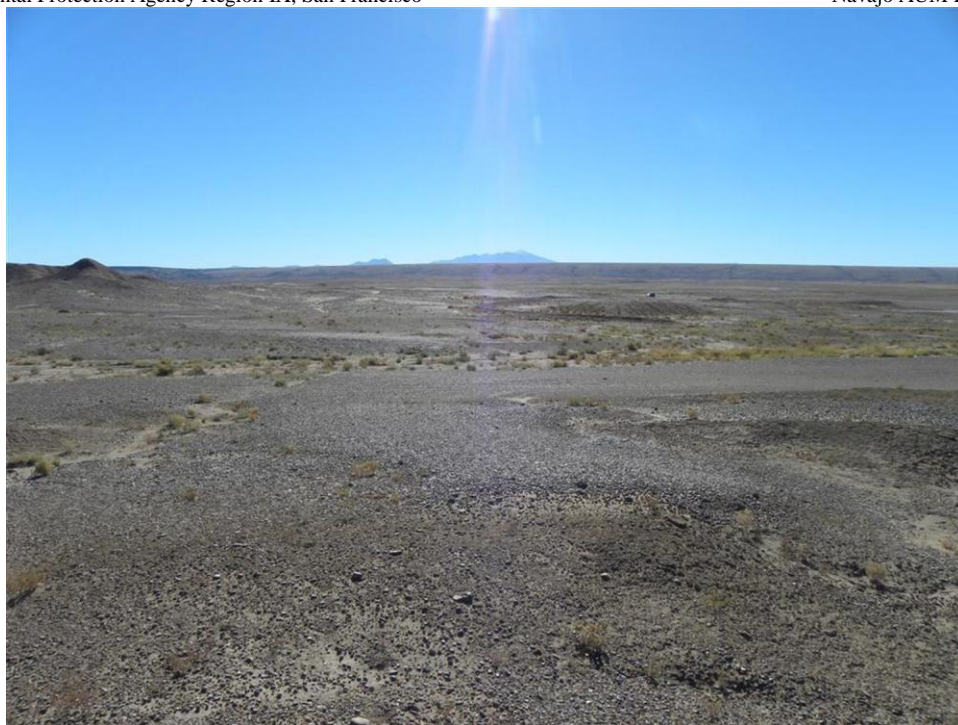
2 reclamation caps; cap 1 - large cap near offsite debris, clay with uniform rocks; 2 - possible pit area with crescent berm, sandy clay

Photo 7. Charles Huskon No. 8, Site #168, berm area

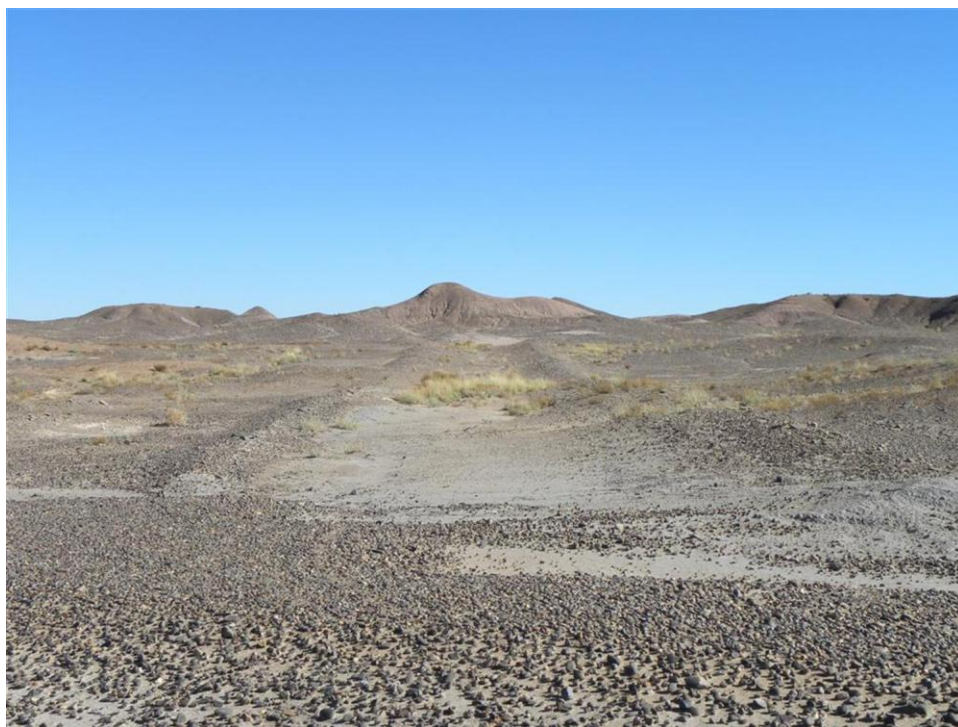
Photo 8. Charles Huskon No. 8, Site #168, berm/trench area

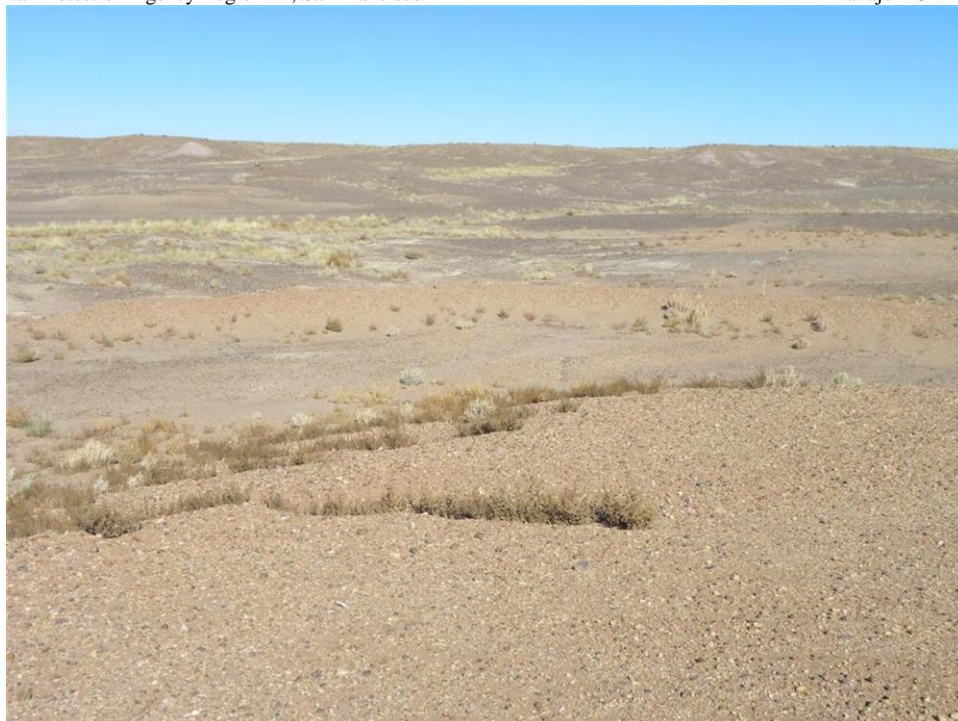
Photo 9. Charles Huskon No. 8, Site #168, berm area

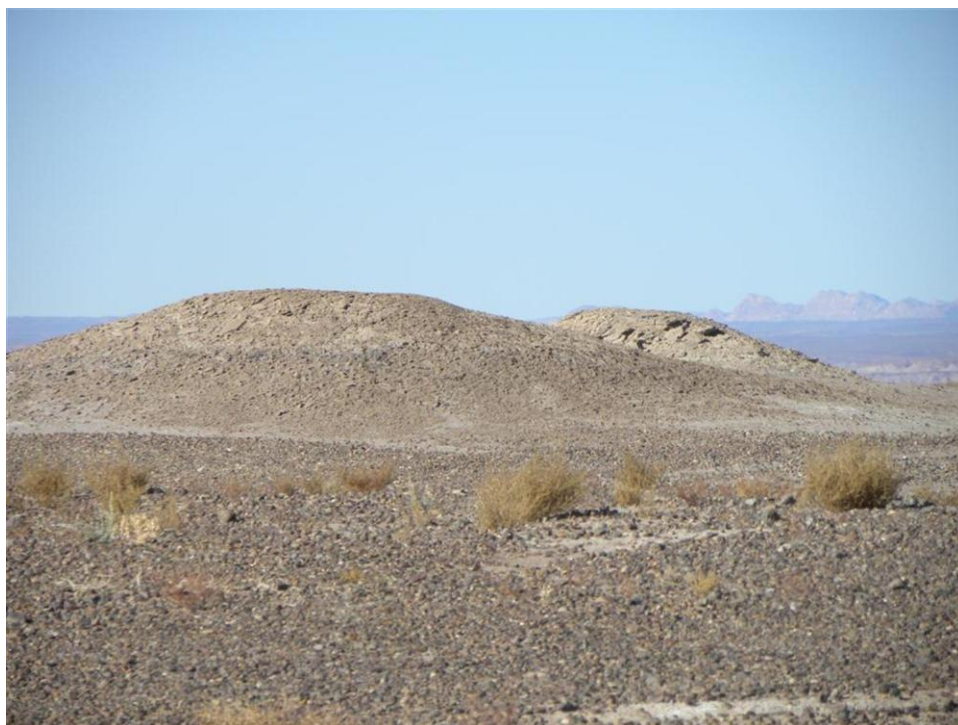
4 possible waste piles: 1 - offsite 30' diameter x 15' h mound; 2 - 30' diameter x 15' h mound; 3 - 30' x 10' x 4' grey mound; 4 - 45' x 15' x 8' grey mound

Photo 10. Charles Huskon No. 8, Site #168, possible waste piles

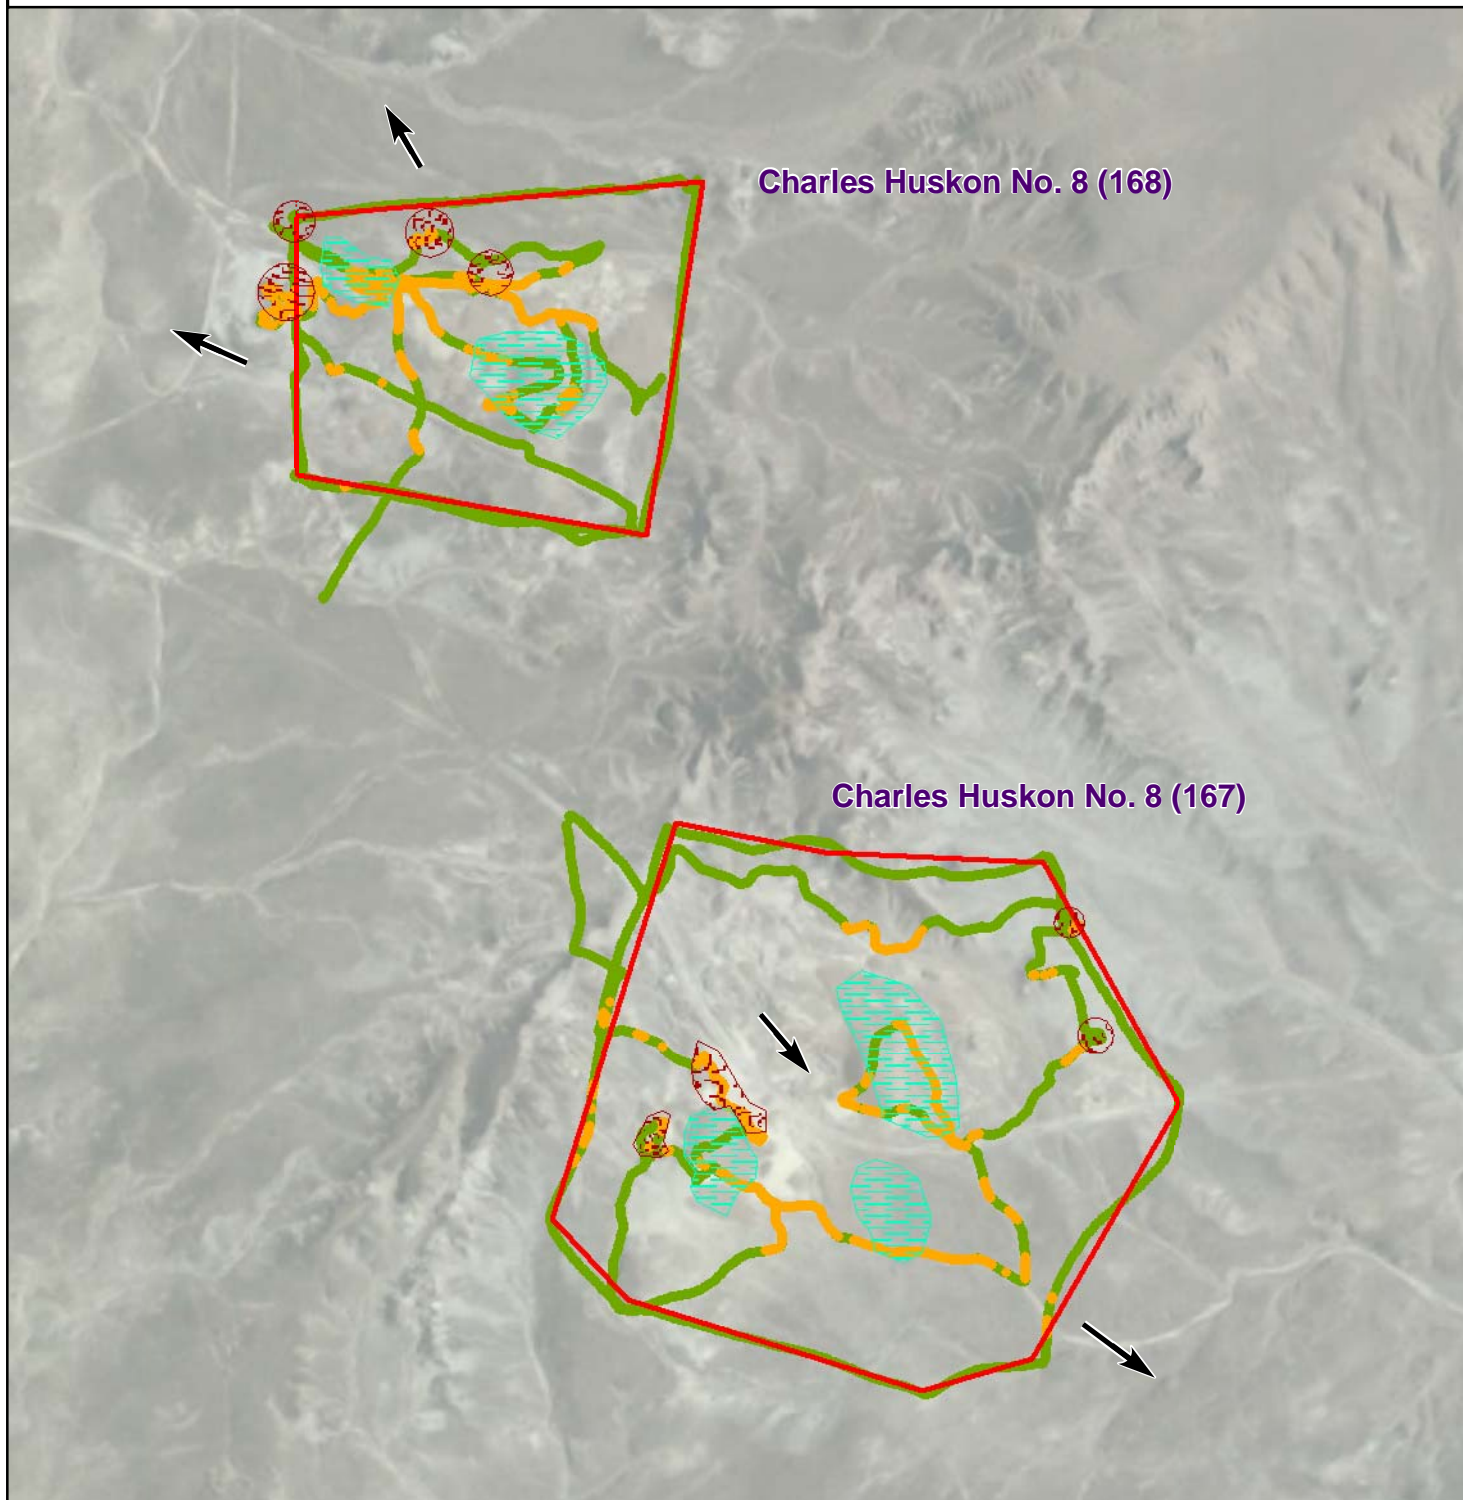
**Figure 1 - Gamma Radiation Measurements, Above Two Times Background  
Charles Huskon No. 8 (167, 168)  
Cameron Chapter, Navajo Nation**

A total of 3,315 gamma radiation measurements were collected from the mine site, ranging from 12,866 cpm to 237,985 cpm. The measurements collected at the waste piles were found at maximum levels ranging from approximately 100,000 cpm to 240,000 cpm, and at the reclamation caps at maximum levels ranging from approximately 25,000 cpm to 100,000 cpm. The measurements are represented in Figures 1 and 2.

Gamma survey conducted 11/2010  
Measured as counts per minute (cpm)

Average background 17,751 cpm
