# Navajo Abandoned Uranium Mine

## Site Screen Report

**Mine Name: A & B No. 5**  
**Mine ID: 171**

**August 2011**

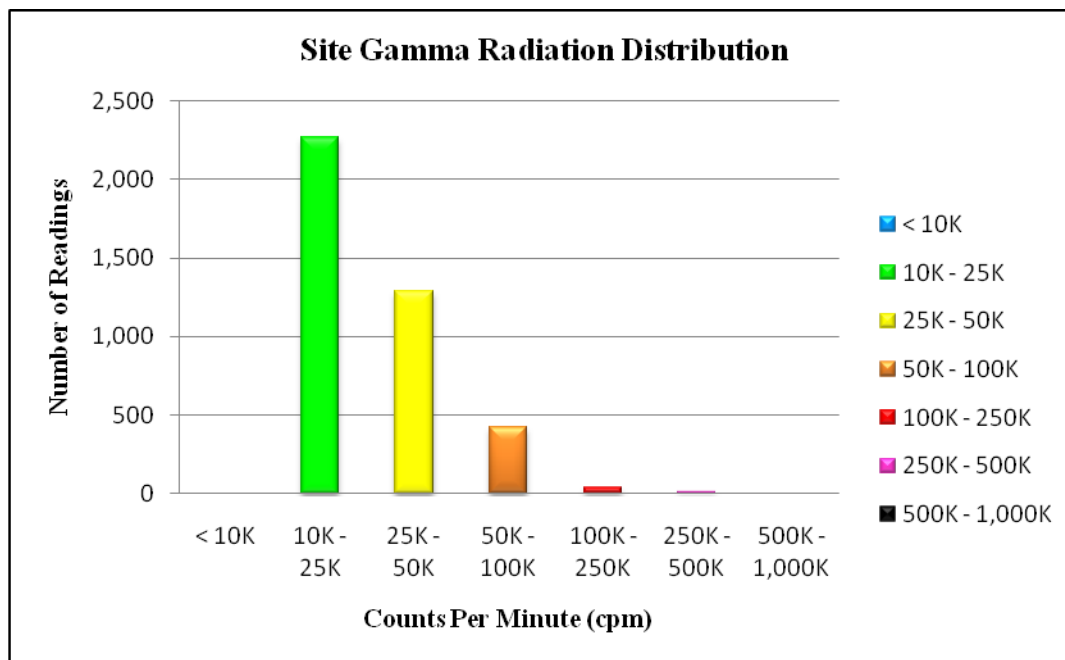
**Distribution Chart and Statistics:**

<b>Site Gamma Radiation Statistics</b>	
Number of Readings	4,027
Minimum (cpm)	12,889
Maximum (cpm)	458,658
Mean (cpm)	31,582
Median (cpm)	23,526
Standard Deviation	24,856

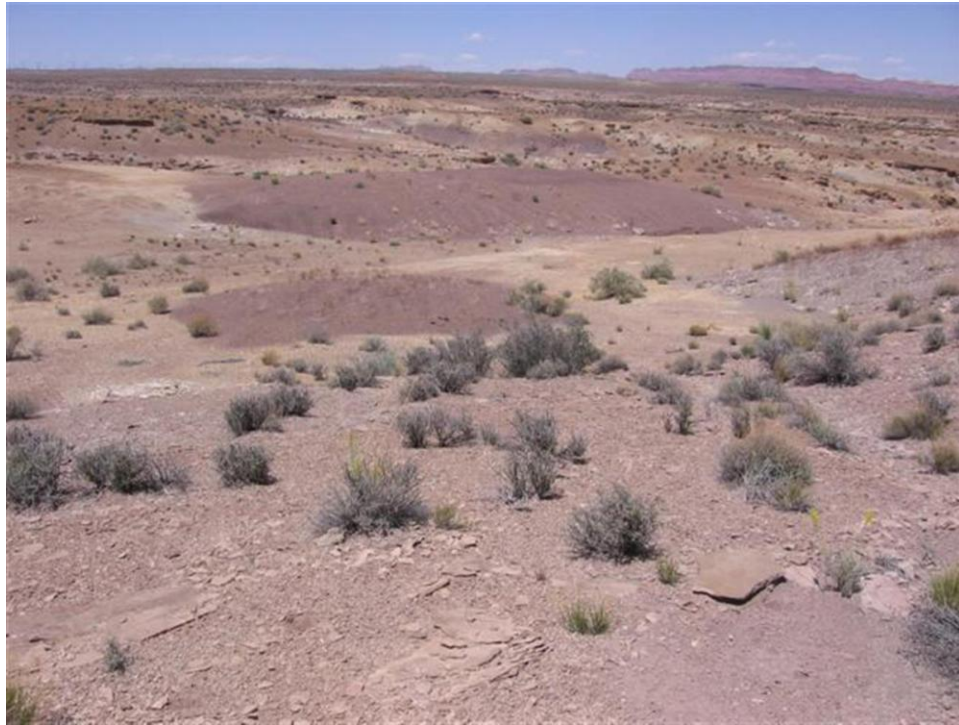
**Photo 1:** Mine Site #171; Reclamation areas

4 reclamation caps surrounding open pit area: Cap 1 - 90' dia; Cap 2 - 150'x100'x6'; Cap 3 - 60'x40' x4'; Cap 4 - 300'x150', northwest corner of site, small ridges running east to west

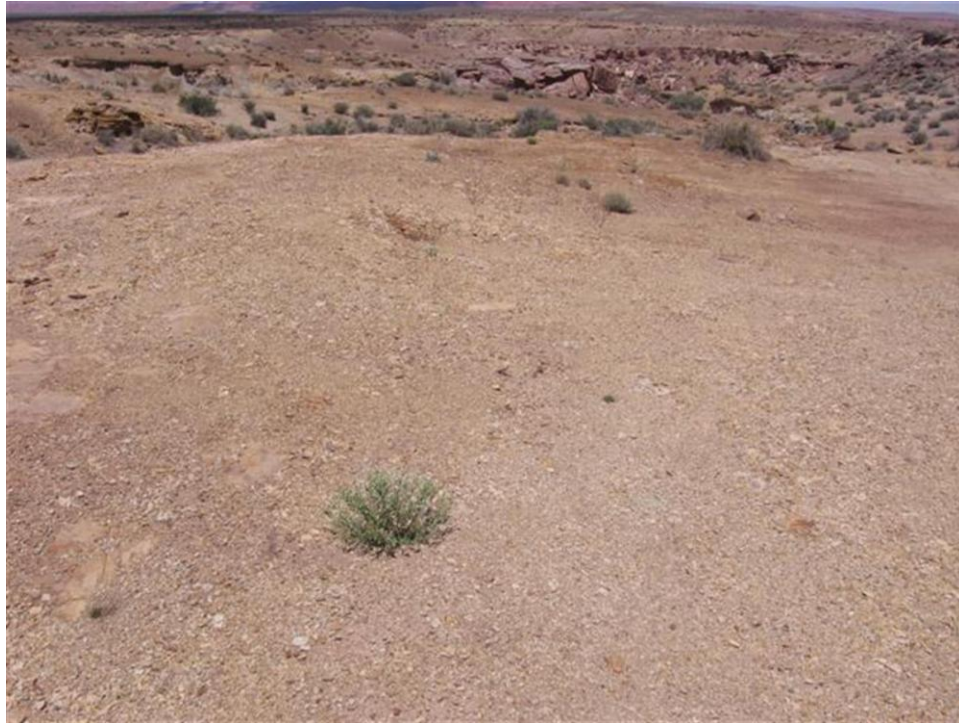
**Photo 2:** Mine Site #171; Former pit area

Open pit area, 200' x 80', tan-yellow gravel

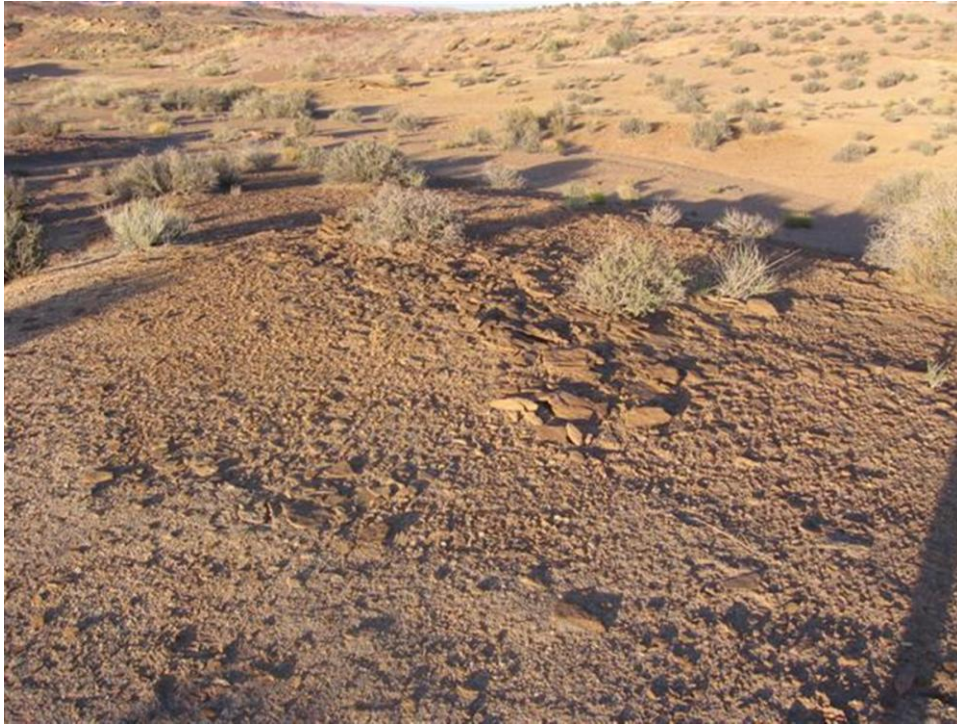
**Photo 3:** Mine Site #171; Waste pile

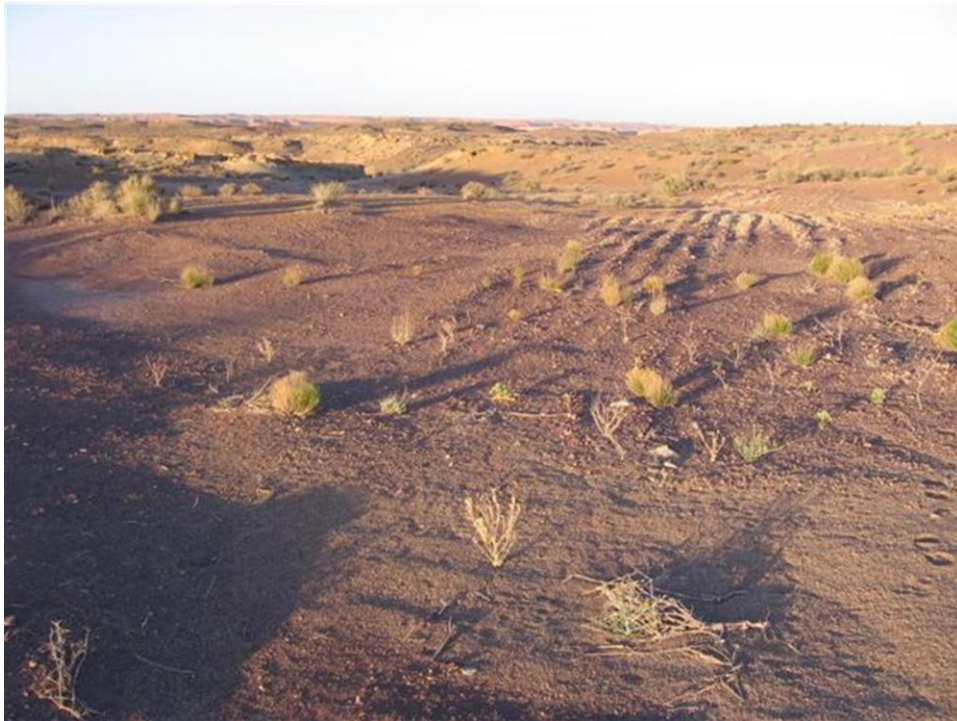
**Photo 4:** Mine Site #171; Reclamation area

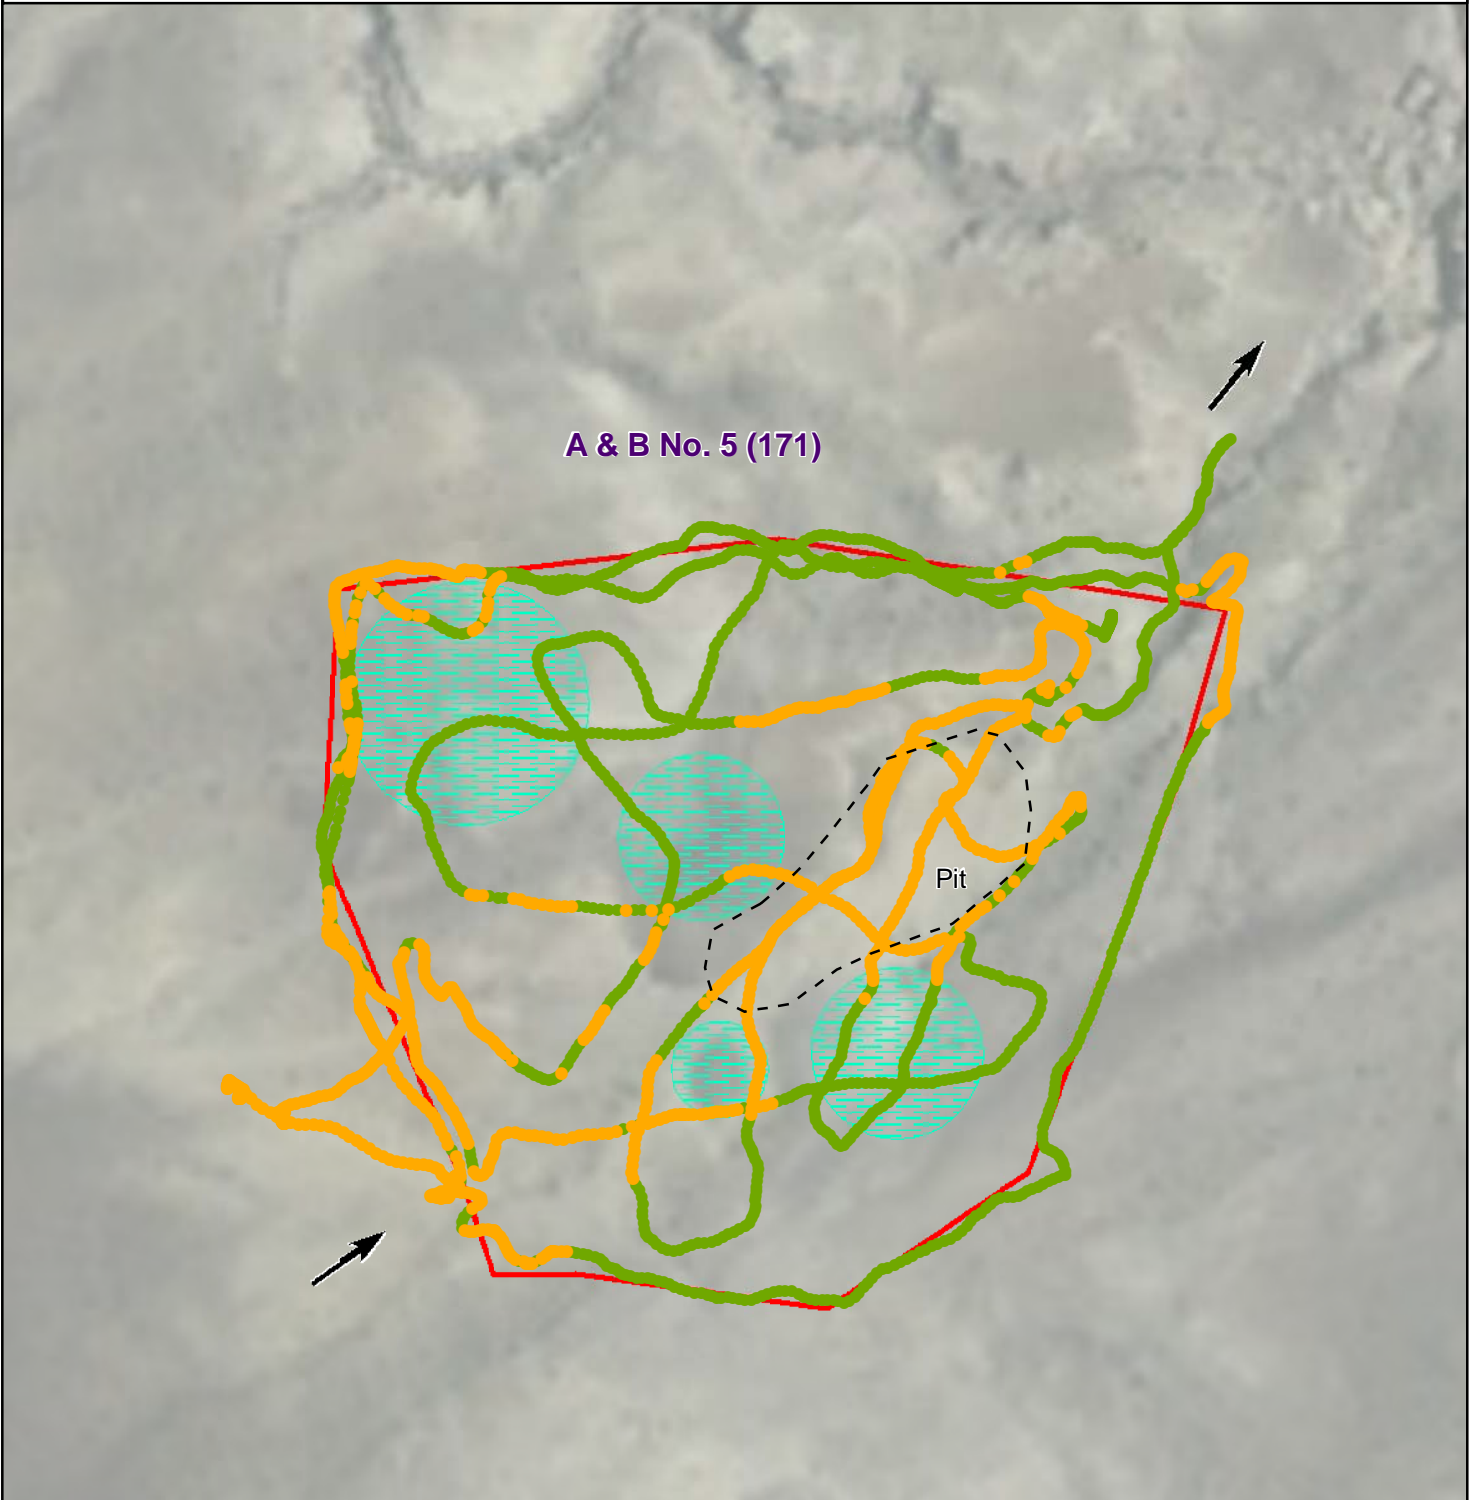
**Figure 1 - Gamma Radiation Measurements, Above Two Times Background  
A & B No. 5 (171)  
Bodaway / Gap Chapter, Navajo Nation**

Average background 15,031 cpm

A total of 4,027 gamma radiation measurements were collected from the mine site, ranging from 12,889 cpm to 458,658 cpm. Measurements collected in the vicinity of the pit area were found at a maximum level of approximately 450,000 cpm, and the reclamation areas of approximately 50,000 cpm. The measurements are represented in Figures 1 and 2.

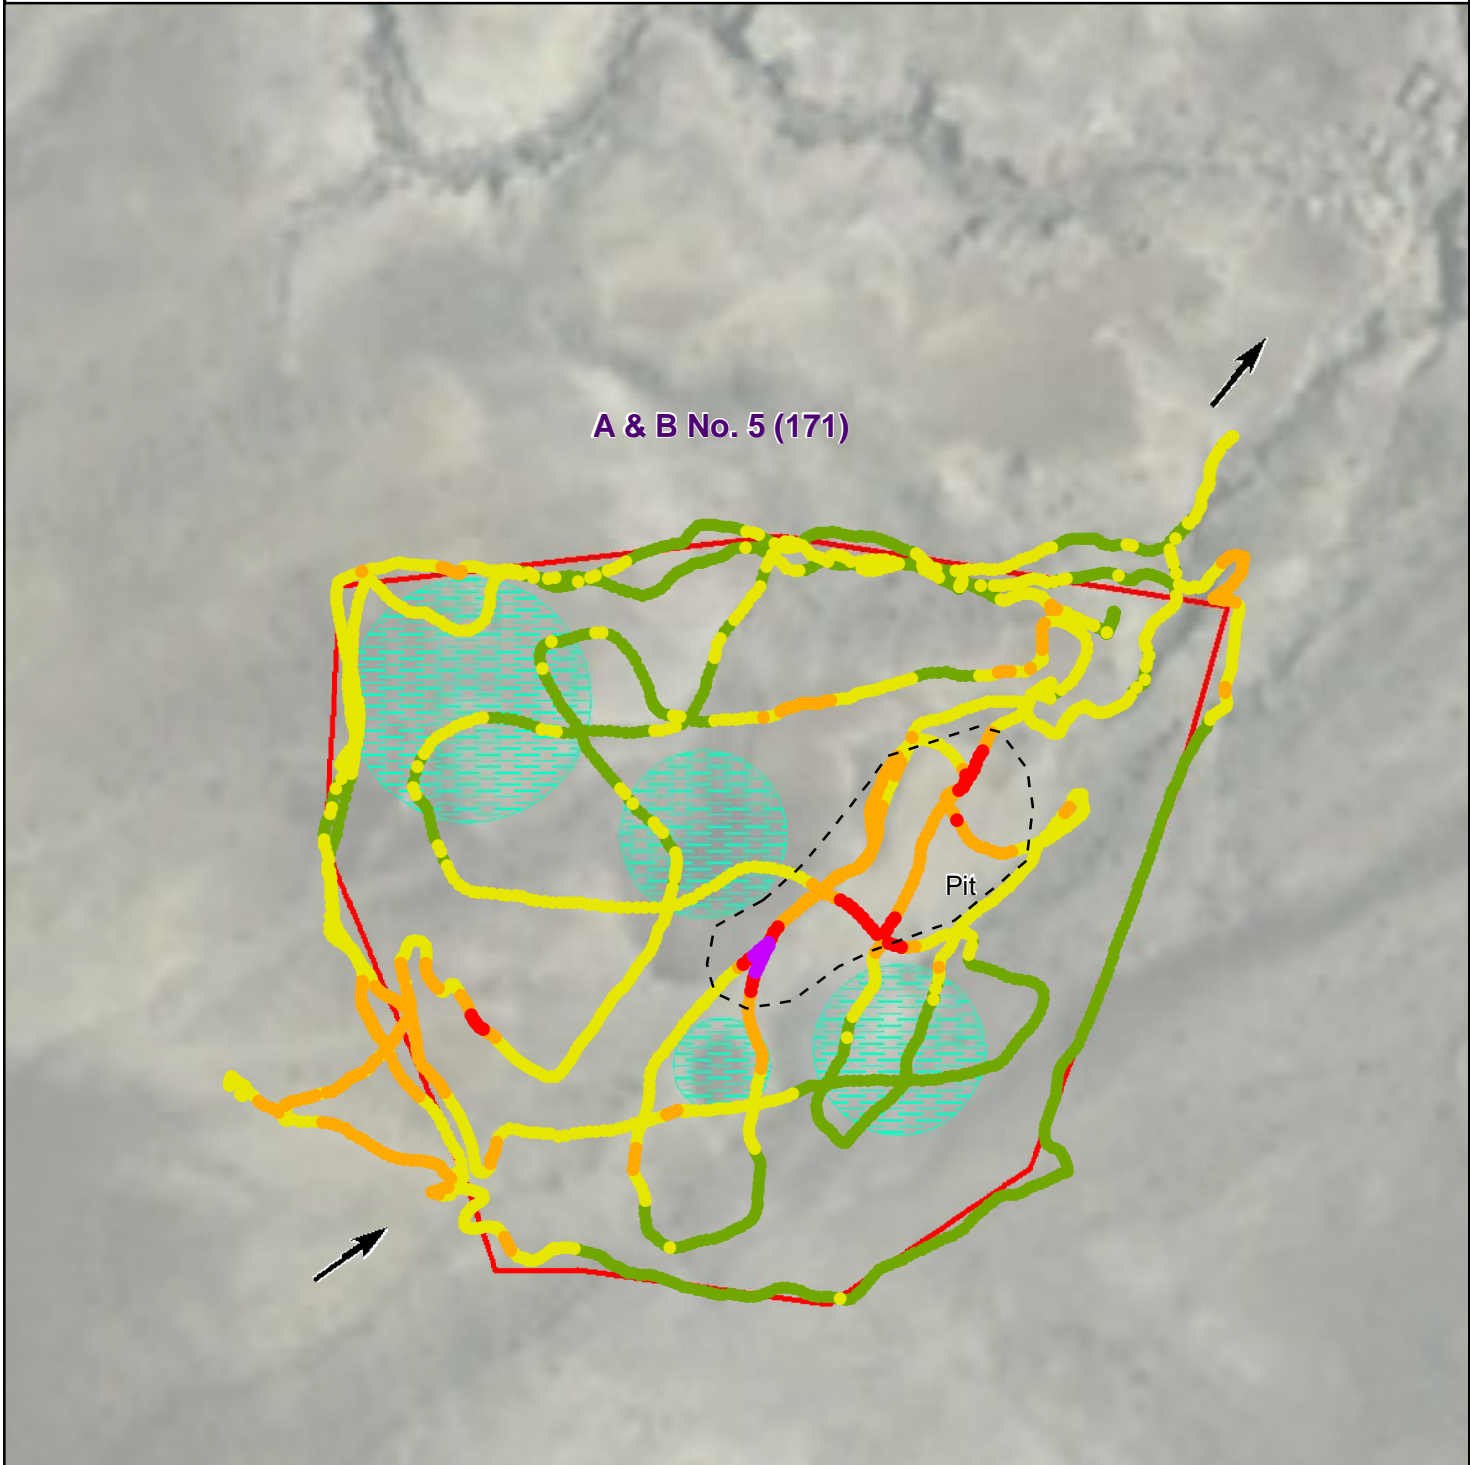
**Figure 2 - Gamma Radiation Measurements  
A & B No. 5 (171)  
Bodaway / Gap Chapter, Navajo Nation**

Measured as counts per minute (cpm) Average background 15,031 cpm
