Navajo Abandoned Uranium Mine

Site Screen Report

Mine Name: Earl Huskon No. 1
Mine ID: 178

Weston Solutions, Inc.

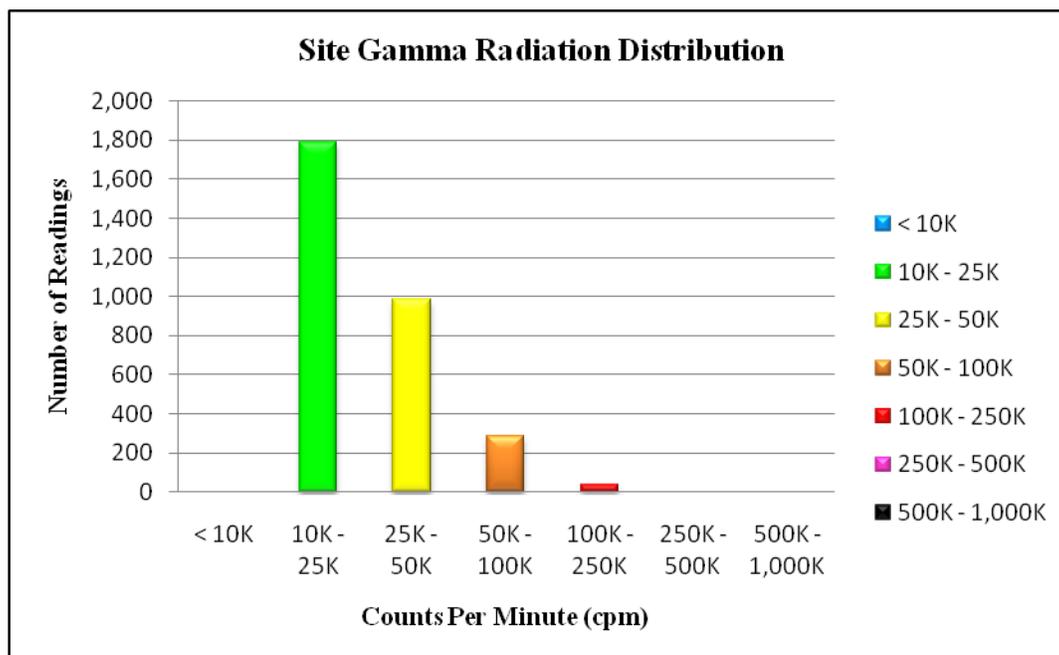
Distribution Chart and Statistics:

Site Gamma Radiation Statistics	
Number of Readings	3,098
Minimum (cpm)	10,897
Maximum (cpm)	224,505
Mean (cpm)	29,696
Median (cpm)	22,833
Standard Deviation	20,458

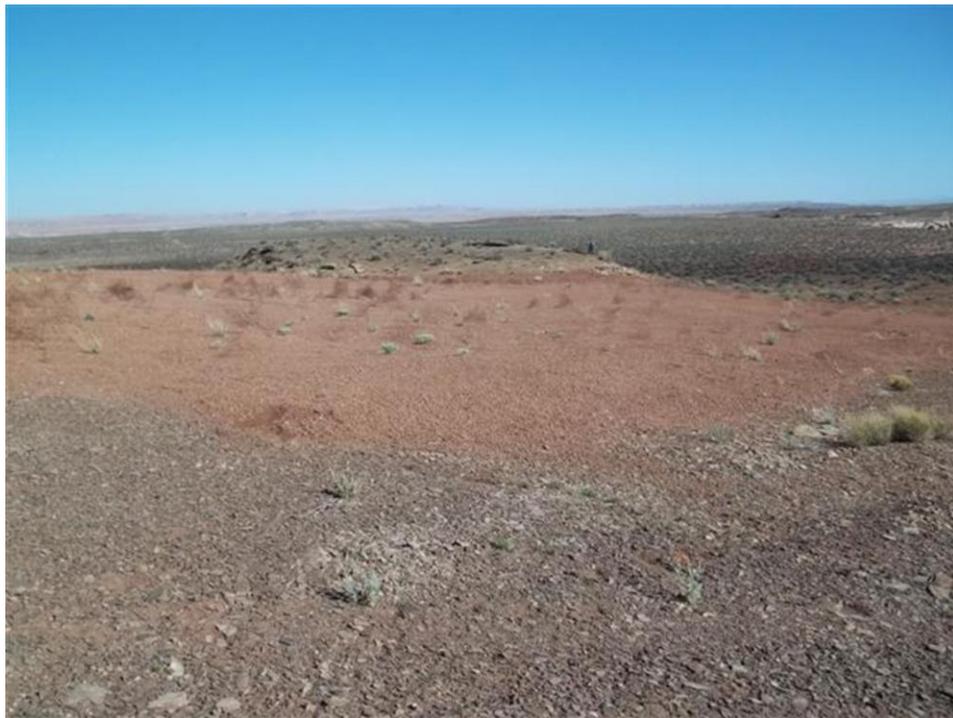
Photo 4: Mine Site #178; Reclamation area

No waste rock piles, but scattered waste rock found along side of reclamation cap

Reclamation cap in central portion of site

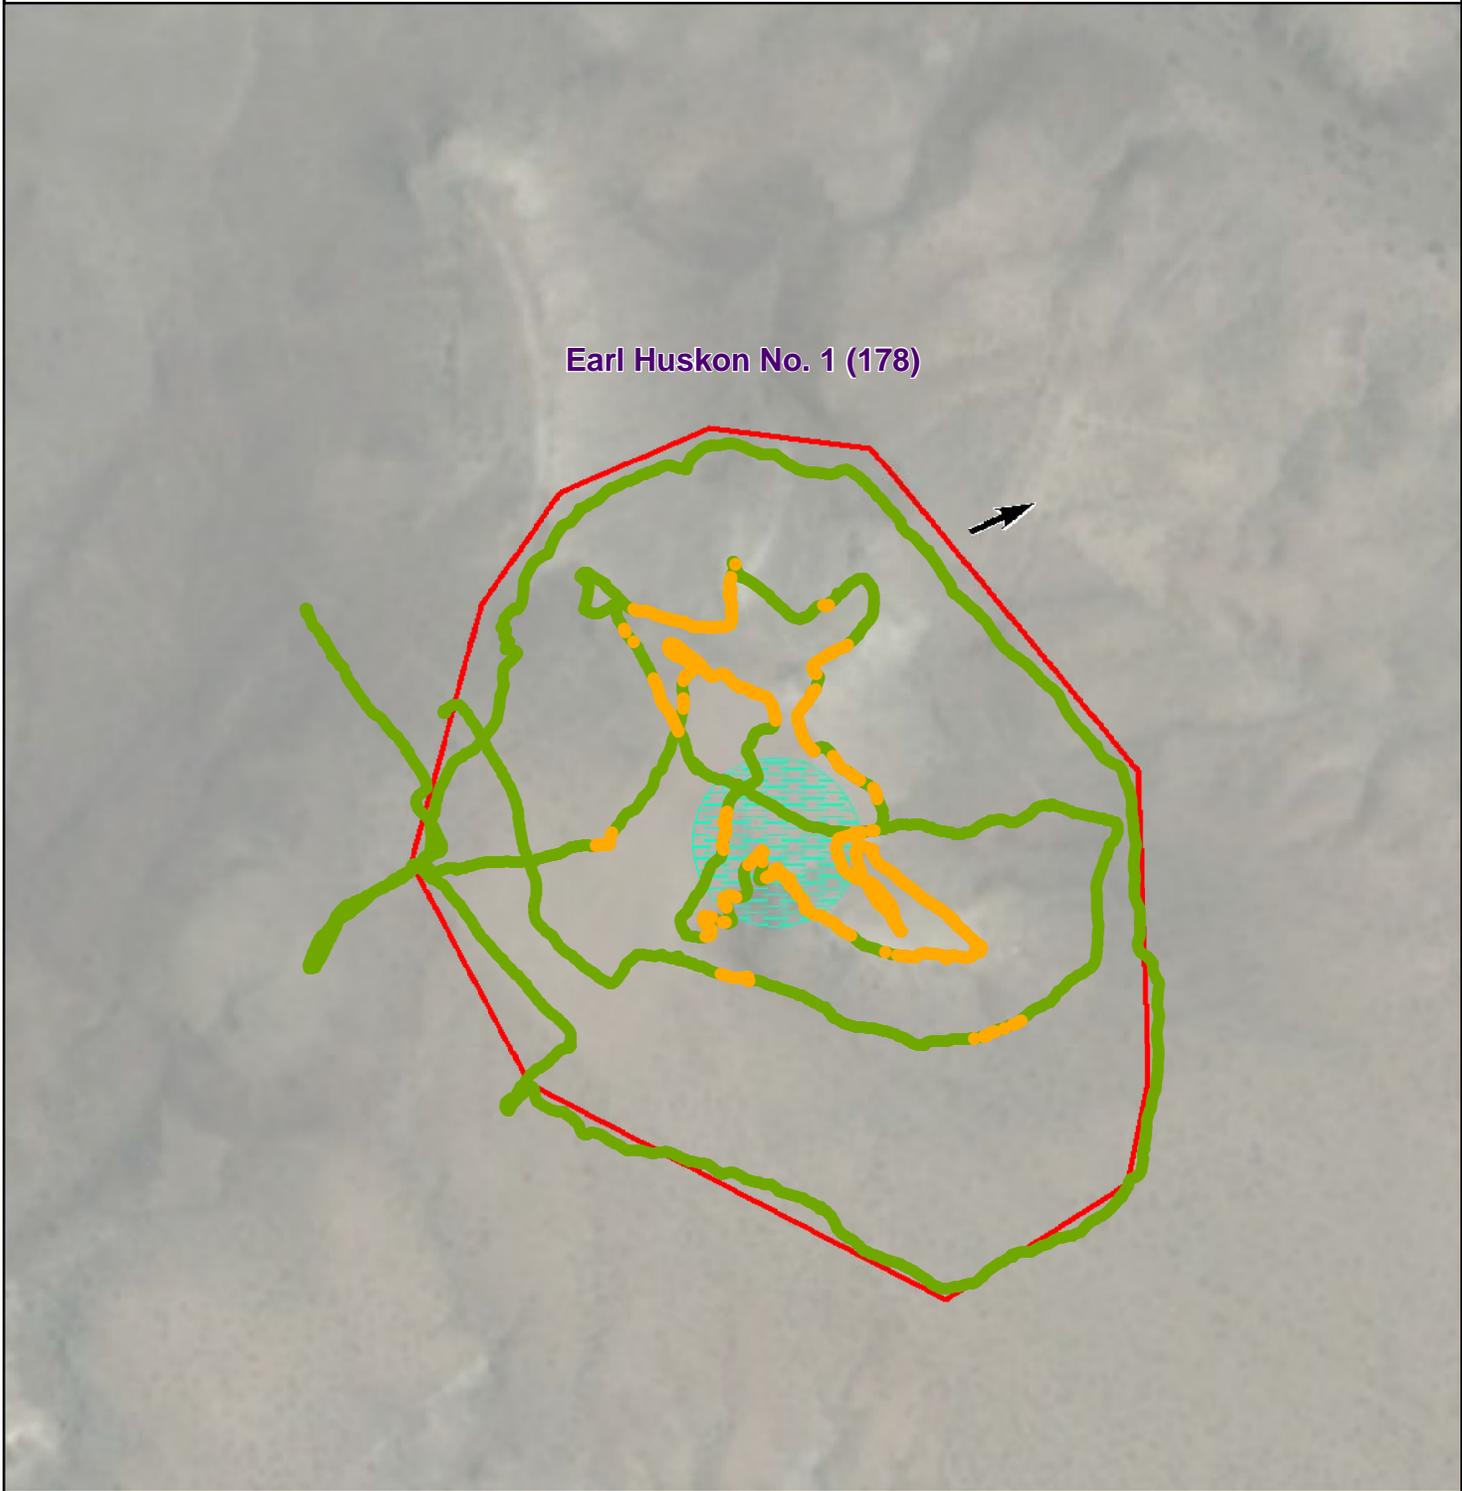
**Figure 1 - Gamma Radiation Measurements, Above Two Times Background
Earl Huskon No. 1 (178)
Bodayay / Gap Chapter, Navajo Nation**

A total of 3,098 gamma radiation measurements were collected from the mine site, ranging from 10,897 cpm to 224,505 cpm. Measurements collected in the vicinity of the waste rock were found at a maximum level of approximately 225,000 cpm, and the reclamation area of approximately 70,000 cpm. The measurements are represented in Figures 1 and 2.
