# Navajo Abandoned Uranium Mine

## Site Screen Report

**Mine Name: Skyline Road**  
**Mine ID: 182**

**April 2012**

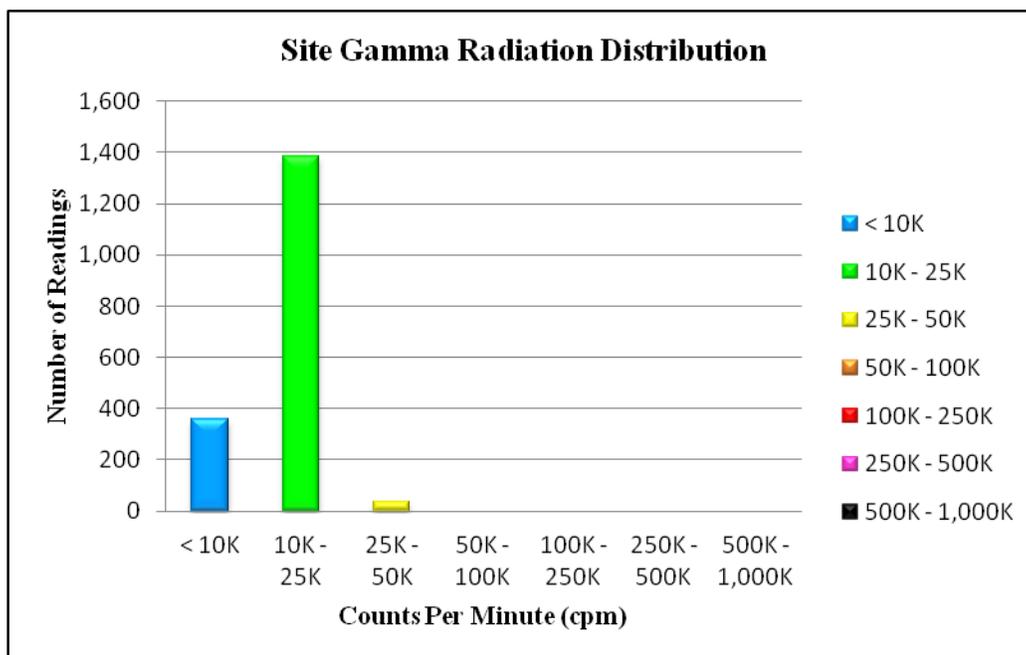
<b>Site Gamma Radiation Statistics</b>	
Number of Readings	1,781
Minimum (cpm)	5,292
Maximum (cpm)	29,847
Mean (cpm)	13,676
Median (cpm)	13,682
Standard Deviation	4,575

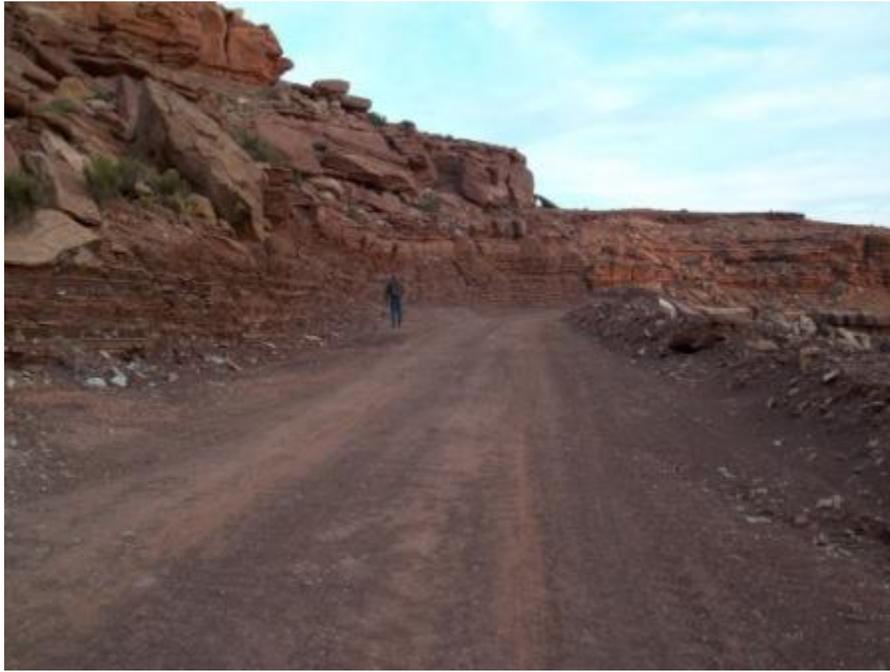
**Photo 1**

Mine Site #182 – Road through site

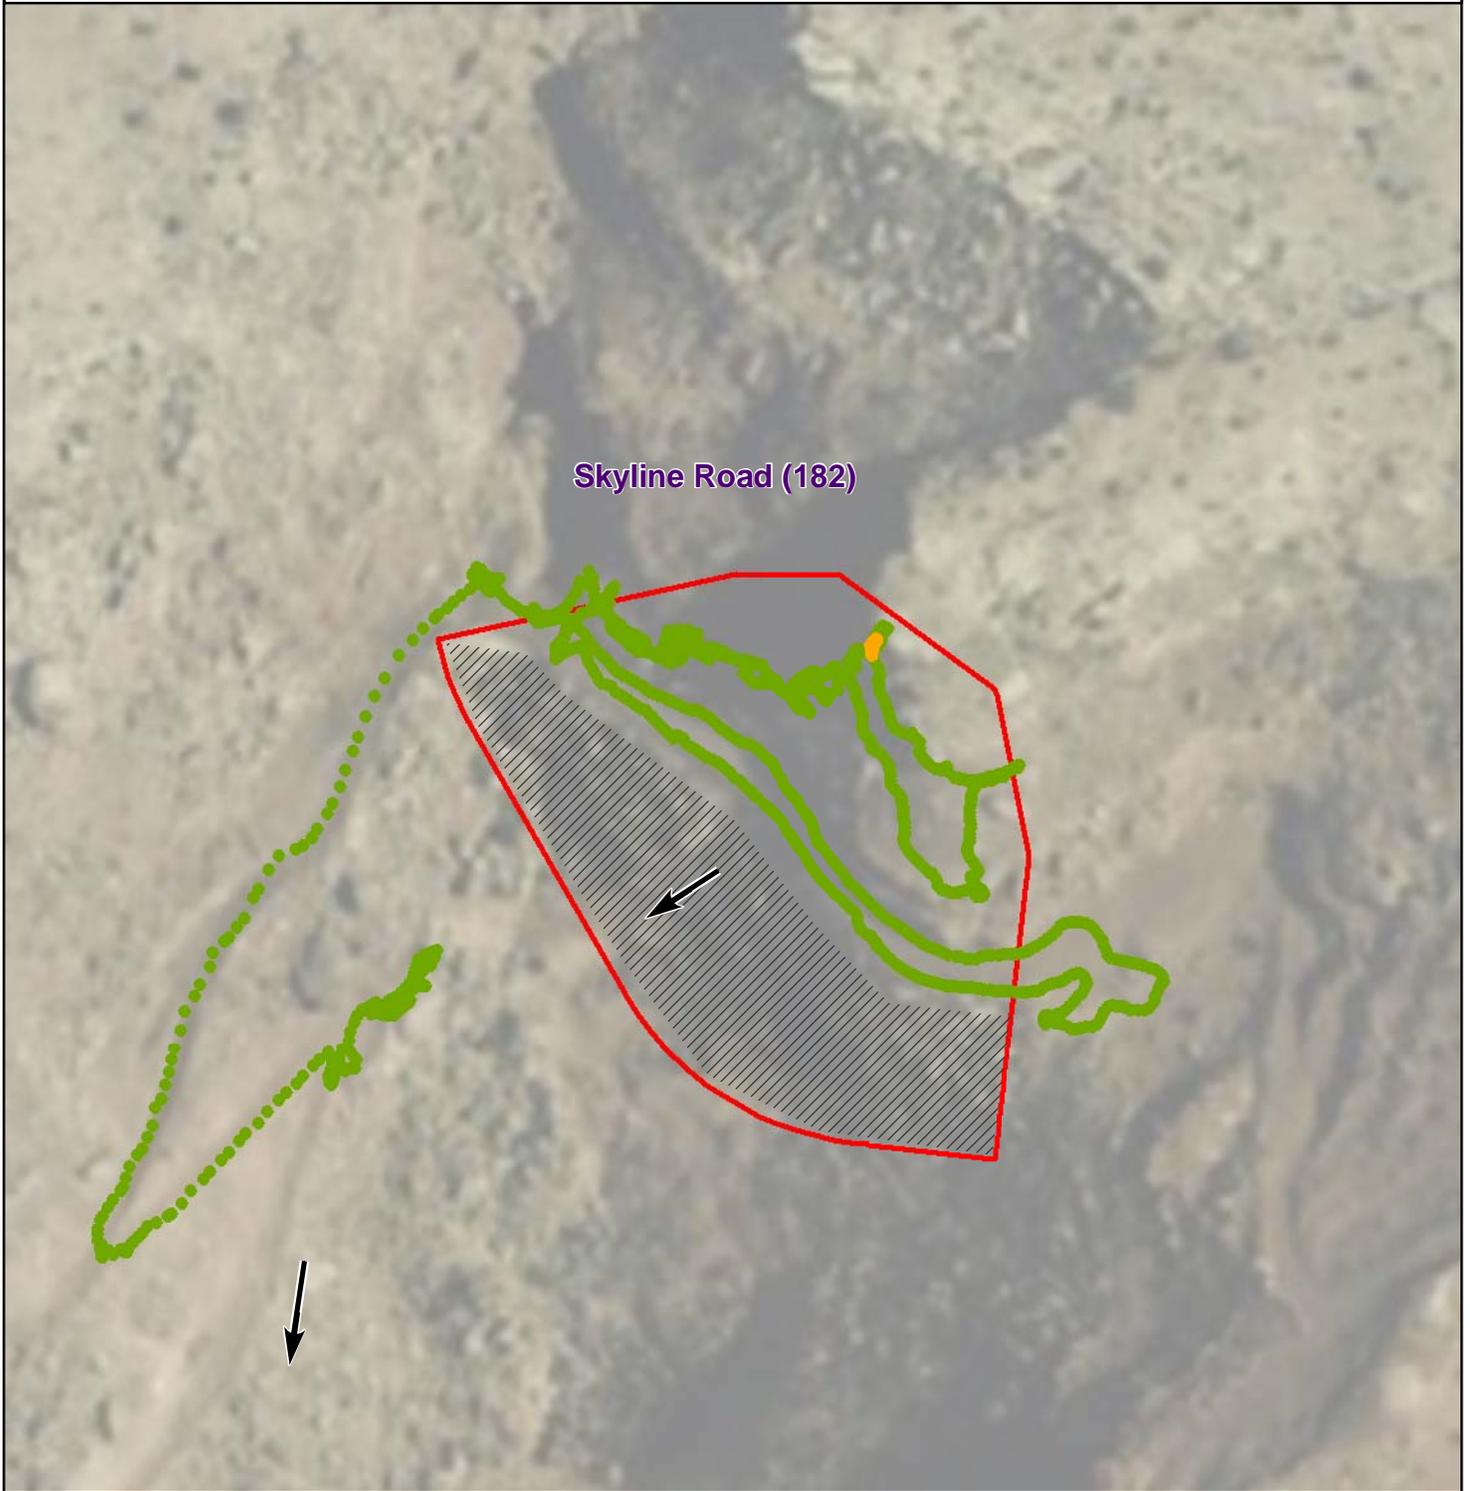
**Figure 1 - Gamma Radiation Measurements, Above Two Times Background  
Skyline Road (182)  
Oljato Chapter, Navajo Nation**

A total of 1,781 gamma radiation measurements were collected from the mine site, ranging from 5,292 cpm to 29,847 cpm. Maximum levels of approximately 30,000 cpm were found near the erosional holes/pits. The measurements are represented in Figures 1 and 2.

Measured as counts per minute (cpm)

Average background 13,426 cpm

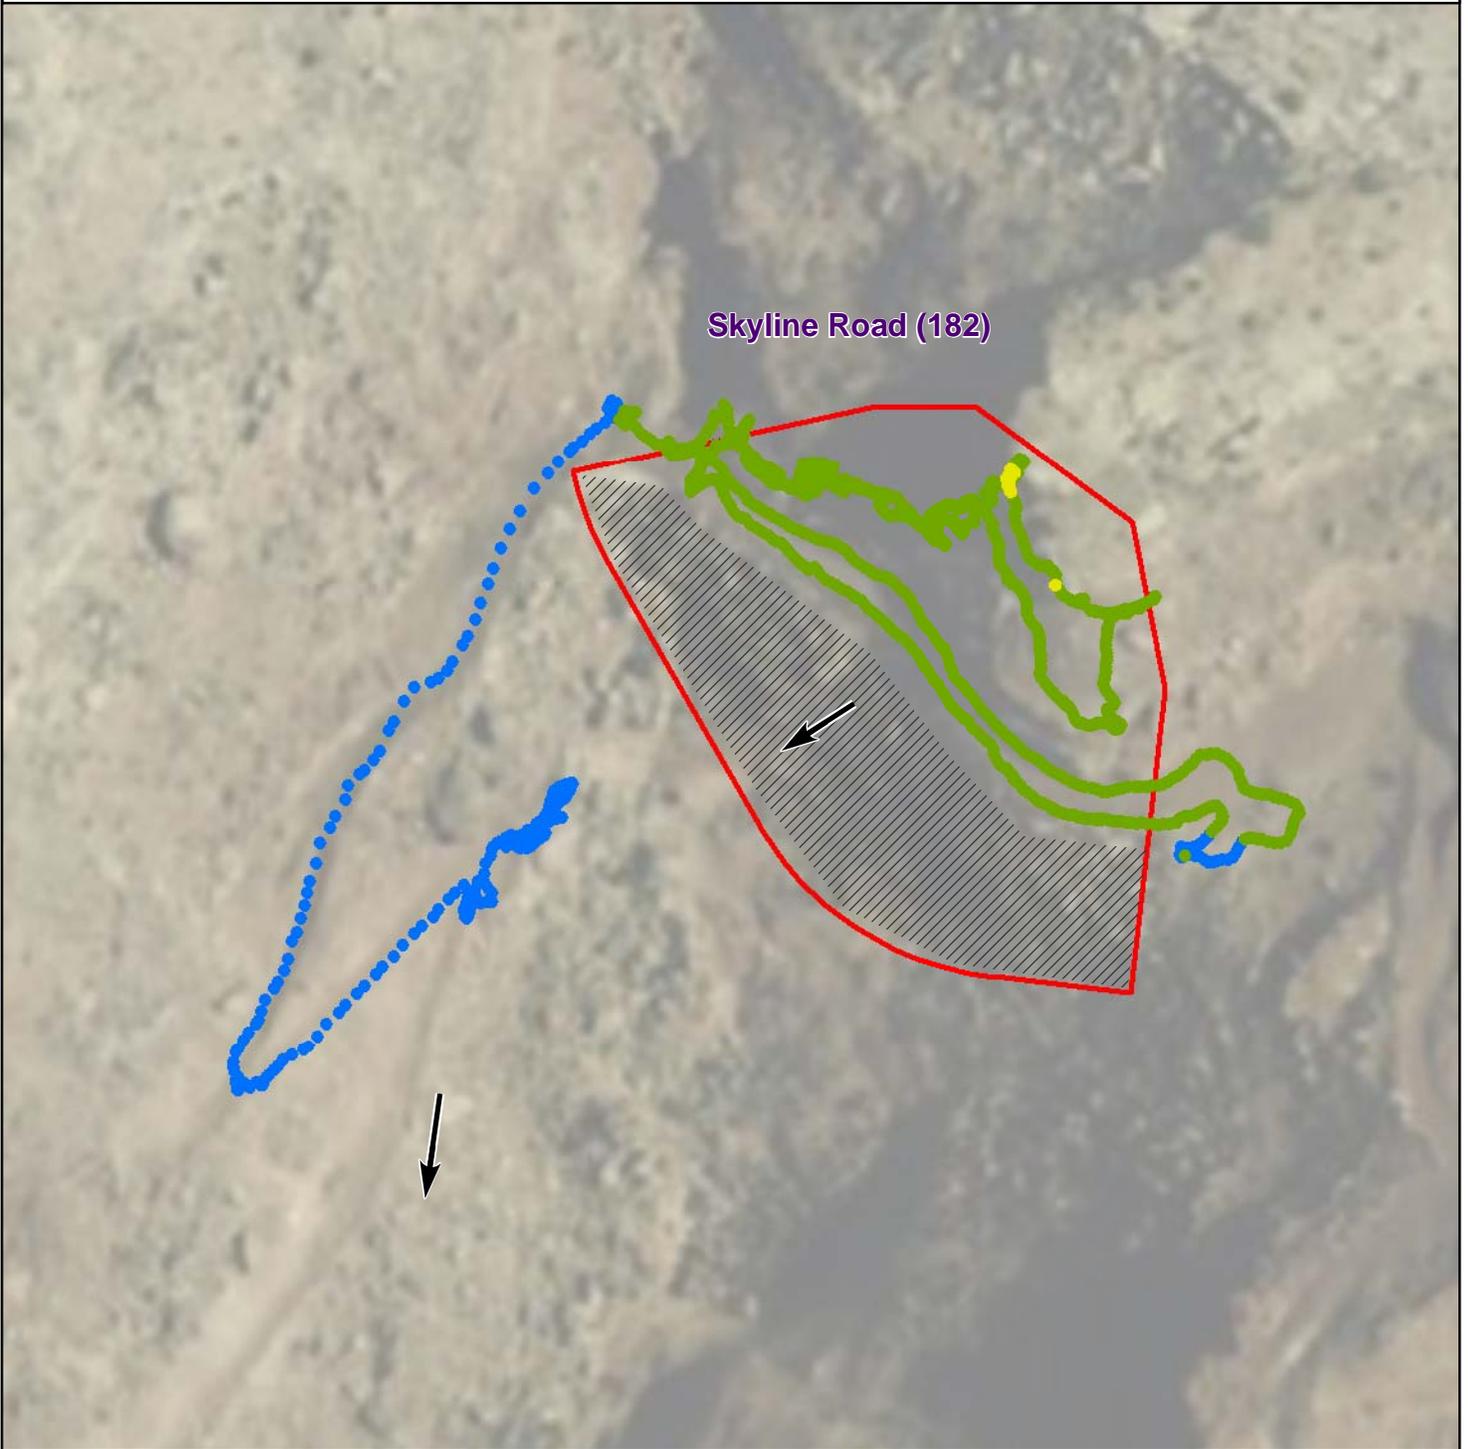
**Figure 2 - Gamma Radiation Measurements  
Skyline Road (182)  
Oljato Chapter, Navajo Nation**

**Average background 13,426 cpm Measured as counts per minute (cpm)**
