Navajo Abandoned Uranium Mine

Site Screen Report

Chester Mud No. 1 AUM Site

August 2010

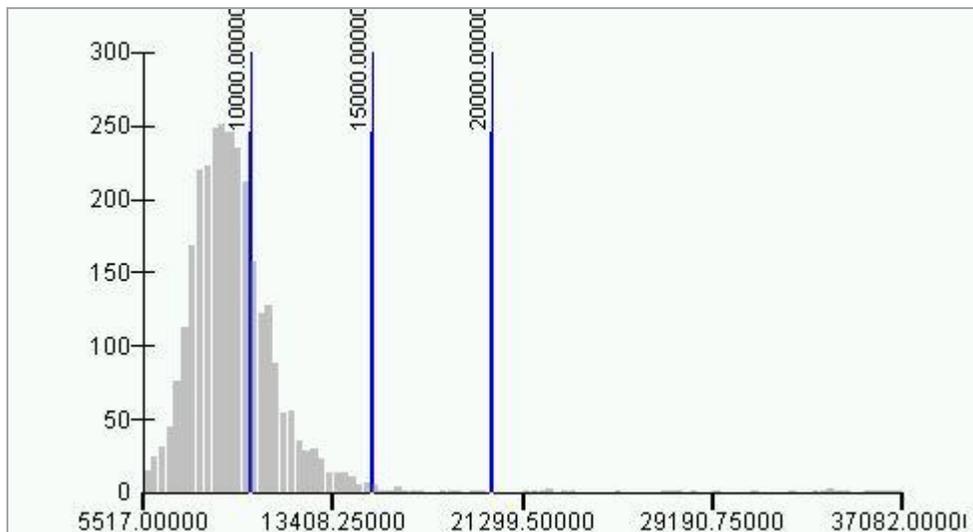
The following chart and statistics were generated by ESRI ArcGIS 9.3.1, and show the general distribution of the site gamma radiation measurements. The horizontal X axis represents the gamma radiation reading levels in cpm (lowest levels to the left). The vertical Y axis represents the frequency of each gamma radiation level.

Count:	2969
Minimum:	5517.00000
Maximum:	37082.00000
Sum:	28136923.00000
Mean:	9476.90232
Median:	9070.00000
Standard Deviation:	2768.58616

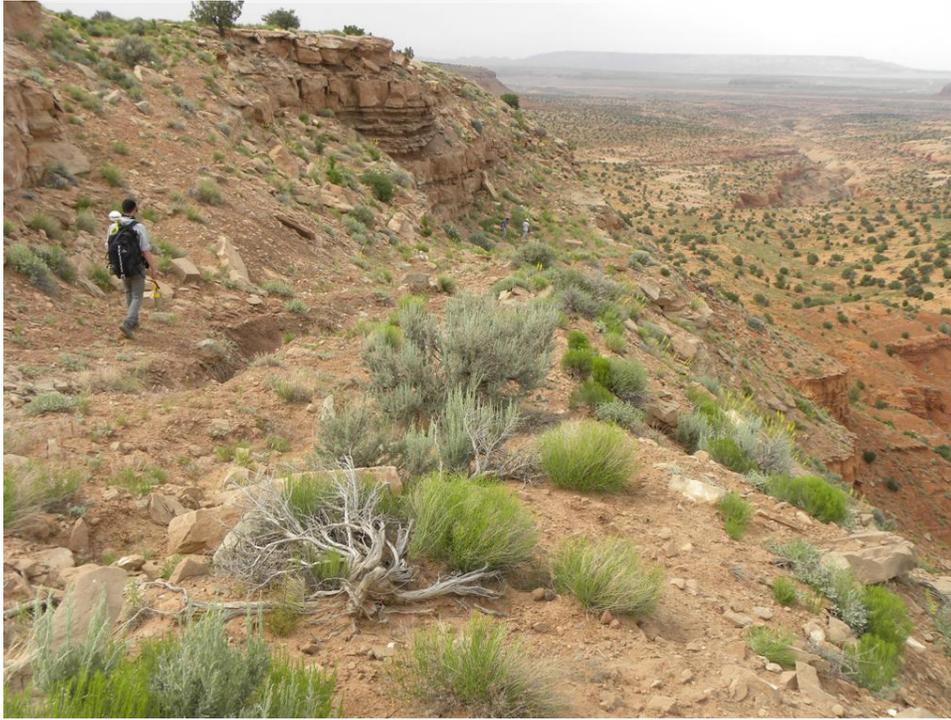
Photo 1. Chester Mud No. 1 Mine Site

1 adit, sealed with rock and foam

Waste rock scattered throughout site

Sealed adit; scattered unreclaimed waste rock

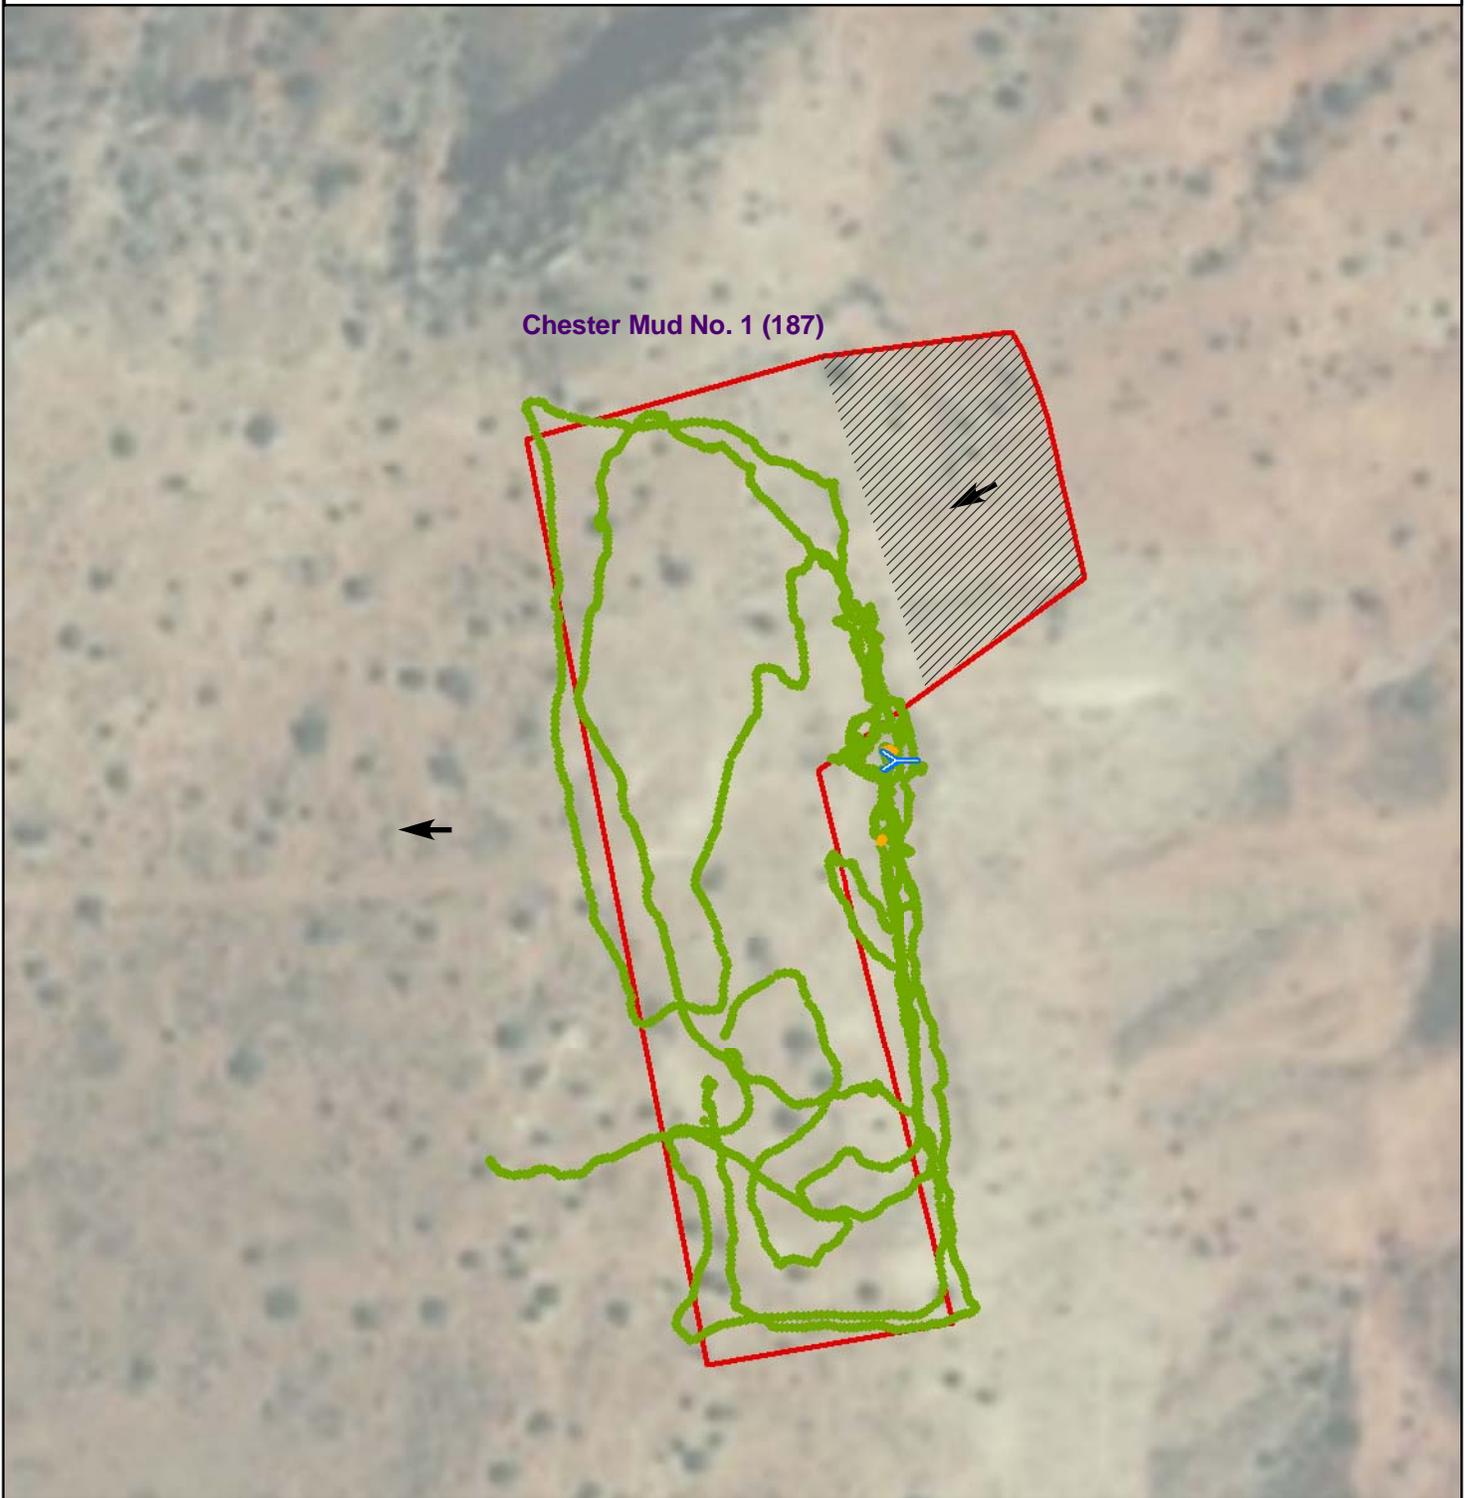
**Figure 1 - Gamma Radiation Measurements, Above Two Times Background
Chester Mud No. 1 (187)
Sweetwater Chapter, Navajo Nation**

A total of 2,969 gamma radiation measurements were collected from the mine site, ranging from 5,517 cpm to 37,082 cpm. Measurements collected in the vicinity of the adit were found at levels up to approximately 30,000 cpm. The measurements are represented in Figures 1 and 2.

Gamma survey conducted 06/2010
Measured as counts per minute (cpm)

Average background = 8,630 cpm

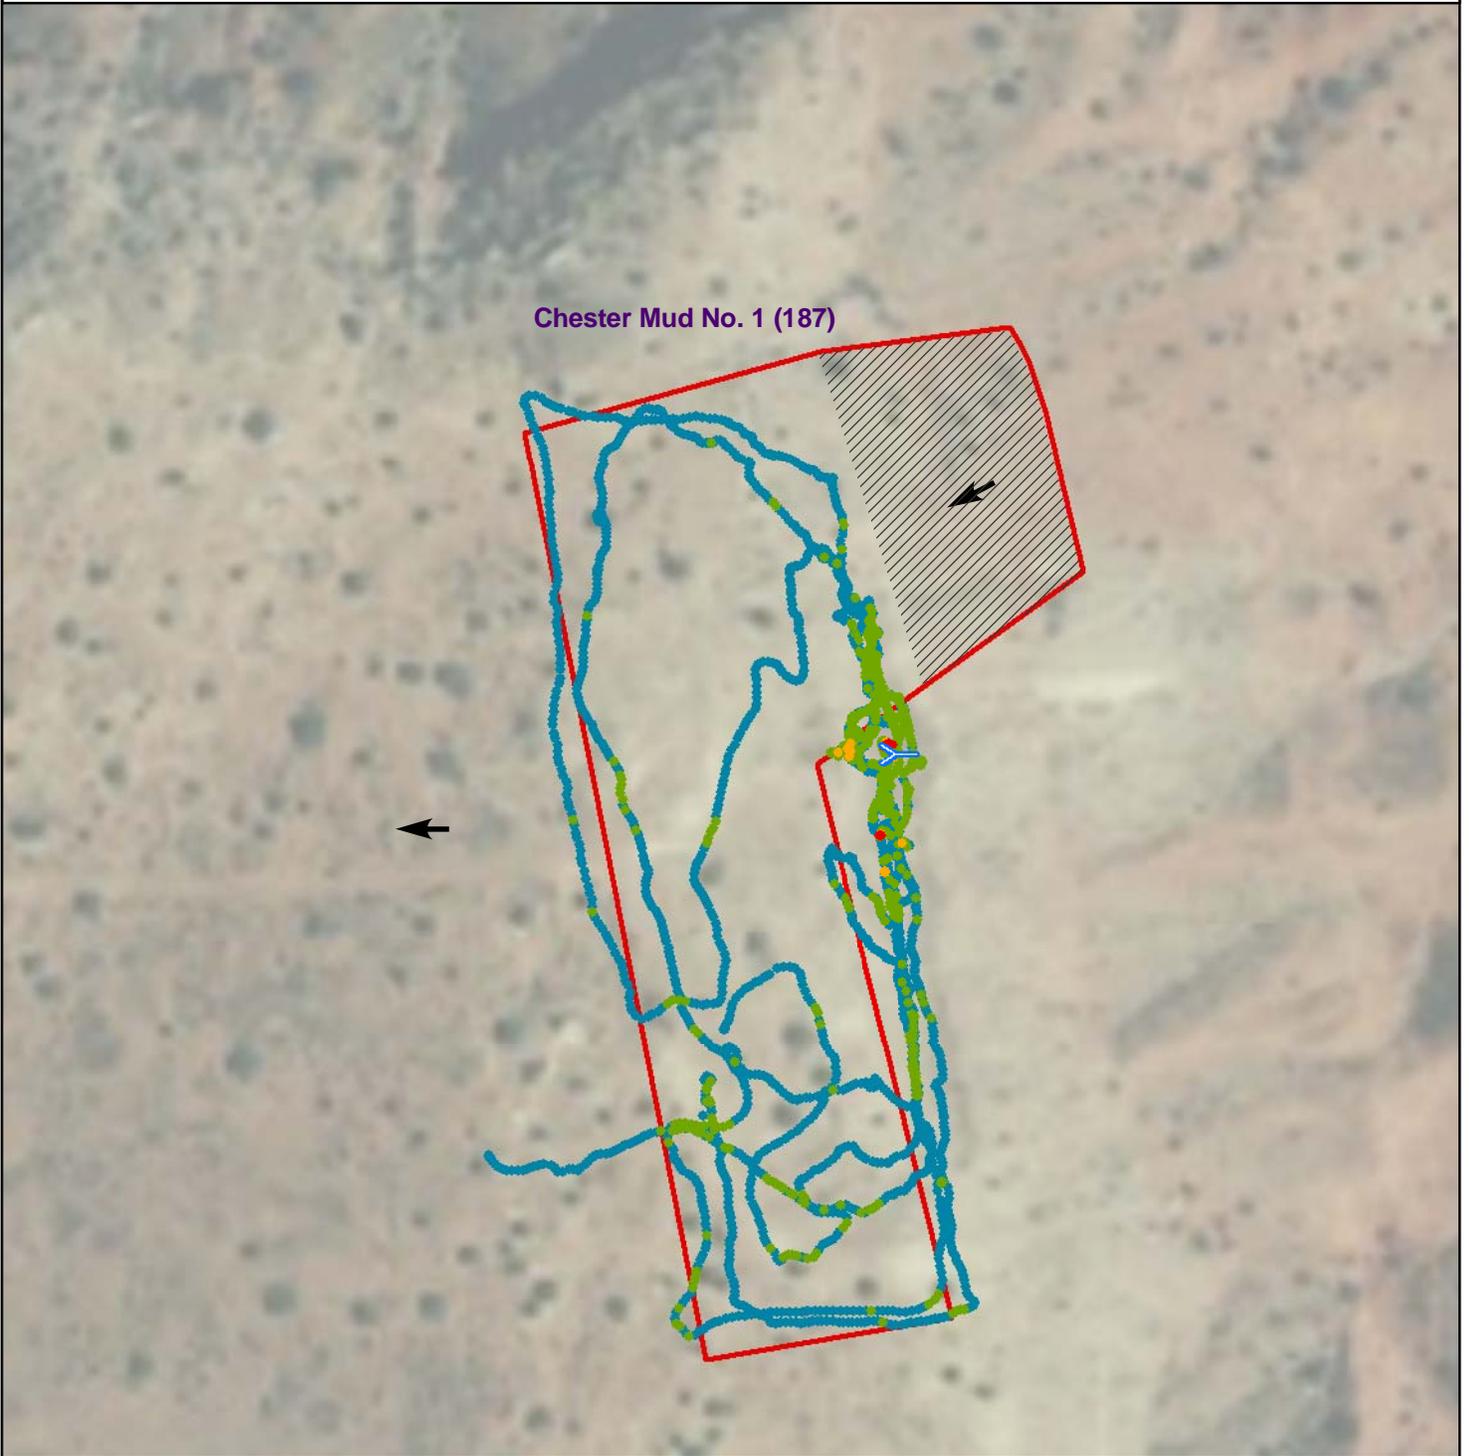
**Figure 2 - Gamma Radiation Measurements
Chester Mud No. 1 (187)
Sweetwater Chapter, Navajo Nation**

**Gamma survey conducted 06/2010
Measured as counts per minute (cpm)**

Average background 8,630 cpm
