Navajo Abandoned Uranium Mine

Site Screen Report

Mine Name: Whirlwind
Mine ID: 196

April 2012

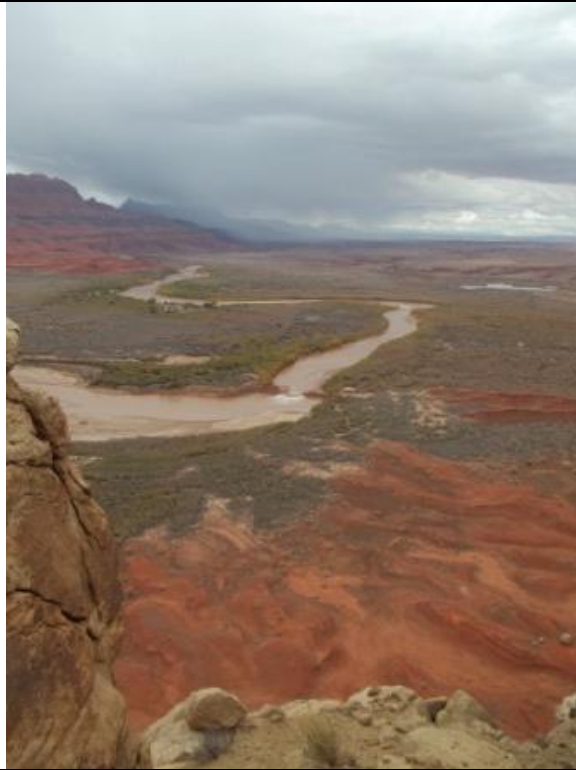
Photo 6

Mine Site #196 – Lake Powell below site
