# Navajo Abandoned Uranium Mine

## Site Screen Report

## Nakai Chee Begay AUM Site

**March 2010**

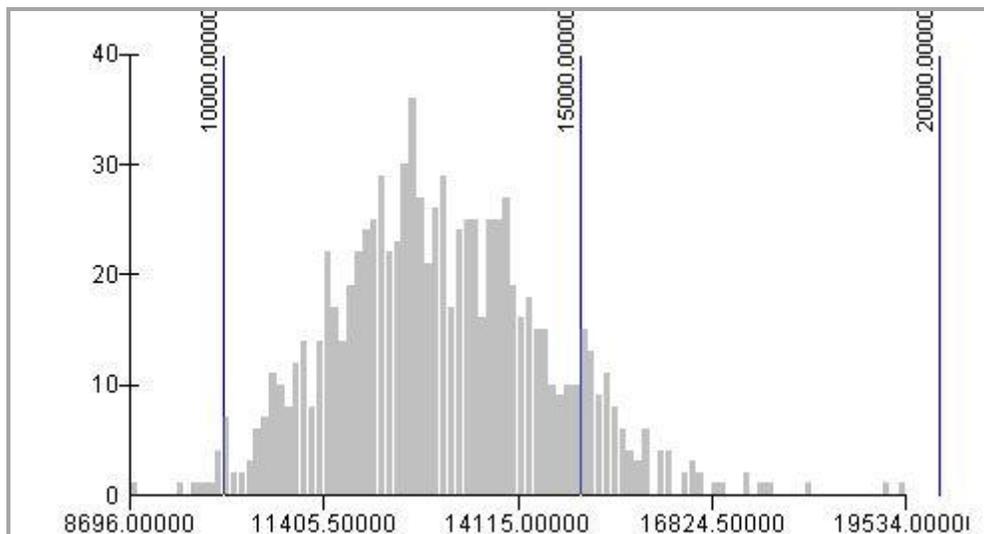
The following chart and statistics were generated by ESRI ArcGIS 9.3.1, and show the general distribution of the site gamma radiation measurements. The horizontal X axis represents the gamma radiation reading levels in cpm (lowest levels to the left). The vertical Y axis represents the frequency of each gamma radiation level.

Count:	904
Minimum:	8696.00000
Maximum:	19534.00000
Sum:	11799318.00000
Mean:	13052.34292
Median:	12958.00000
Standard Deviation:	1483.10819

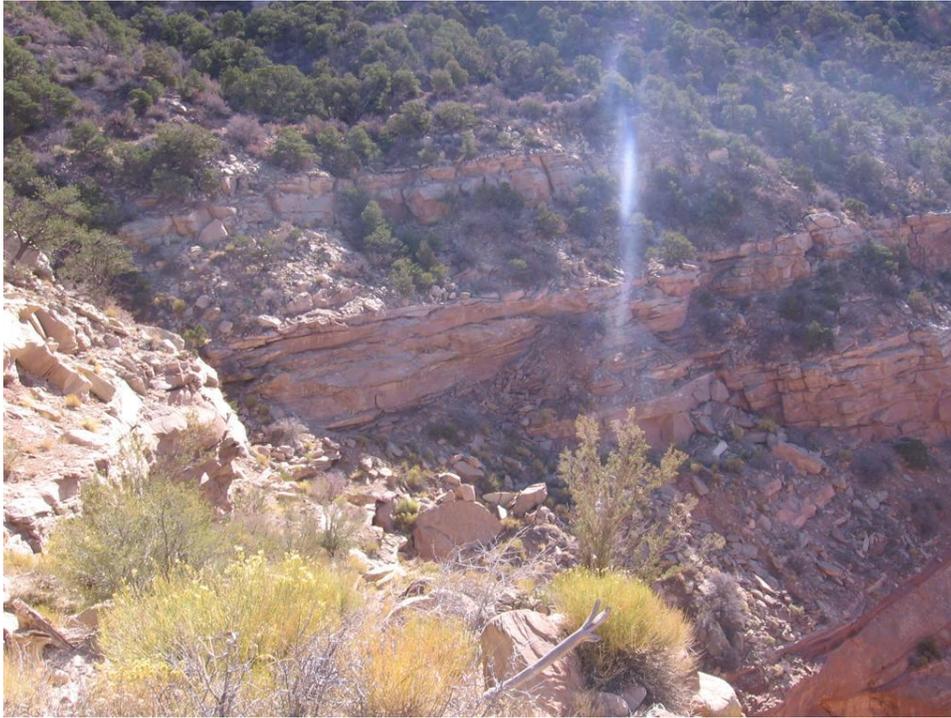
Waste debris extending southwest from adit 200 ft down cliff, approximately 50 ft wide, inaccessible, total estimated volume of 463 yd<sup>3</sup>

Photo 1. Waste debris down slope

Sealed adit; unreclaimed waste rock

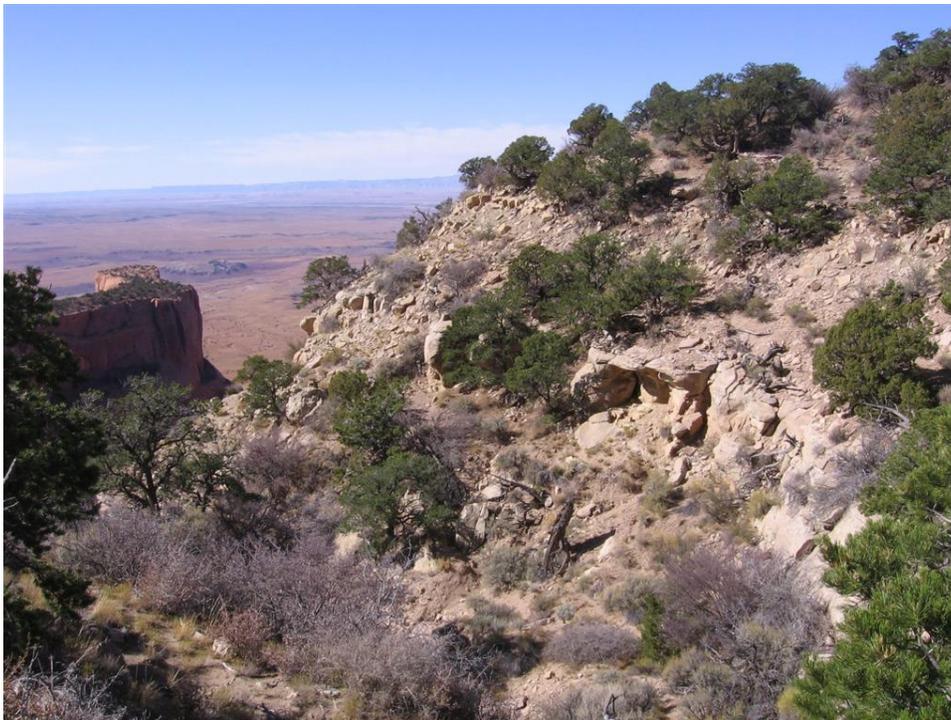
A total of 904 gamma radiation measurements were collected from the mine site, ranging from 8,696 cpm to 19,534 cpm. The majority of the site, including the adit and waste debris, were inaccessible. Measurements in the vicinity of the cliff face were found at levels up to 14,000 cpm. The measurements are represented in Figures 1 and 2.

Photo 2. Inaccessible portion of mine site

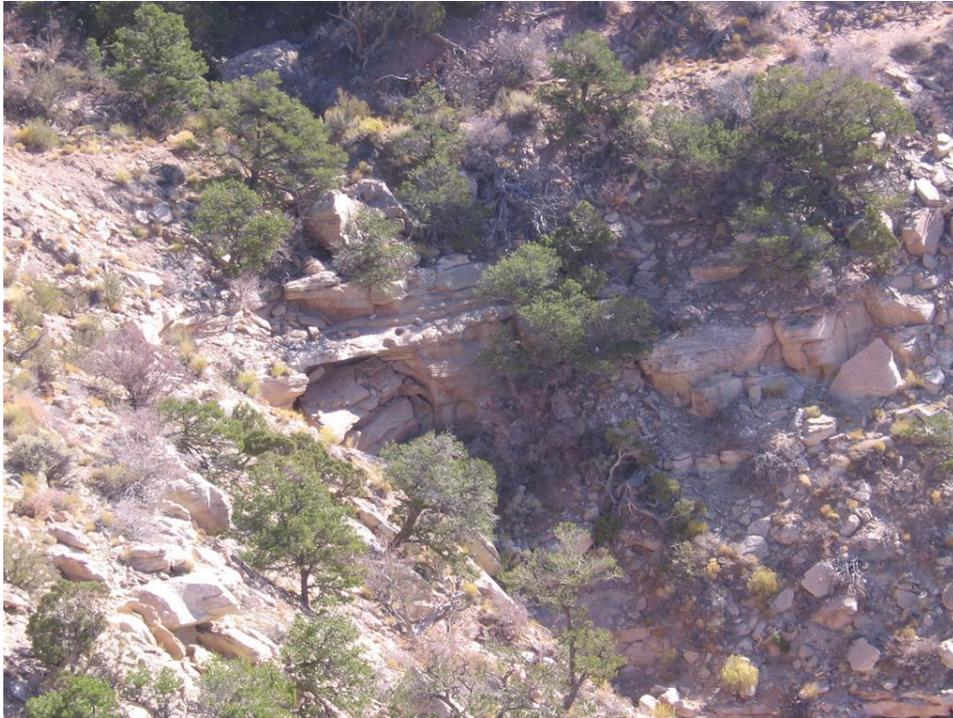
Inaccessible adit, roughly 6' x 6', appeared to be sealed with stone

Photo 3. Stone sealed adit

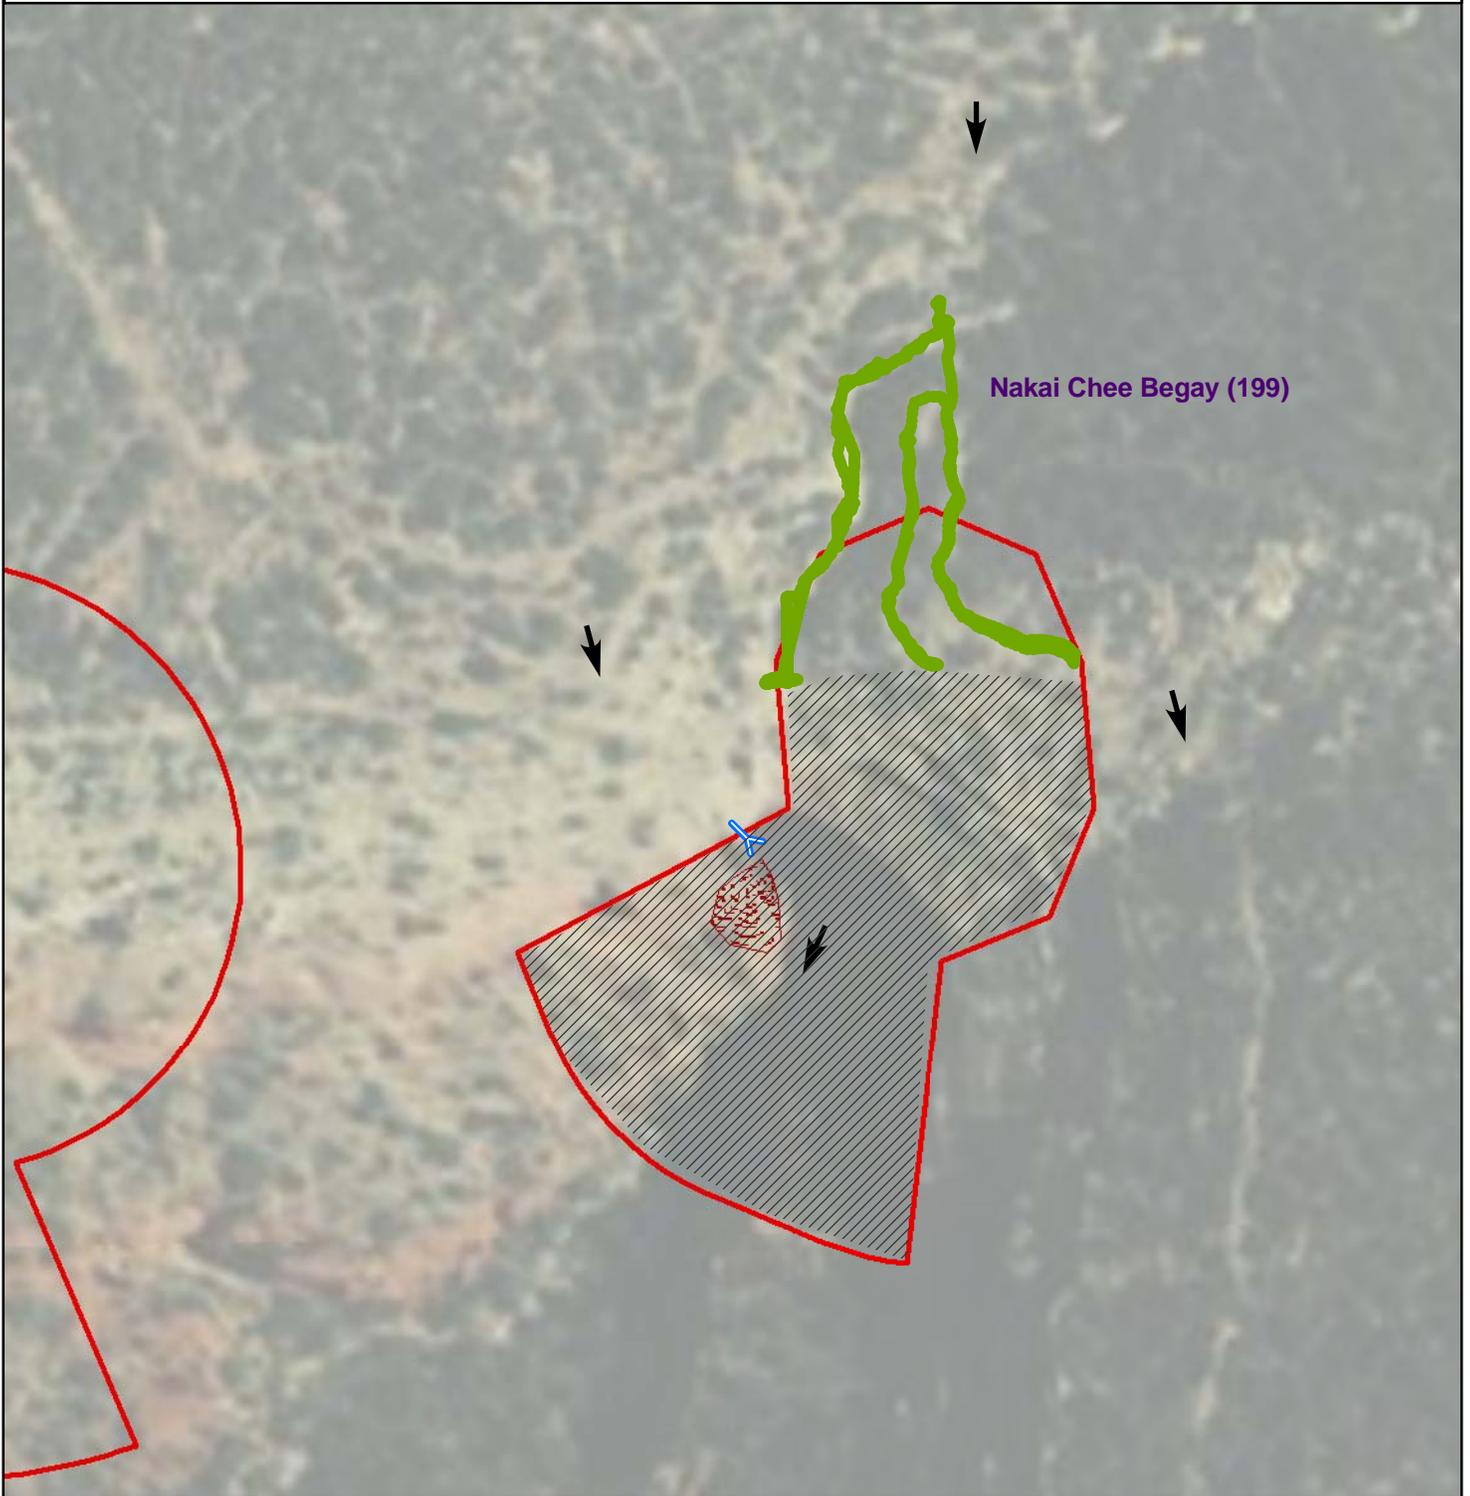
**Figure 1 - Gamma Radiation Measurements, Above Two Times Background  
Nakai Chee Begay (199)  
Round Rock Chapter, Navajo Nation, Arizona**

Gamma survey conducted 10/2009  
Measured as counts per minute (cpm)

Average background = 12,055 cpm

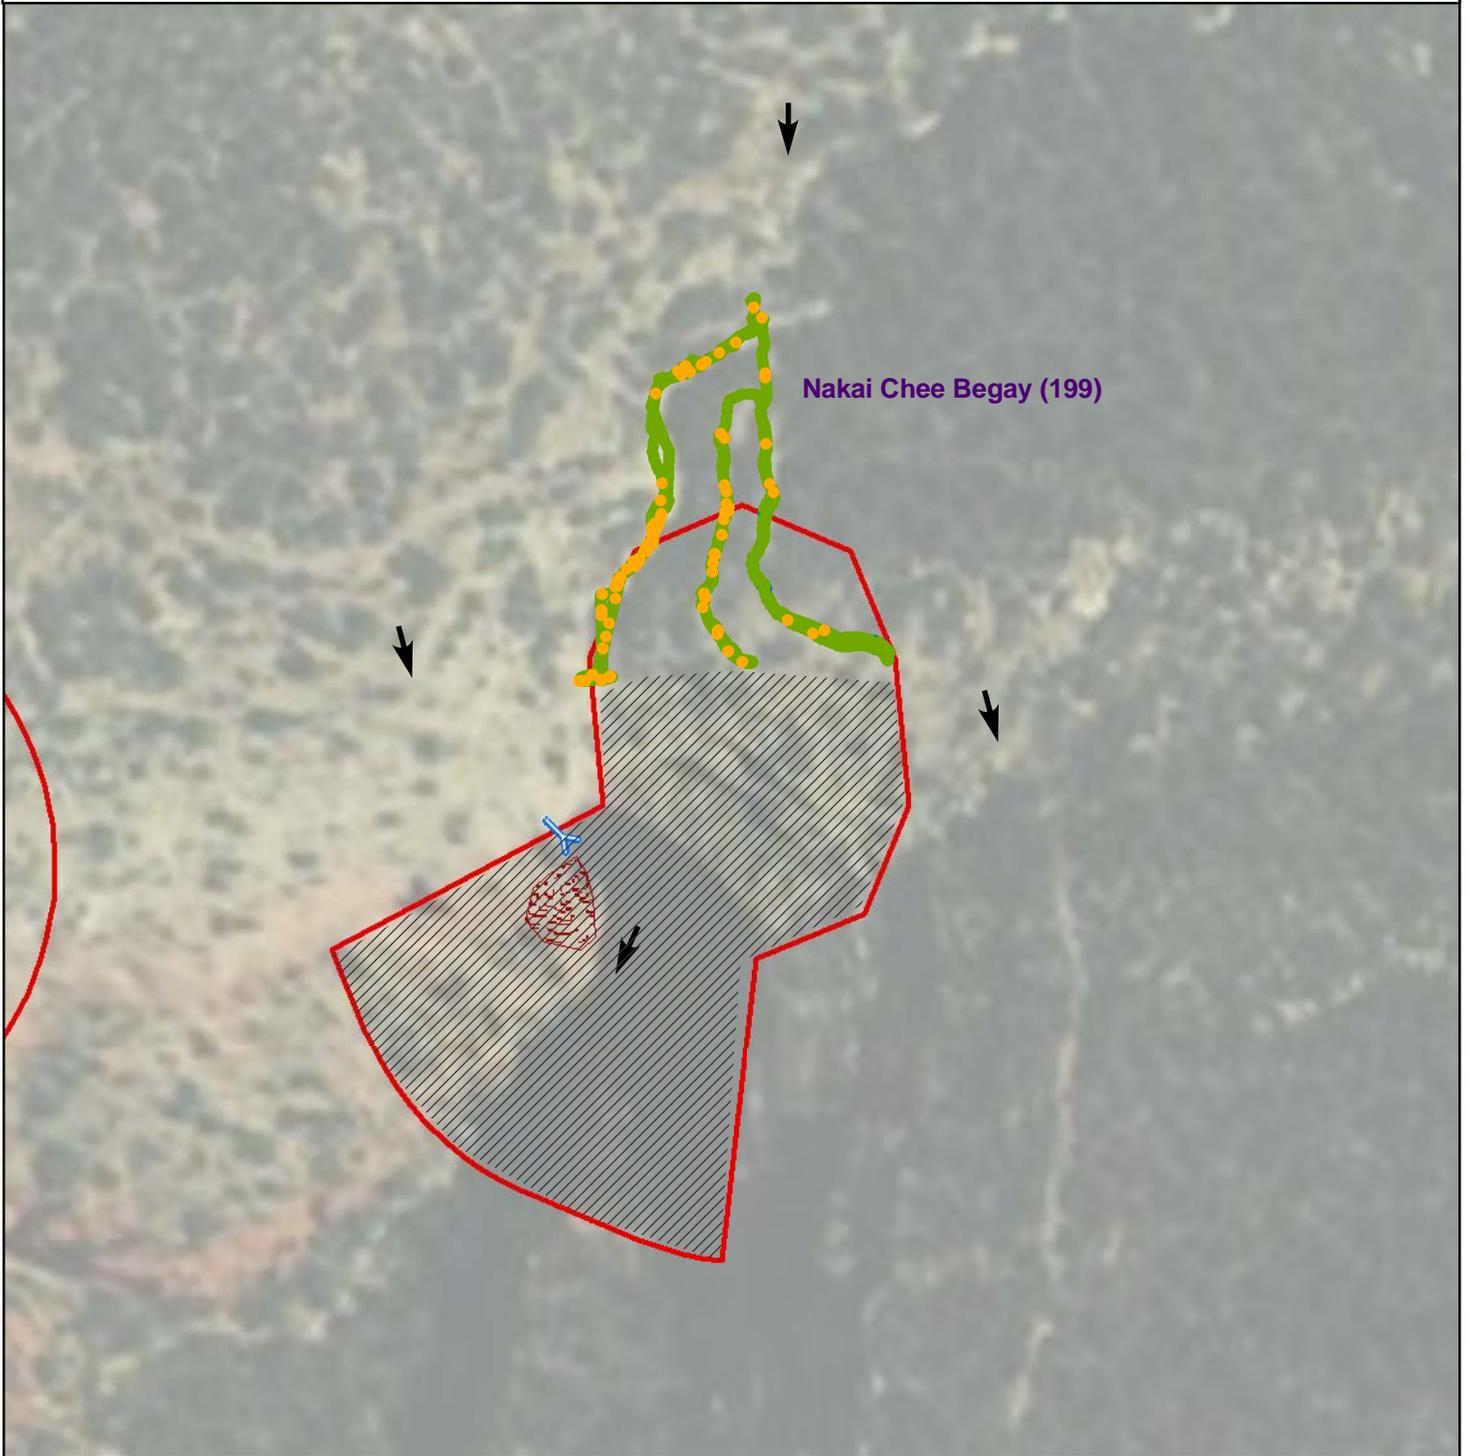
**Figure 2 - Gamma Radiation Measurements  
Nakai Chee Begay (199)  
Round Rock Chapter, Navajo Nation, Arizona**

**Gamma survey conducted 10/2009  
Measured as counts per minute (cpm)**

**Average background = 12,055 cpm**
