Navajo Abandoned Uranium Mine

Site Screen Report

Black No. 2 Mine AUM Site

Navajo AUM Northern Region

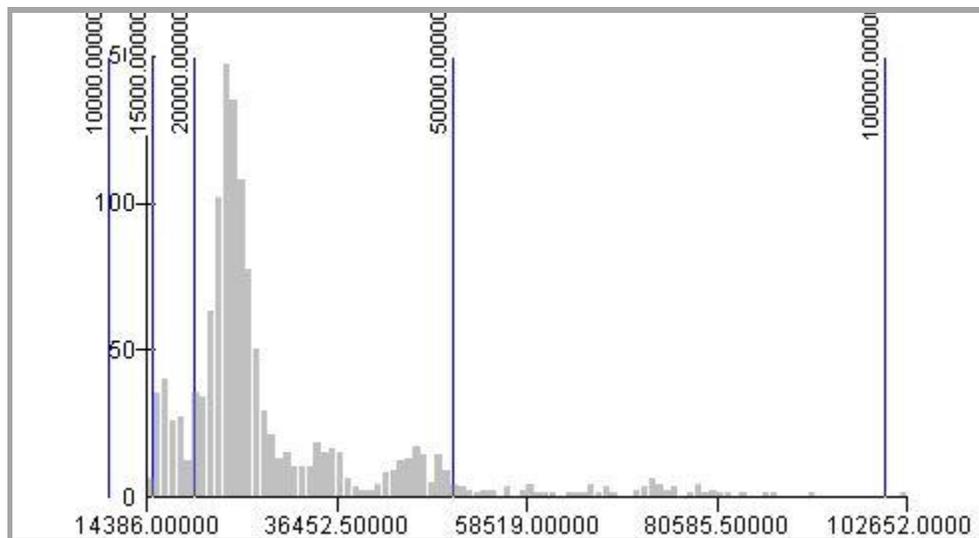
The following chart and statistics were generated by ESRI ArcGIS 9.3.1, and show the general distribution of the site gamma radiation measurements. The horizontal X axis represents the gamma radiation reading levels in cpm (lowest levels to the left). The vertical Y axis represents the frequency of each gamma radiation level.

Count:	1260
Minimum:	14386.00000
Maximum:	102652.00000
Sum:	36291519.00000
Mean:	28802.79286
Median:	24704.00000
Standard Deviation:	12422.70499

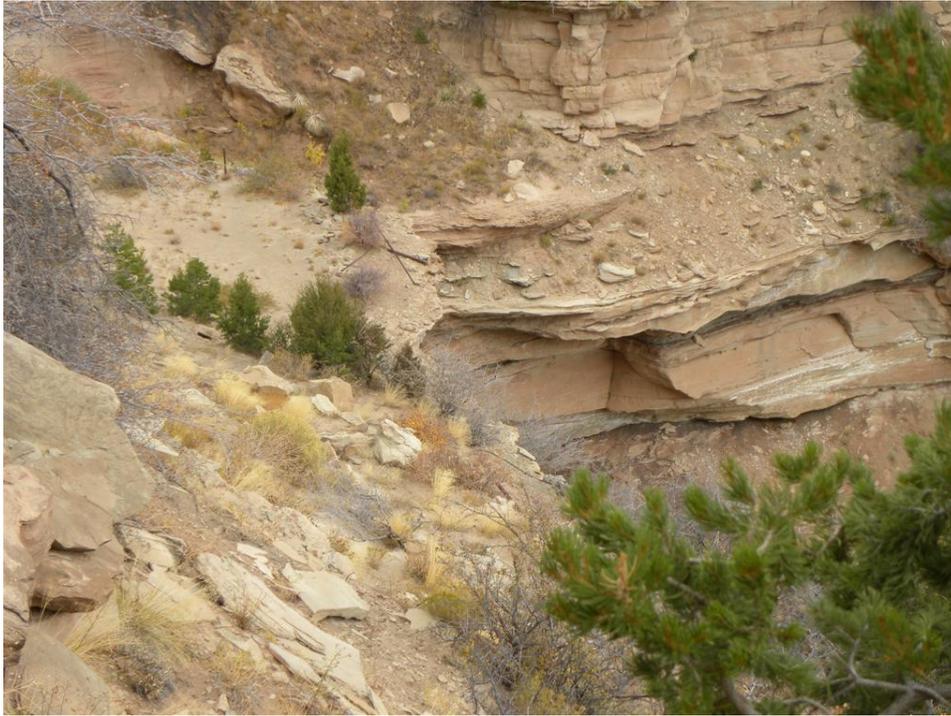
Debris extending southwest approximately 50' down canyon, 75' x 75', with a total estimated volume of 1,042 yd³

Photo 1. Waste debris off cliff side

2 inaccessible adits, one sealed, one open; unreclaimed waste pile

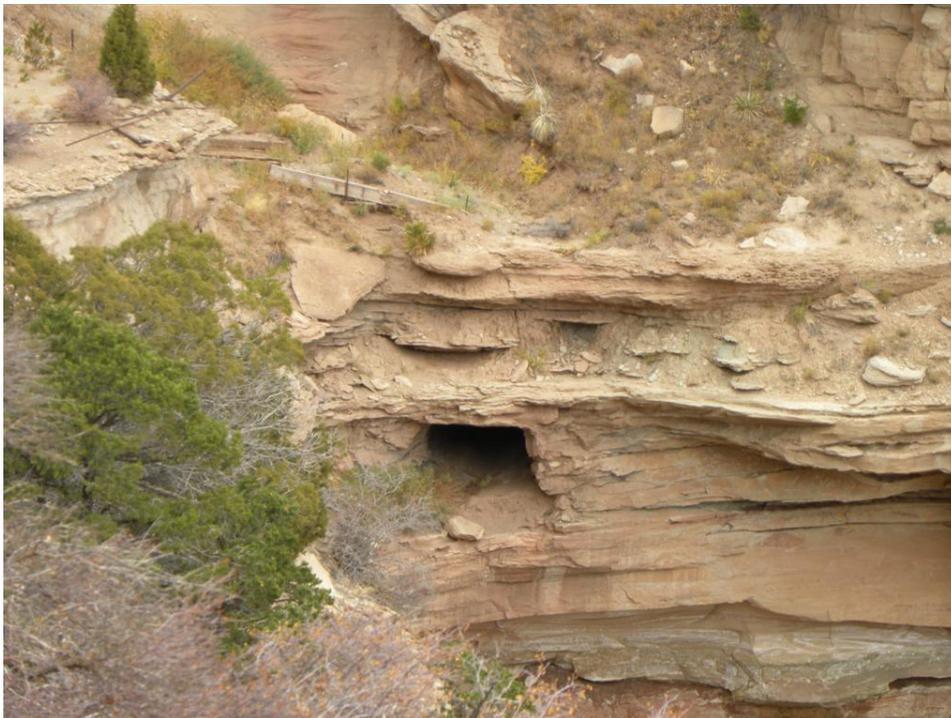
2 adits, both inaccessible: one sealed; one open

Photo 2. Inaccessible open adit

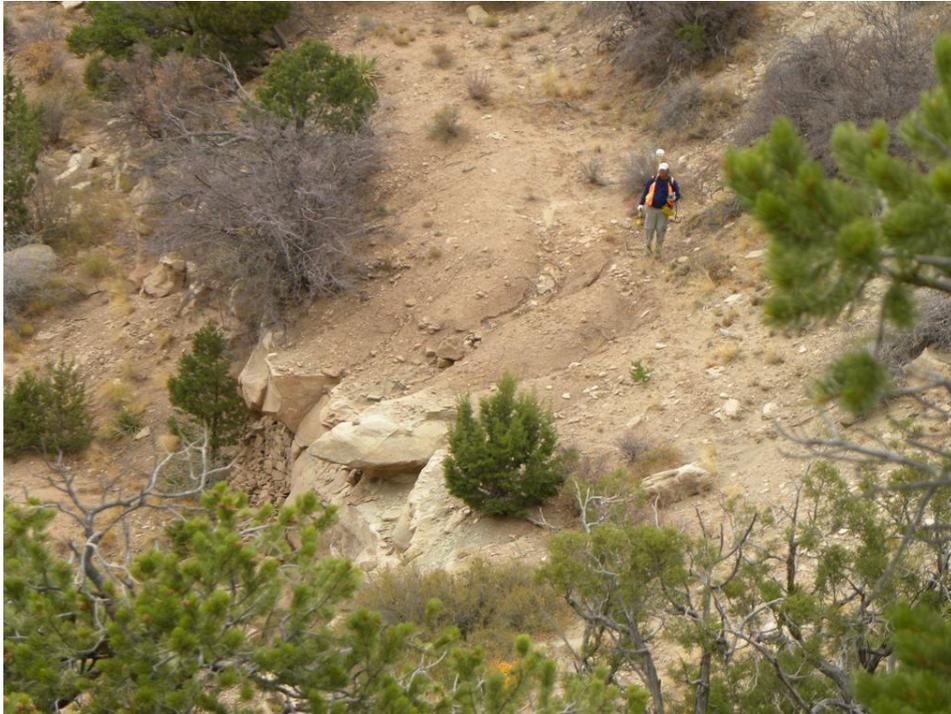
Photo 3. Mine site path

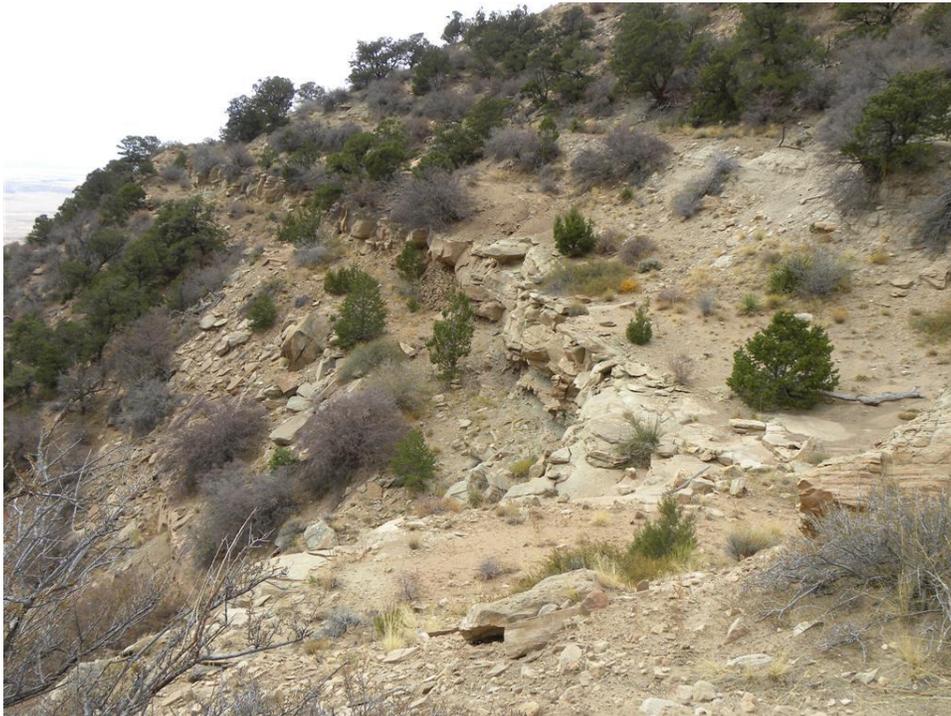
Photo 4. Steep grades downslope.

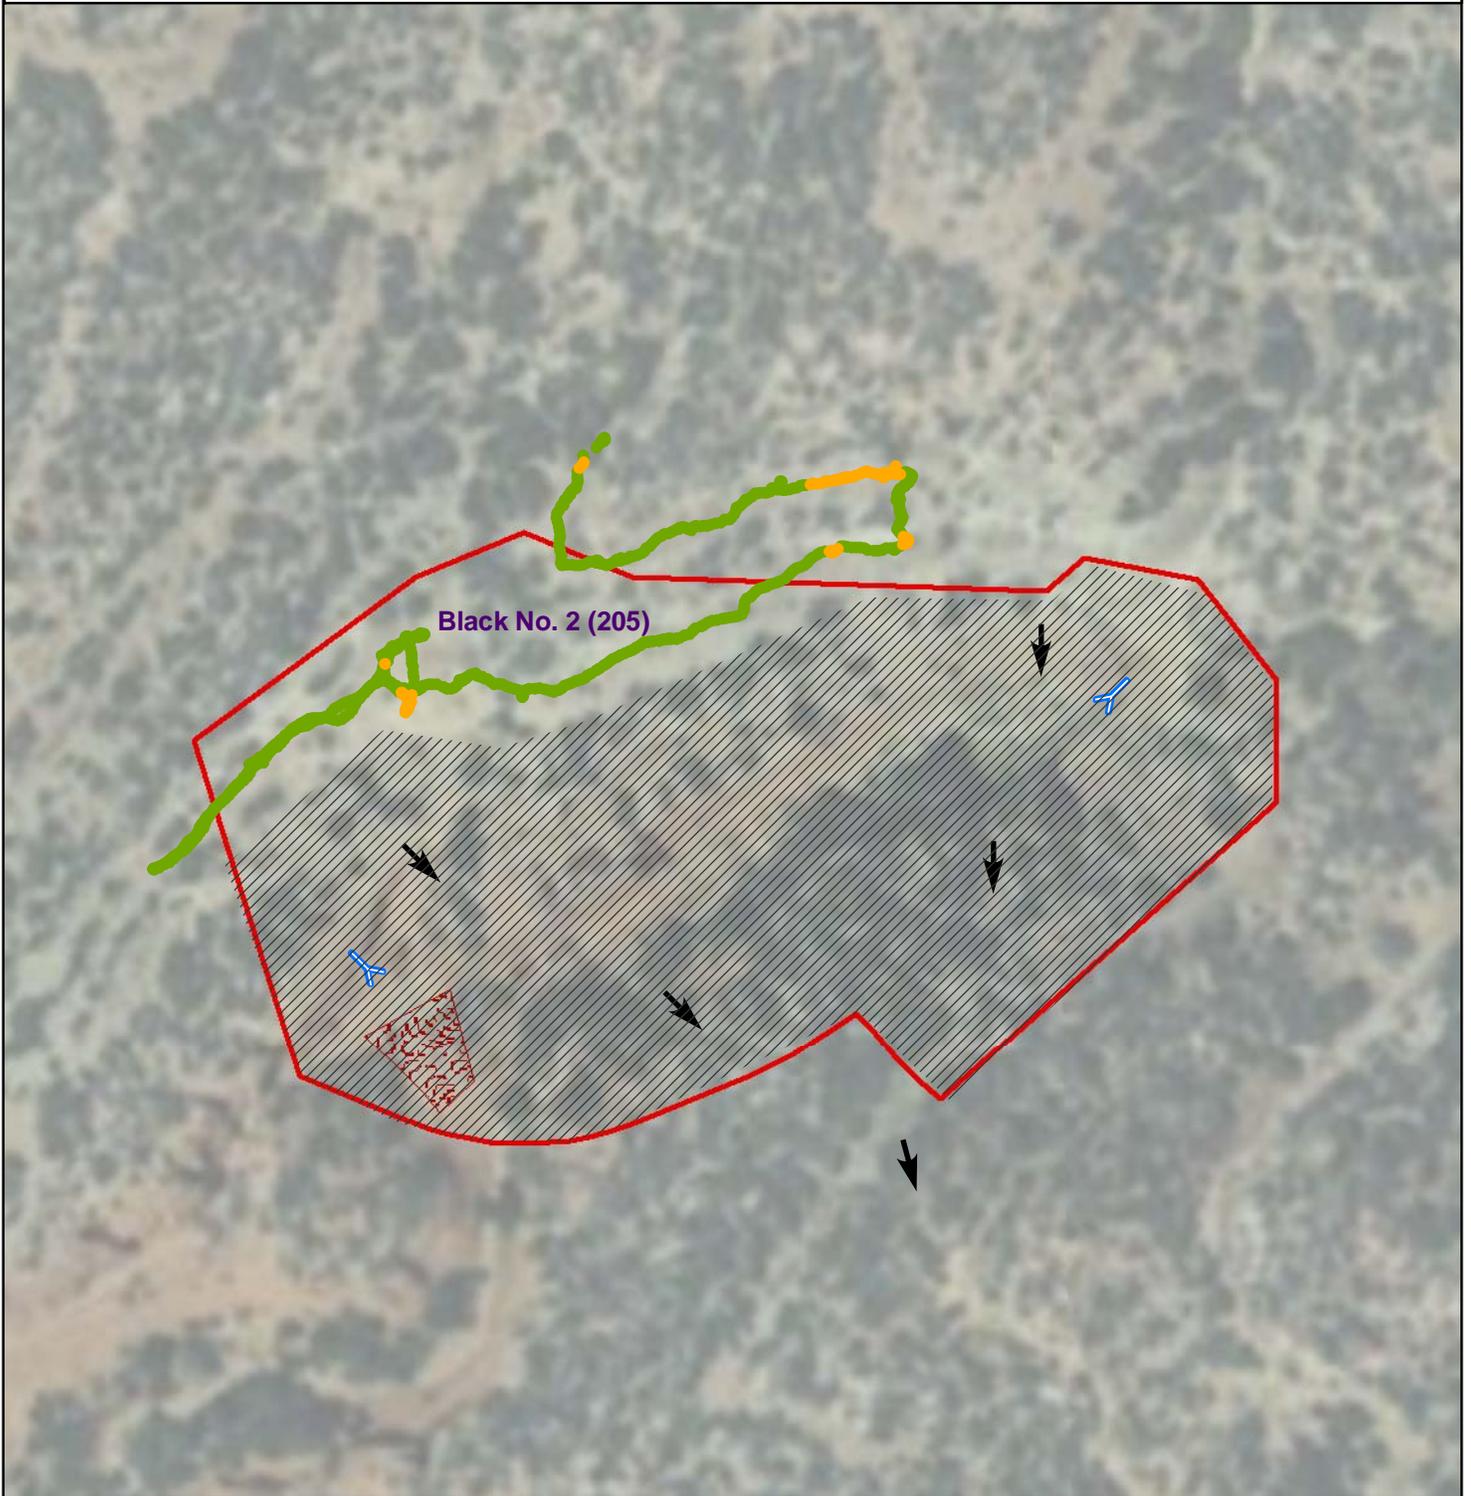
**Figure 1 - Gamma Radiation Measurements, Above Two Times Background
Black No. 2 (205)
Round Rock Chapter, Navajo Nation, Arizona**

A total of 1,260 gamma radiation measurements were collected from the mine site, ranging from 14,386 cpm to 102,652 cpm. Measurements in the vicinity of the waste debris were found at levels greater than 50,000 cpm. The highest levels were found above the adit. The measurements are represented in Figures 1 and 2.

Gamma survey conducted 10/2009
Measured as counts per minute (cpm)

Average background = 19,496 cpm

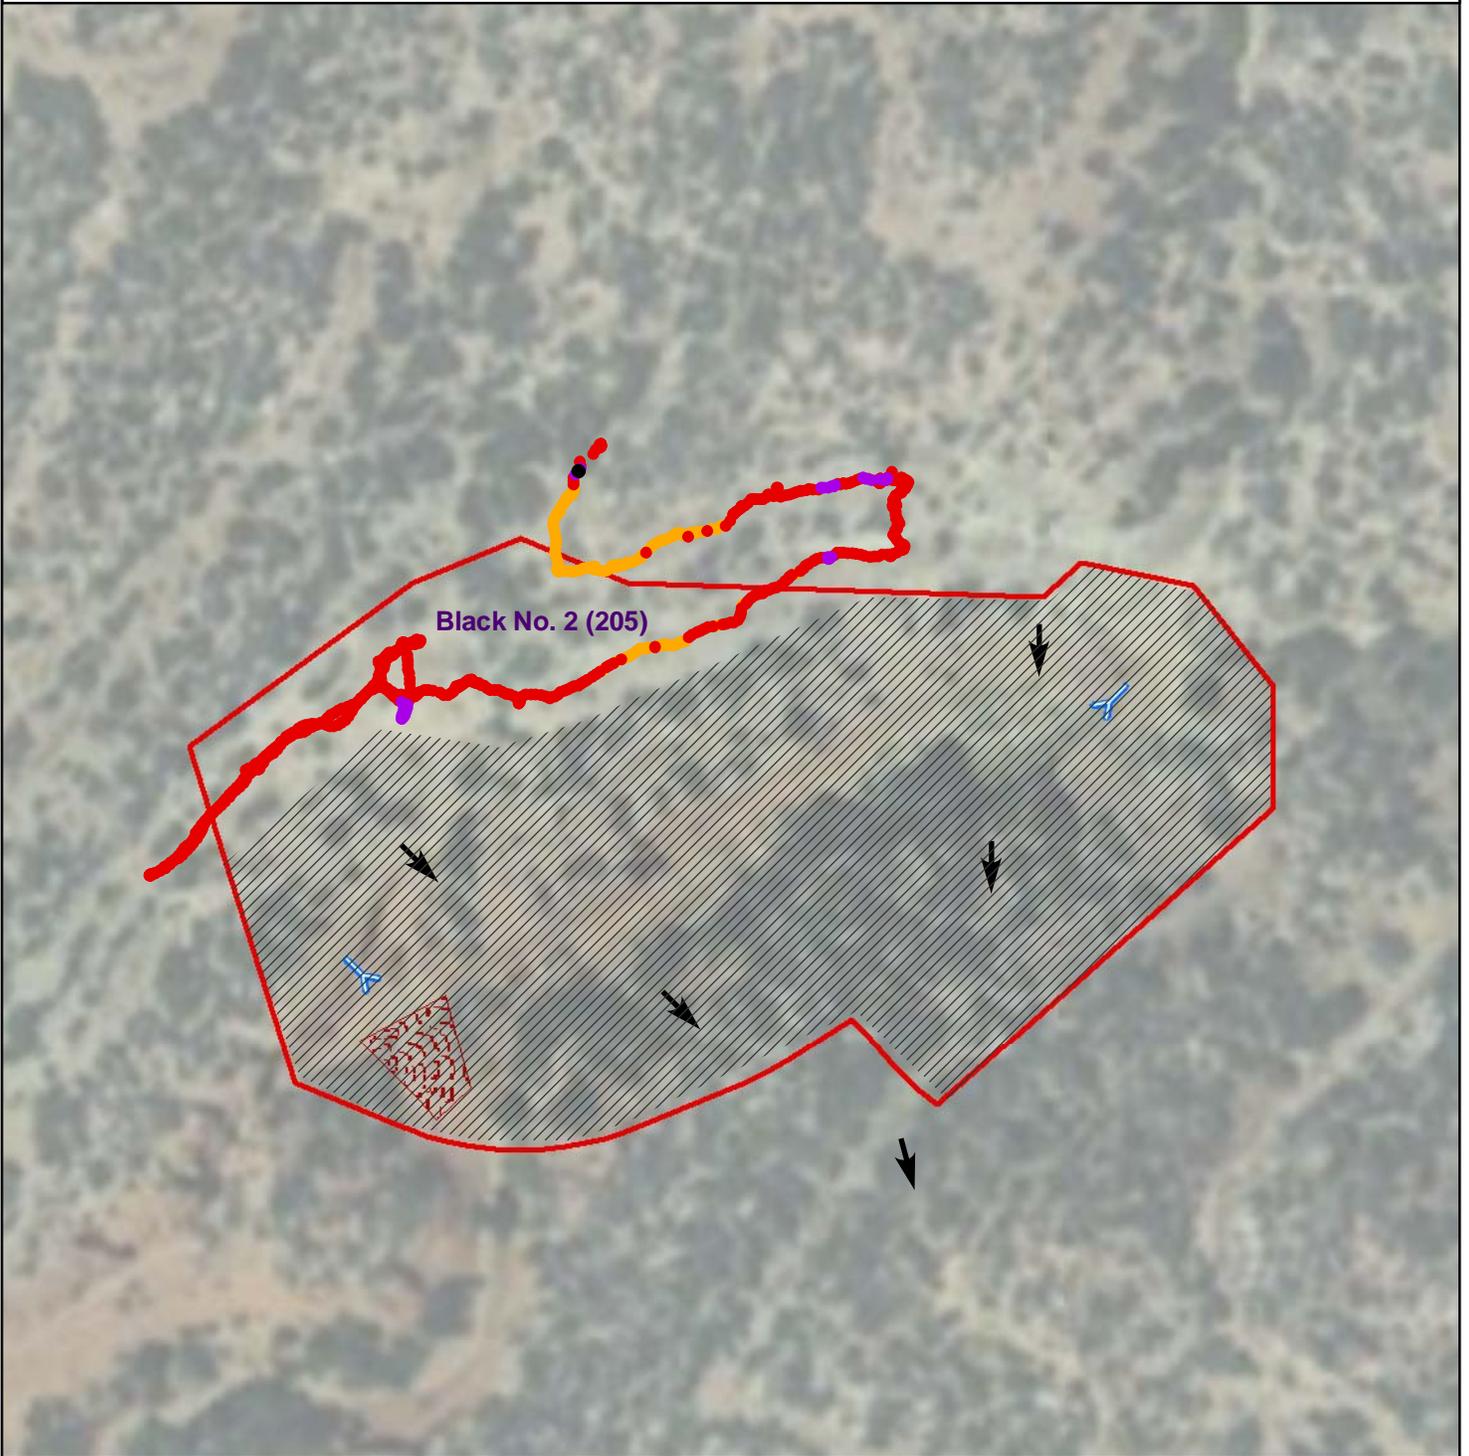
**Figure 2 - Gamma Radiation Measurements
Black No. 2 (205)
Round Rock Chapter, Navajo Nation, Arizona**

Gamma survey conducted 10/2009
Measured as counts per minute (cpm)

Average background = 19,496 cpm
