# Navajo Abandoned Uranium Mine

## Site Screen Report

**Mine Name: Binale 1**

**Mine ID: 221**

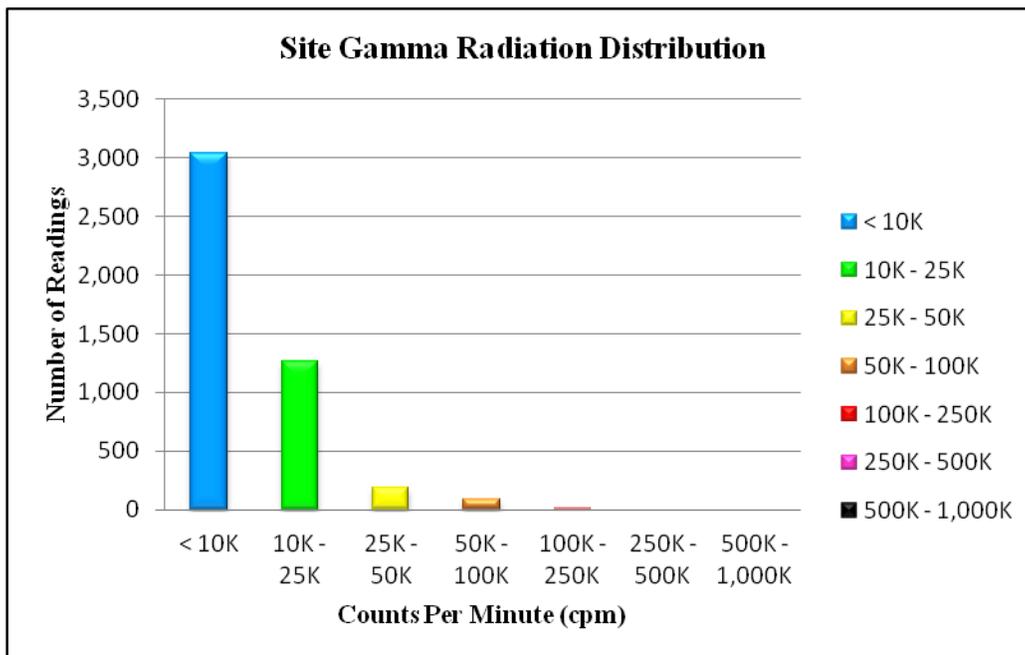
**Distribution Chart and Statistics:**

<b>Site Gamma Radiation Statistics</b>	
Number of Readings	4,595
Minimum (cpm)	4,662
Maximum (cpm)	128,497
Mean (cpm)	11,392
Median (cpm)	8,032
Standard Deviation	10,896

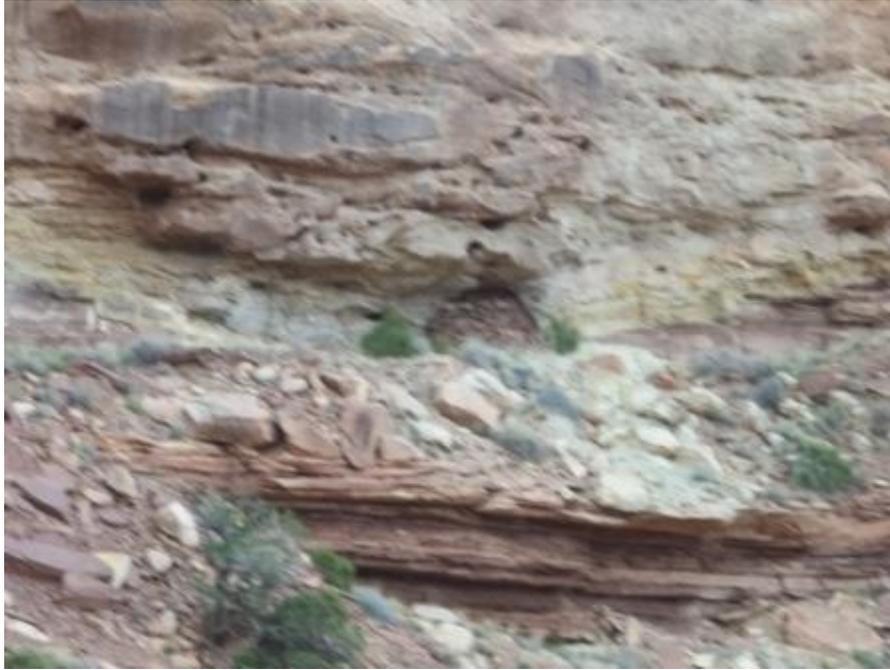
**Photo 3**

1 adit, stone sealed, approximately 10' x 12', alongside the hiking trail running through the site

Mine Site #221 - Adit

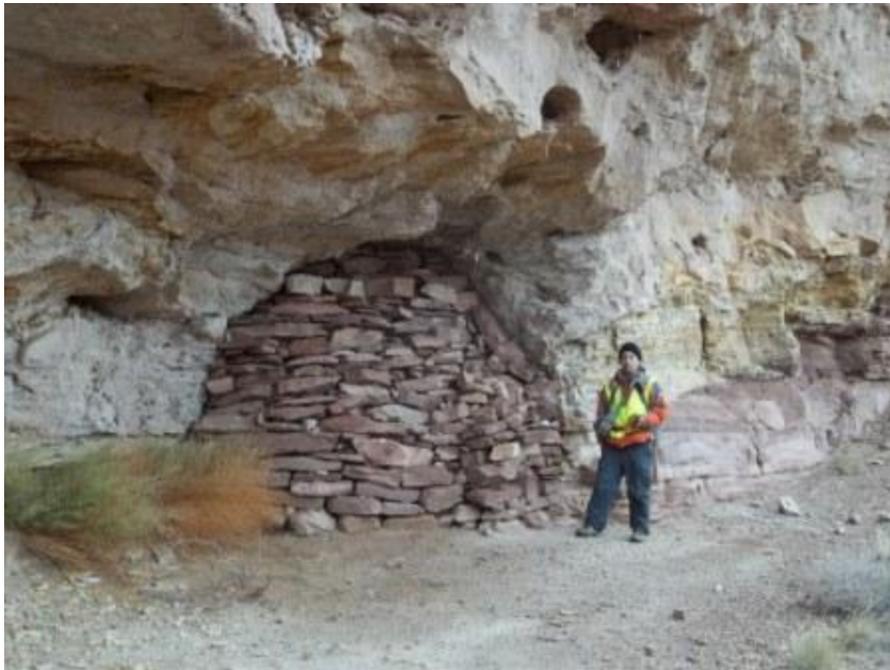
**Photo 4**

Mine Site #221- Adit

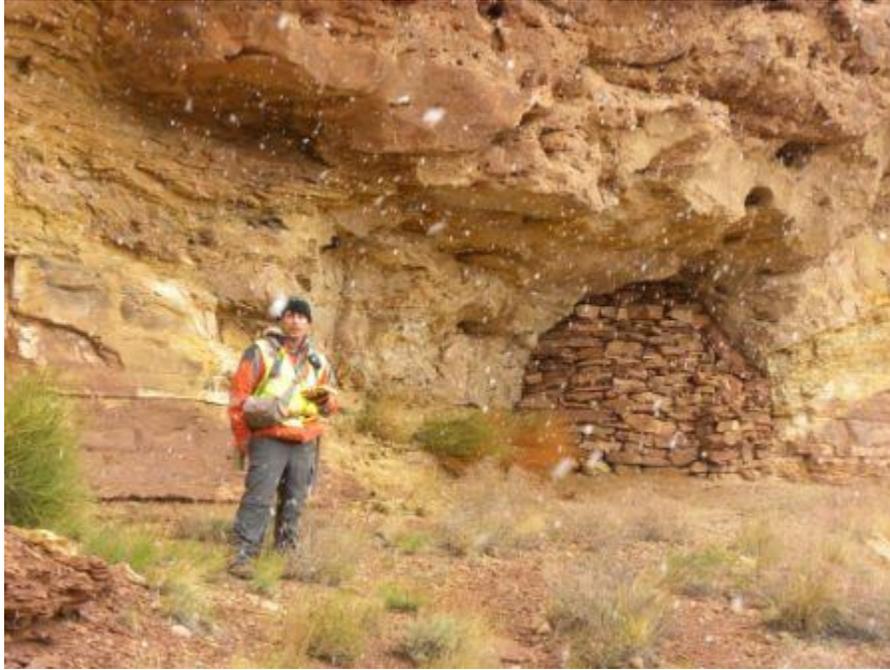
**Photo 5**

Mine Site #221- Adit

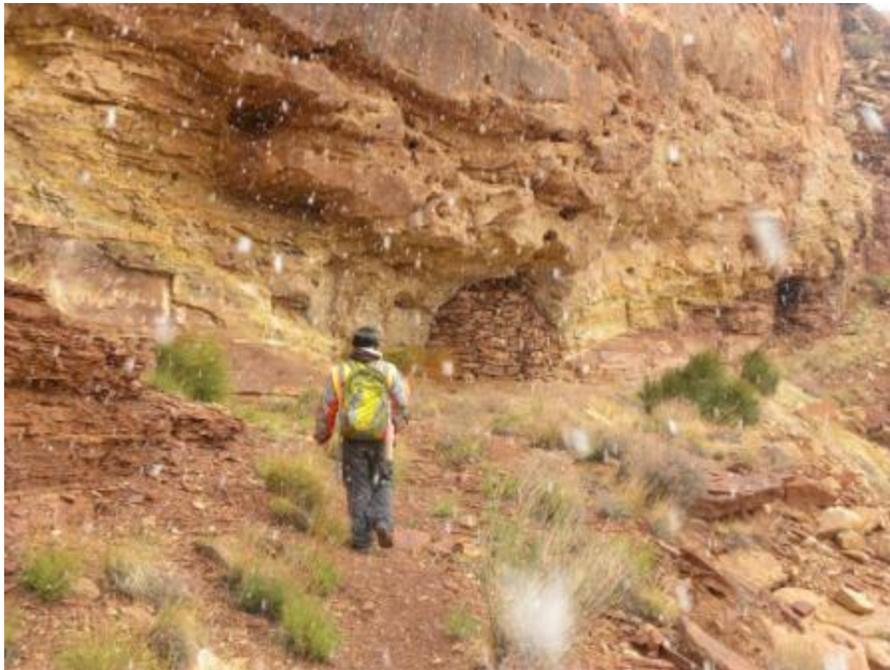
**Photo 6**

Mine Site #221- Adit

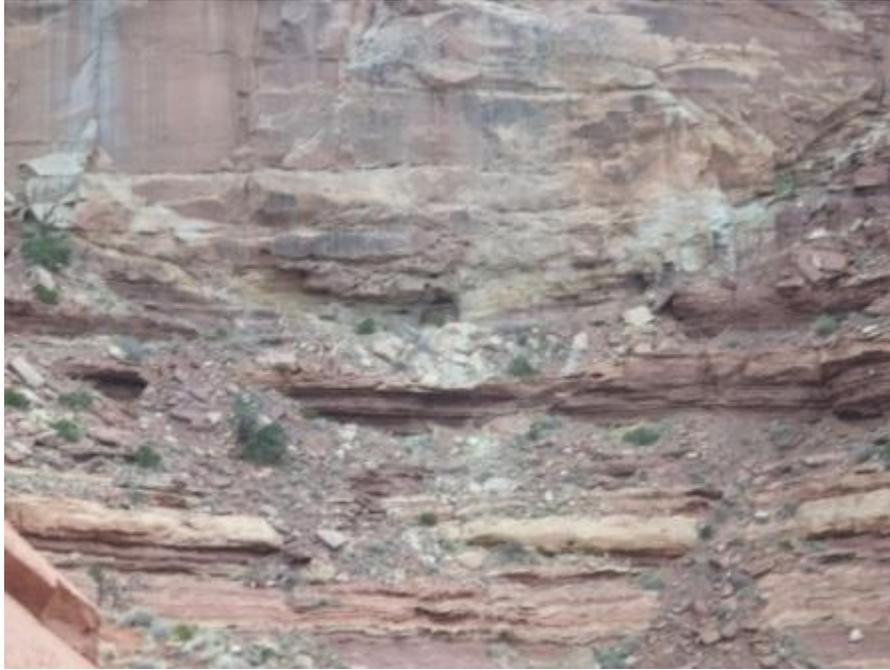
**Photo 7**

Waste rock below the adit, down the cliffside, approximately 75' x 25'

Mine Site #221 – Waste rock below adit

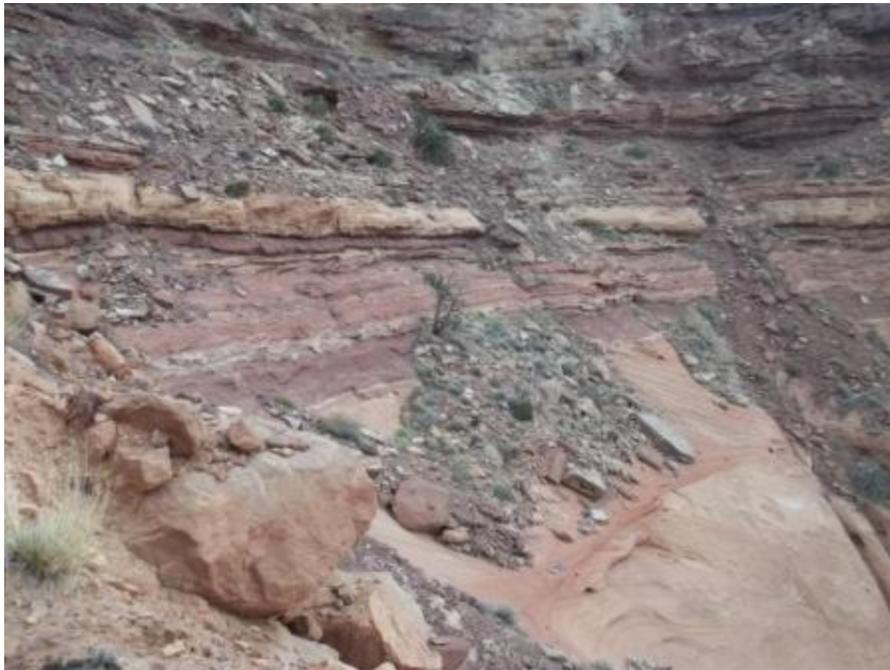
**Photo 8**

Mine Site #221– Waste rock below adit

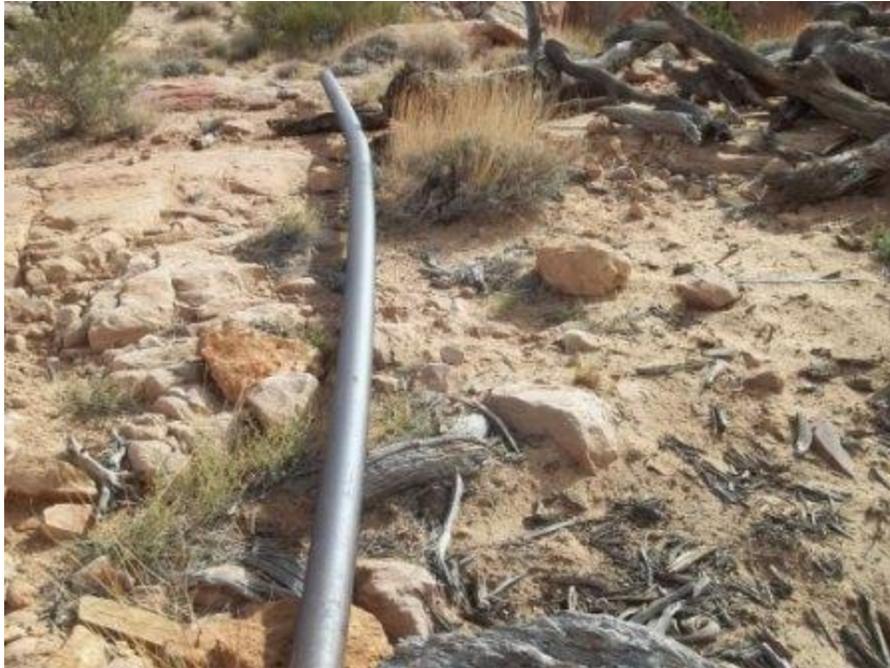
**Photo 10**

Mining debris (cable, metal scraps, pipe) immediately south of the site

Mine Site #180 - Mining debris

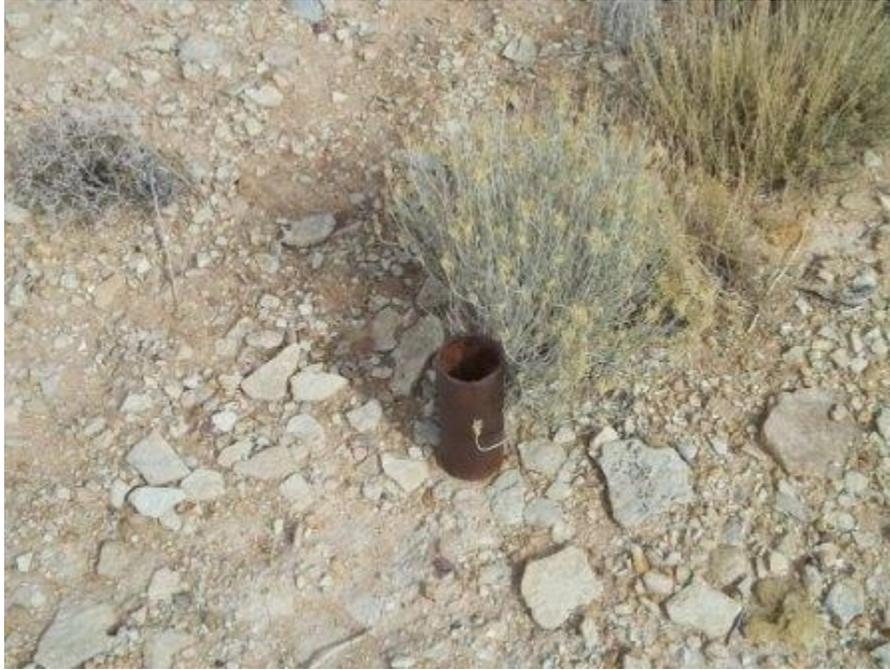
<b>Photo 11</b>	Mine Site #180 – Vent pipe above adit
-----------------	---------------------------------------

A total of 4,595 gamma radiation measurements were collected from the mine site, ranging from 4,662 cpm to 128,497 cpm. Maximum levels of approximately 125,000 cpm were found at the entrance to the adit, 15,000 cpm were found at the vent hole above the adit, and 15,000 cpm were found at bermed area at the top of the site. The measurements are represented in Figures 1 and 2.

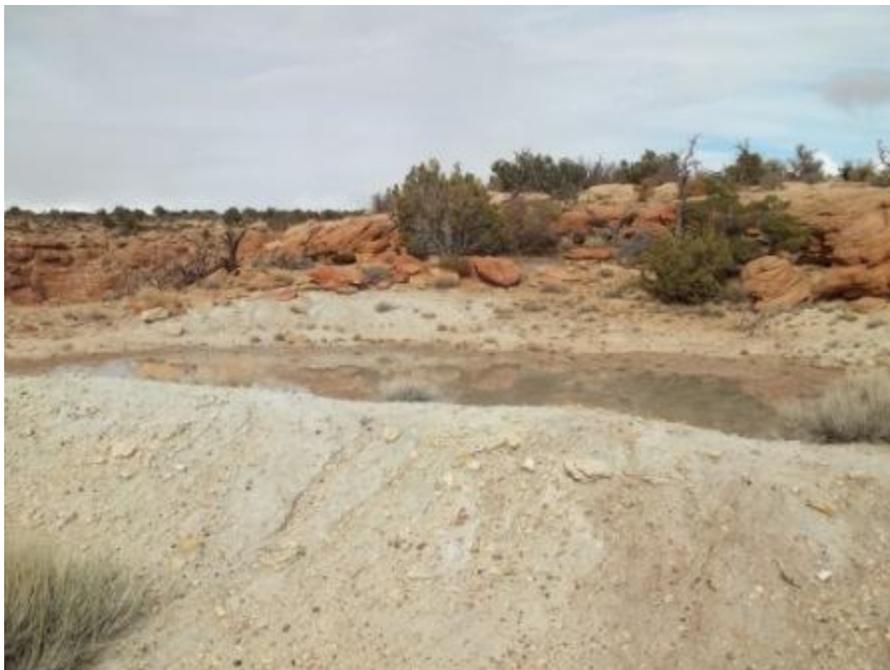
<b>Photo 12</b>	Mine Site #180 – Standing water
-----------------	---------------------------------

**0 to 0.25 miles:** Onsite - Bermed area with standing water at top of the site

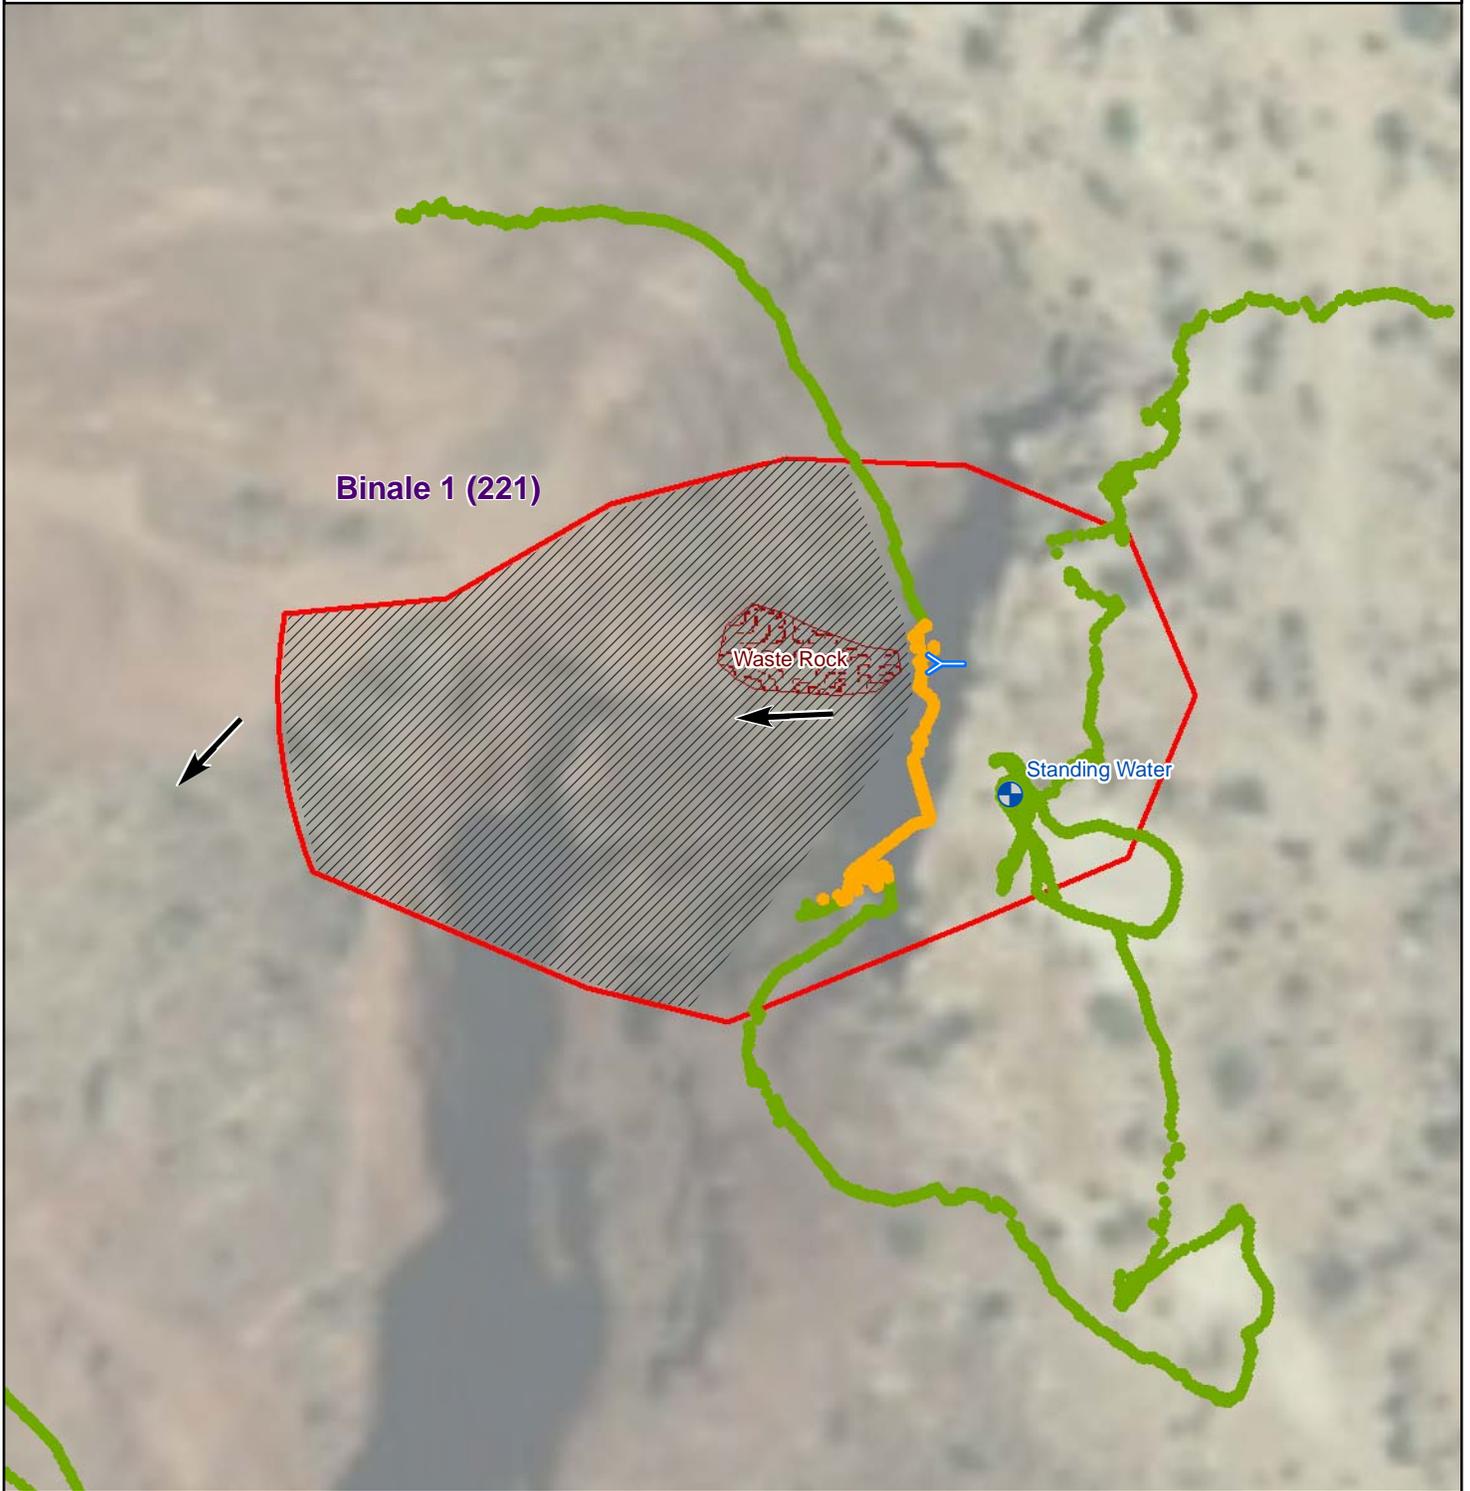
**Figure 1 - Gamma Radiation Measurements, Above Two Times Background  
Binale 1 (221)  
Oljato Chapter, Navajo Nation**

Average background 10,289 cpm

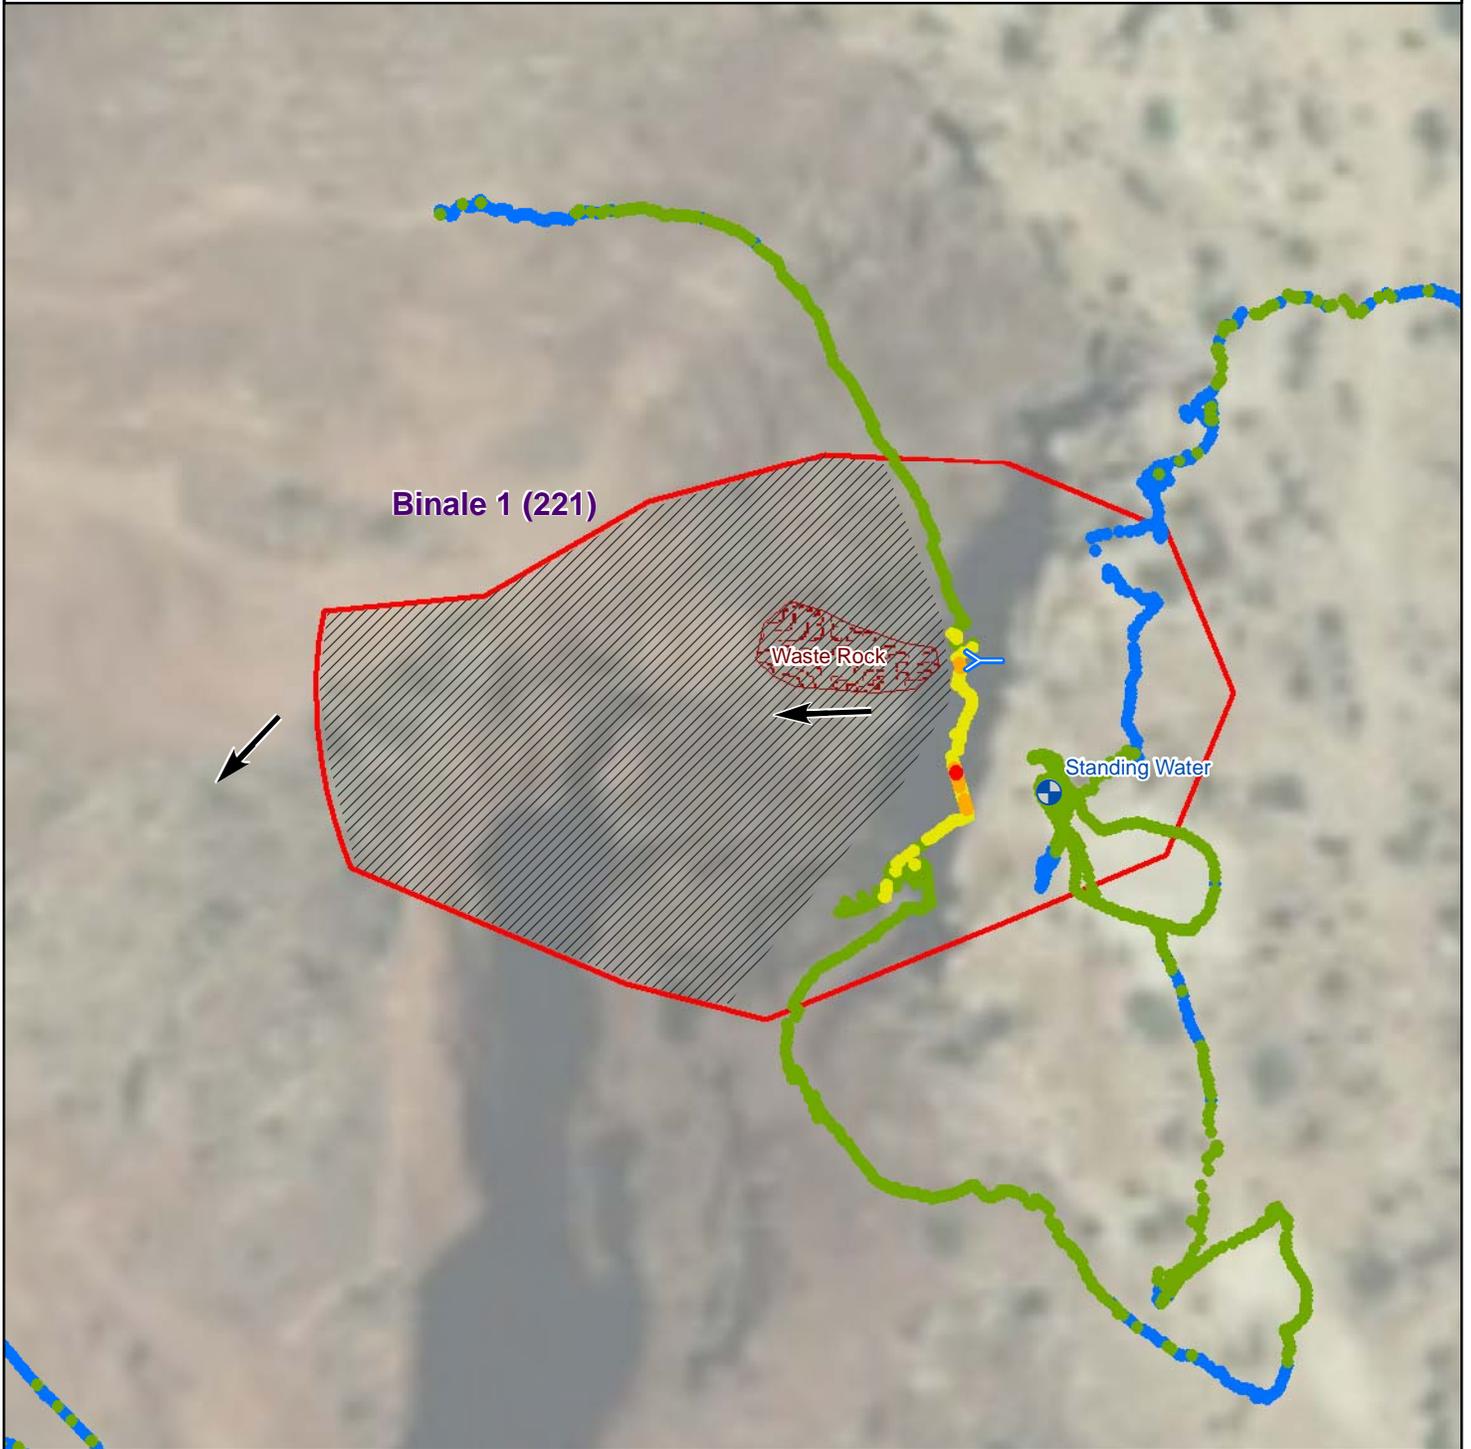
**Figure 2 - Gamma Radiation Measurements  
Binale 1 (221)  
Oljato Chapter, Navajo Nation**

**Average background 10,289 cpm**
