Navajo Abandoned Uranium Mine

Site Screen Report

Mine Name: Monument No. 3
Mine ID: 226

April 2012

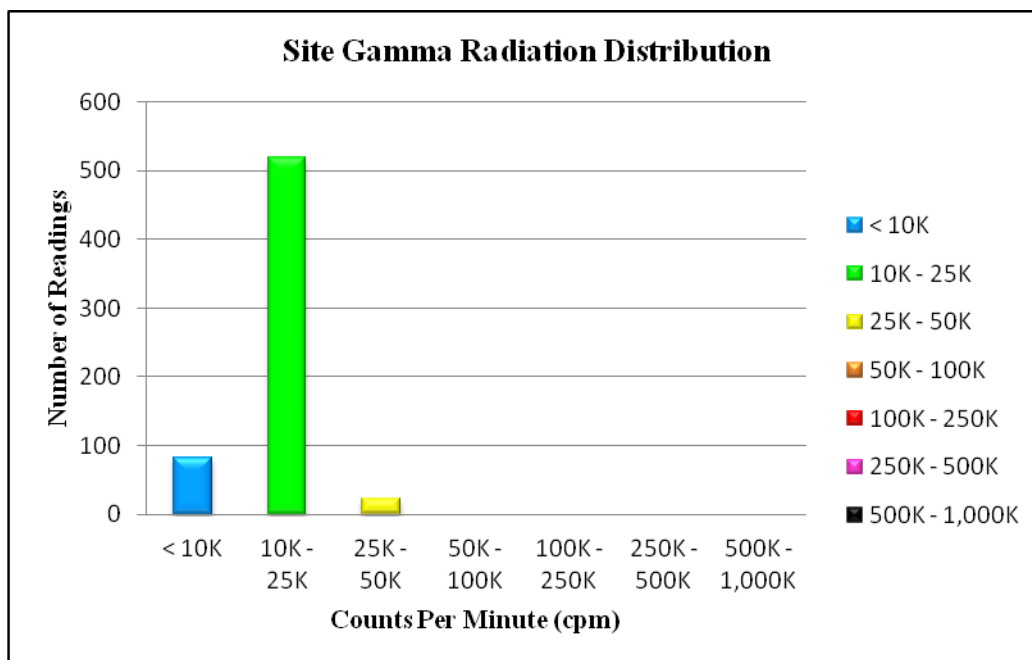
Distribution Chart and Statistics:

Site Gamma Radiation Statistics	
Number of Readings	624
Minimum (cpm)	5,873
Maximum (cpm)	43,688
Mean (cpm)	14,550
Median (cpm)	13,927
Standard Deviation	5,119

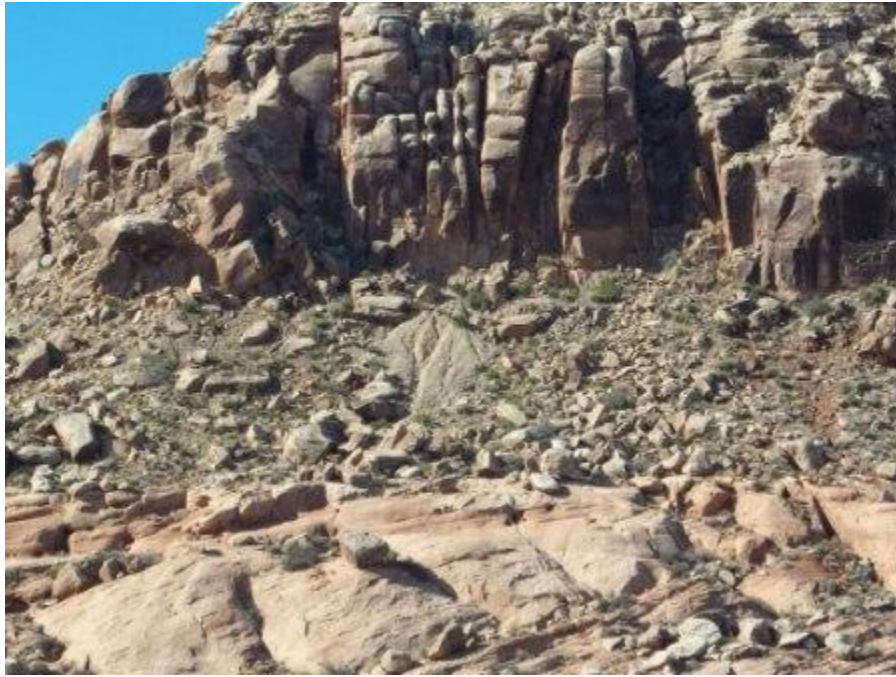
Photo 1

Mine Site #226

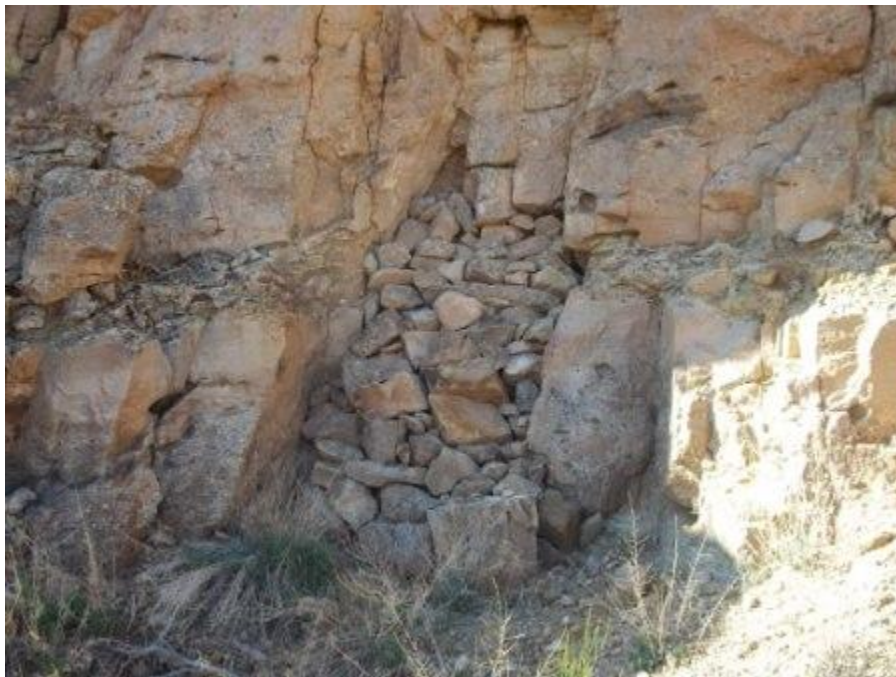
Photo 2

1 adit, stone sealed, approximately 7' x 5', alongside the hiking trail running through the site

Mine Site #226 - Adit

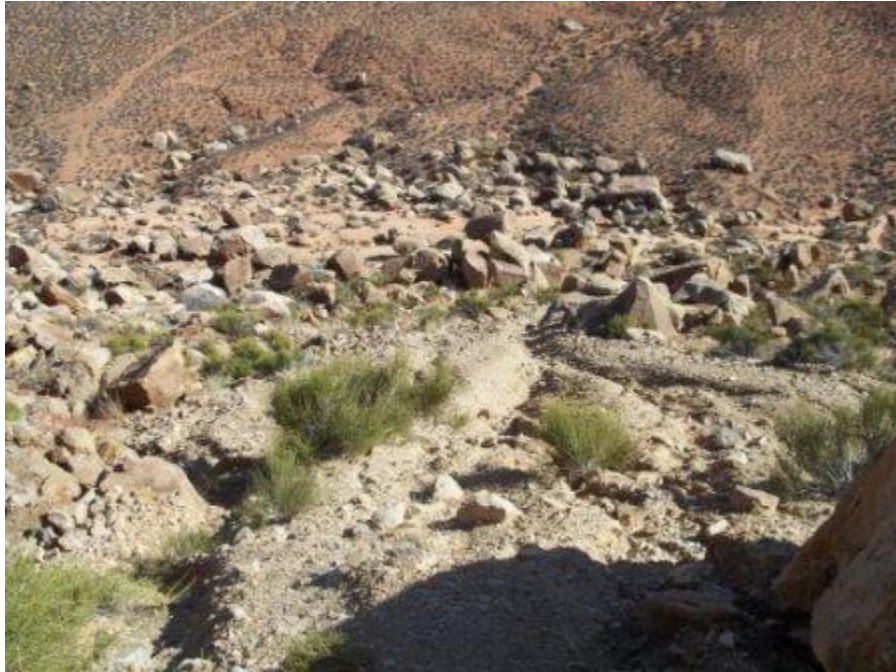
Photo 3

Waste rock/tailings below the adit, approximately 150' long x 60' wide

Mine Site #226 - Tailings

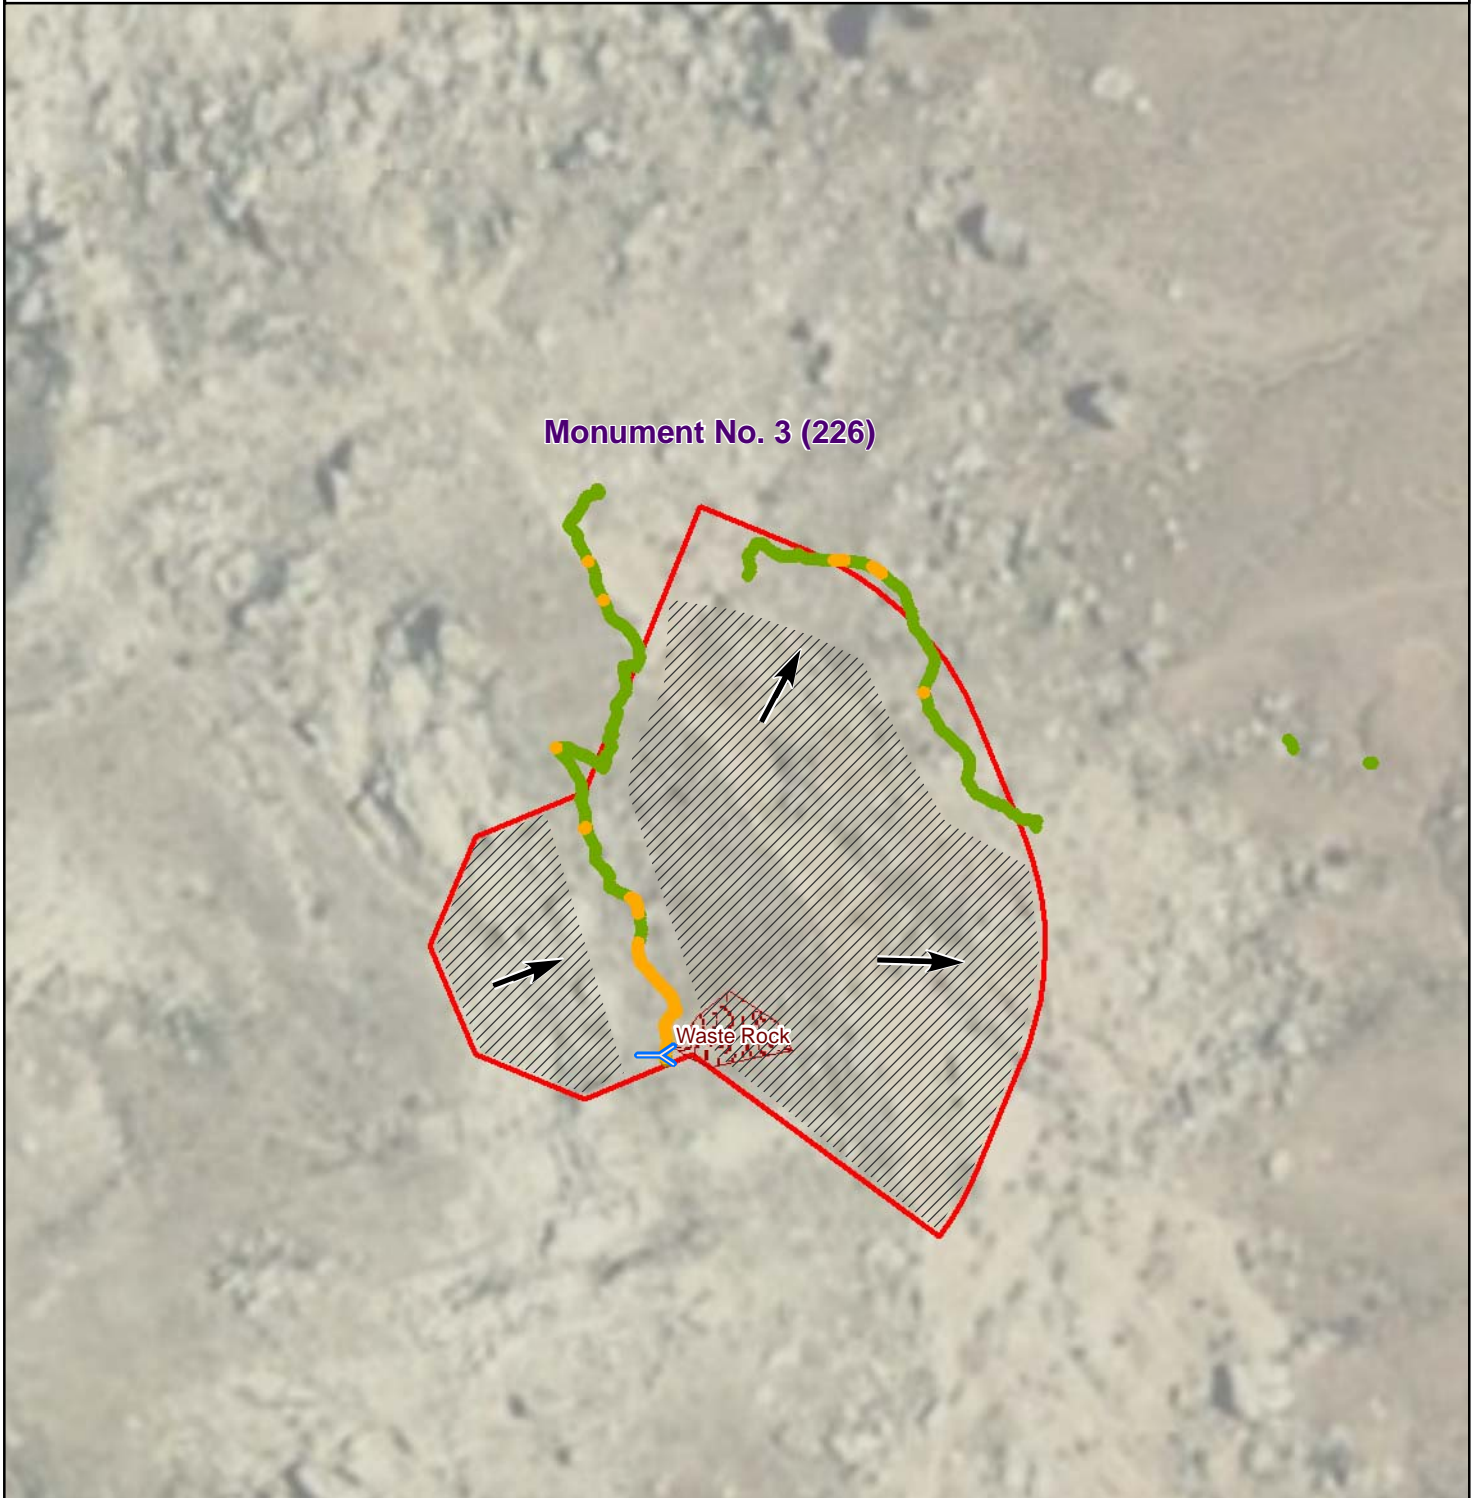
**Figure 1 - Gamma Radiation Measurements, Above Two Times Background
Monument No. 3 (226)
Oljato Chapter, Navajo Nation**

A total of 624 gamma radiation measurements were collected from the mine site, ranging from 5,873 cpm to 43,688 cpm. Maximum levels of approximately 45,000 cpm were found in the vicinity of the waste rock. The measurements are represented in Figures 1 and 2.

Average background 9,058 cpm

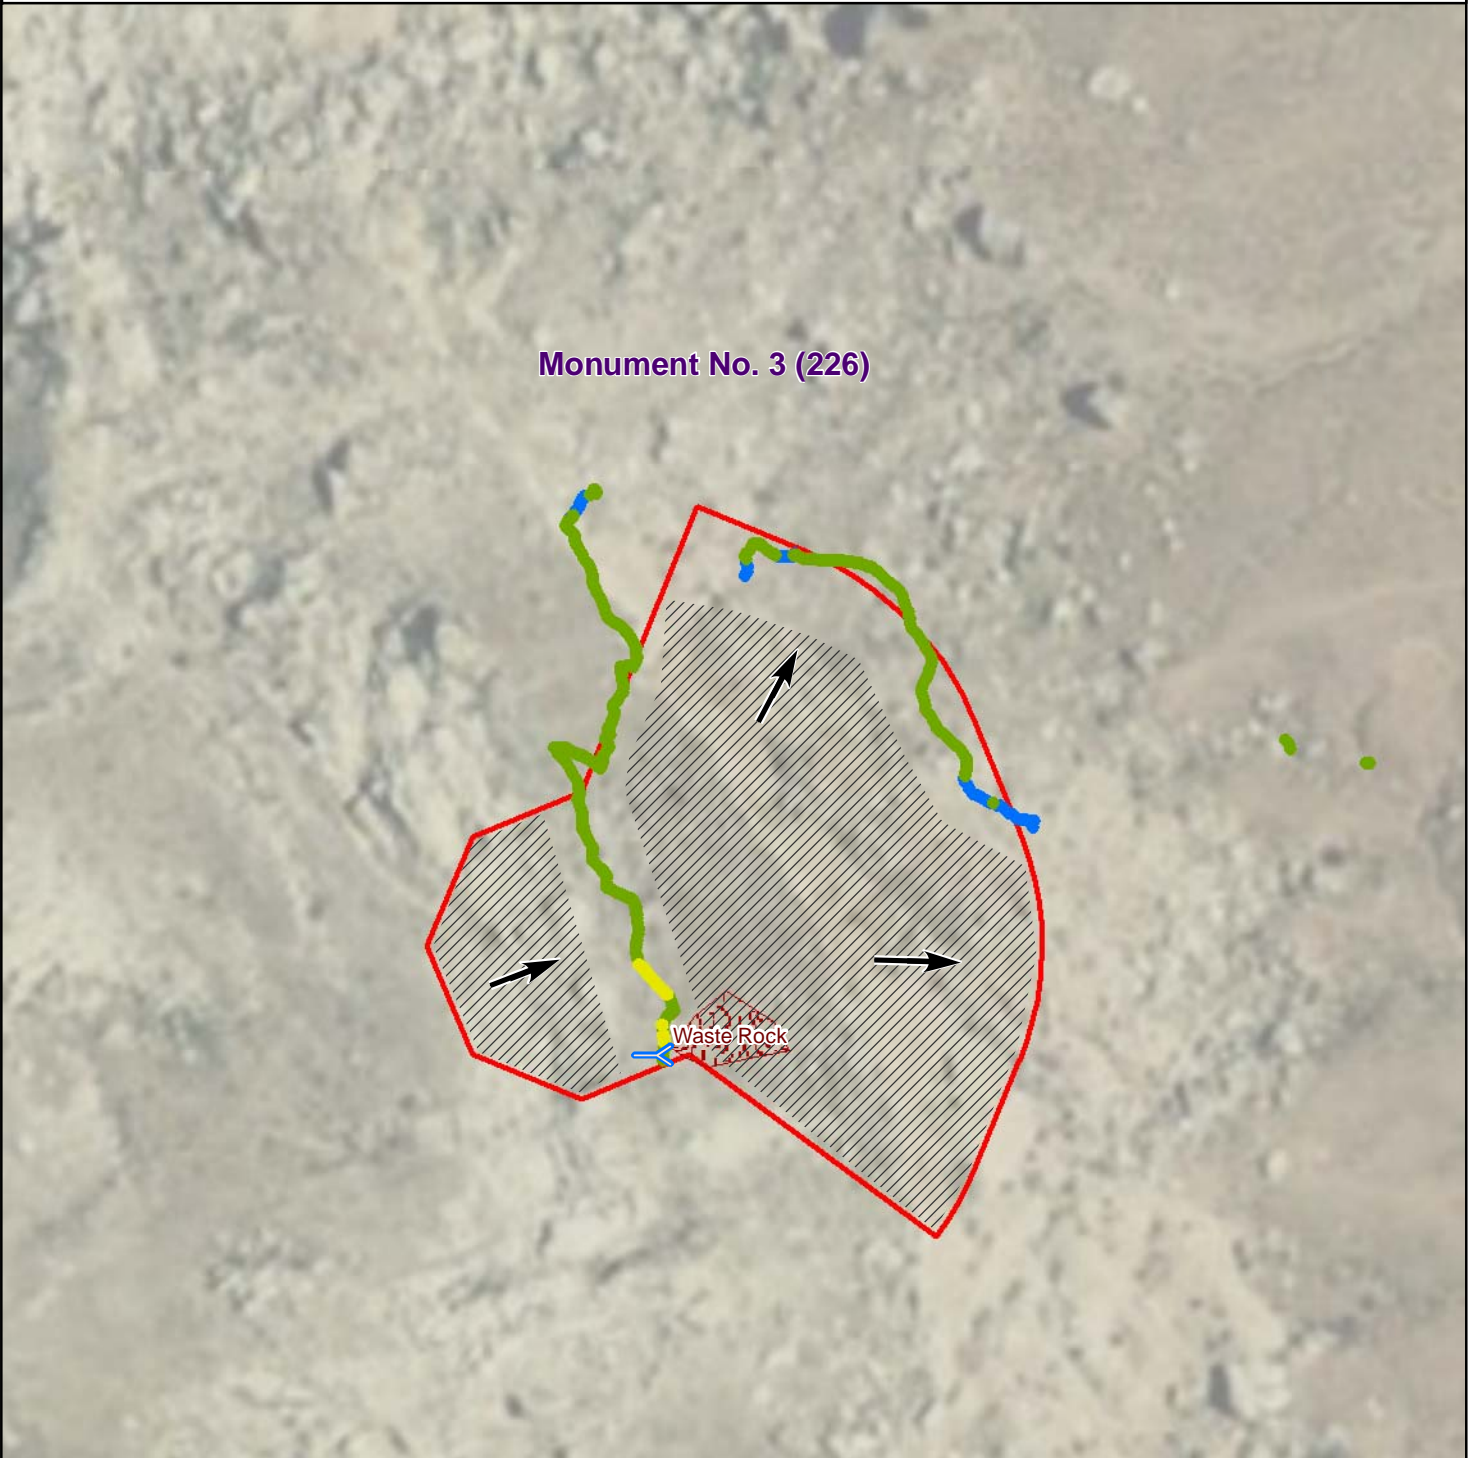
**Figure 2 - Gamma Radiation Measurements
Monument No. 3 (226)
Oljato Chapter, Navajo Nation**

Average background 9,058 cpm
