Navajo Abandoned Uranium Mine

Site Screen Report

Mine Name: Kachina No. 6
Mine ID: 230

Weston Solutions, Inc.

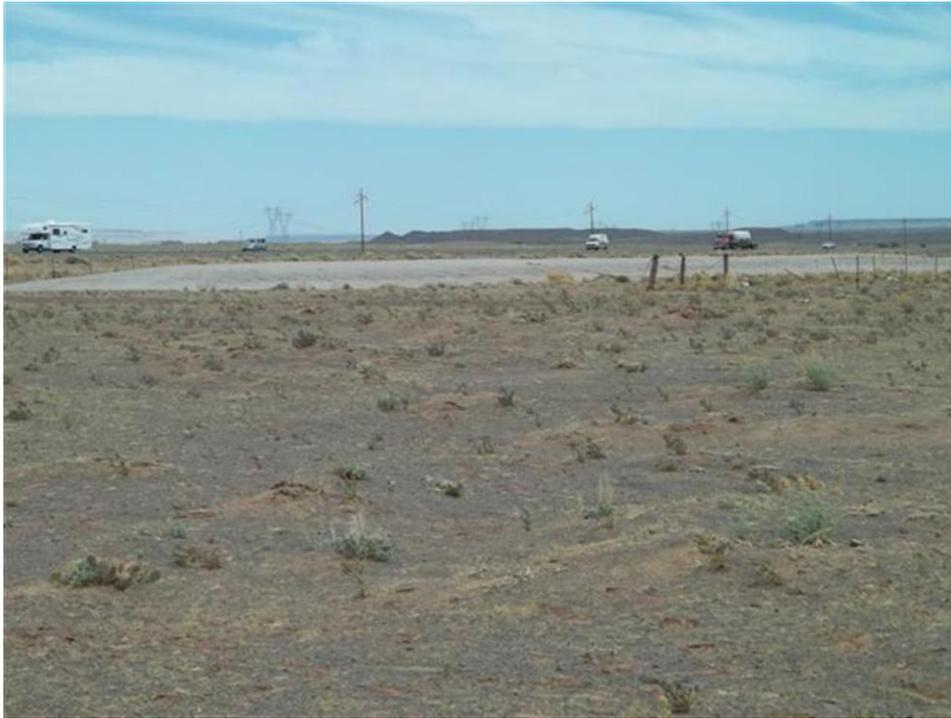
Photo 1: Mine Site #230; Site and Hwy 89

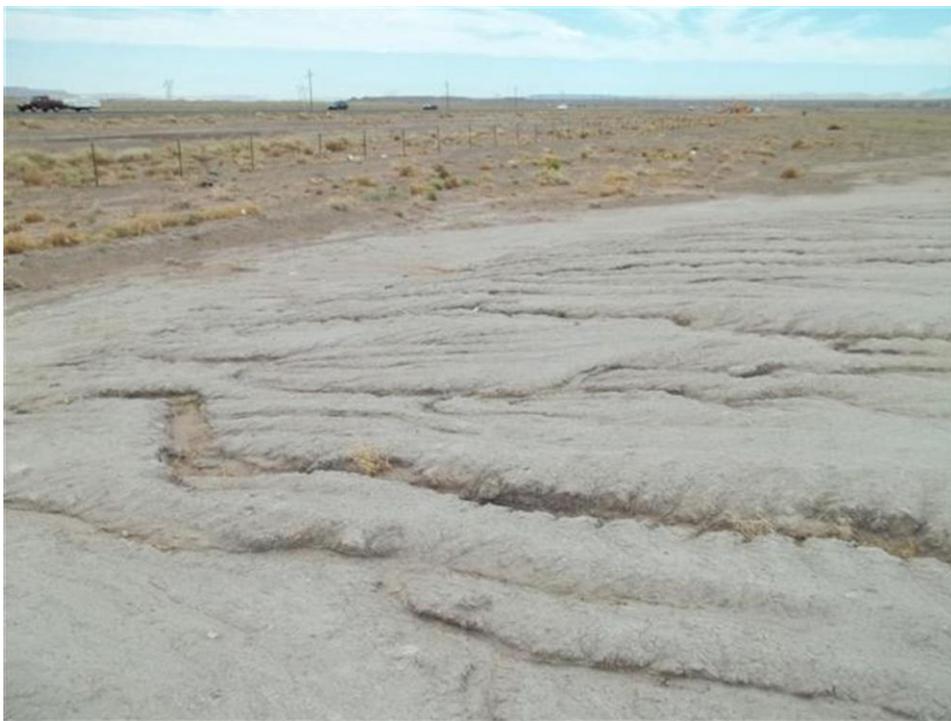
Photo 2: Mine Site #230; Mound area

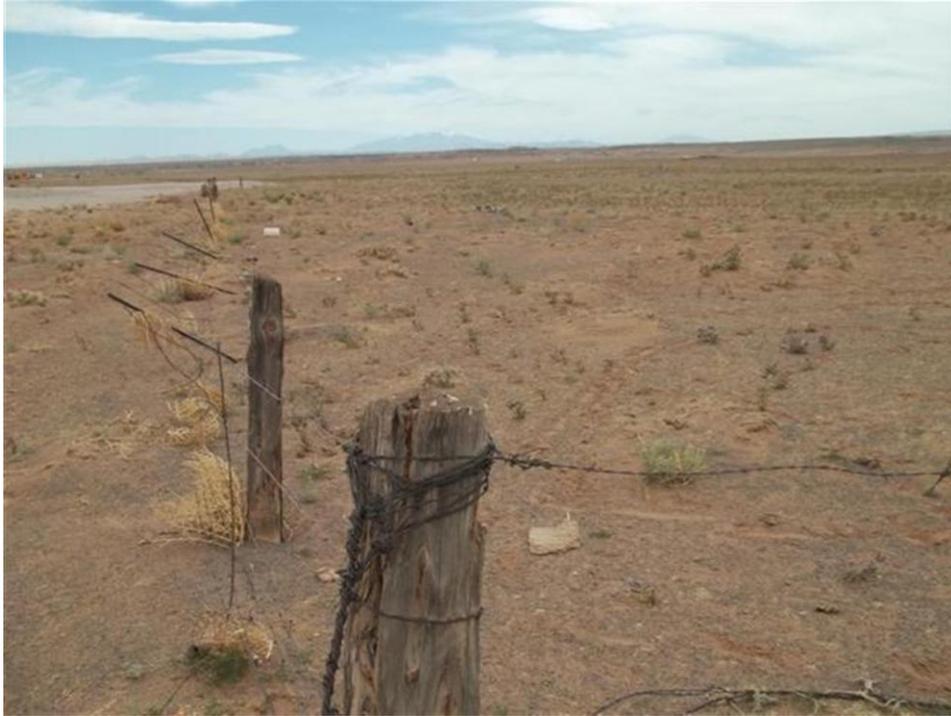
Reclamation cap in center/north part of site; fenced area in NW part of site

Photo 3: Mine Site #230; Fenced area

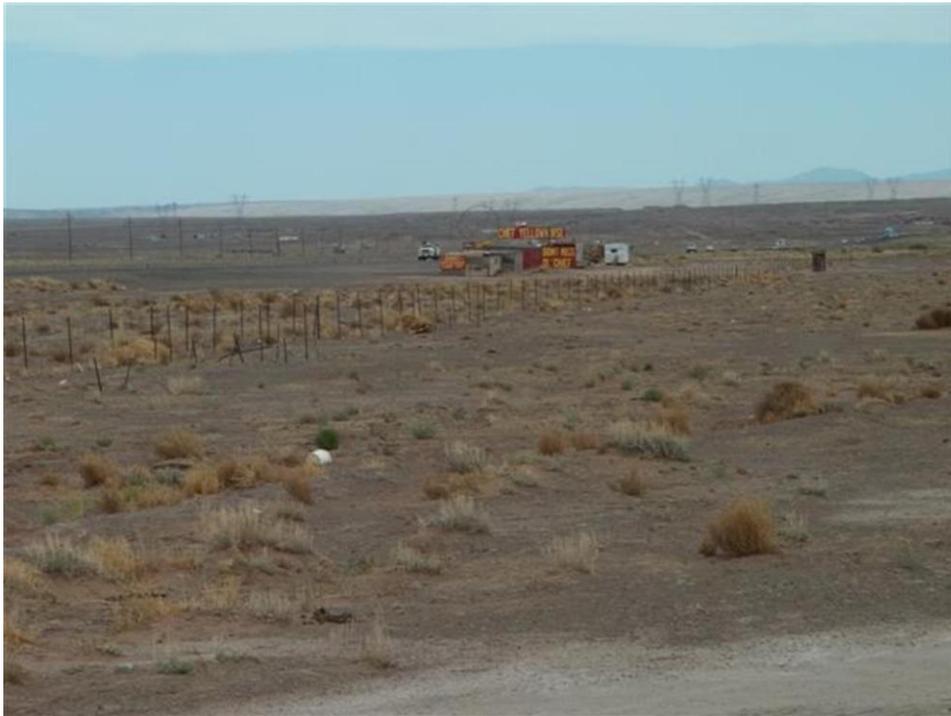
200 feet to 0.25 mile: Chief Yellow Horse vendor stand 0.2 mi S of site

Photo 4: Mine Site #230; Vendor stand south of site

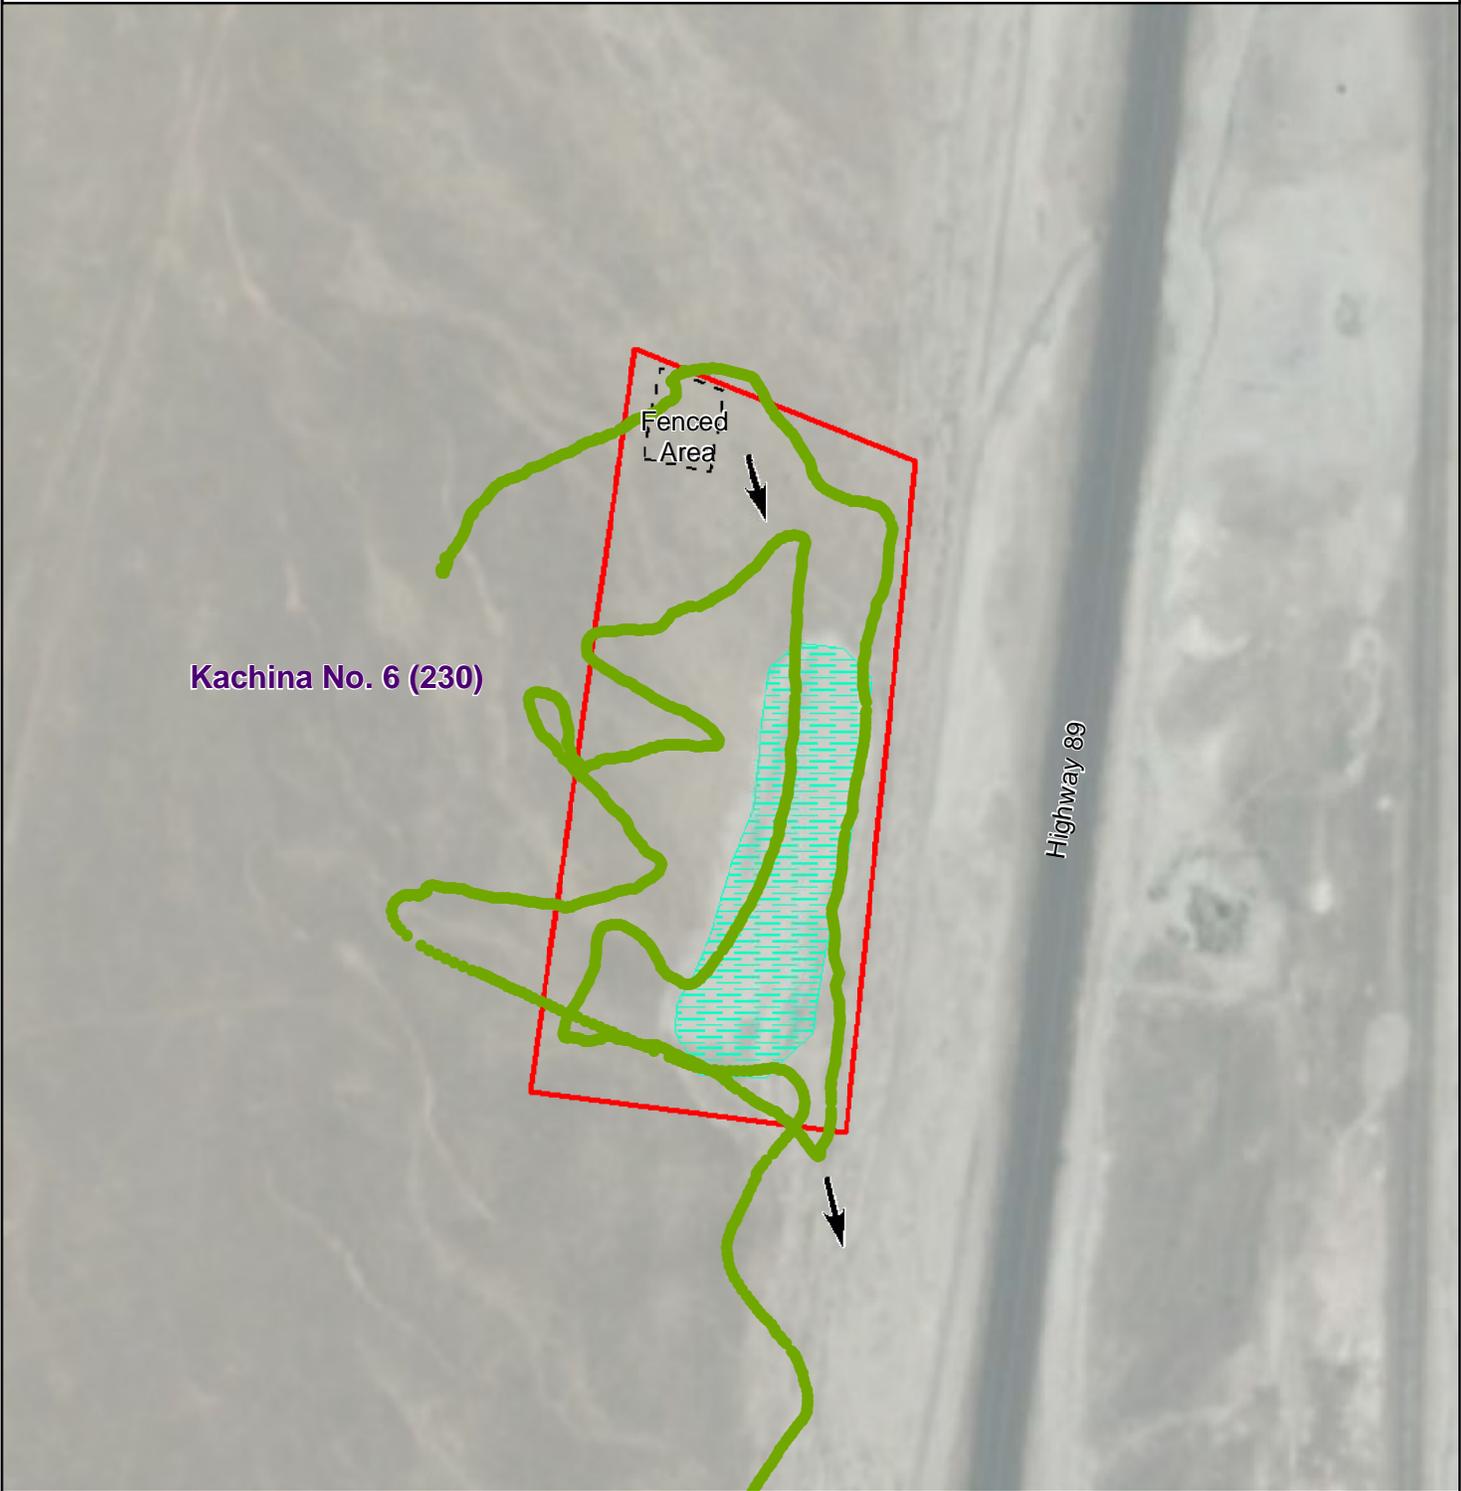
A total of 1,375 gamma radiation measurements were collected from the mine site, ranging from 10,700 cpm to 19,787 cpm. The measurements are represented in Figures 1 and 2.

**Figure 1 - Gamma Radiation Measurements, Above Two Times Background
Kachina No. 6 (230)
Coalmine Mesa Chapter, Navajo Nation**

Average background 10,730 cpm

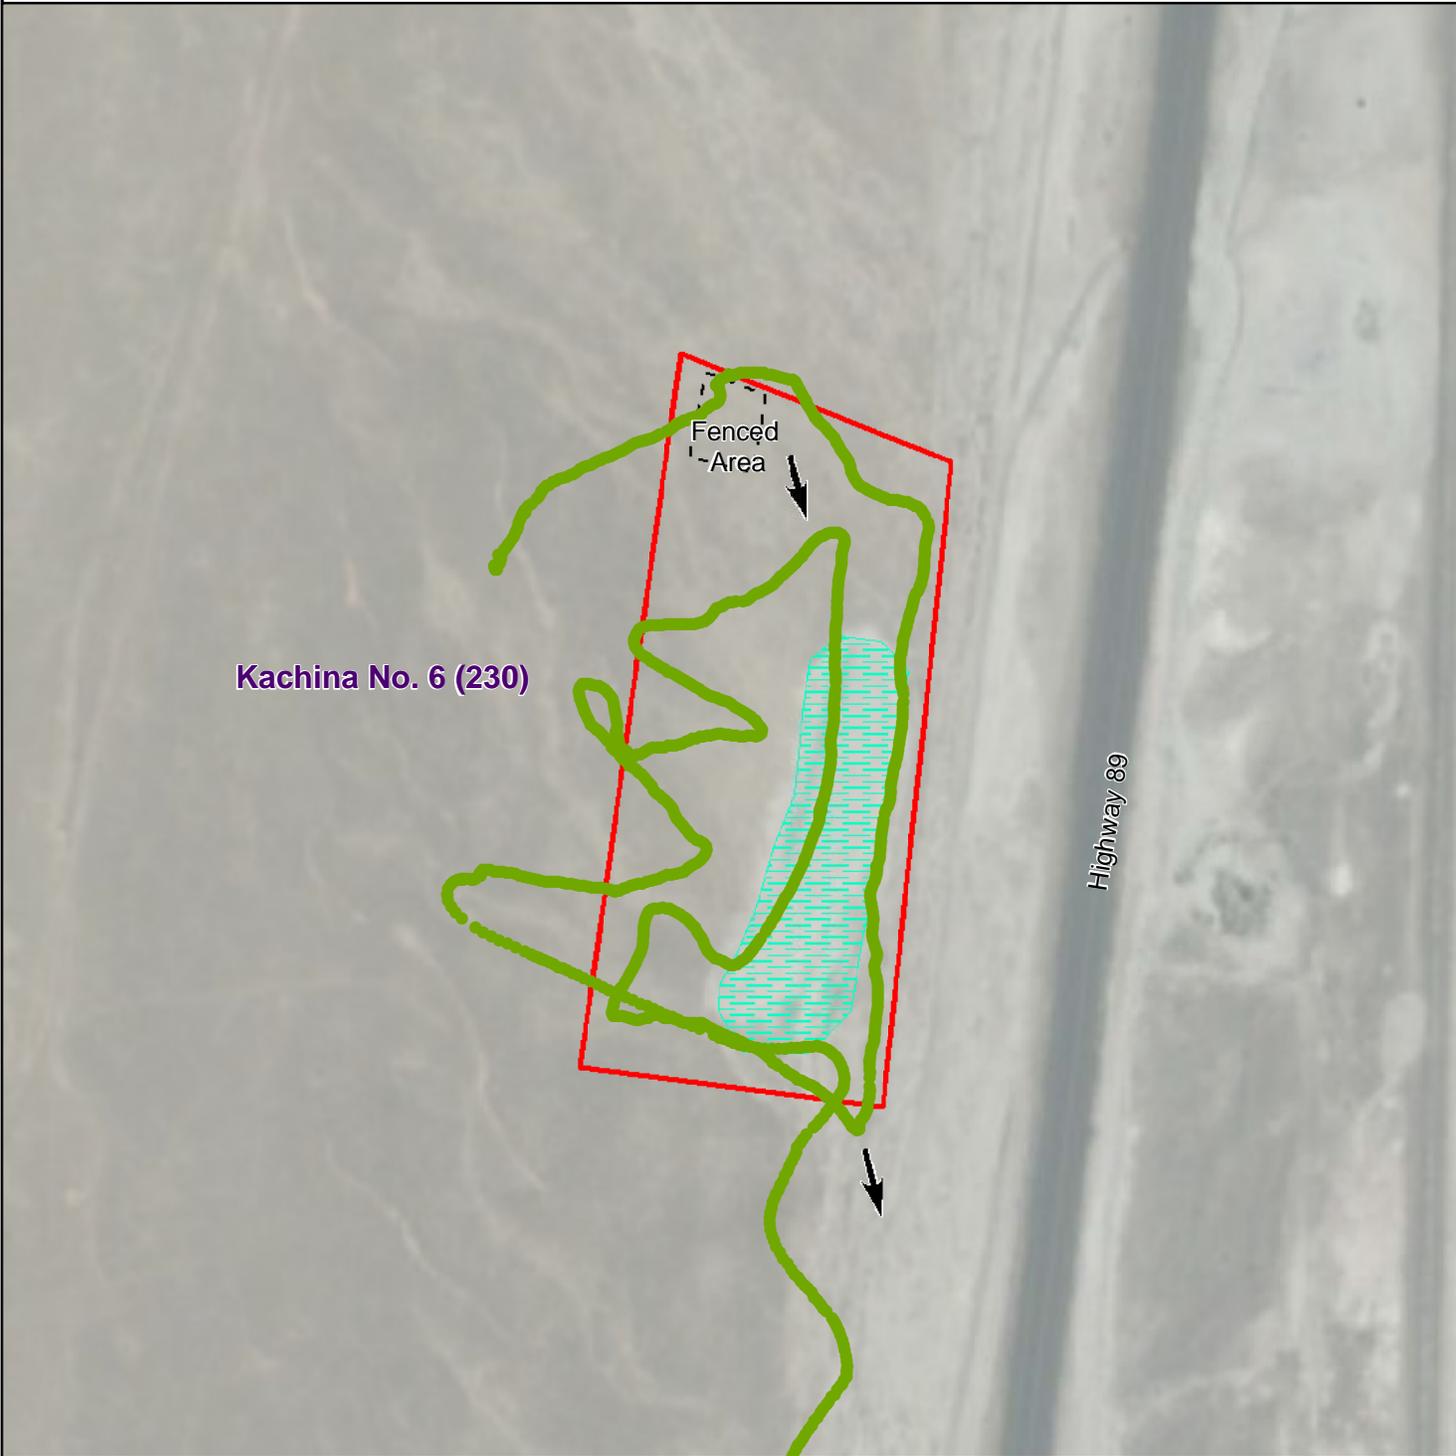
**Figure 2 - Gamma Radiation Measurements
Kachina No. 6 (230)
Coalmine Mesa Chapter, Navajo Nation**

Measured as counts per minute (cpm) Average background 10,730 cpm
