Navajo Abandoned Uranium Mine

Site Screen Report

Mine Name: AEC Sample 13756 & USGS Sample MV-8
Mine ID: 243

April 2012

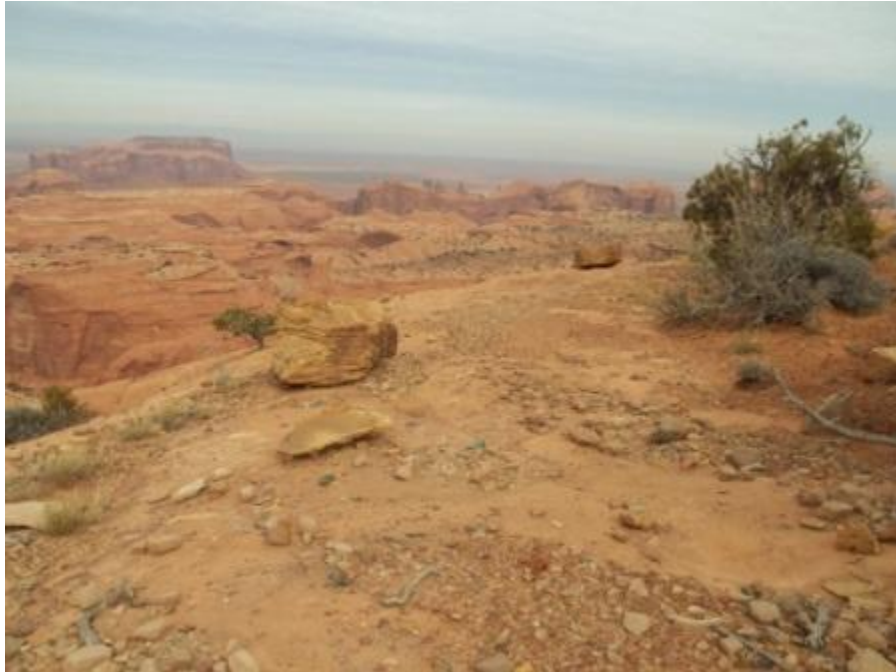
Photo 3

Mine Site #243
