Navajo Abandoned Uranium Mine

Site Screen Report

Mine Name: Golden Crown
Mine ID: 245

Weston Solutions, Inc.

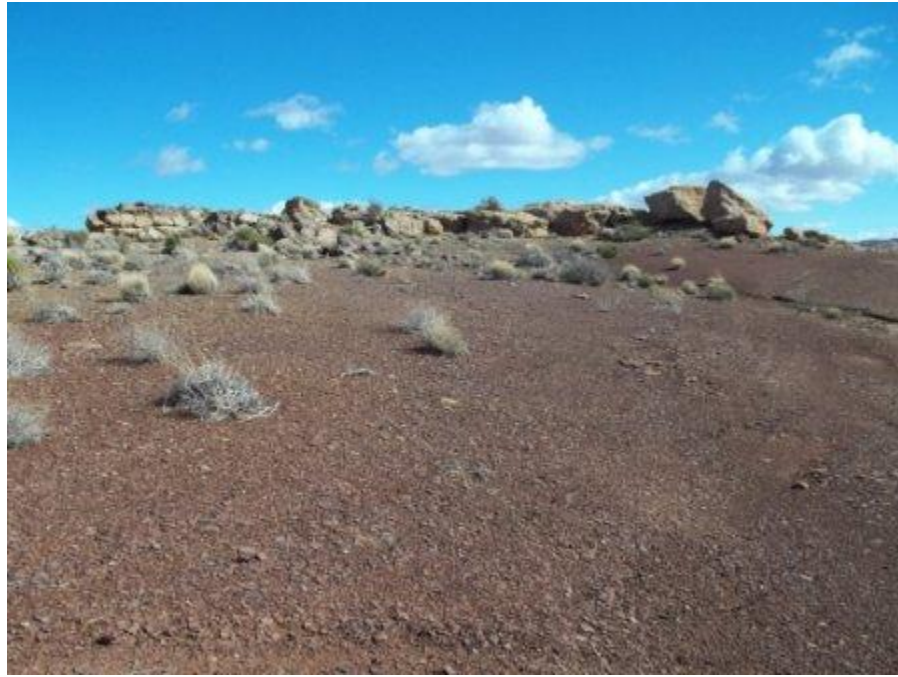
Photo 1

Mine Site #245

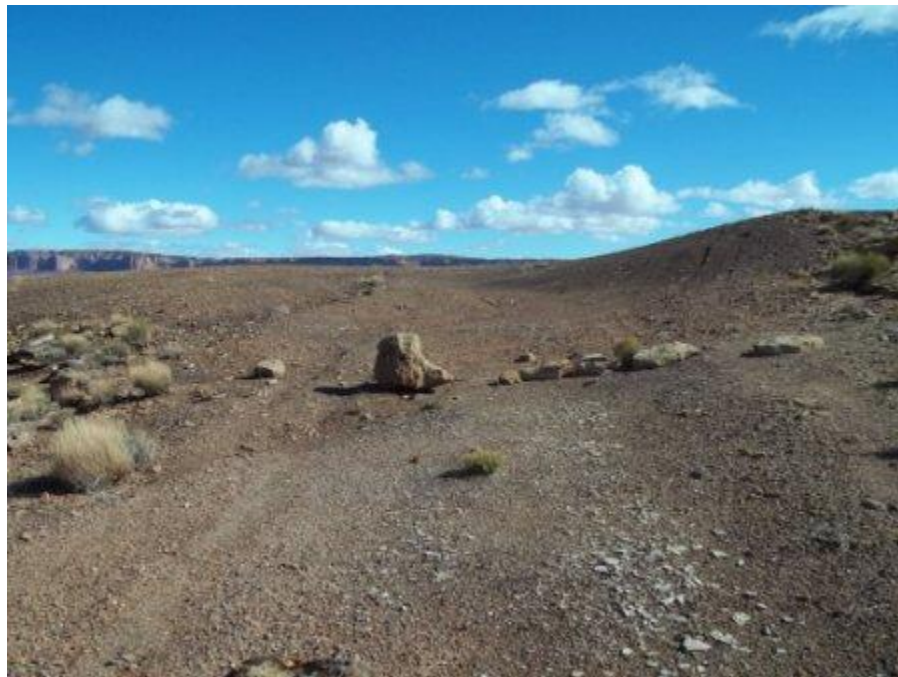
Photo 2

A total of 2,731 gamma radiation measurements were collected from the mine site, ranging from 6,159 cpm to 227,917 cpm. Maximum levels of approximately 50,000 cpm were found near the reclamation cap and 225,000 cpm were found near the yellow outcrop. The measurements are represented in Figures 1 and 2.

Mine Site #245 - Elevated gamma readings

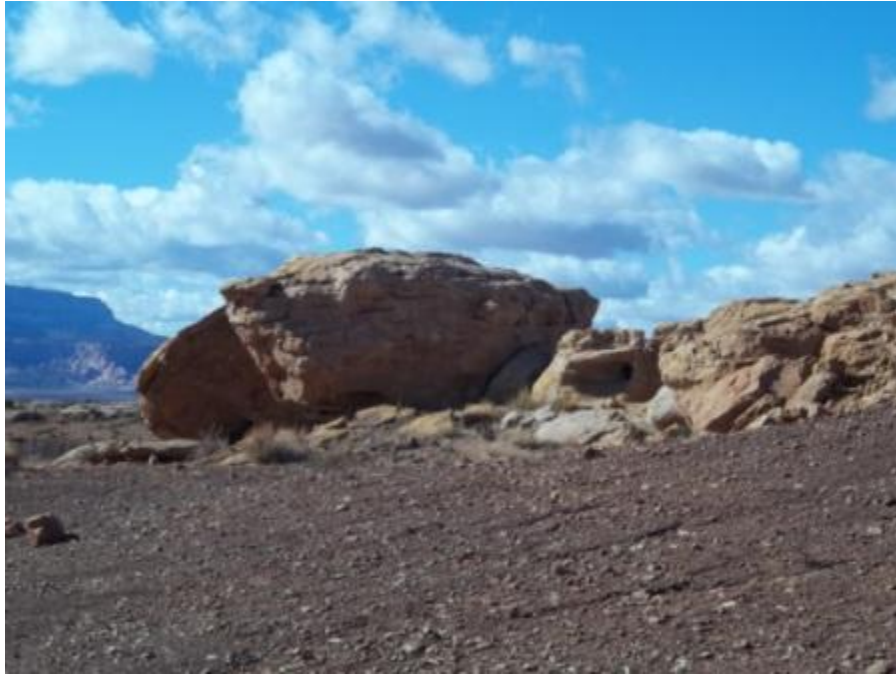
Photo 3

Reclamation cap, 250' long x 200' wide, red clay; yellow-tan rock outcrop, near the cap with elevated readings

Mine Site #245 – Capped area
