# **Navajo Abandoned Uranium Mine**

## **Site Screen Report**

### **King No. 2 AUM Site**

**March 2010**

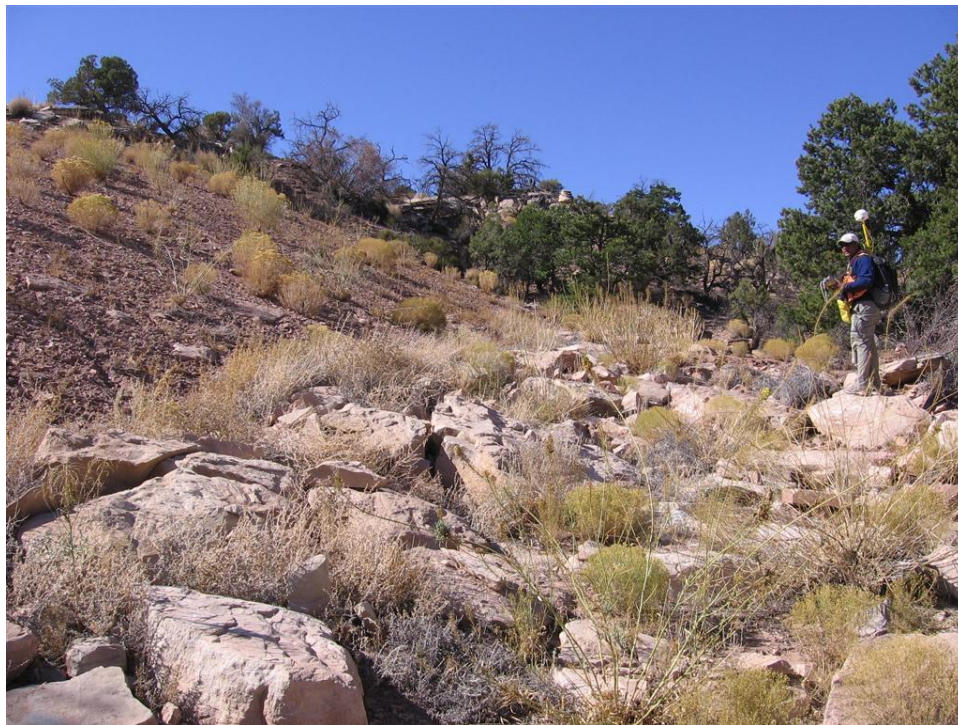
Photo 3. Waste rock

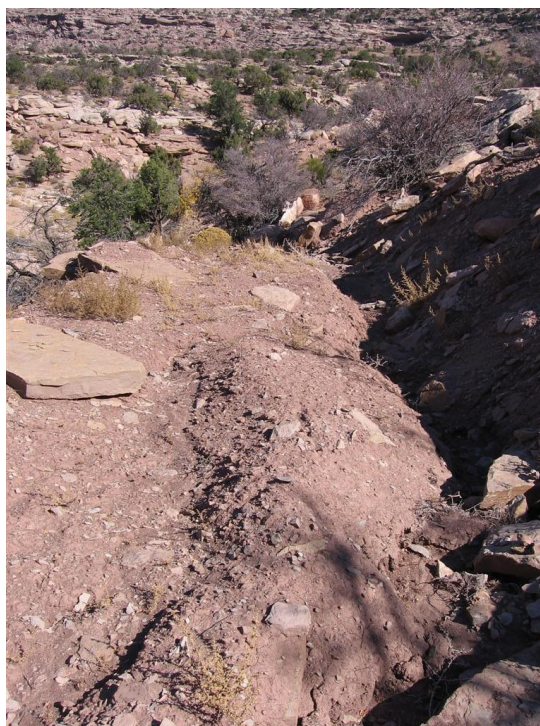
A total of 1,800 gamma radiation measurements were collected from the mine site, ranging from 5,475 cpm to 43,474 cpm. Measurements in the vicinity of the waste debris were found at levels of approximately 40,000 cpm, and in the drainage up to 25,000 cpm. The measurements are represented in Figures 1 and 2.

Photo 4. Waste debris and drainage
