# Navajo Abandoned Uranium Mine

## Site Screen Report

### **NA-0424 AUM Site**

**August 2010**

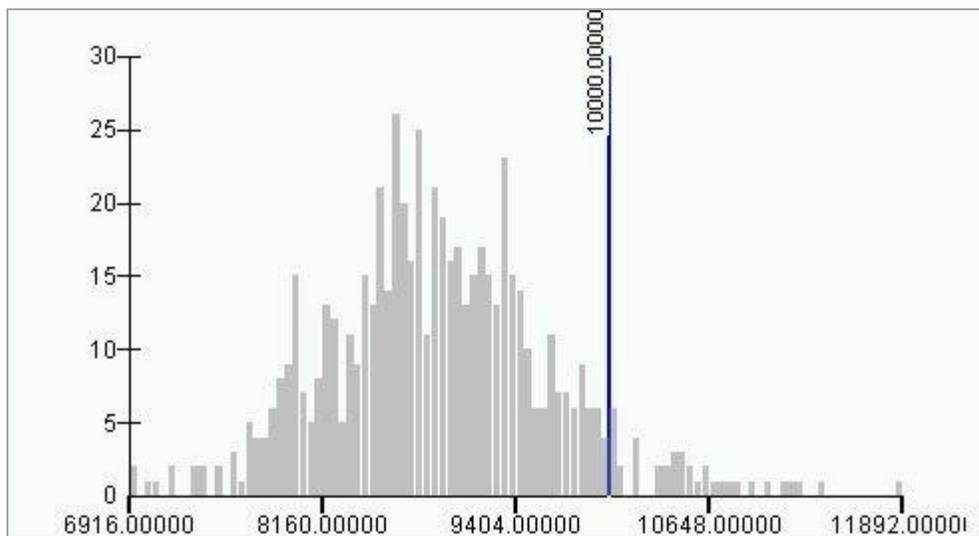
The following chart and statistics were generated by ESRI ArcGIS 9.3.1, and show the general distribution of the site gamma radiation measurements. The horizontal X axis represents the gamma radiation reading levels in cpm (lowest levels to the left). The vertical Y axis represents the frequency of each gamma radiation level.

Count:	612
Minimum:	6916.00000
Maximum:	11892.00000
Sum:	5453062.00000
Mean:	8910.23203
Median:	8873.50000
Standard Deviation:	719.78038

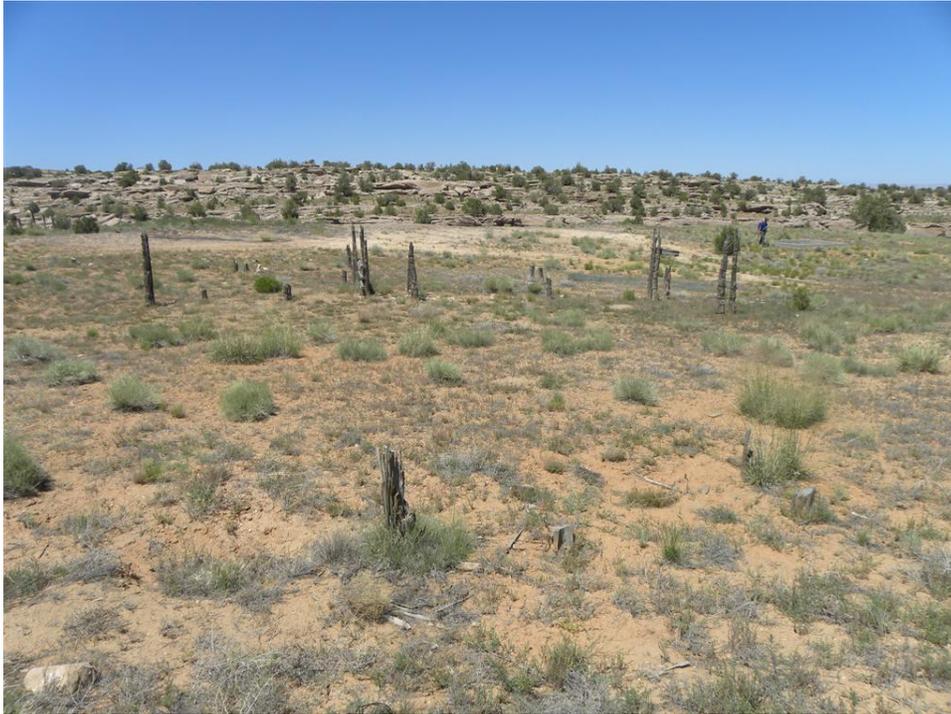
Photo 1. NA-0424 site

NA-0424 mine consists of an area of 2,627.7 m<sup>2</sup>. According to Beclabito Chapter House personnel, the site likely functioned as a transfer station. Site may be mistaken for NA-0420 (ID# 276). The mine was not identified as ever being operational. No other historical information or any additional ownership / lease information was identified in the EPA/AUM database.

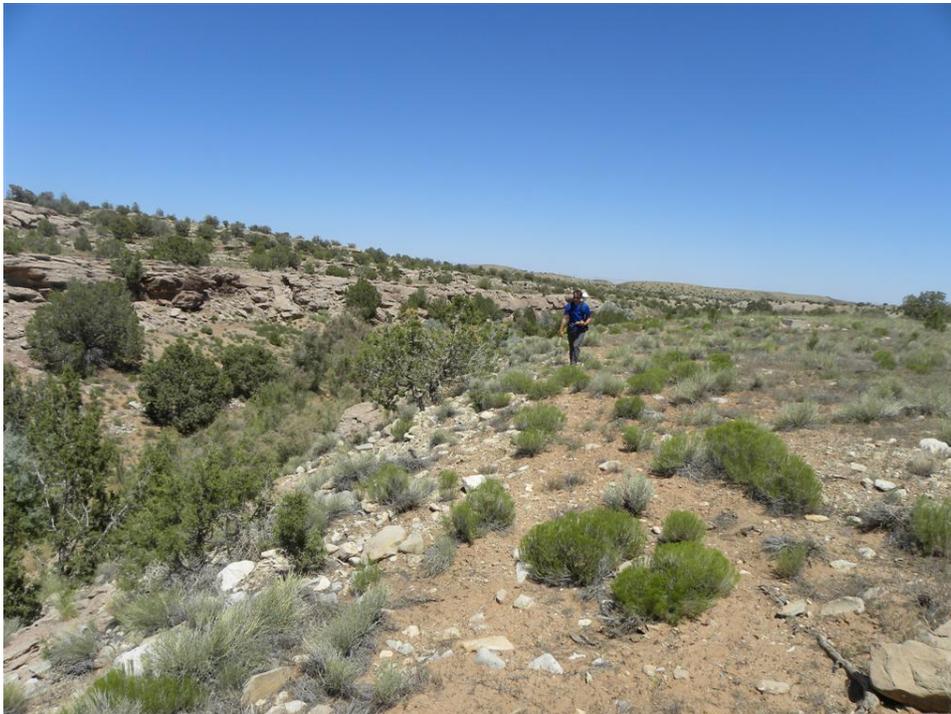
Possible wetlands in the drainage area located between the site and Beclabito Day School

Photo 2. NA-0424 site, drainage north of site (looking east)

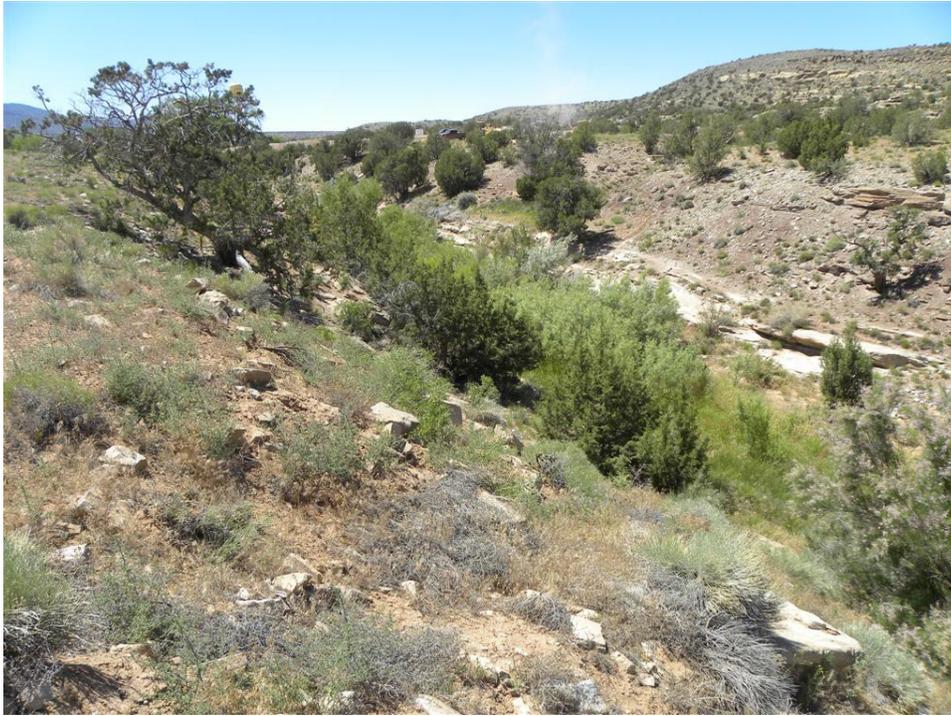
Photo 3. NA-0424 site, drainage north of site (looking west), towards Beclabito Day School

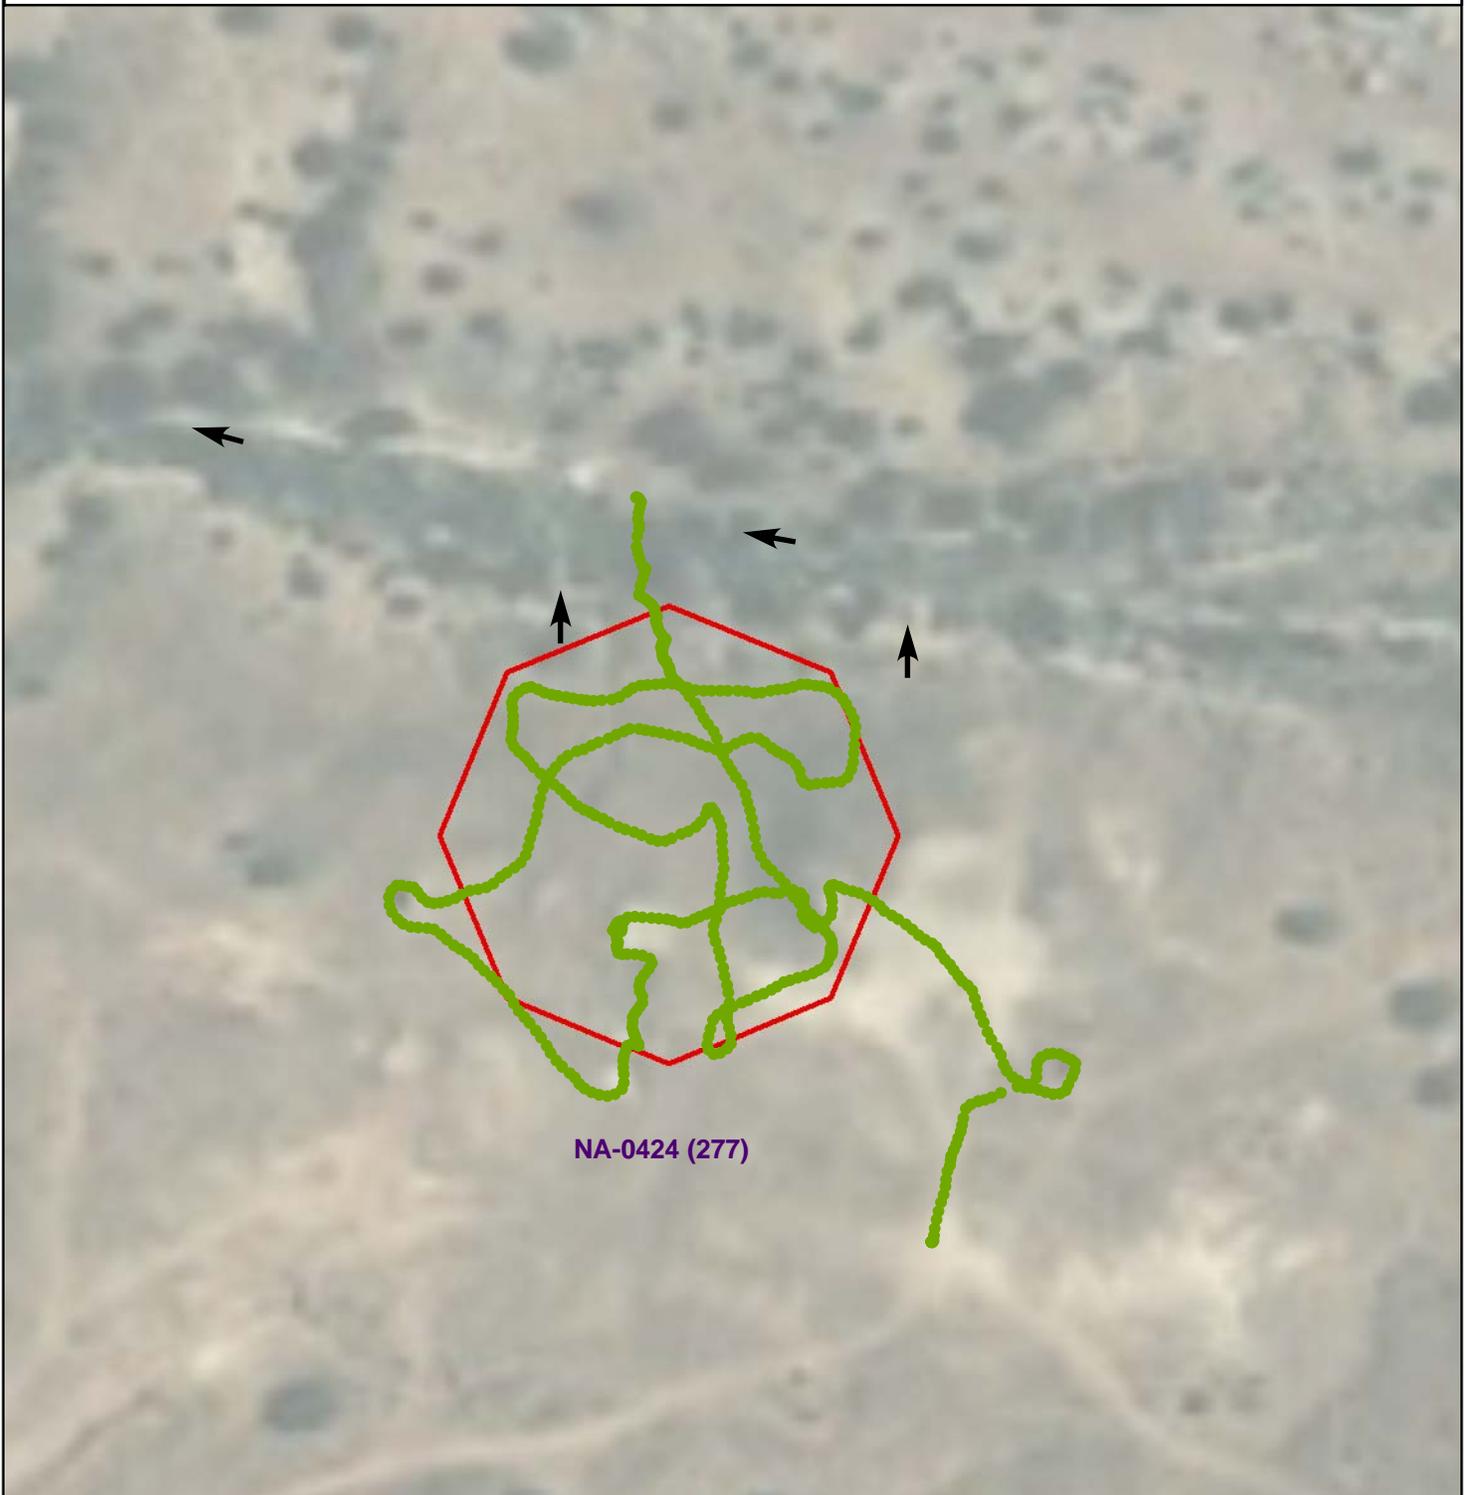
Figure 1 - Gamma Radiation Measurements, Above Two Times Background  
NA-0424 (277)  
Beclabito Chapter, Navajo Nation

A total of 612 gamma radiation measurements were collected from the mine site, ranging from 6,916 cpm to 11,892 cpm. The measurements are represented in Figures 1 and 2.

Gamma survey conducted 06/2010  
Measured as counts per minute (cpm)

Average background = 9,861 cpm

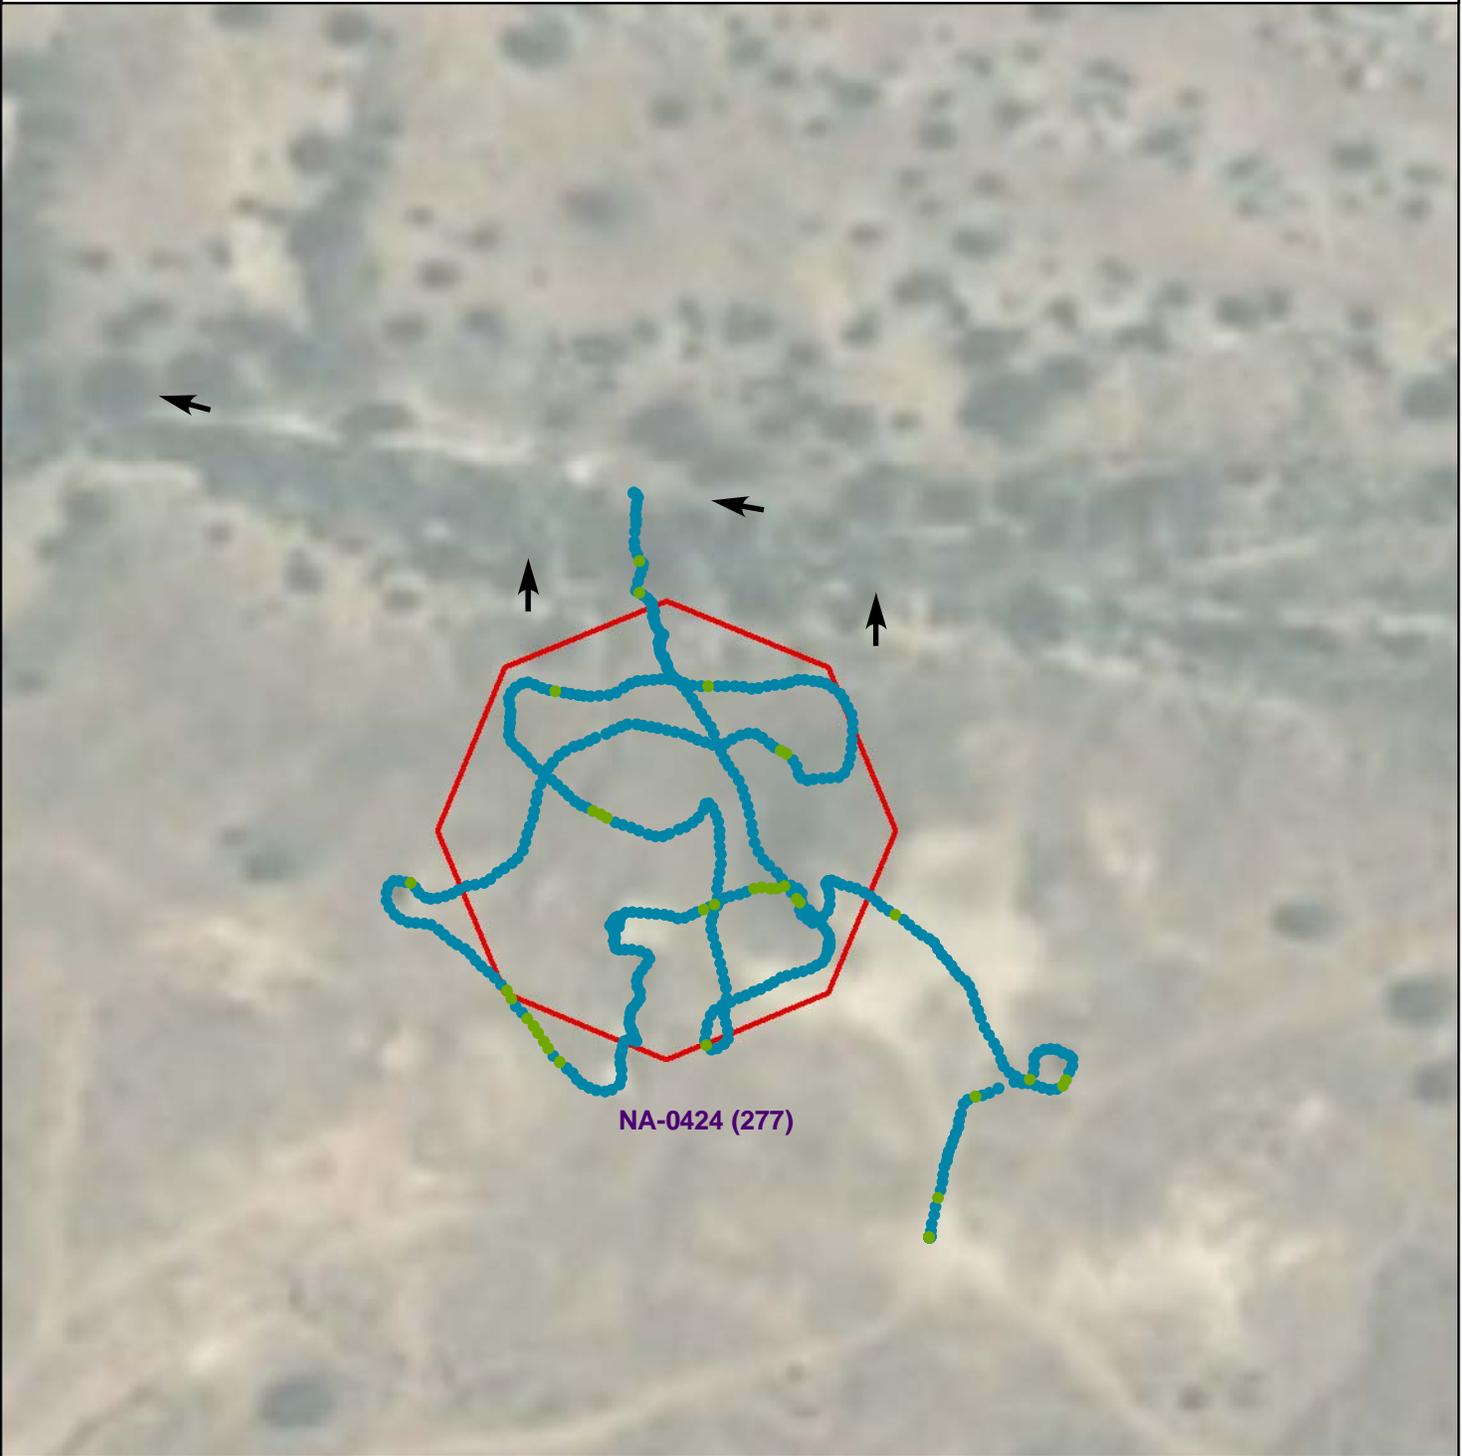
**Figure 2 - Gamma Radiation Measurements  
NA-0424 (277)  
Beclabito Chapter, Navajo Nation**

**Gamma survey conducted 06/2010  
Measured as counts per minute (cpm)**

**Average background 9,861 cpm**
