Navajo Abandoned Uranium Mine

Site Screen Report

NA-0238 AUM Site

Weston Solutions, Inc.

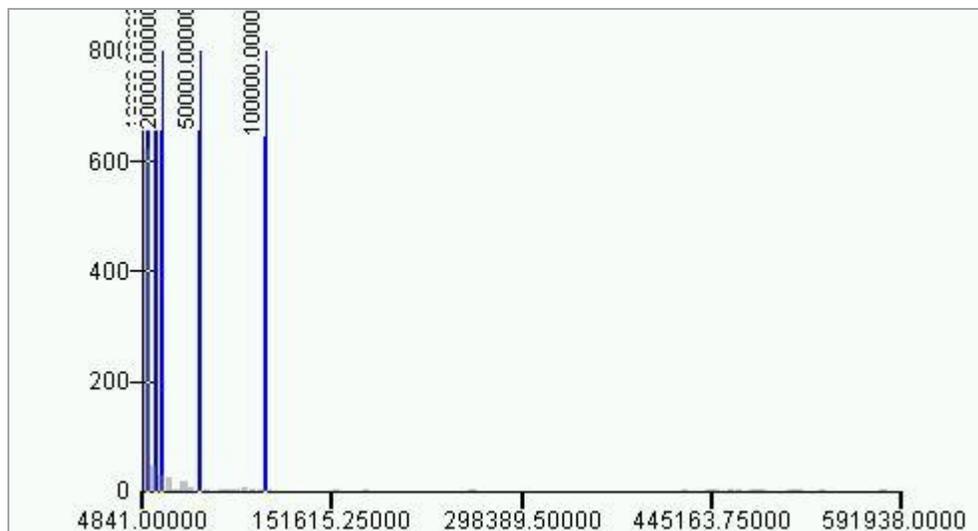
The following chart and statistics were generated by ESRI ArcGIS 9.3.1, and show the general distribution of the site gamma radiation measurements. The horizontal X axis represents the gamma radiation reading levels in cpm (lowest levels to the left). The vertical Y axis represents the frequency of each gamma radiation level.

Count:	840
Minimum:	4841.00000
Maximum:	591938.00000
Sum:	32495618.00000
Mean:	38685.25952
Median:	7592.00000
Standard Deviation:	105603.06728

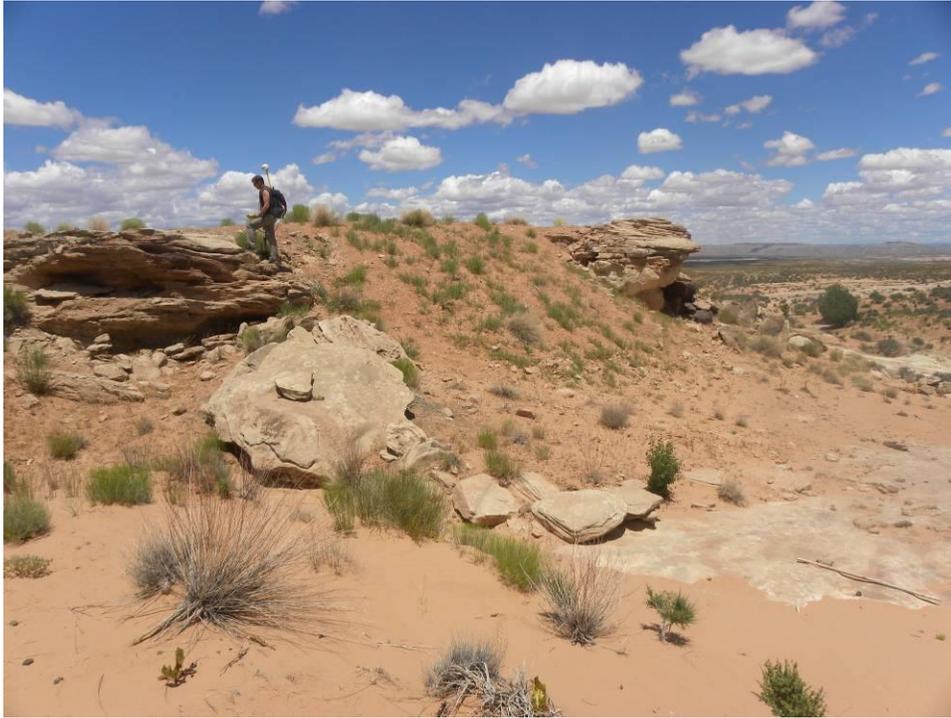
Photo 1. NA-0238 site

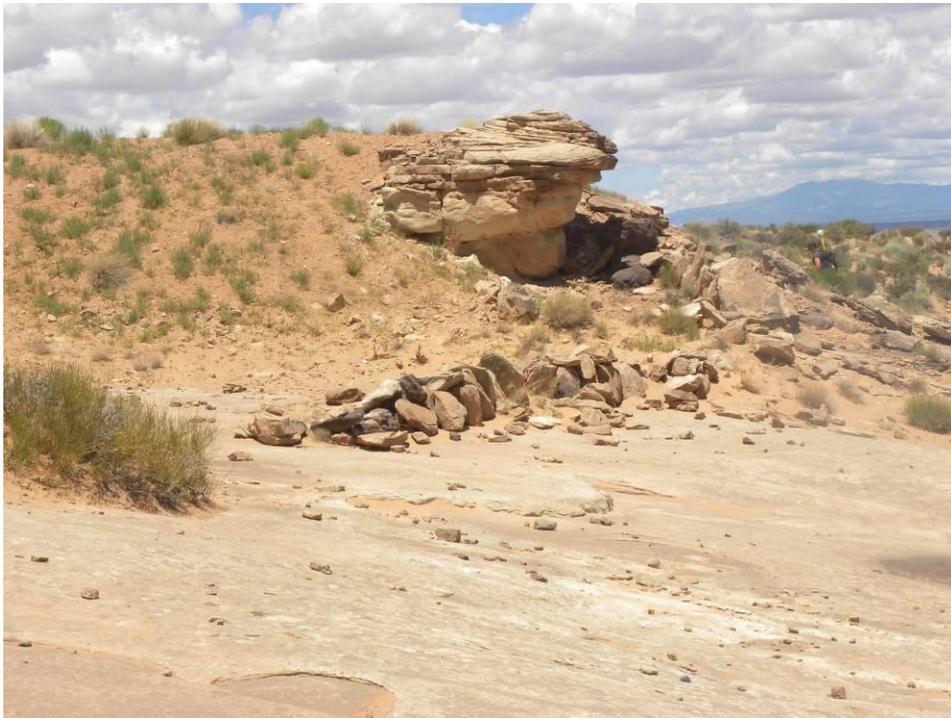
Reclamation cap of fine, red clay with gamma radiation hot spot; yellow rock with elevated radiation levels onsite; rock wall consisting of dark rocks and elevated gamma radiation readings

Photo 2. NA-0238 site, rock wall and reclamation cap

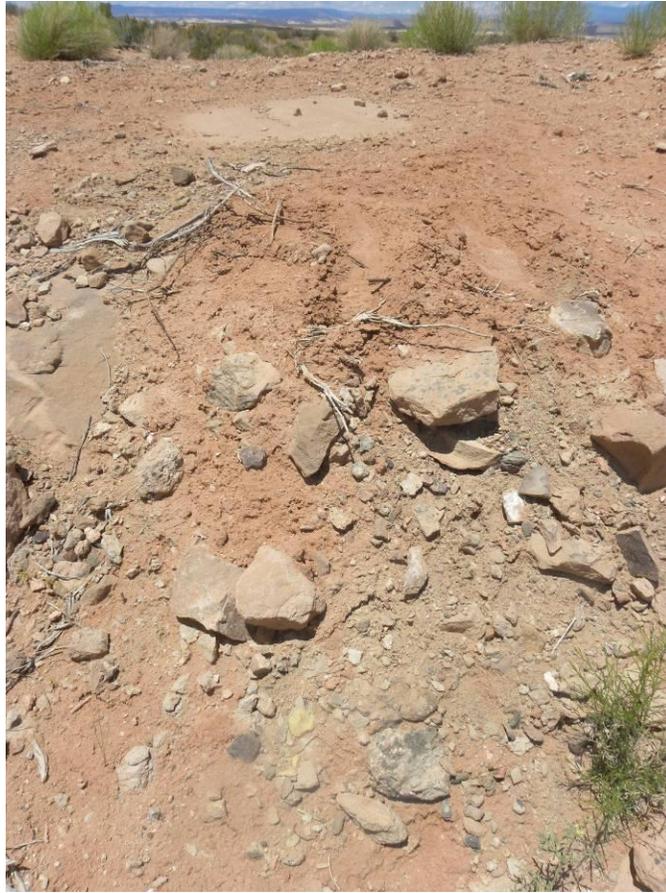
Reclamation cap of fine, red clay with gamma radiation hot spot

Photo 4. Hot spot with exposed yellow rock

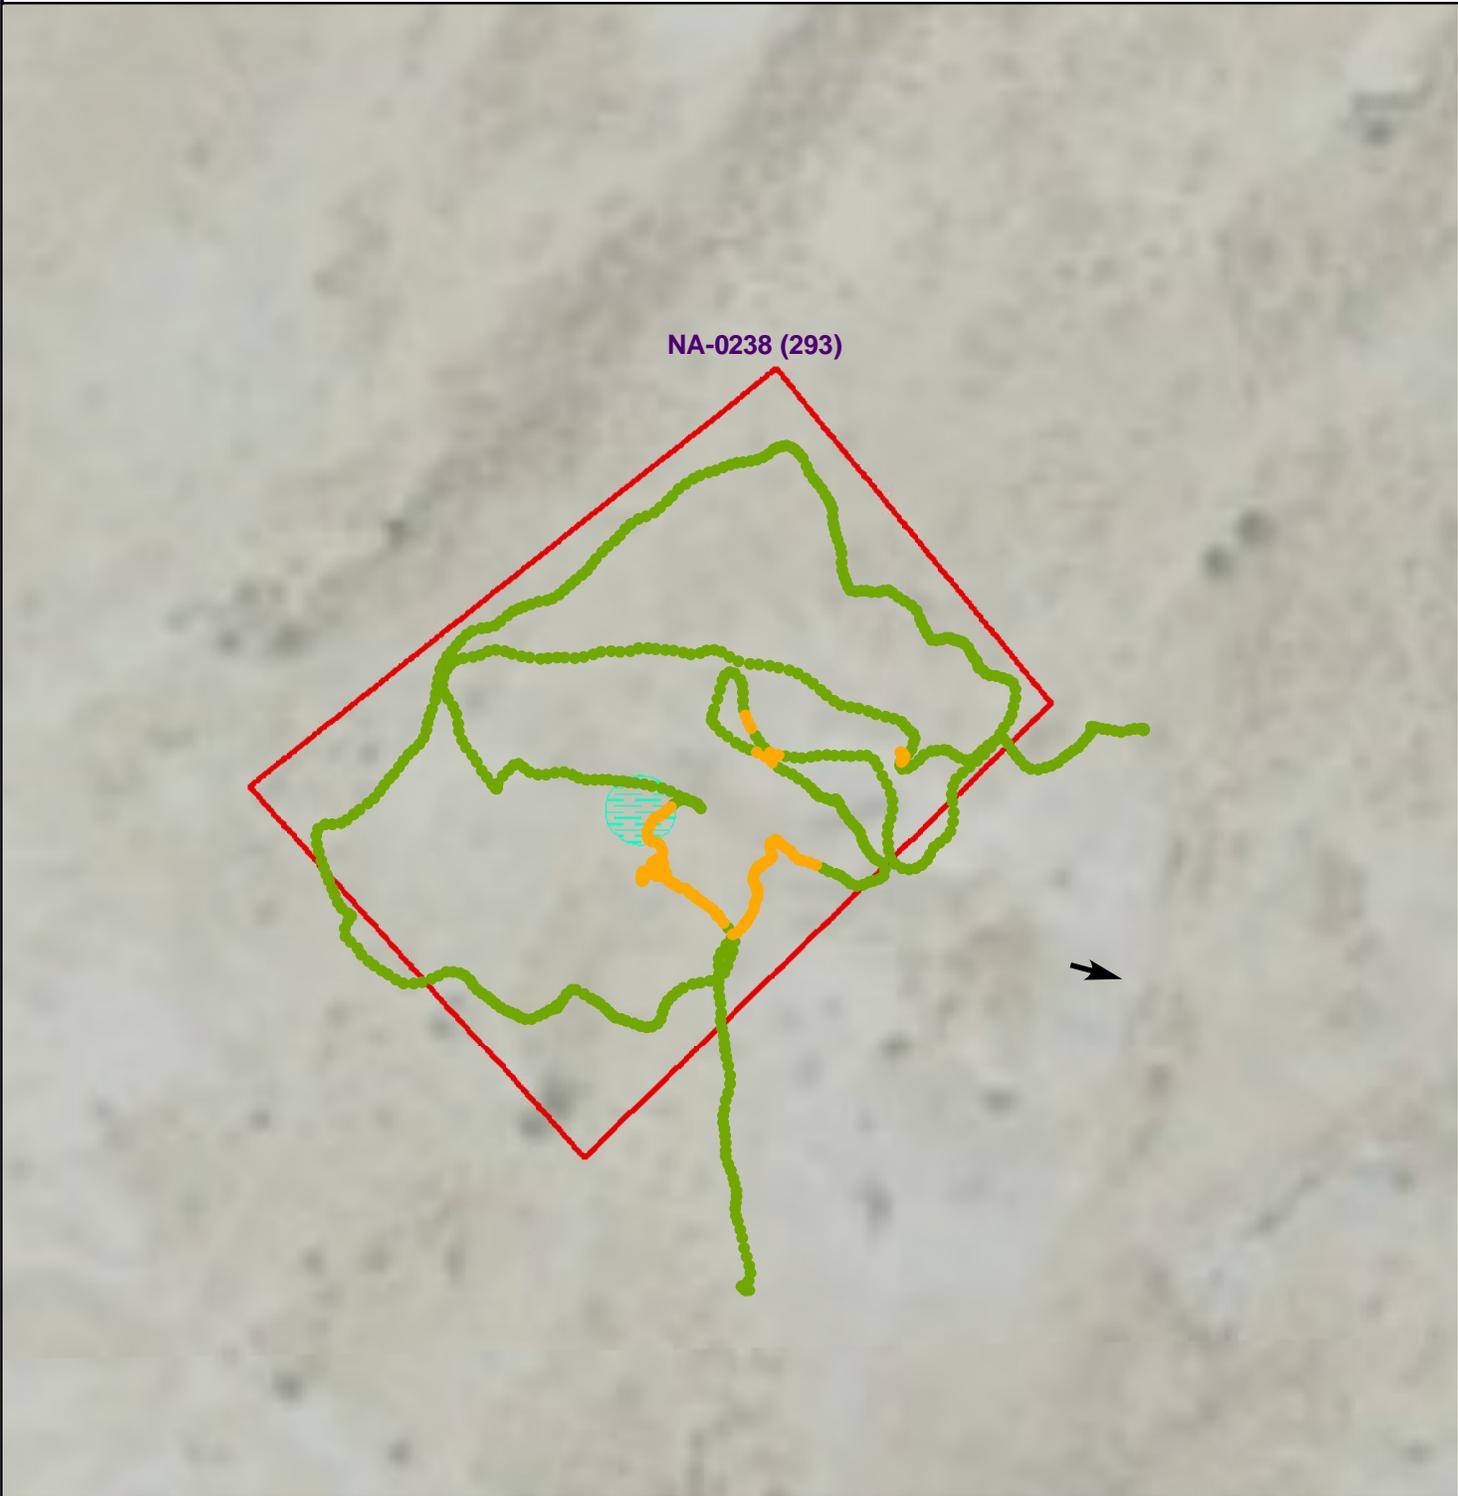
A total of 840 gamma radiation measurements were collected from the mine site, ranging from 4,841 cpm to 591,938 cpm. Measurements collected in the vicinity of the rockwall were found at levels up to approximately 25,000 cpm, and at an isolated hotspot at levels over 550,000 cpm. The measurements are represented in Figures 1 and 2.

**Figure 1 - Gamma Radiation Measurements, Above Two Times Background
 NA-0238 (293)
 Red Mesa Chapter, Navajo Nation**

Gamma survey conducted 06/2010
 Measured as counts per minute (cpm)

Average background = 5,643 cpm

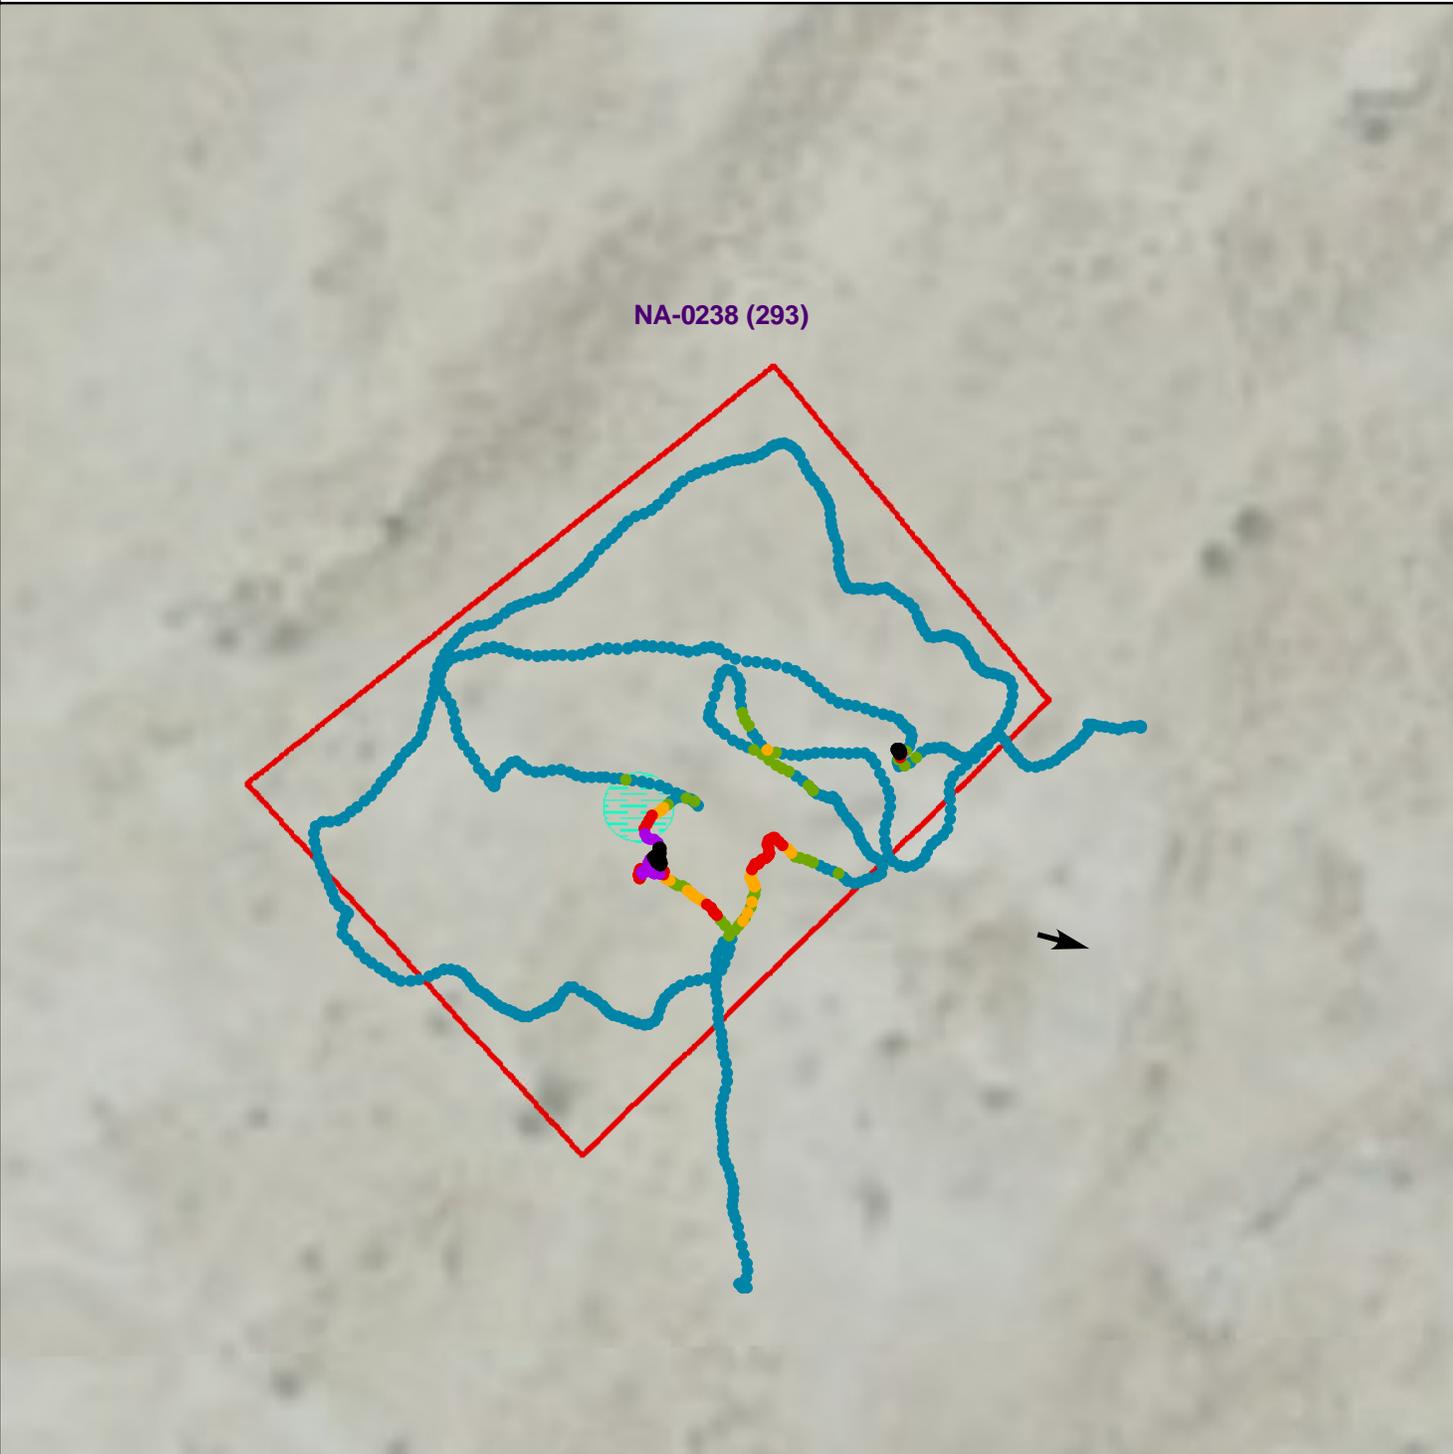
**Figure 2 - Gamma Radiation Measurements
NA-0238 (293)
Red Mesa Chapter, Navajo Nation**

**Gamma survey conducted 06/2010
Measured as counts per minute (cpm)**

Average background 5,643 cpm
