Navajo Abandoned Uranium Mine

Site Screen Report

Pete AUM Site

August 2010

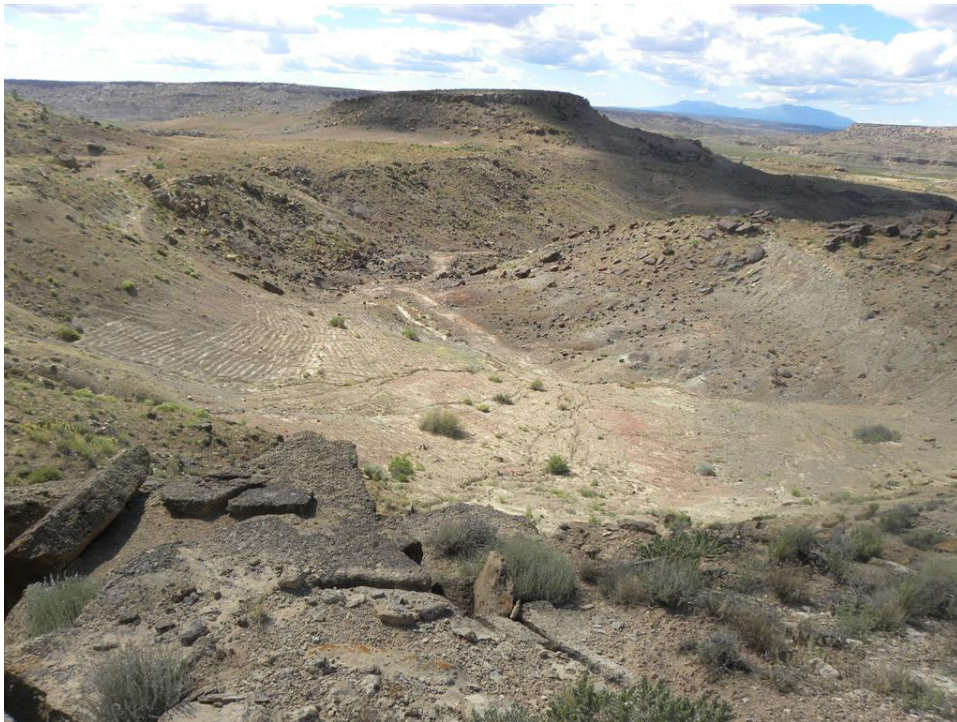
A total of 4,178 gamma radiation measurements were collected from the mine site, ranging from 7,457 cpm to 330,086 cpm. Measurements collected in the vicinity of the northwest cap were found at levels up to approximately 100,000 cpm, at the west cap at levels up to approximately 200,000 cpm, and at the southeast cap at levels up to approximately 300,000 cpm. The measurements are represented in Figures 1 and 2.

3 large gravel / dirt excavation / reclaimed areas sloping down site edges: NW cap 500'x500'; W cap 750'x750'; SE cap 750'x1000', majority of SE cap offsite

Photo 2. Pete site, NW gravel/dirt cap area

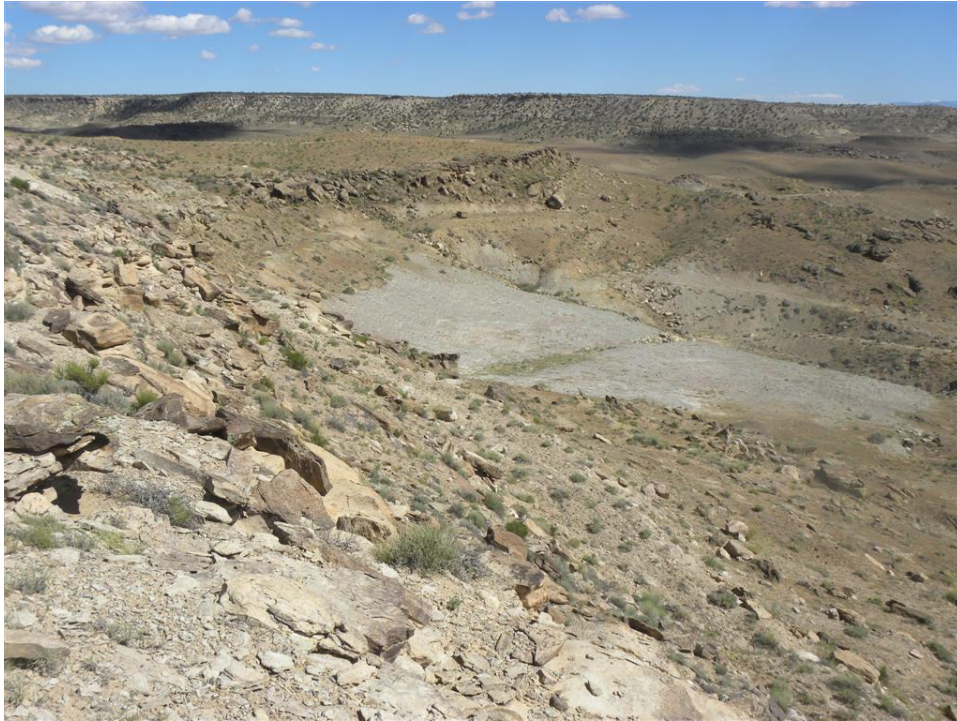
Photo 3. Pete site, W gravel/dirt cap area

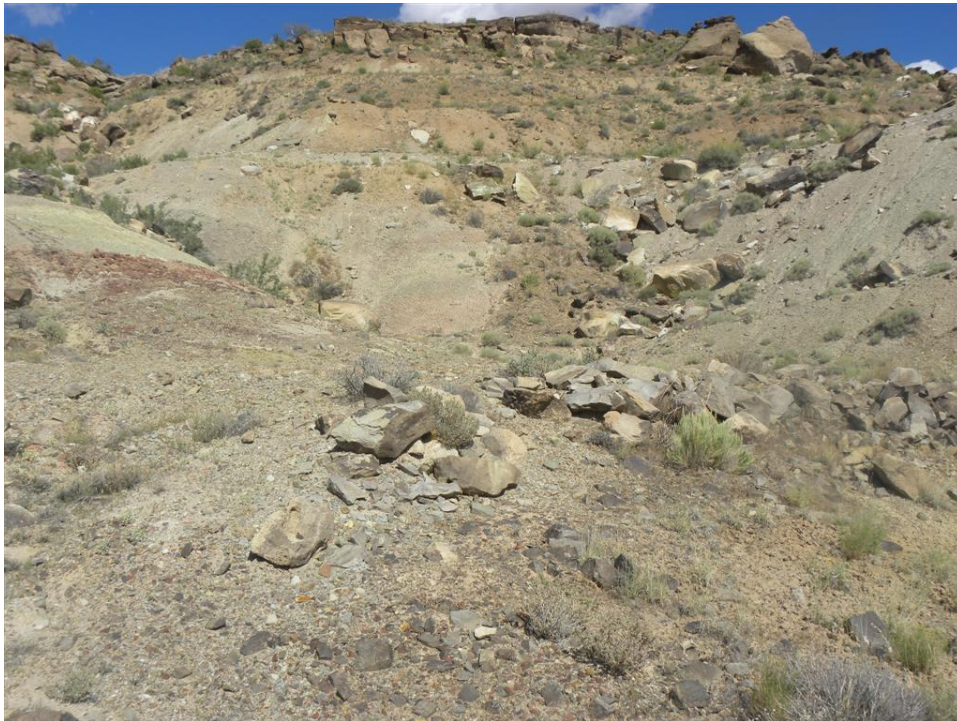
Photo 4. Pete site, W gravel/dirt cap area

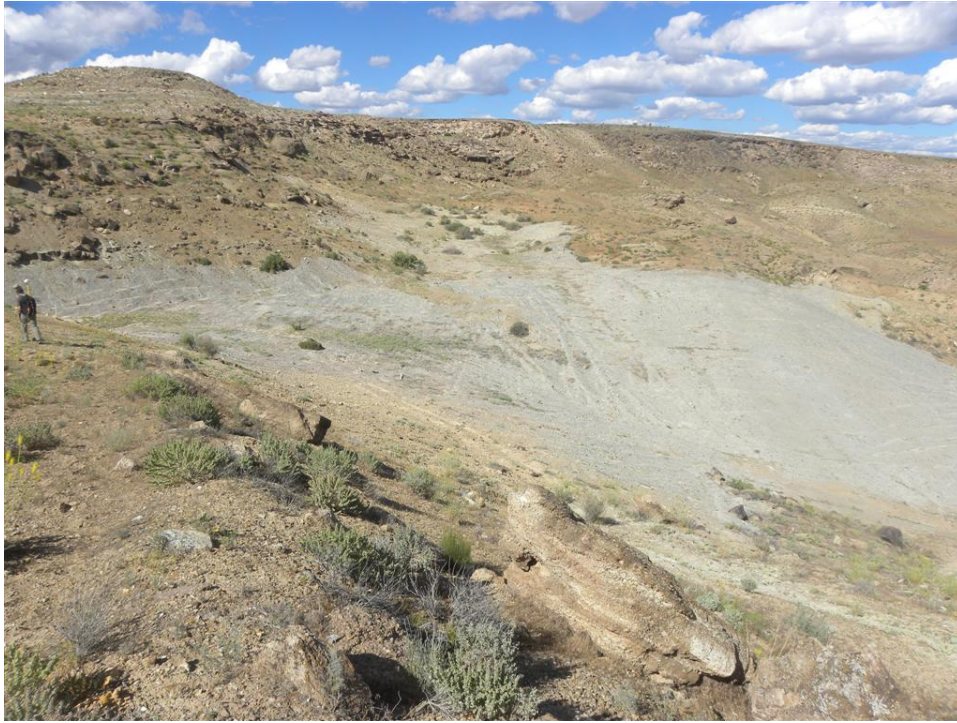
Photo 5. Pete site, SE gravel/dirt cap area
