# Navajo Abandoned Uranium Mine

## Site Screen Report

### **Aneth 1 AUM Site**

**August 2010**

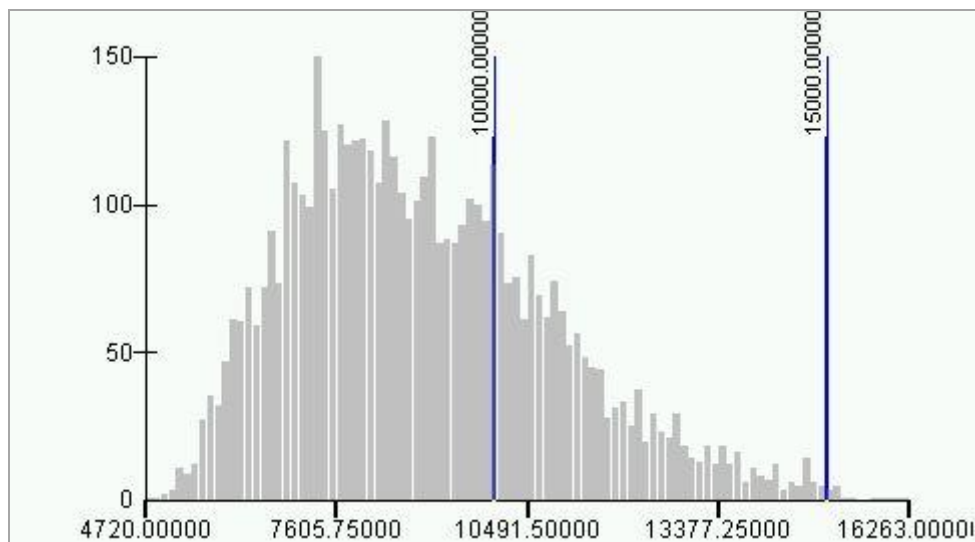
The following chart and statistics were generated by ESRI ArcGIS 9.3.1, and show the general distribution of the site gamma radiation measurements. The horizontal X axis represents the gamma radiation reading levels in cpm (lowest levels to the left). The vertical Y axis represents the frequency of each gamma radiation level.

Count:	5124
Minimum:	4720.00000
Maximum:	16263.00000
Sum:	45775459.00000
Mean:	8933.54001
Median:	8672.50000
Standard Deviation:	1982.40482

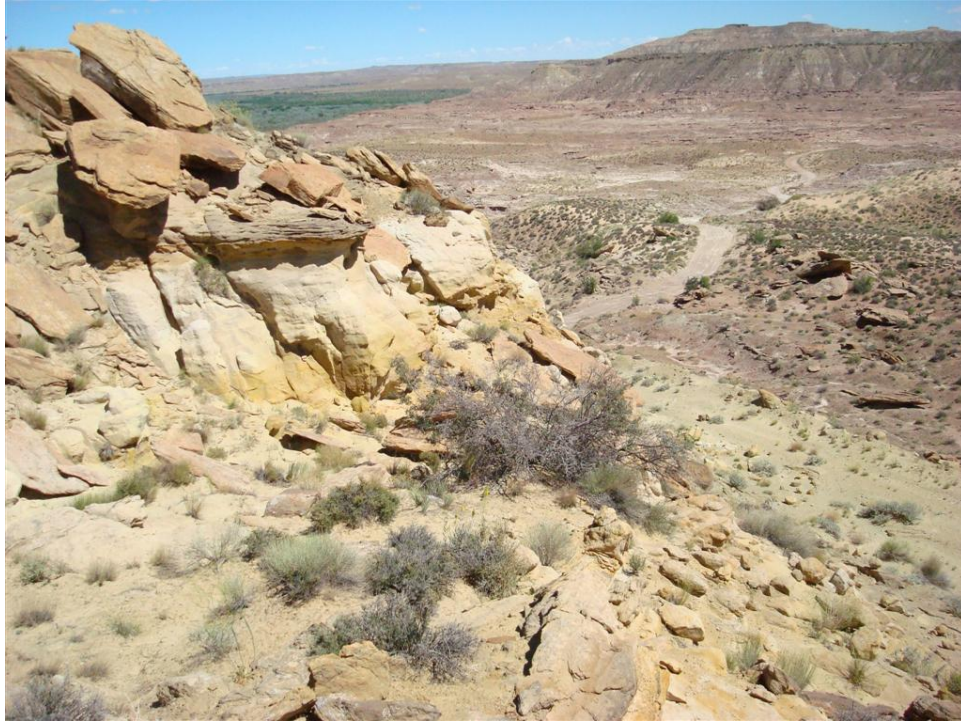
Photo 1. Aneth 1 site, San Juan River in the distance

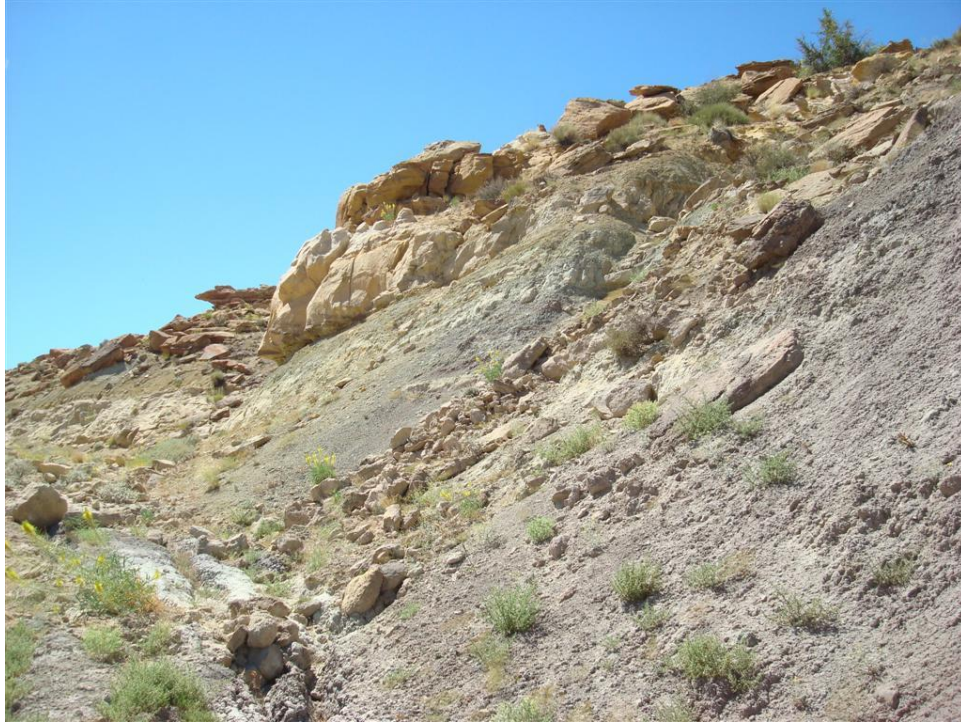
Photo 1. Aneth 1 site

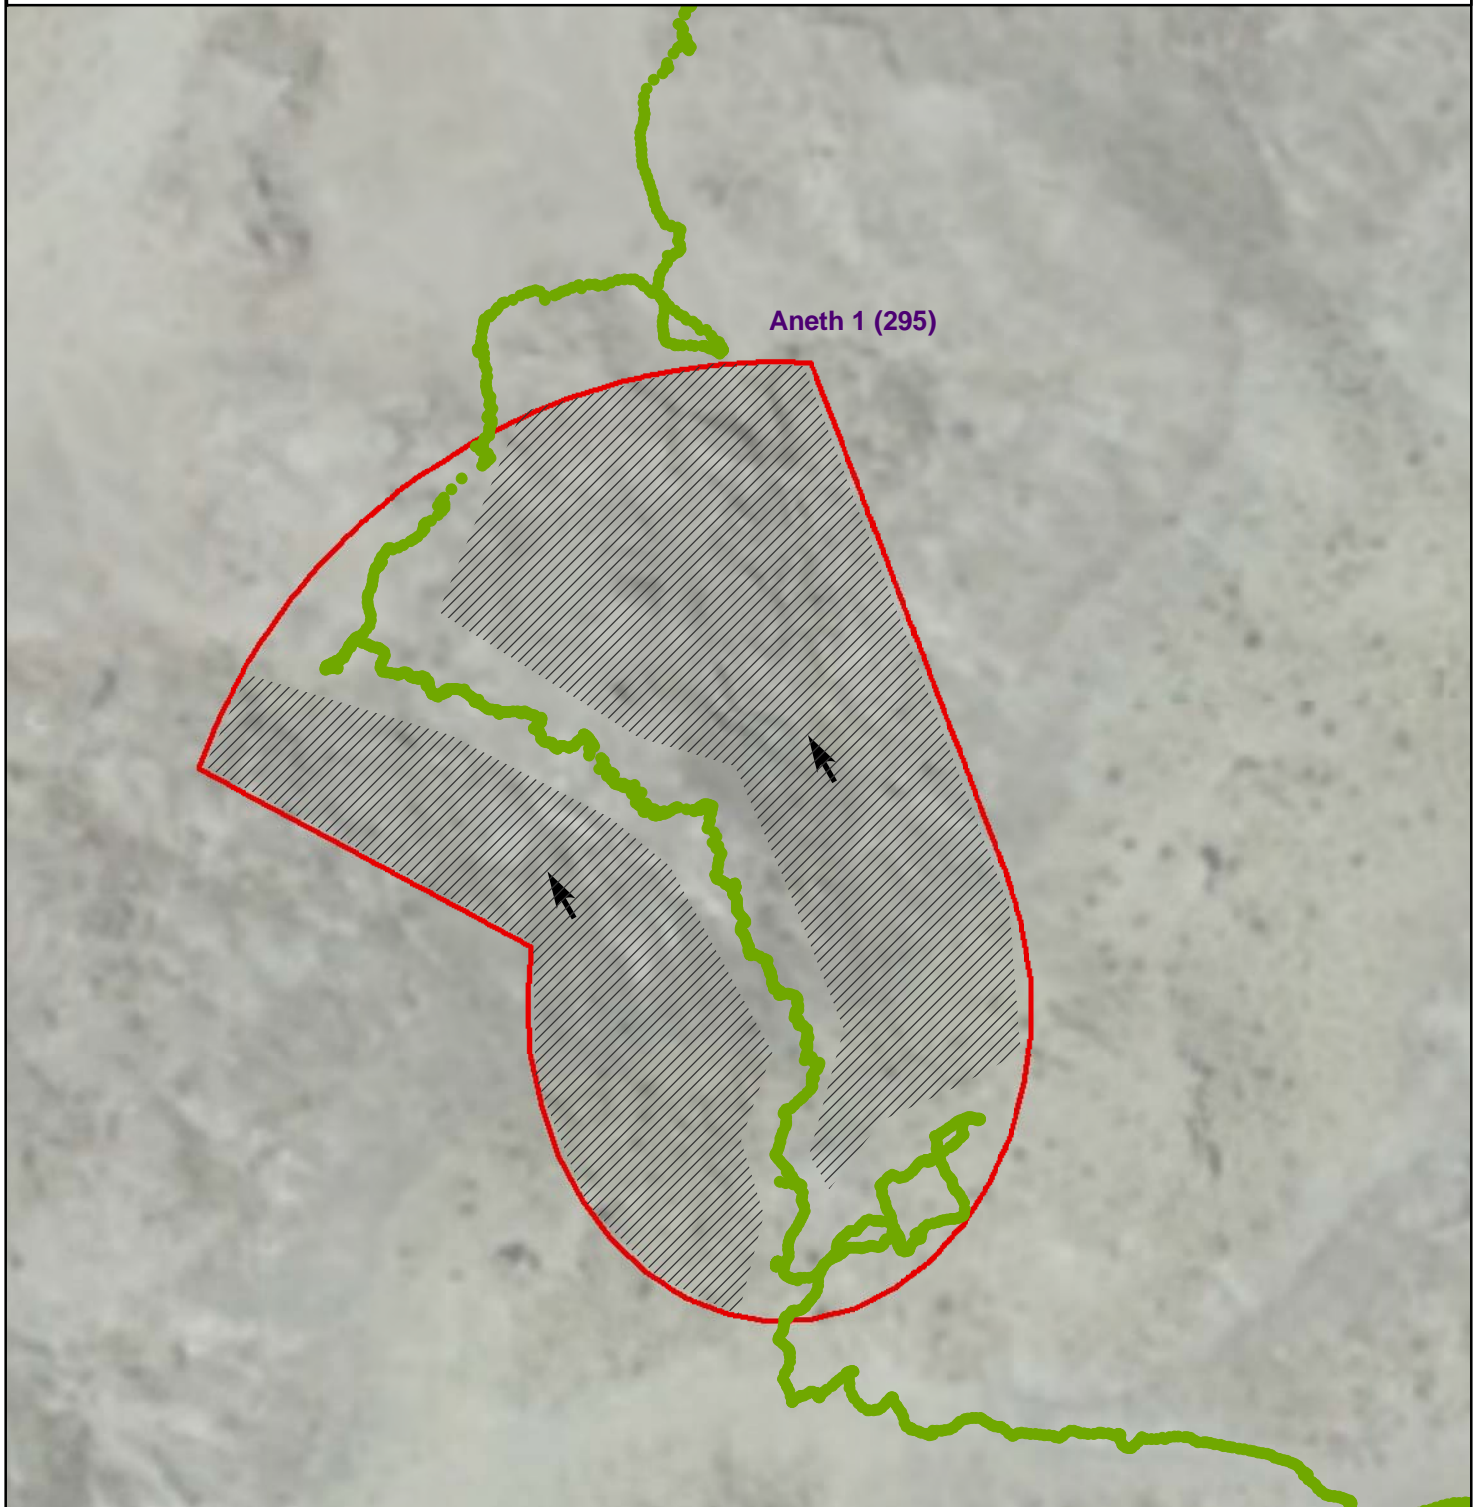
**Figure 1 - Gamma Radiation Measurements, Above Two Times Background  
Aneth 1 (295)  
Teec Nos Pos Chapter, Navajo Nation**

A total of 5,124 gamma radiation measurements were collected from the mine site, ranging from 4,720 cpm to 16,263 cpm. The measurements are represented in Figures 1 and 2.

Gamma survey conducted 06/2010  
Measured as counts per minute (cpm)

Average background = 8,745 cpm

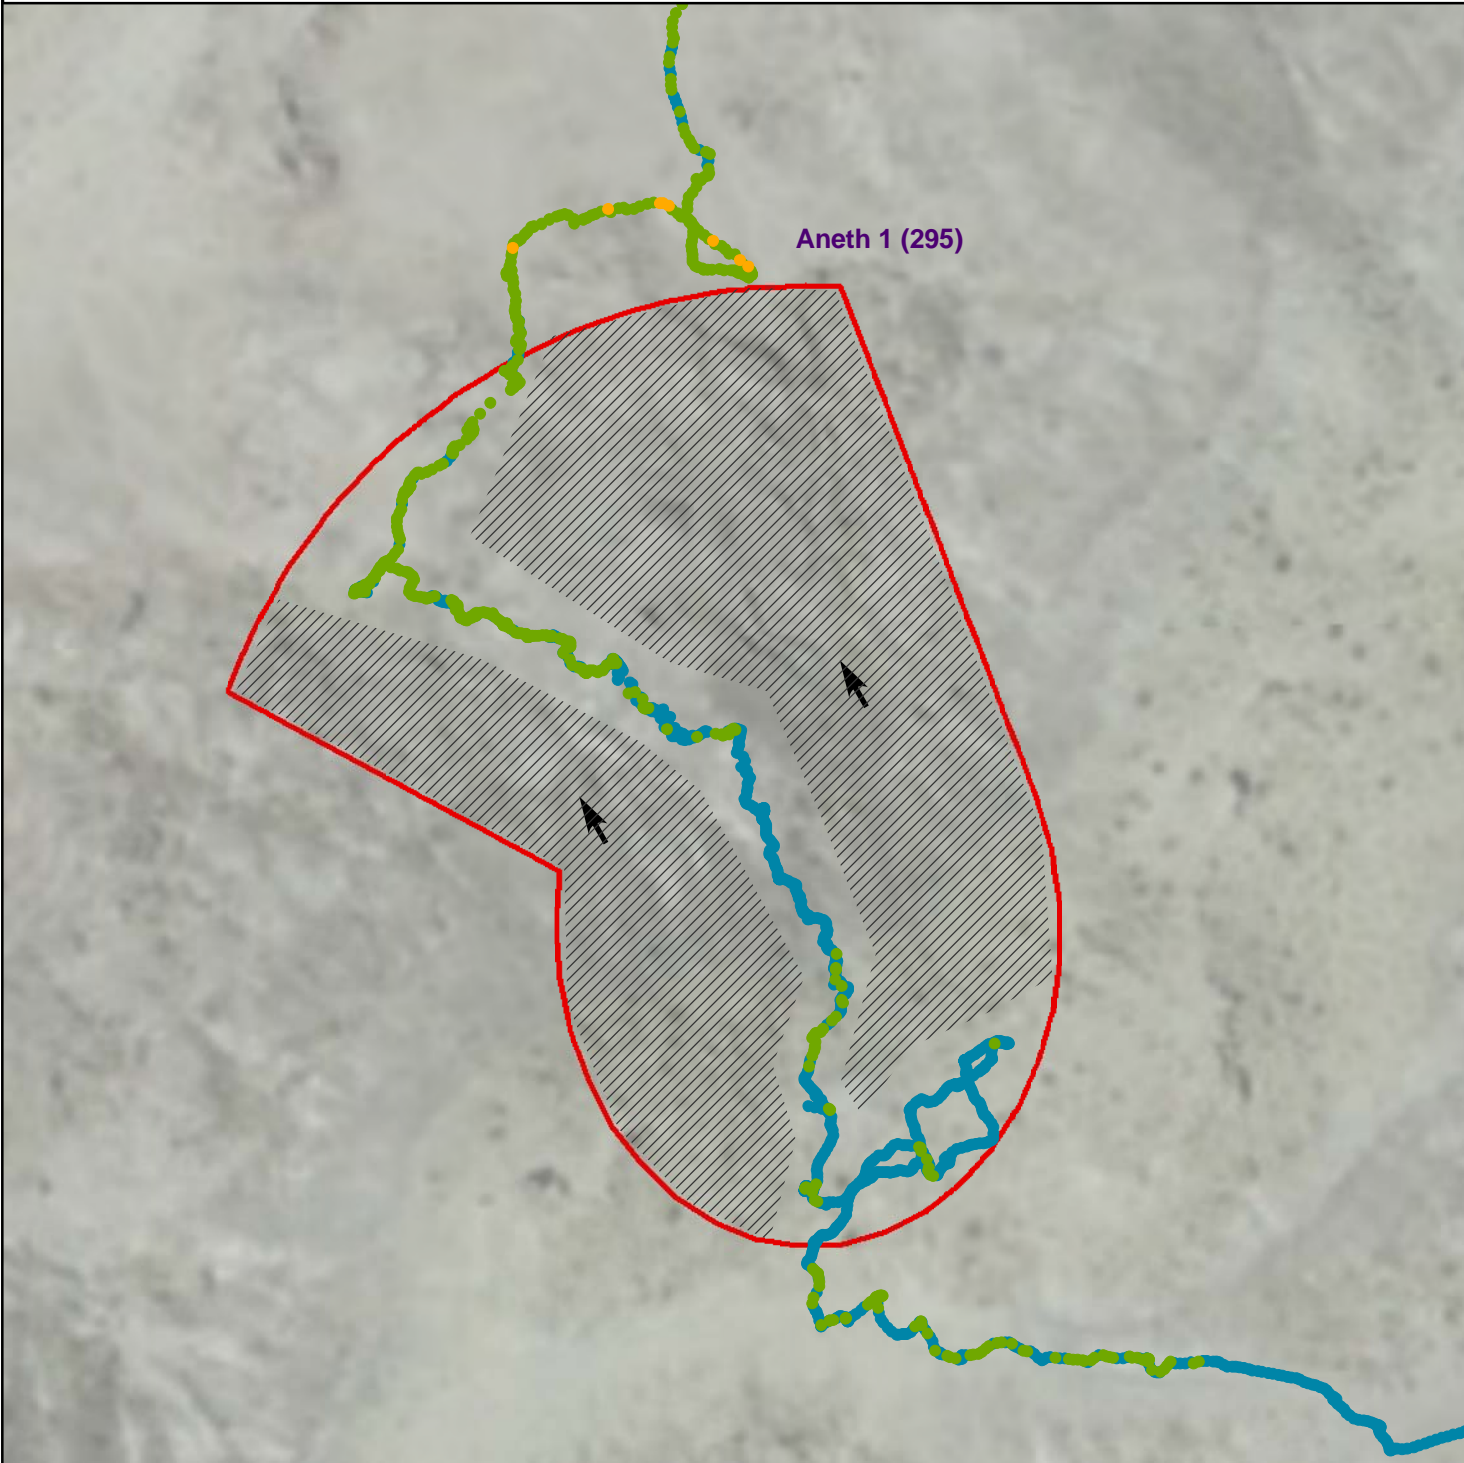
**Figure 2 - Gamma Radiation Measurements  
Aneth 1 (295)  
Teec Nos Pos Chapter, Navajo Nation**

**Gamma survey conducted 06/2010  
Measured as counts per minute (cpm)**

**Average background 8,745 cpm**
