Navajo Abandoned Uranium Mine Site Screen Report

Section 32 AUM Site

Navajo AUM Eastern Region

May 2009

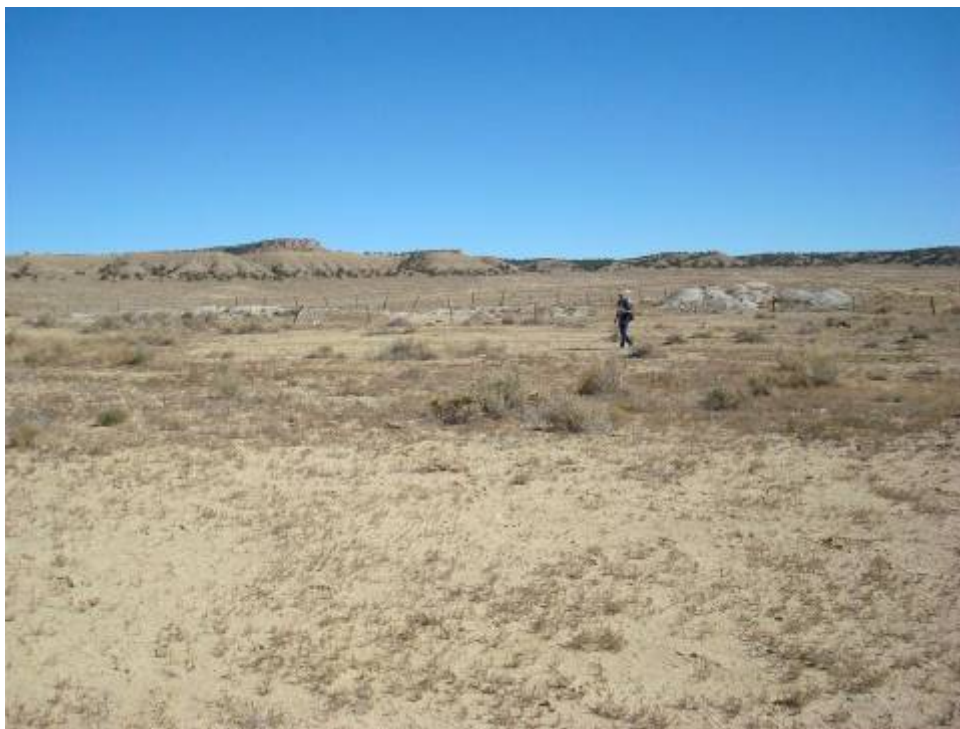
Photo 2. Section 32 Mine site, towards the south east.
waste piles in background are located on adjoining Section 33 Mine site
