**Expanded Site Screening
North East Church Rock – Quivira Mines
Navajo Nation, New Mexico**

April 2010

**United States Environmental Protection Agency
Region 9**

**Weston Solutions, Inc.
428 Thirteenth Street, 6th Floor, Suite B
Oakland, CA 94612**

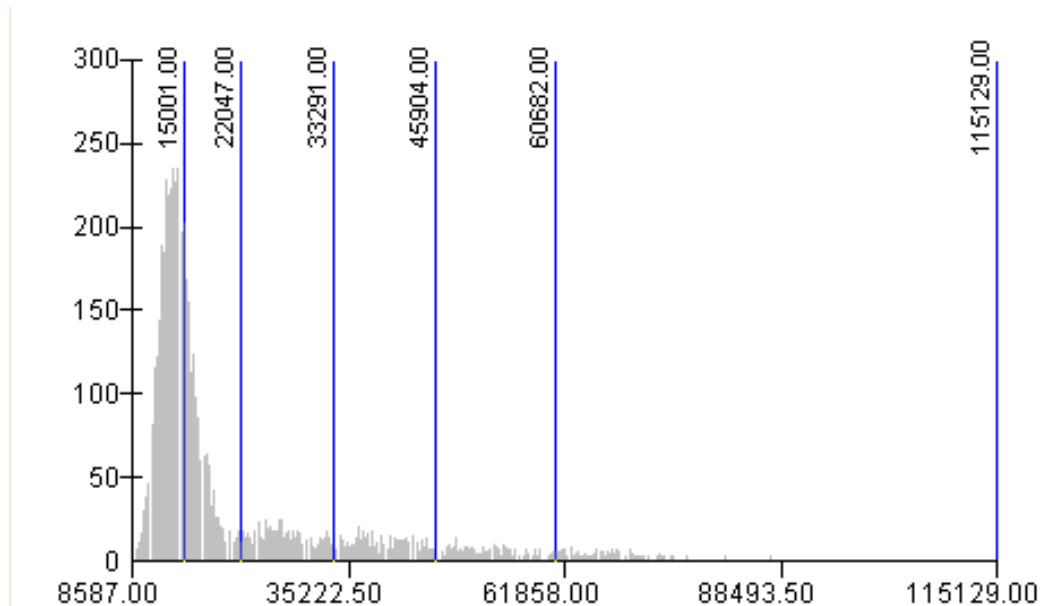
The following model was created by ESRI ArcGIS using the Jenks method:

Weston used this model as a basis to select the breaks used in the classification scheme. The actual breaks selected by Weston were determined based on additional factors, such as background gamma radiation measurements (13,615 cpm), Navajo Abandoned Mine Lands Reclamation Program action levels (50,000 cpm), and rounded break numbers, influenced by the Jenks model.

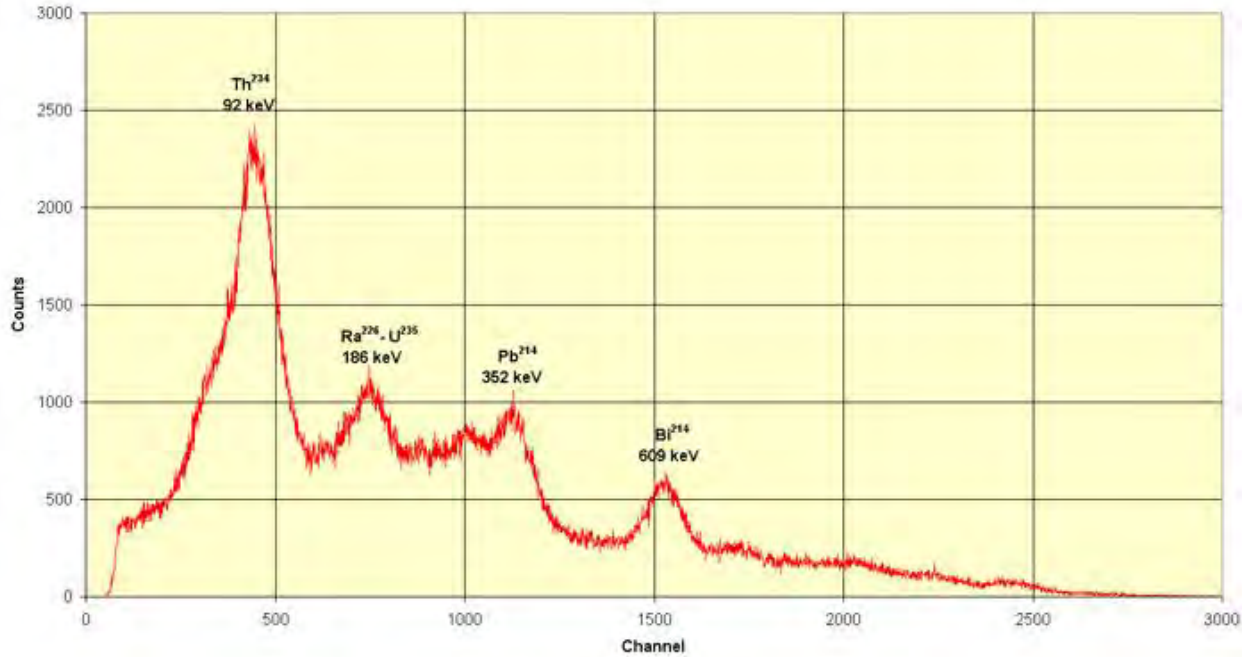
Figure 1. Uranium Outcrop Grab Sample

Figure 1 depicts a typical gamma ray spectrum of U-238 ore with a few of the primary gamma peaks from progeny identified by their respective energies. This figure shows the relative abundance of the gamma ray energies from thorium-234 (Th-234), radium-226 (Ra-226), lead-214 (Pb-214), and bismuth-214 (Bi-214), all of which are U-238 progeny. The majority of the gamma rays associated with U-238 have energies less than the 609 keV of Bi-214, as shown in Figure 1 by the decline in the curve beyond the energy of Bi-214. The relative abundance of these gamma ray energies is important because the detectors used to measure gamma radiation levels in the field show a variable response based on the energies detected.

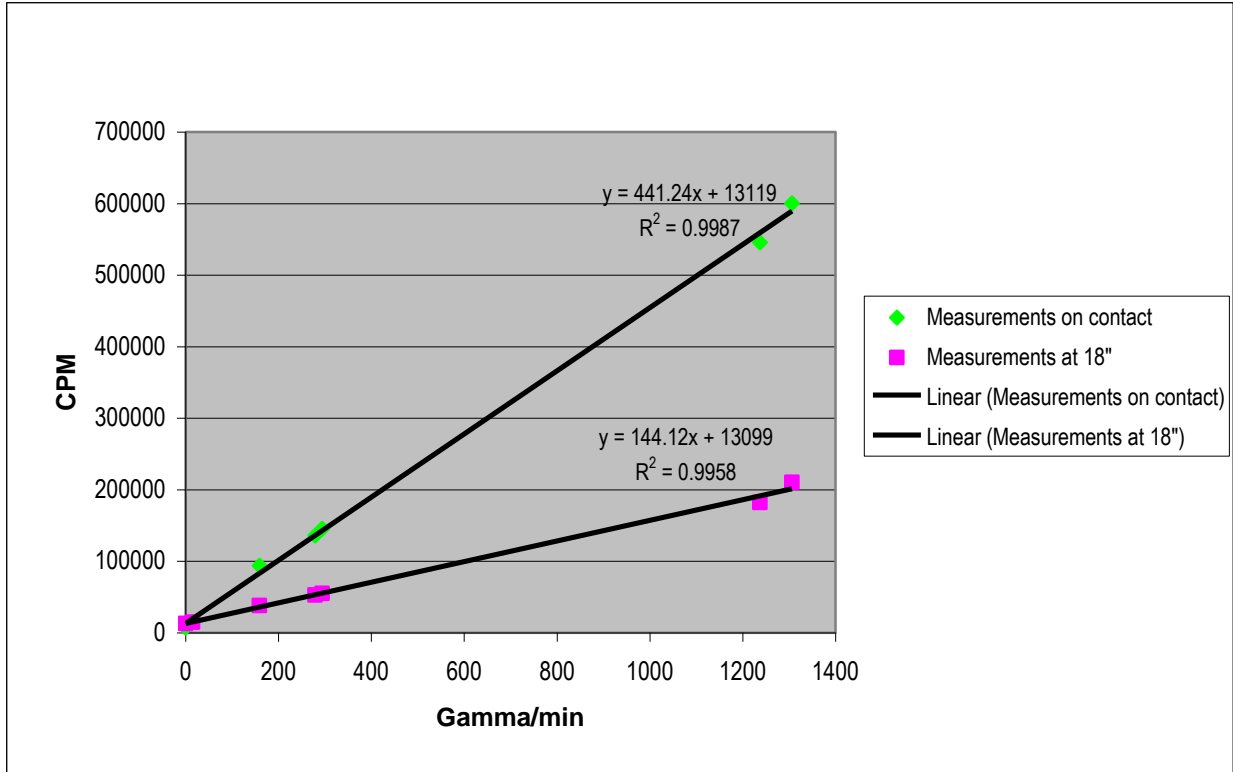
Figure 2. Least square fit of calibration pad data

Prior to performing the radiation survey of the Navajo AUM sites, Weston collected gross gamma count rate data above each of these calibration pads using the 2X2 NaI detectors. Count rate measurements were collected on contact with the pad and at a height of 18 inches above each pad. Measurements collected on contact were more consistent than those collected at 18 inches because of variability in the actual height at which detectors were held during the 18-inch measurements. These data are presented in Figure 2, which compares count rate of the instrument in cpm versus gamma emission rate from each pad in gammas per minute.

Pad concentrations are converted to gamma emission rates because each pad contains a mixture of U-238 and progeny, Th-232 and progeny, and K-40. The gamma emission rate from each pad is the sum of all gamma rays with energy greater than 60 keV and abundance greater than 1%.

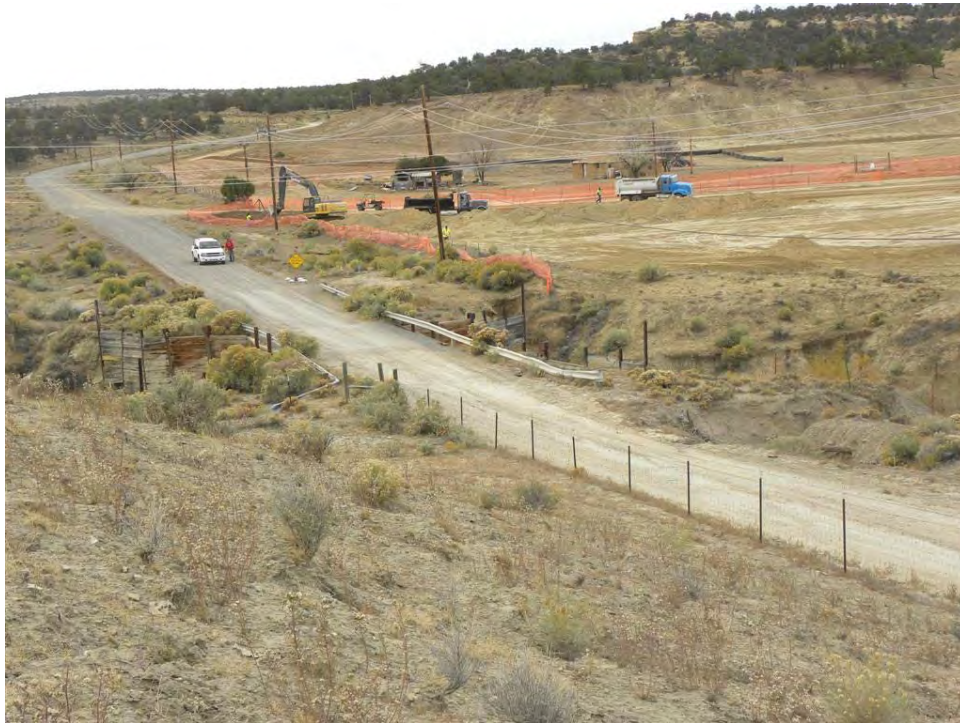
Photo 1. Road and bridge separating NE Church Rock and NE Church Rock 1

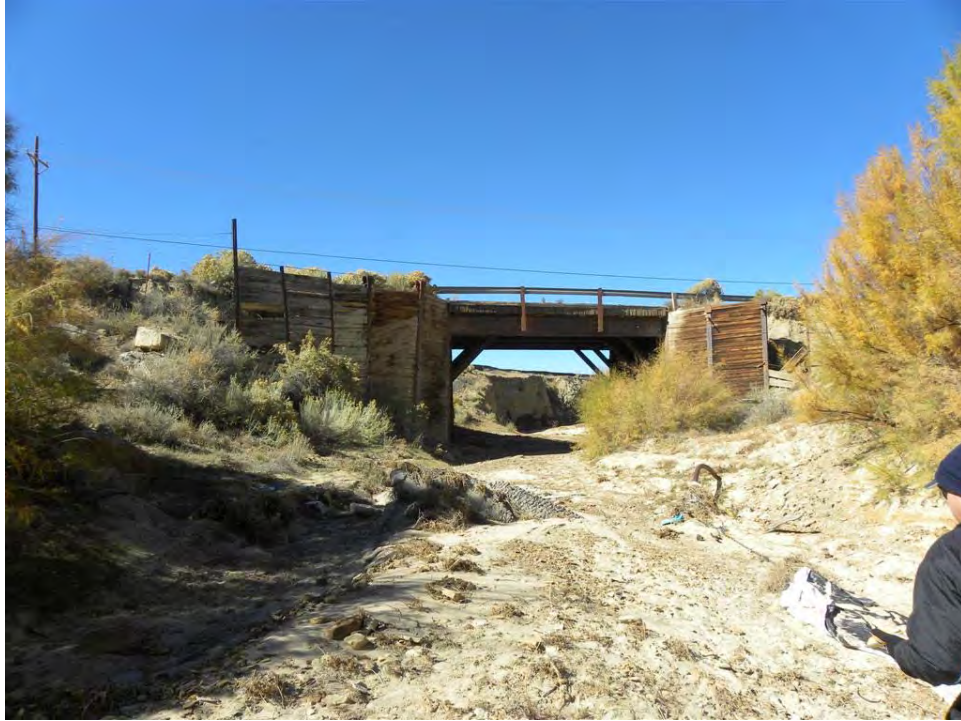
Photo 9. Bridge crossing arroyo between NE Church Rock and NE Church Rock 1

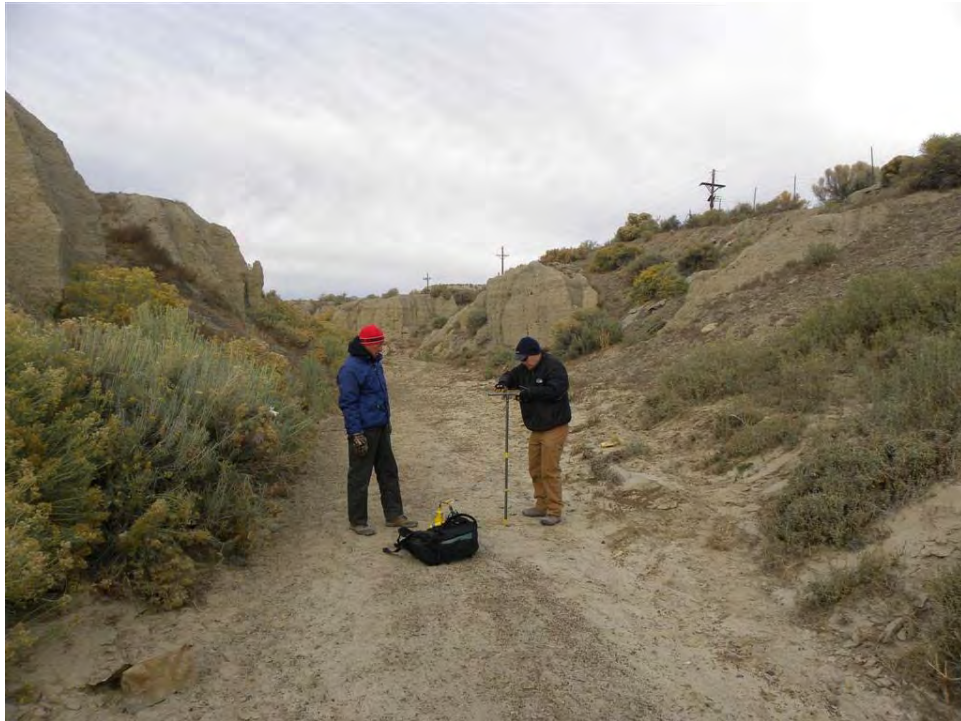
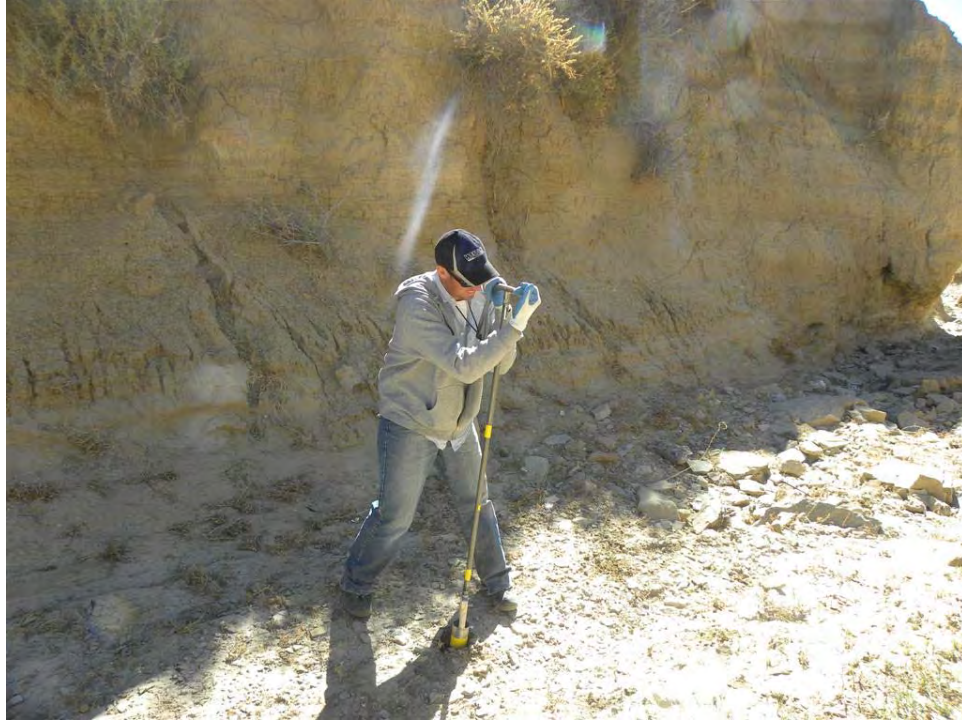
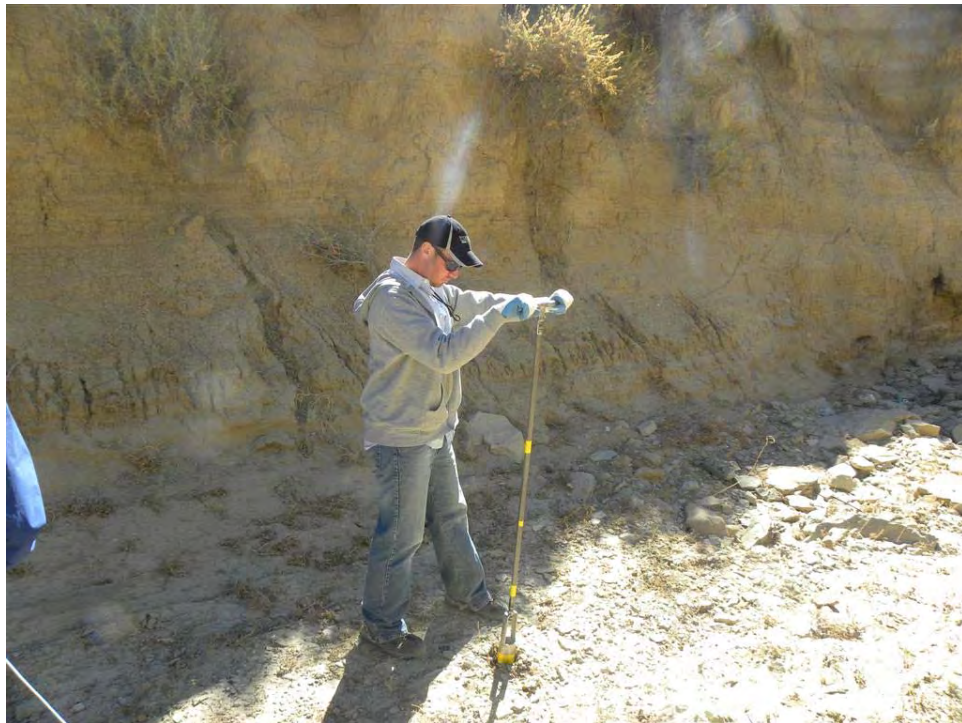
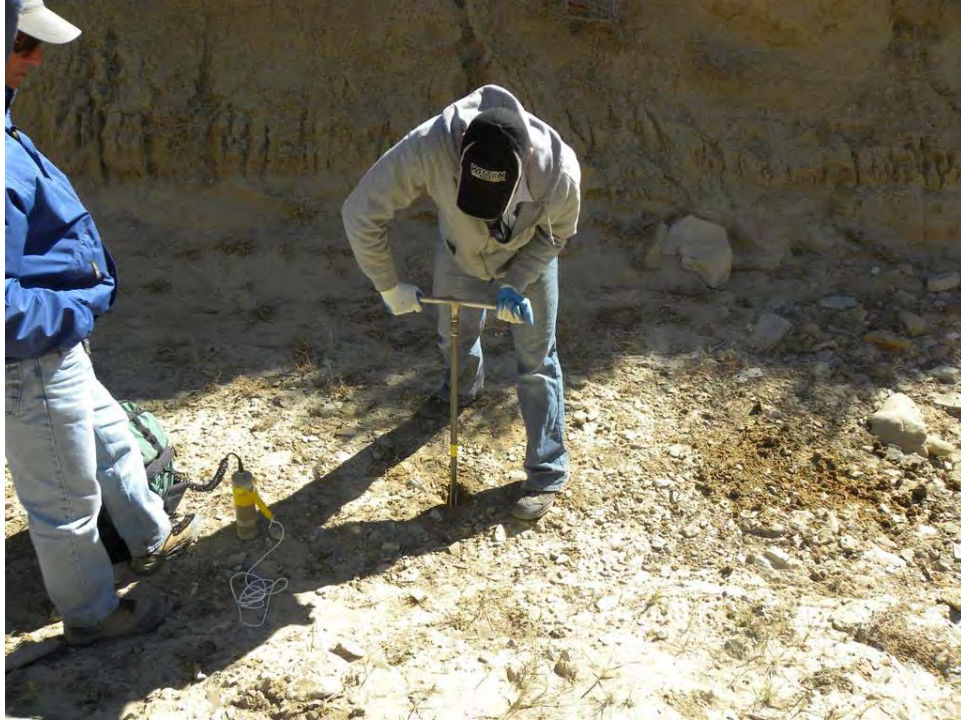
Photo 14. Augering for subsurface measurements

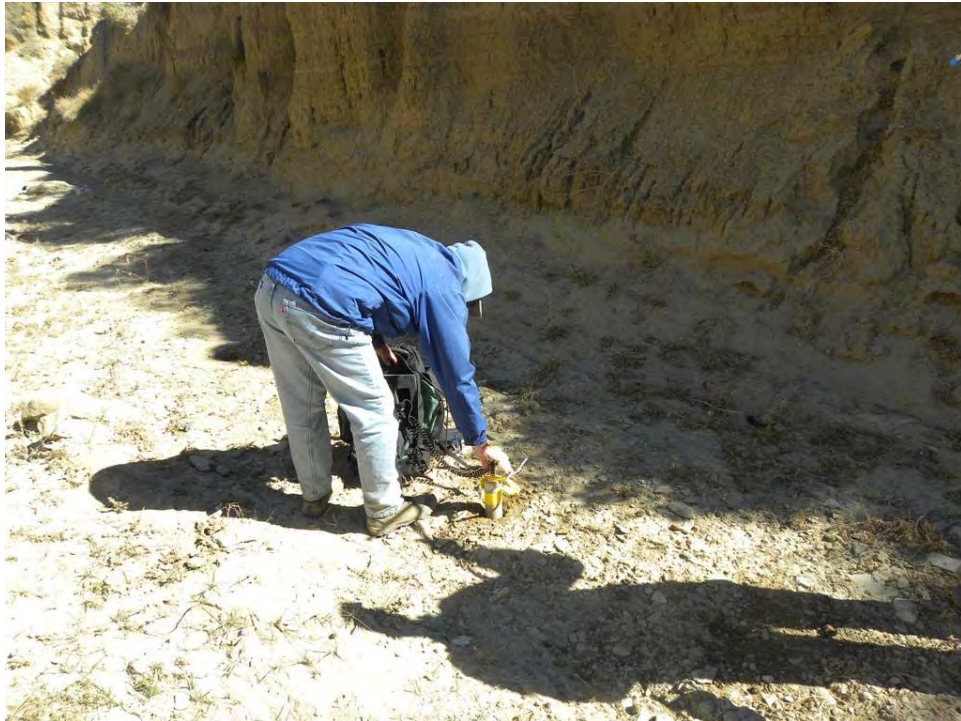
Photo 18. Collecting subsurface measurement in auger hole
