Navajo Abandoned Uranium Mine Site Screen Report

Hogback No. 4 AUM Site

Navajo AUM Eastern Region

Weston Solutions, Inc.

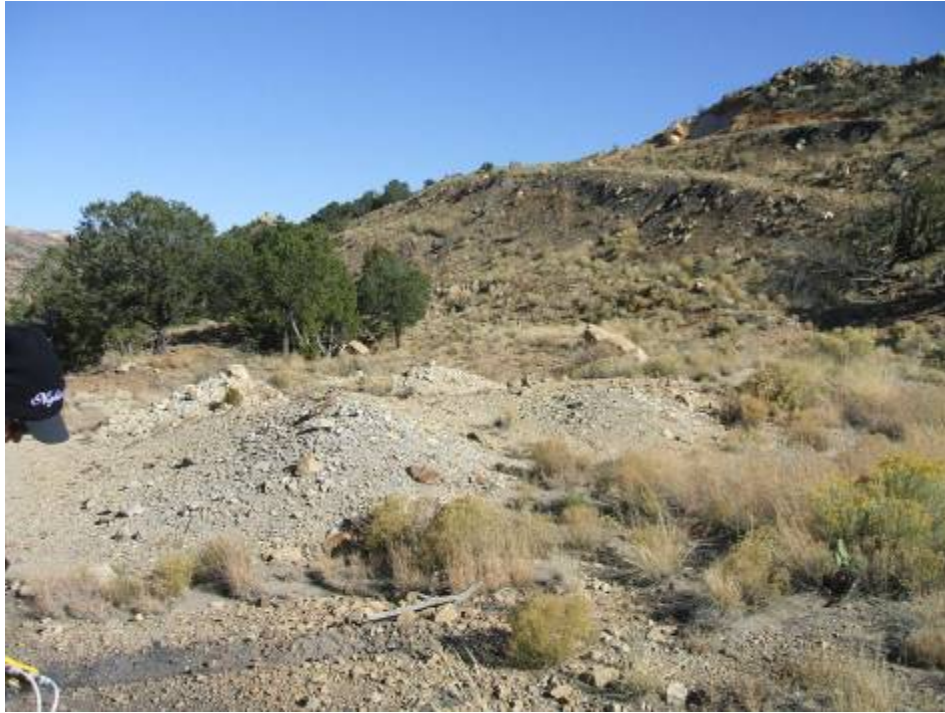
Photo 1. Hogback No 4 mine site and grading, towards the north

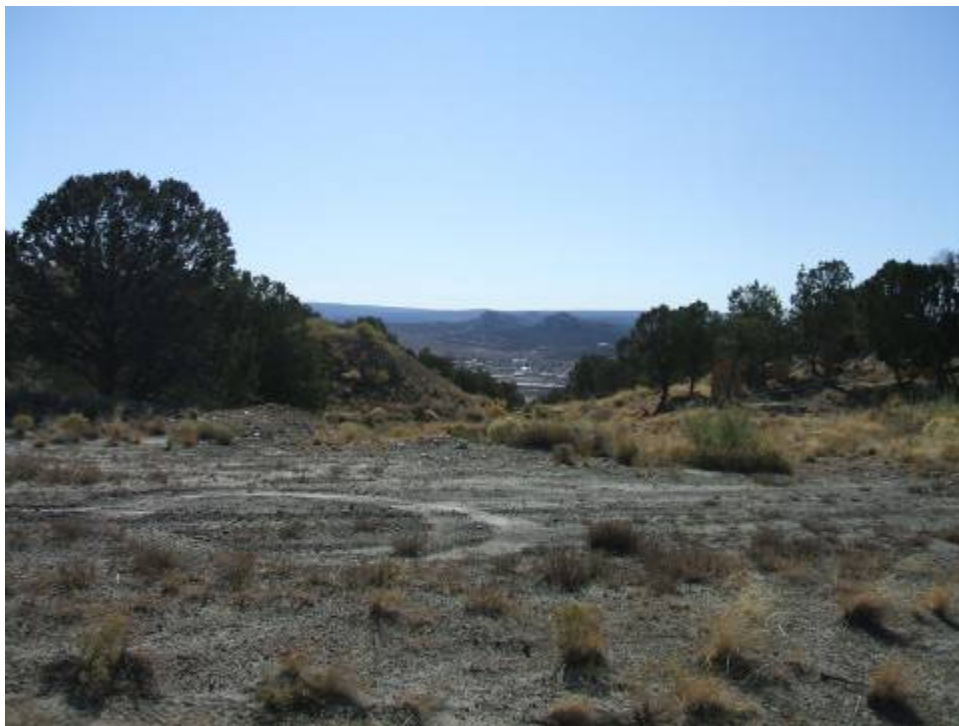
Photo 2. Hogback No 4 mine site, area with dark soil, towards the southeast

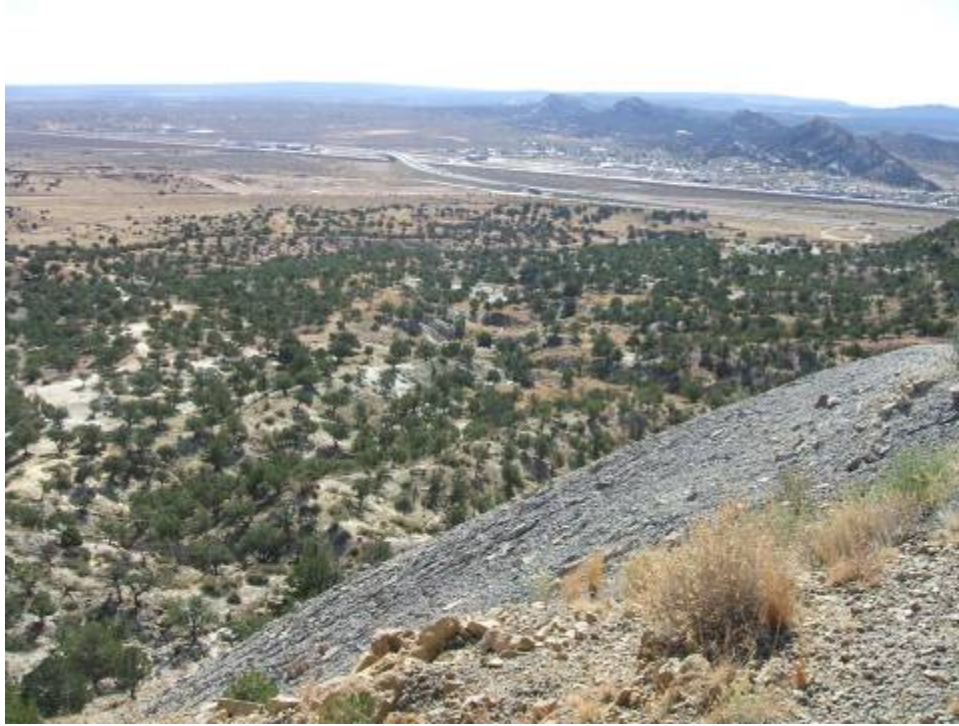
Reclamation status of the mine site is currently unknown. No visible signs of reclamation were observed. Several large piles of gravel were located throughout the site property. No adits or other mine features were observed during the site visit.

Photo 3. Hogback No 4 mine site southern gravel slope, Gallup in the distance, towards the southeast

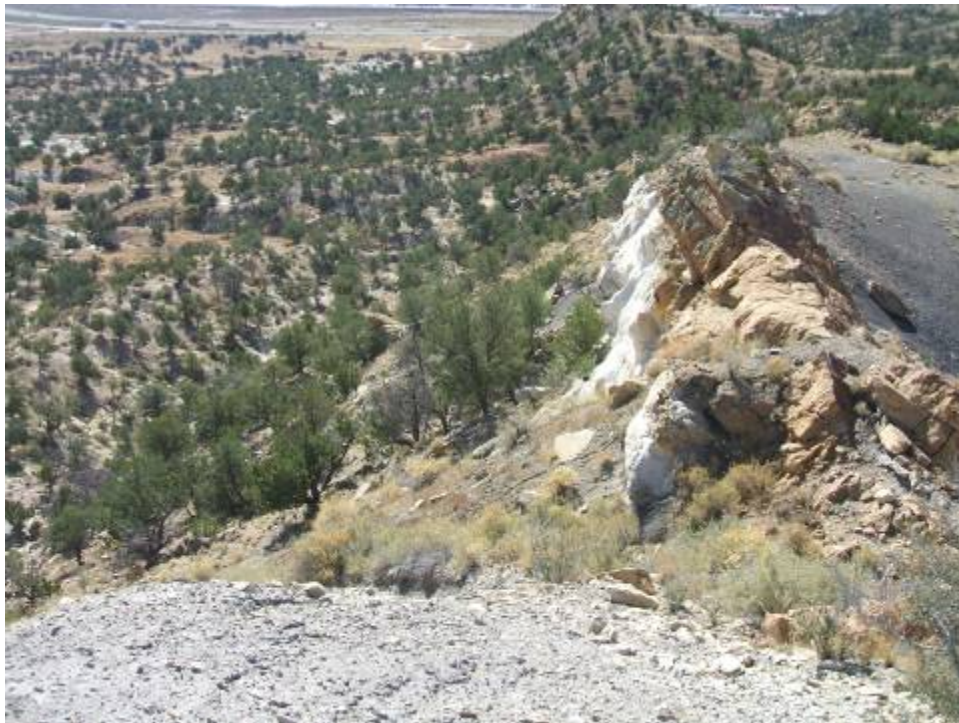
Photo 4. Hogback No 4 mine site cliff area, towards the south

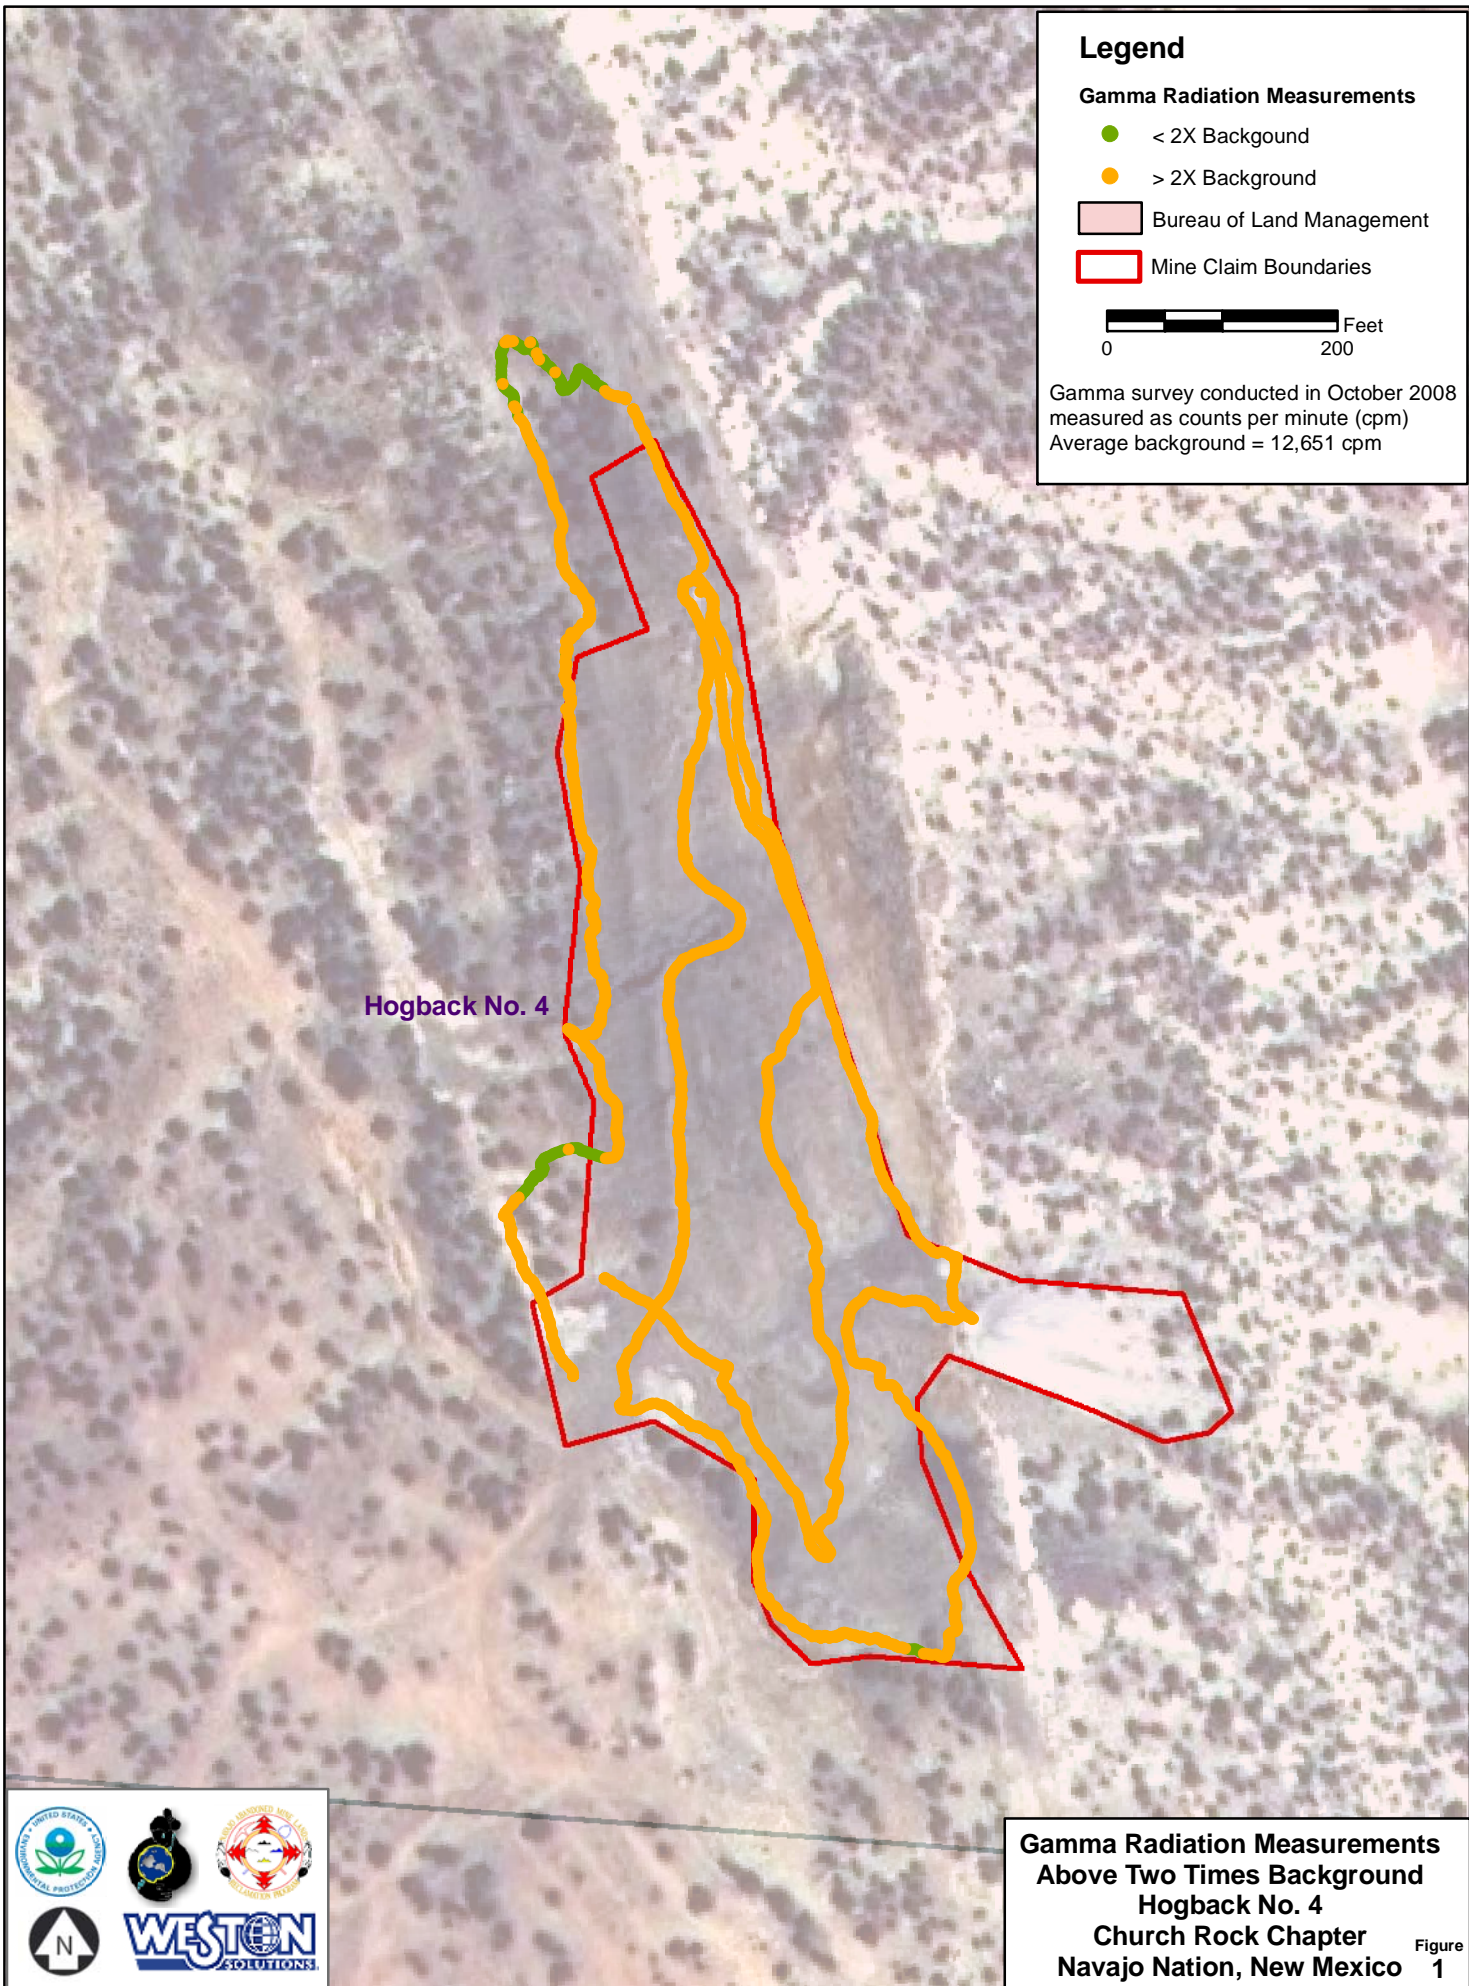
**Gamma Radiation Measurements
 Above Two Times Background
 Hogback No. 4
 Church Rock Chapter
 Navajo Nation, New Mexico** Figure 1

A total of 2,058 gamma radiation measurements were collected from mine sites, ranging from 17,931 cpm to 515,237 cpm. The measurements are represented in Figures 1 and 2.

Gamma survey conducted in October 2008
 measured as counts per minute (cpm)
 Average background = 12,651 cpm

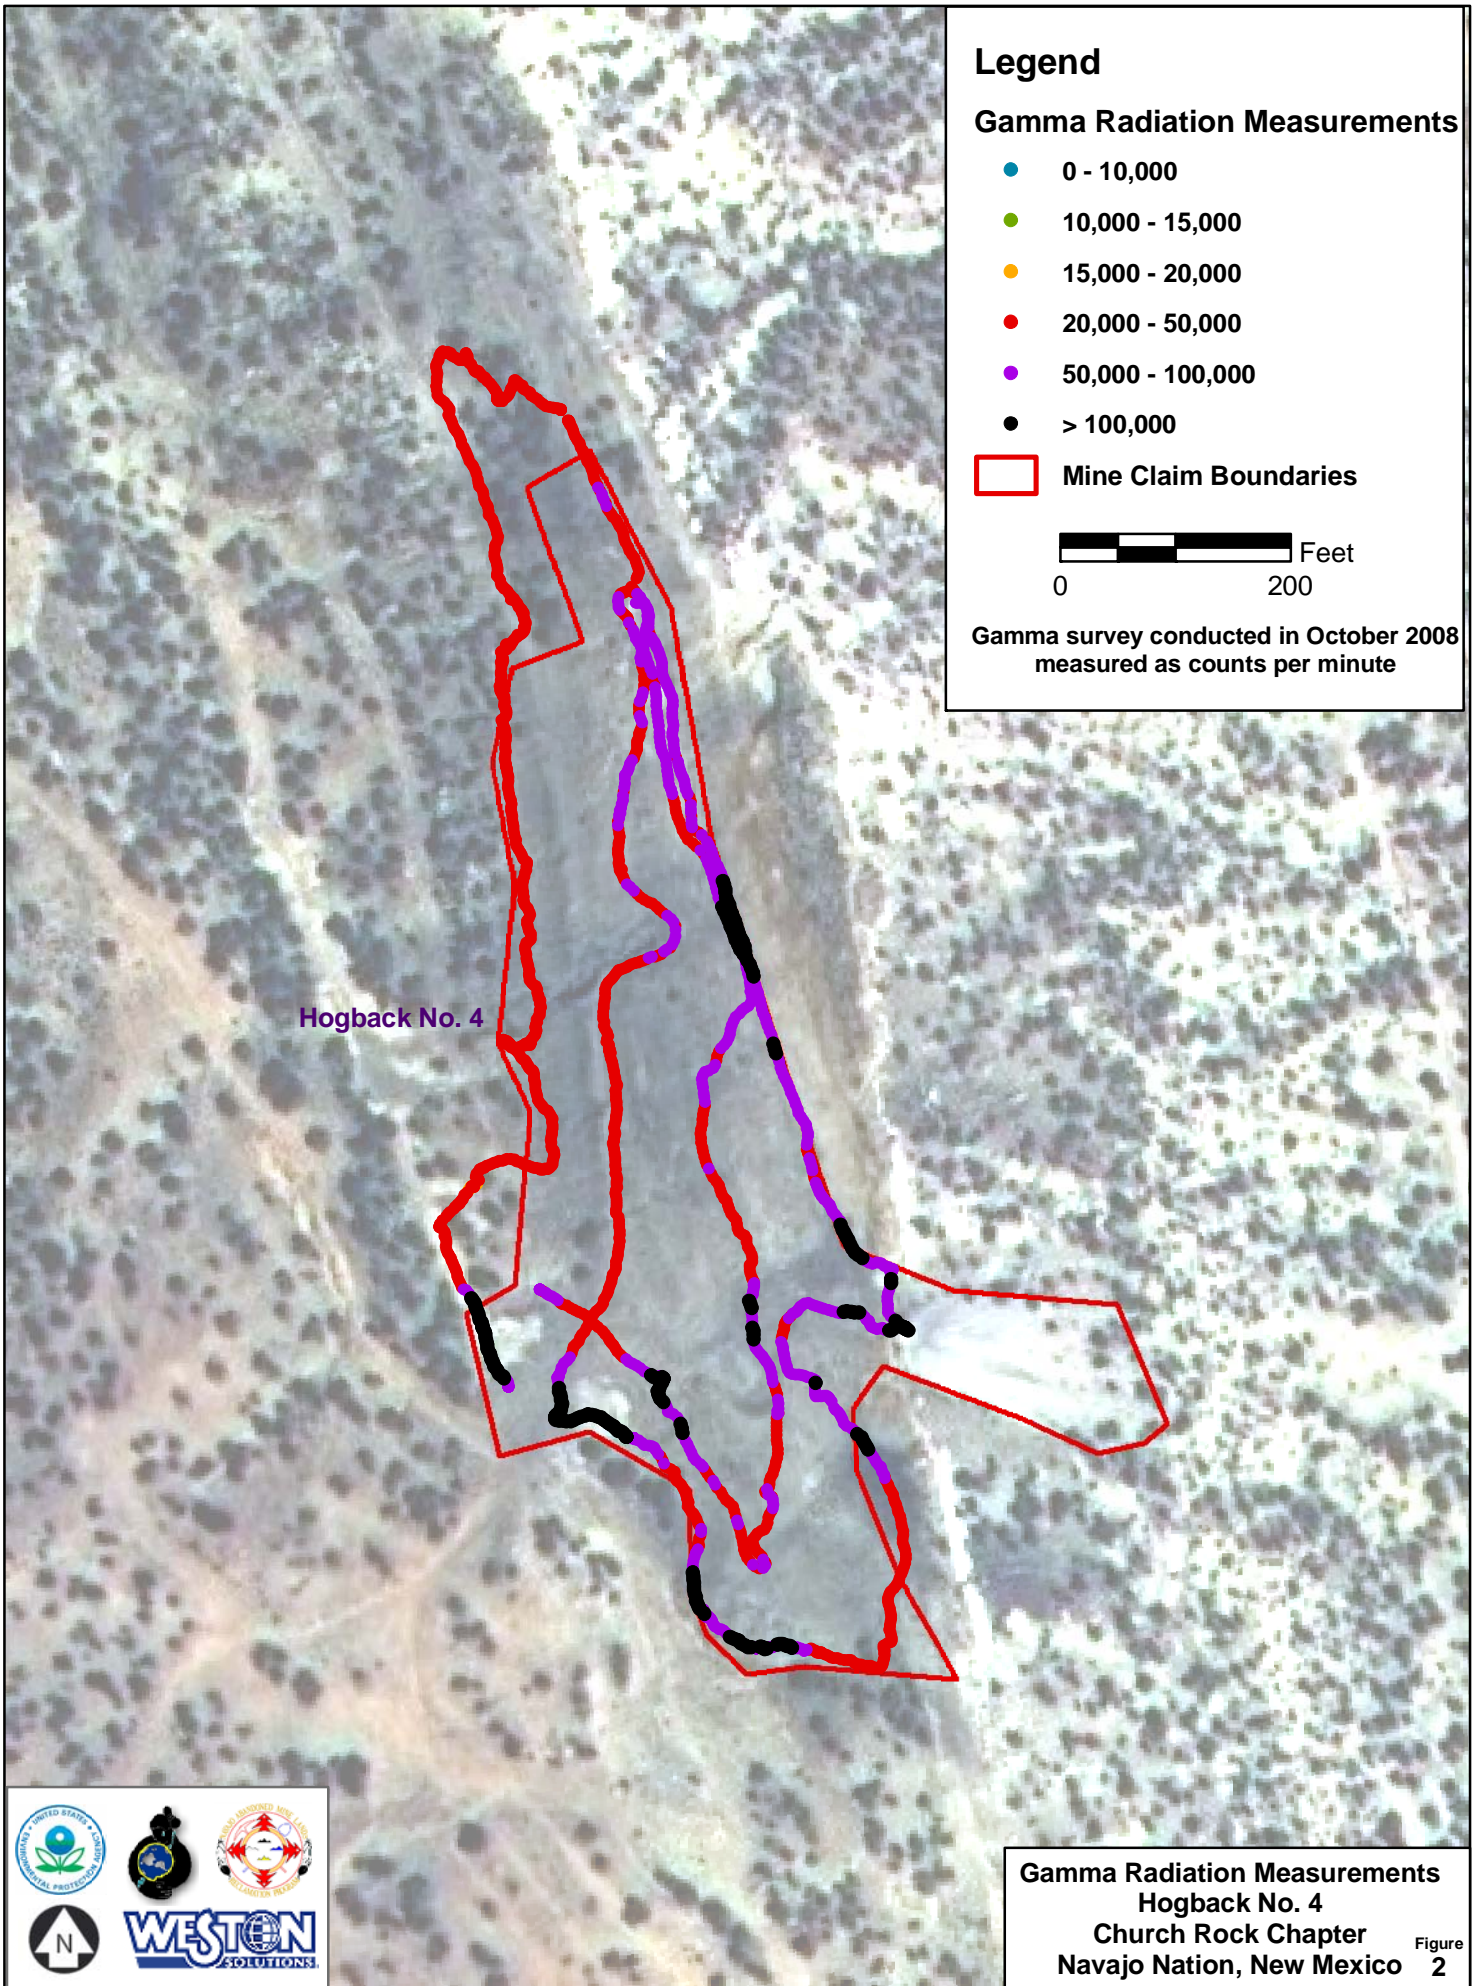
**Gamma Radiation Measurements
Hogback No. 4
Church Rock Chapter
Navajo Nation, New Mexico** Figure 2

Gamma survey conducted in October 2008
measured as counts per minute
