# **Navajo Abandoned Uranium Mine Site Screen Report**

## **Eunice Becenti AUM Site**

### **Navajo AUM Eastern Region**

**May 2009**

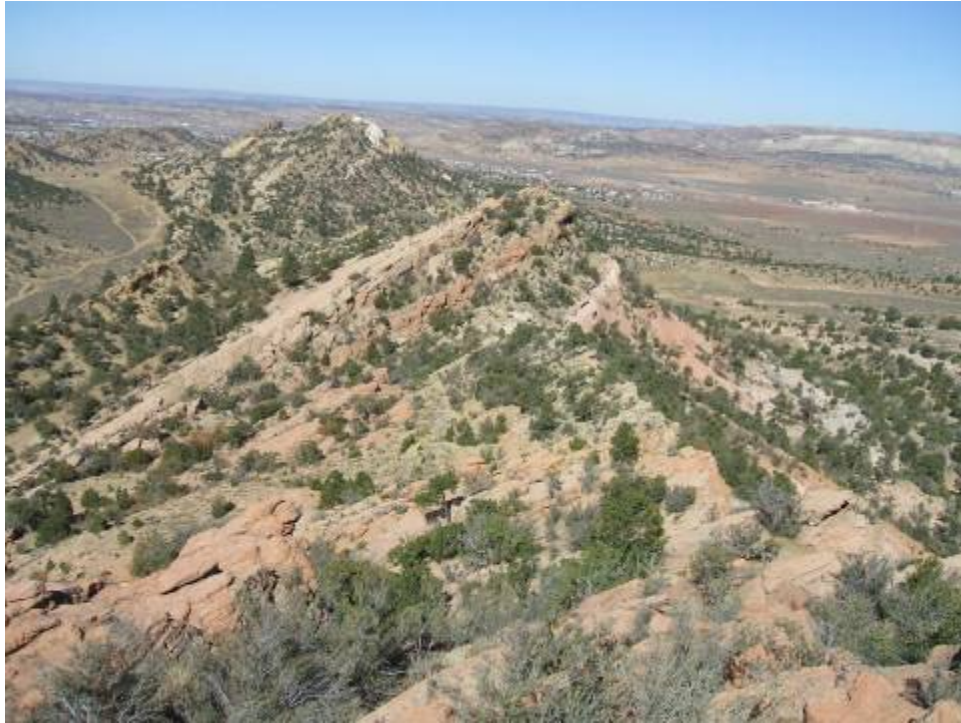
Photo 1. Eunice Becenti mine site, towards the north

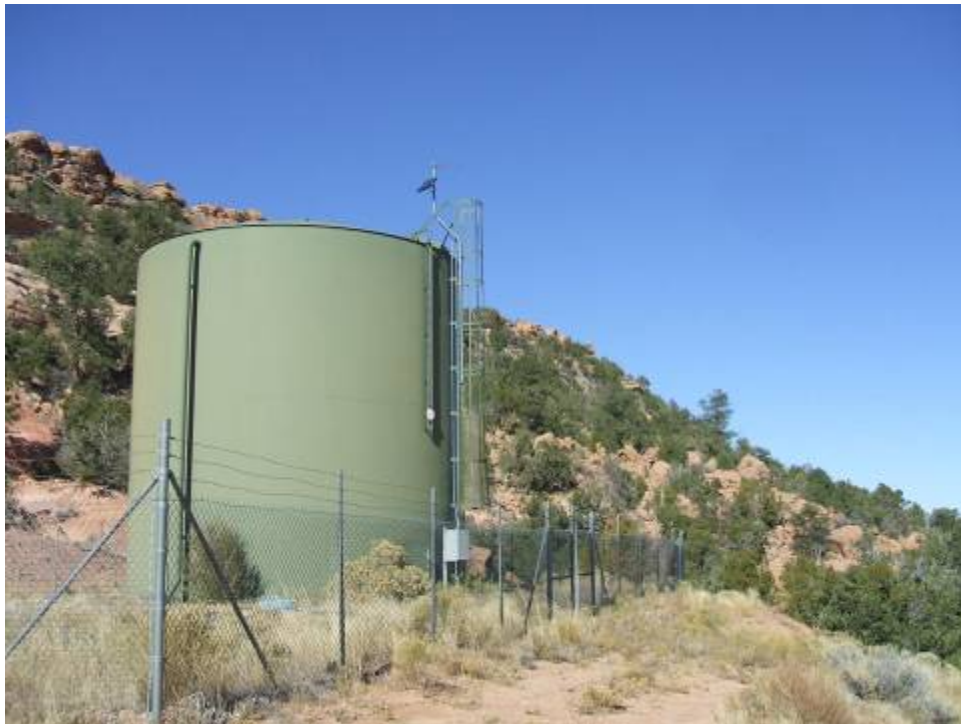
**0.25 miles to 4 miles:** 2 water tanks were observed nearby, a 10,000 gallon tank near the houses 0.25 mile to the east (Photo 5), and a 30,000 gallon tank approximately 0.25 miles southeast of the site (Photo 2). Local residents stated that they collected water the tanks, but did not know the source of the water. Field personnel were unable to determine the source of the tanks. Gamma radiation levels at both tanks were found to be less than 2 times background levels.

Photo 2. Eunice Becenti mine site, water tank at base of hill, approximately 0.25 miles south of site, towards the northwest

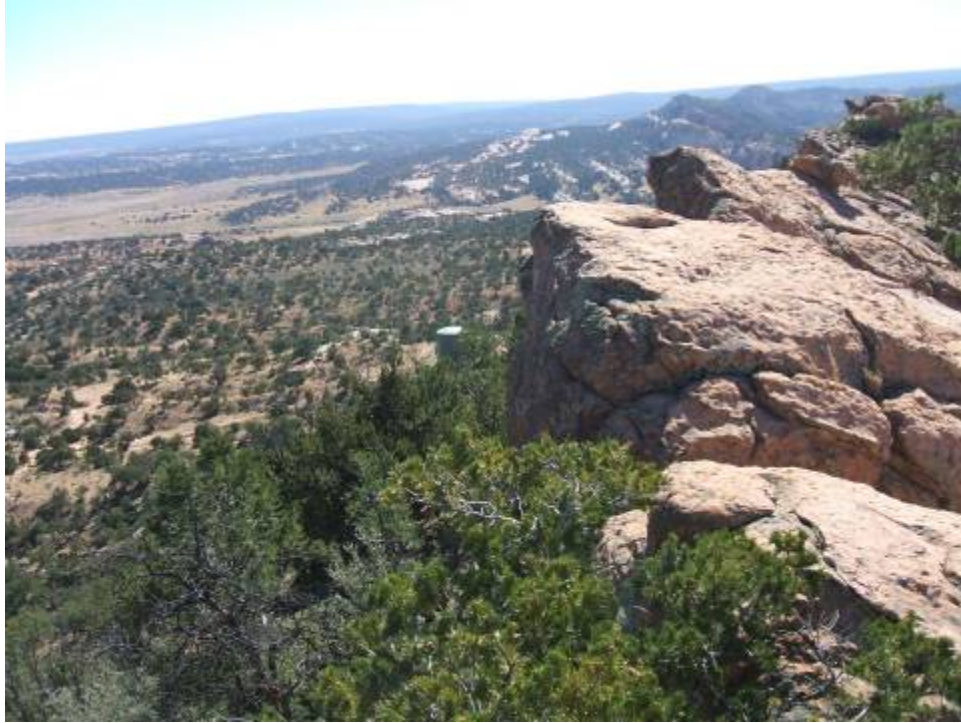
Reclamation status of the mine site is currently unknown. No visible signs of reclamation were observed. No waste piles, adits, or other mine features were observed during the site visit. The site was found alongside a large cliff-face, making much of the site inaccessible.

Photo 3. Eunice Becenti mine site cliff area, towards the south

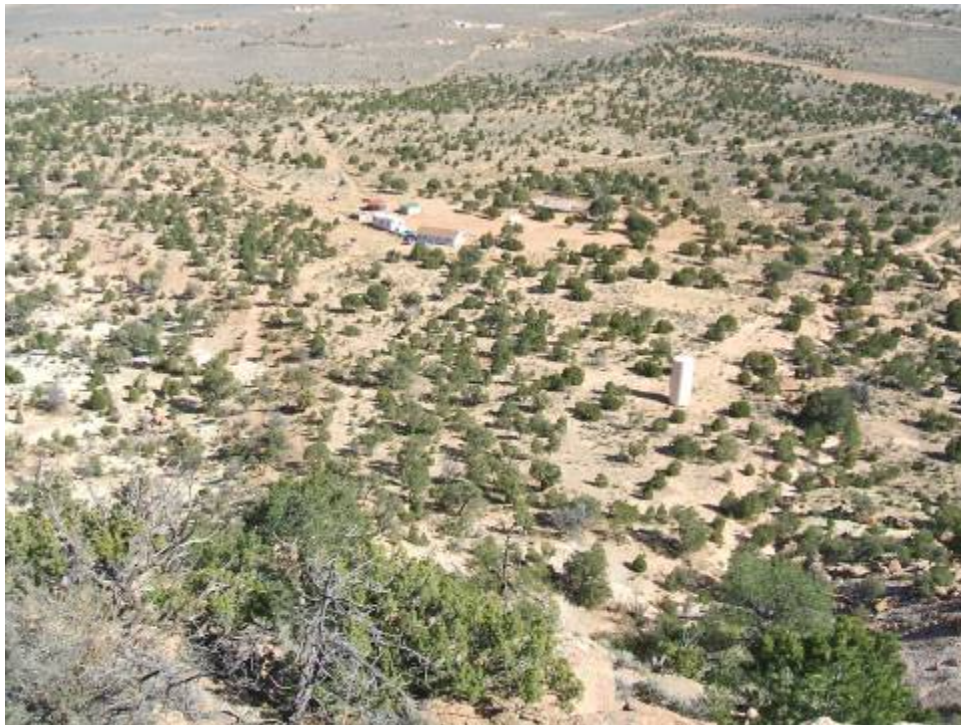
**200 feet to 0.25 mile:** 5 houses were observed approximately 0.25 miles east and northeast of the site (Photo 4). Gamma radiation levels at the houses were found to be less than 2 times background levels.

- 5 houses and 10,000 gallon water tank east and northeast of site – measured at 7,987 counts per minute (cpm)
- 30,000 gallon water tank southeast of site – measured at 6,396 cpm

Photo 4. Eunice Becenti mine site, housing compound and water tank approximately 0.25 miles northeast of site, towards the northeast

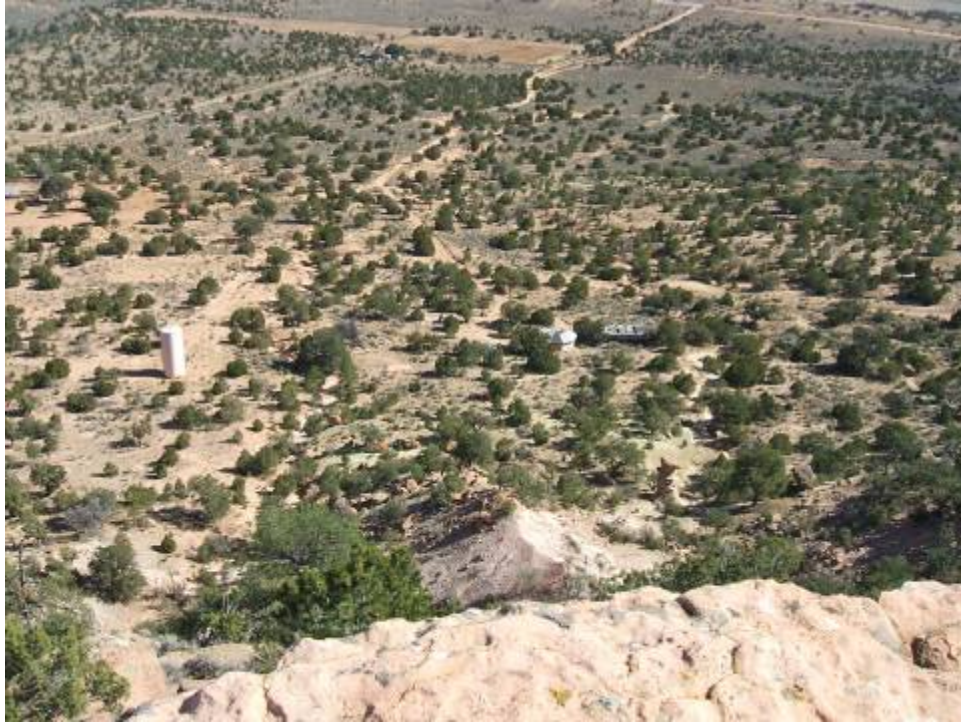
Photo 5. Eunice Becenti mine site, housing compound and water tank approximately 0.25 miles east of site, towards the east

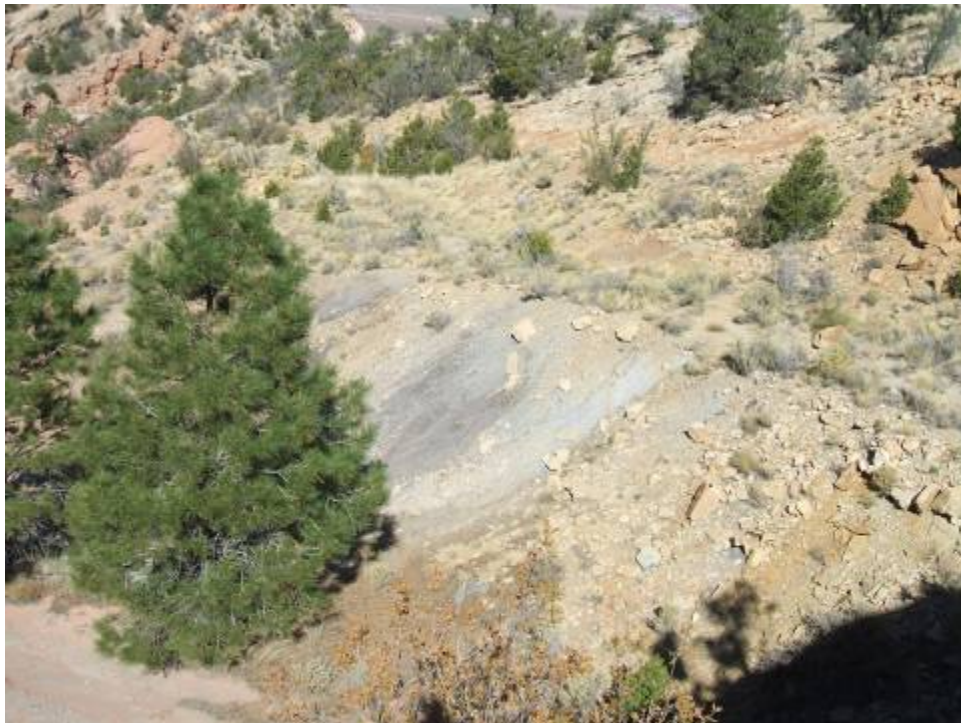
Photo 6. Eunice Becenti mine site, gravel and mudslide area, towards the north

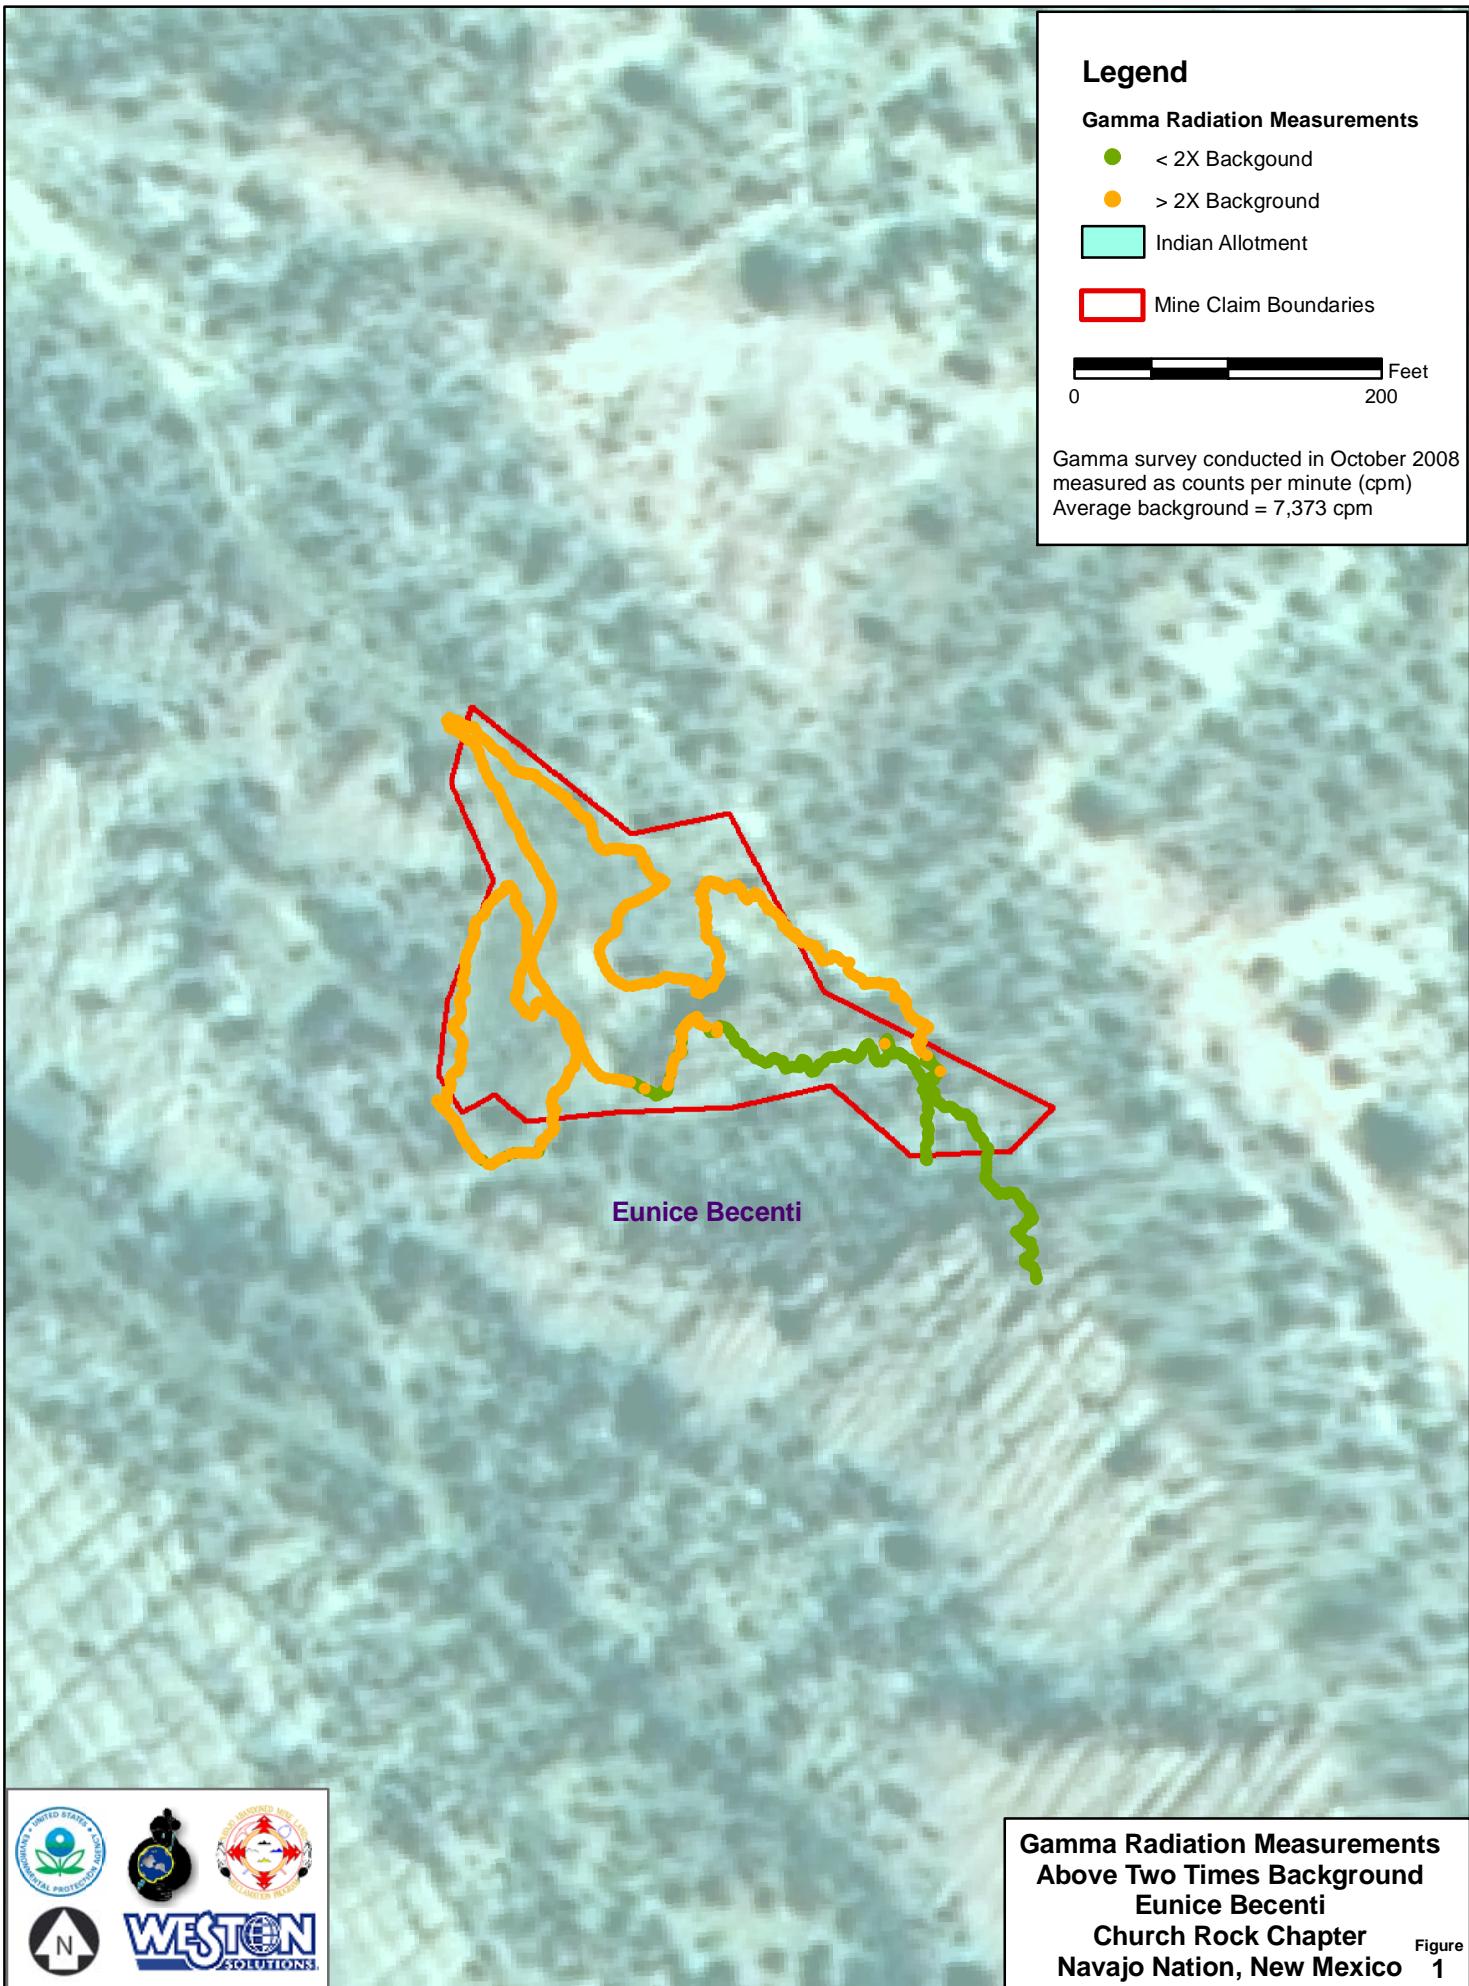
A total of 1,022 gamma radiation measurements were collected from mine sites, ranging from 5,141 cpm to 227,586 cpm. The measurements are represented in Figures 1 and 2.

Gamma survey conducted in October 2008  
measured as counts per minute (cpm)  
Average background = 7,373 cpm

**Gamma Radiation Measurements  
Above Two Times Background  
Eunice Becenti  
Church Rock Chapter  
Navajo Nation, New Mexico** Figure  
1

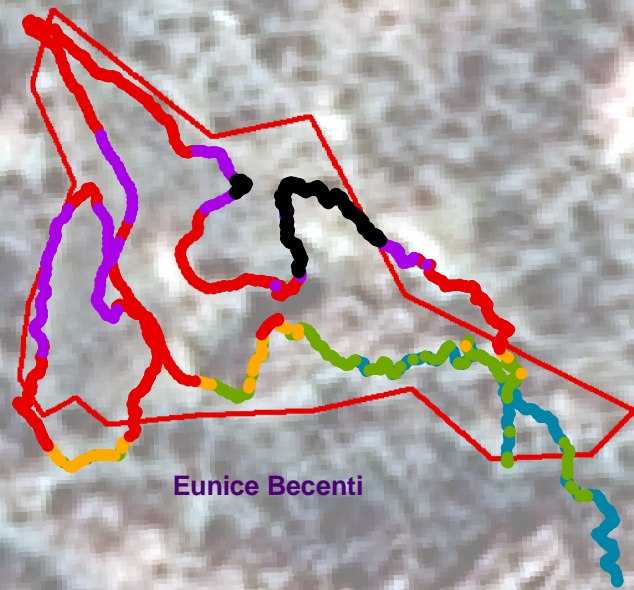
Gamma survey conducted in October 2008  
measured as counts per minute

Gamma Radiation Measurements  
Eunice Becenti  
Church Rock Chapter  
Navajo Nation, New Mexico Figure 2
