Navajo Abandoned Uranium Mine Site Screen Report

Ruby No. 1 AUM Site

Navajo AUM Eastern Region

Weston Solutions, Inc.

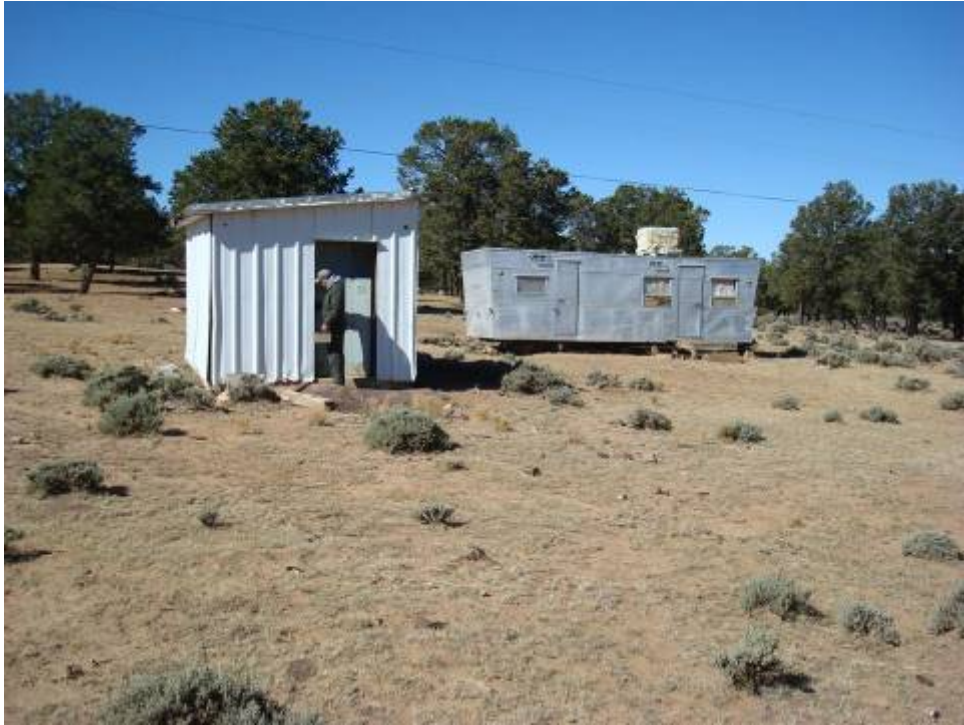
Gamma radiation measurements were collected from materials and buildings acquired from the mine that located at the Yapany property ranged from 11,000 to 14,000 cpm.

Photo 5. Ruby 1 Mine site, former mine buildings at the Yapany residence

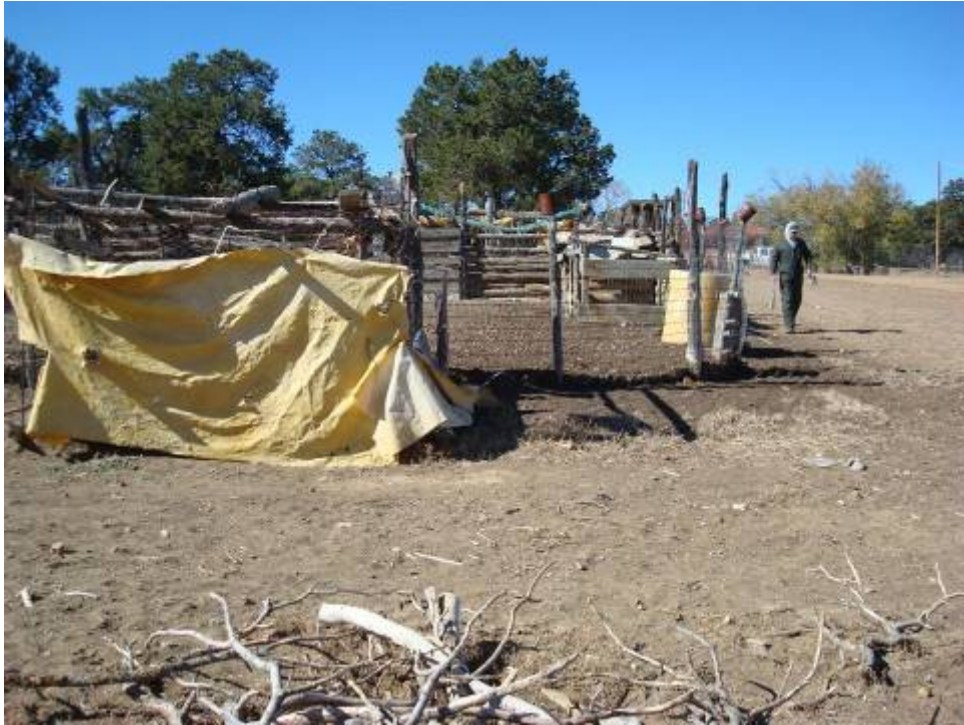
Marie Yapany has a residence located less than ¼ mile from the mine. She was employed there with some of her relatives in the late 1970s and early 1980s. She had acquired a steel shed, portable office, tarps and lumber from the former mine.

Photo 6. Ruby 1 Mine site, yellow tarps from the mine at the Yapany residence
