Navajo Abandoned Uranium Mine Site Screen Report

Ruby No. 3 AUM Site

Navajo AUM Eastern Region

May 2009

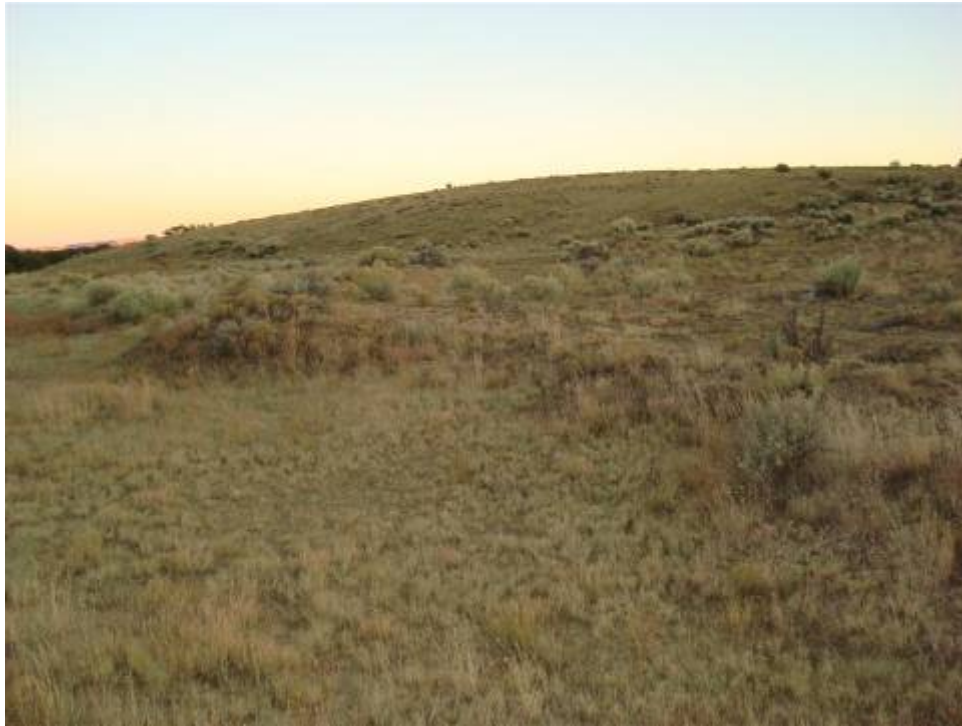
Photo 1. Ruby No. 3 Mine site, towards the south

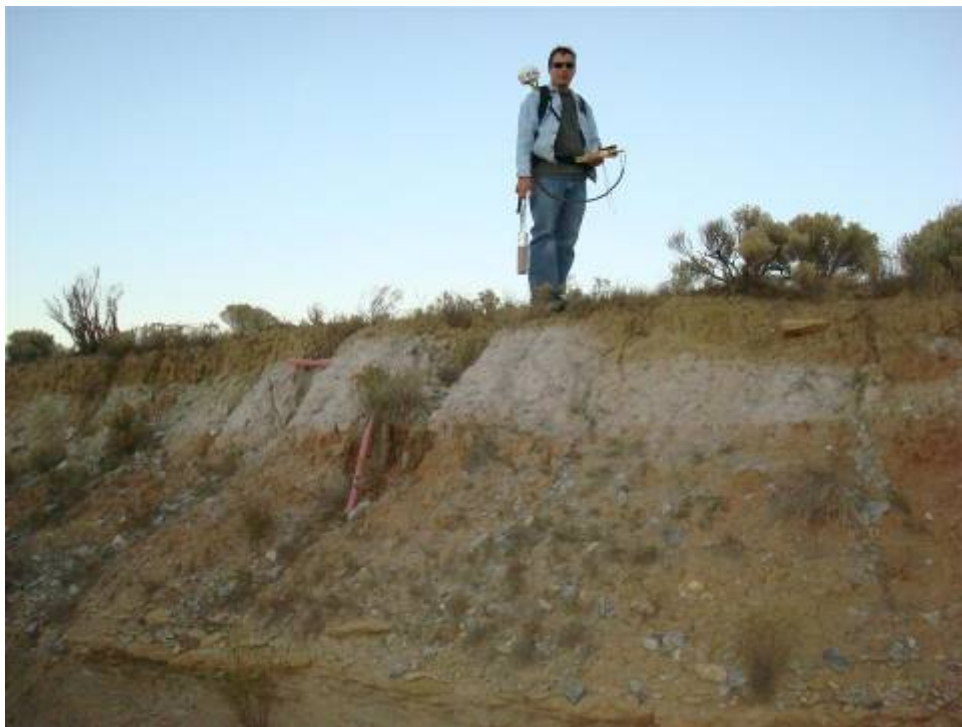
Reclamation status of the mine sites are currently unknown. The mine appears to have been covered with a soil cap. A few areas of the cap have eroded to expose waste rock beneath. Some uranium ore or waste rock was mixed in with the cover soil. No waste piles, adits, or other mine features were observed during the site visit.

Is the cap/seal functionally intact? Erosion of the soil cap was observed at a few areas.

Photo 2. Ruby No. 3 Mine site, erosion of western edge of mine

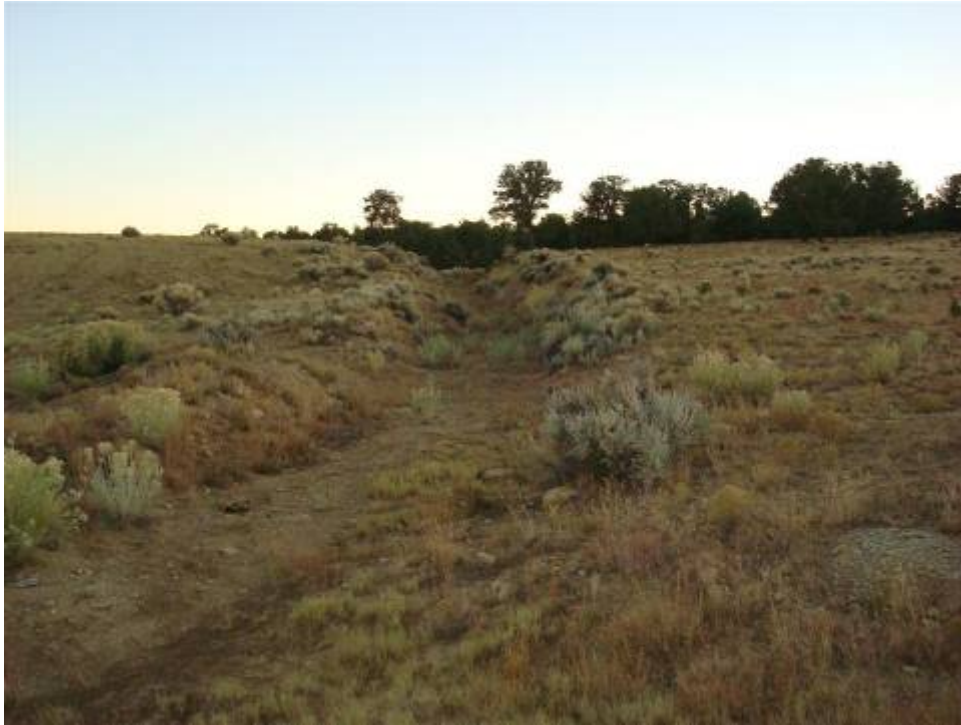
Photo 3. Ruby No. 3 Mine site, erosion of southern portion of mine

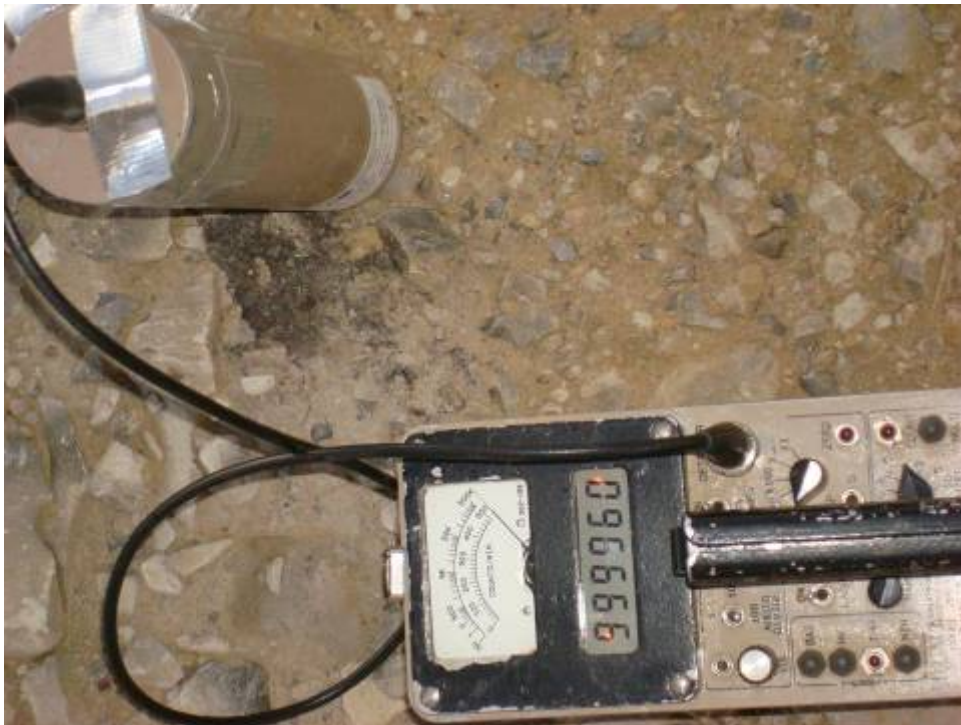
A total of 2,911 gamma radiation measurements were collected from mine sites, ranging from 9,146 cpm to 969,089 cpm. The measurements are represented in Figures 1 and 2. The highest radiation was emitted from exposed uranium found in the road at the central portion of the mine and was beyond the meters measuring capabilities of 999,999 cpm. Gamma radiation measurements collected from the Augustine Largo residence, located within ¼ mile from the mine, were approximately 12,000 cpm.

Photo 4. Ruby No. 3 Mine site, very high gamma radiation emitting from black uranium ore

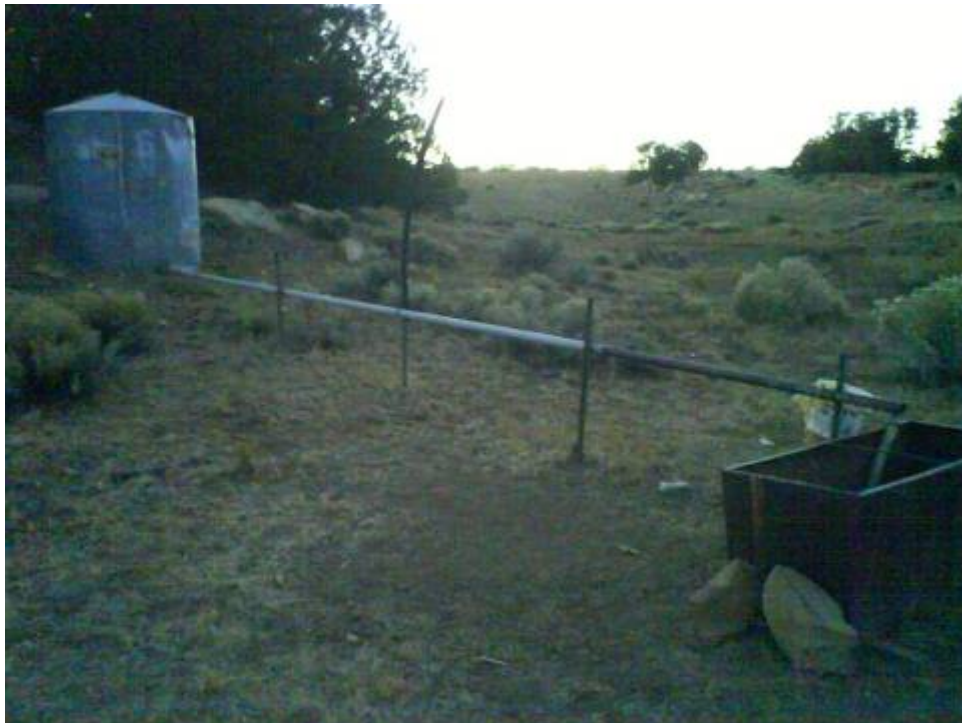
Photo 6. Ruby No. 3 Mine site, water tank and livestock watering trough located approximately 200 feet southeast of mine. Mine is in background
