Navajo Abandoned Uranium Mine Site Screen Report

Section 34 AUM Site

Navajo AUM Eastern Region

May 2009

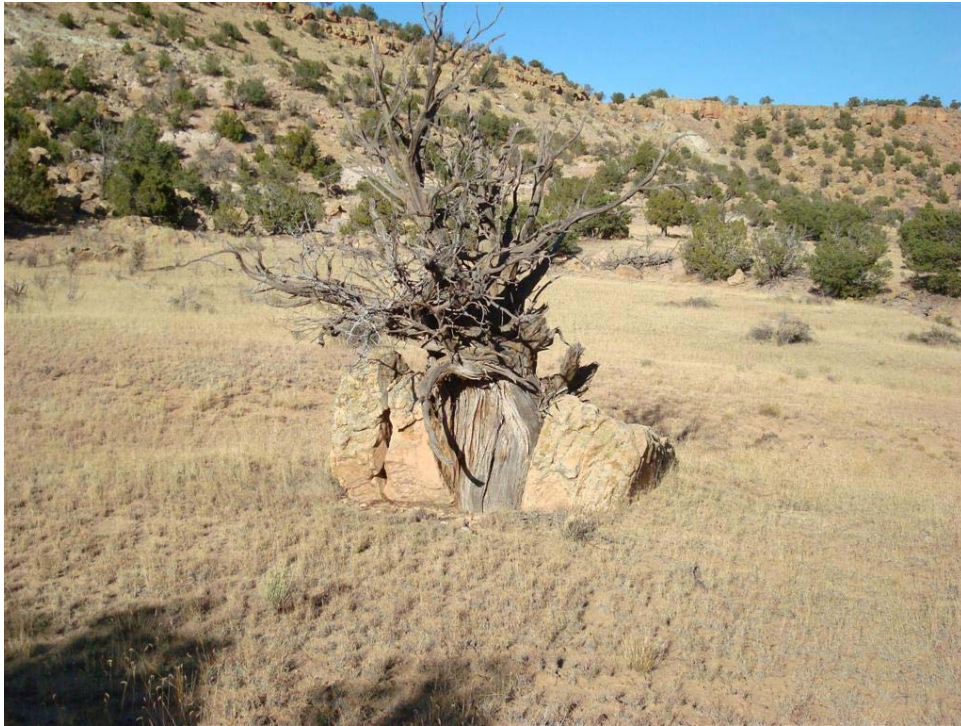
Photo 1. Section 34 Mine site along hillside, towards the northwest

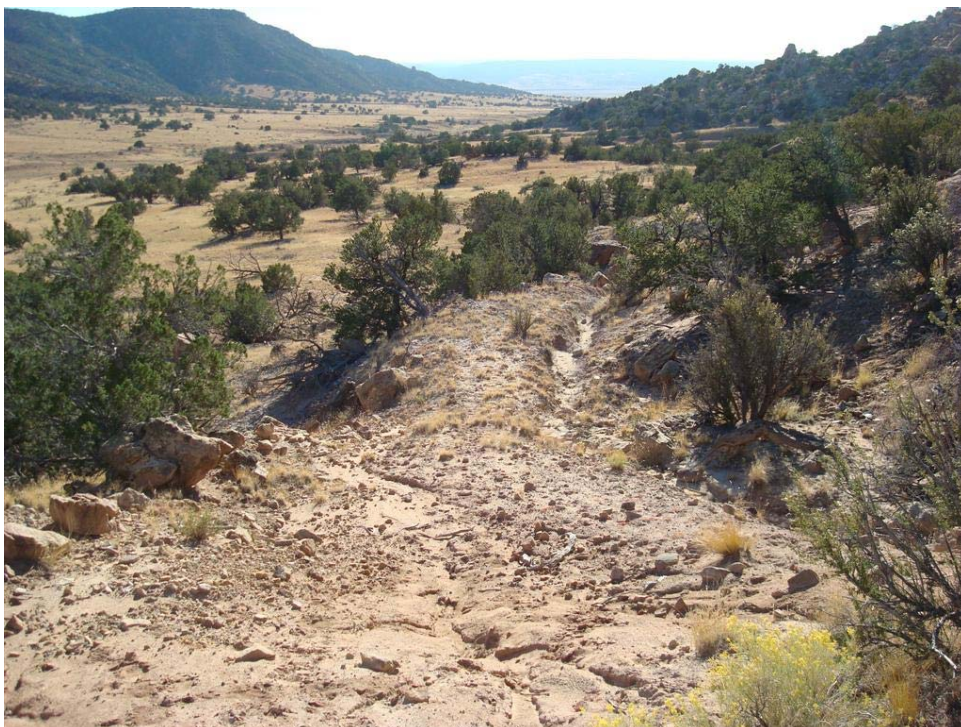
Reclamation status of the mine sites are currently unknown. No visible signs of reclamation were observed. No visible signs of mining operations were observed at the site. A washed-out access road ran through the mine. No waste piles, adits, or other mine features were observed during the site visit.

Photo 2. Section 34 Mine site, towards the south. Washed out access road.
