Navajo Abandoned Uranium Mine Site Screen Report

Pat AUM Site

Navajo AUM Eastern Region

May 2009

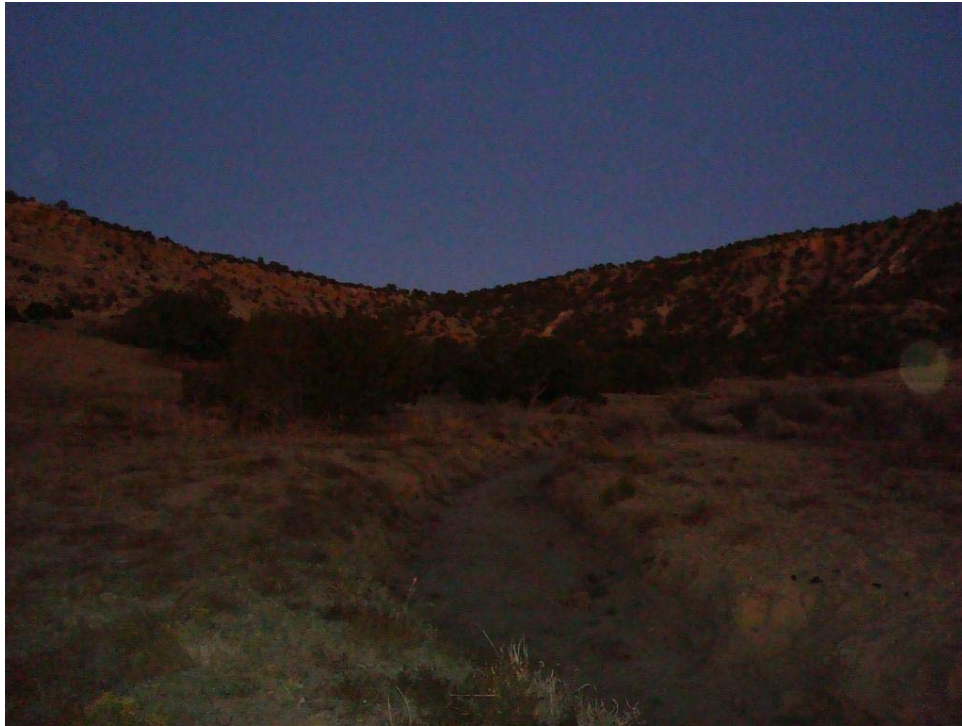
Reclamation status of the mine sites are currently unknown. No visible signs of reclamation were observed. No mining operations were apparent. No waste piles, adits, or other mine features were observed during the site visit.

Photo 1. Pat Mine site, towards the east

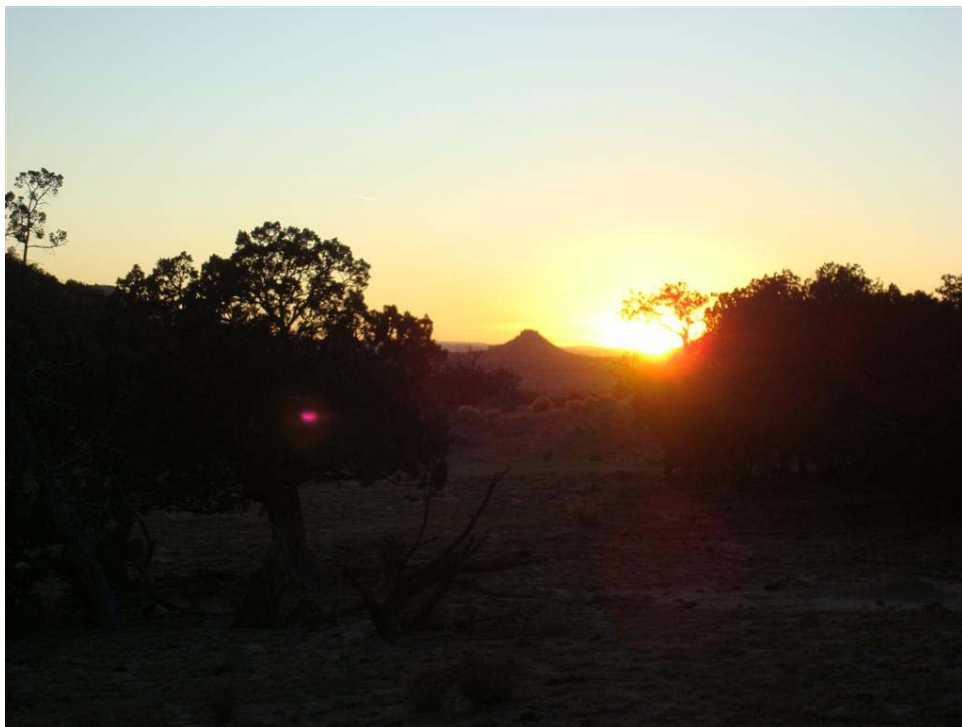
Photo 2. Pat Mine site, towards the west

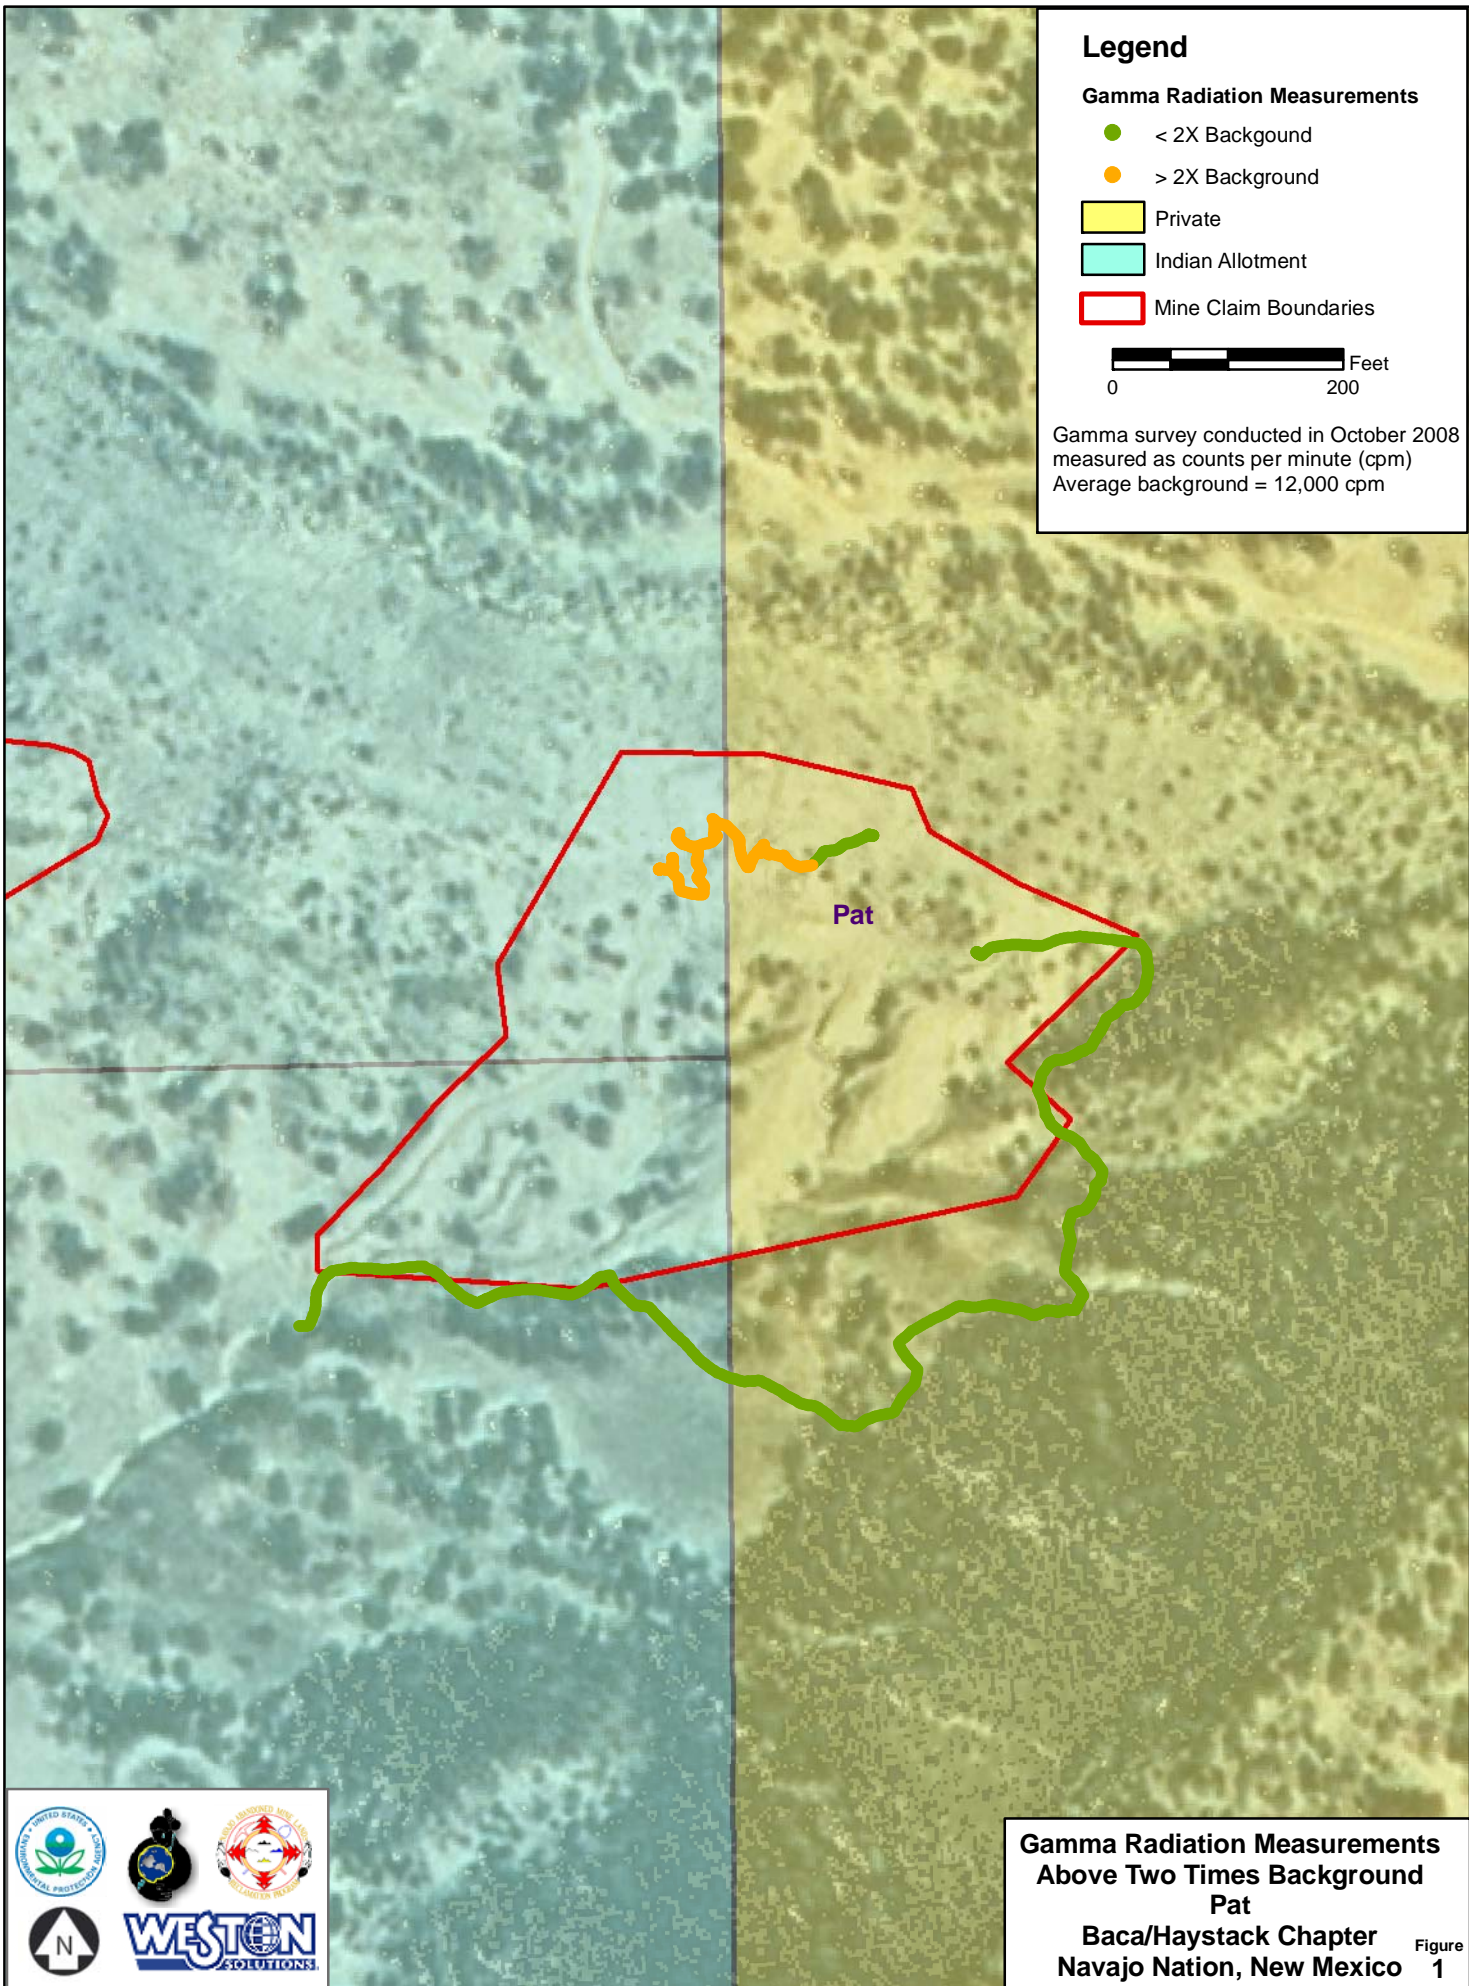
Gamma Radiation Measurements Above Two Times Background Pat
Baca/Haystack Chapter Navajo Nation, New Mexico Figure 1

A total of 1,680 gamma radiation measurements were collected from mine sites, ranging from 6,784 cpm to 647,159 cpm. The measurements are represented in Figures 1 and 2. The New Mexico Mining and Minerals Division identified radiological measurements levels at the stockpile as 1000 counts per second (cps); and the stope as 150 cps.

Gamma survey conducted in October 2008
 measured as counts per minute (cpm)
 Average background = 12,000 cpm

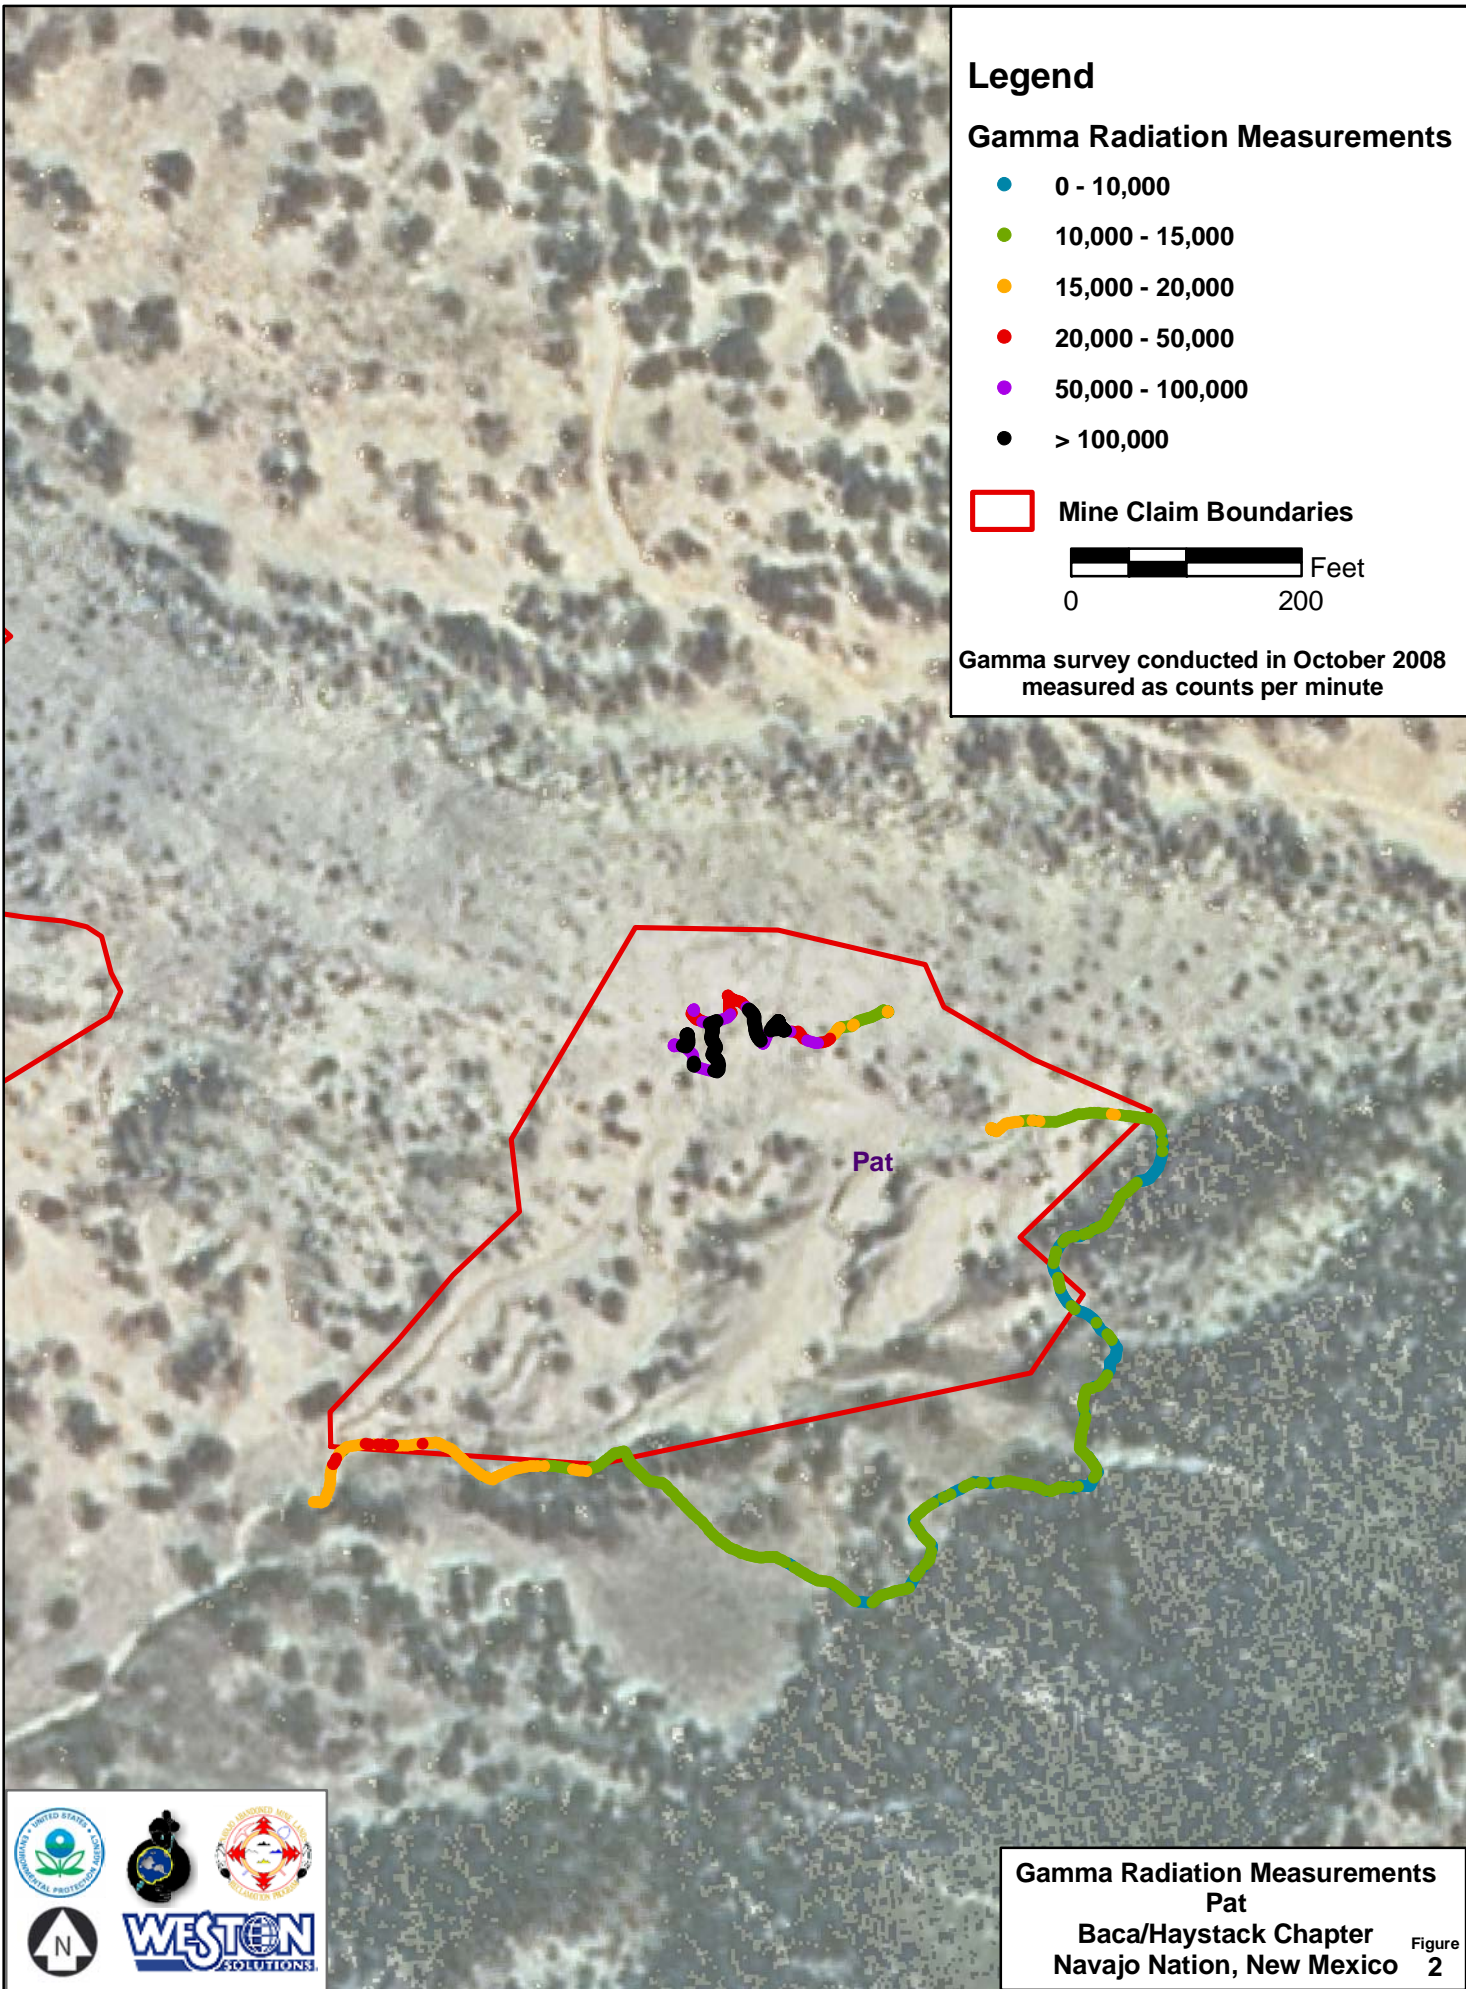
Gamma Radiation Measurements
Pat
Baca/Haystack Chapter
Navajo Nation, New Mexico

Gamma survey conducted in October 2008
measured as counts per minute
