# Navajo Abandoned Uranium Mine

## Site Screen Report

**Mine Name: Casey No. 3**  
**Mine ID: 373**

**August 2011**

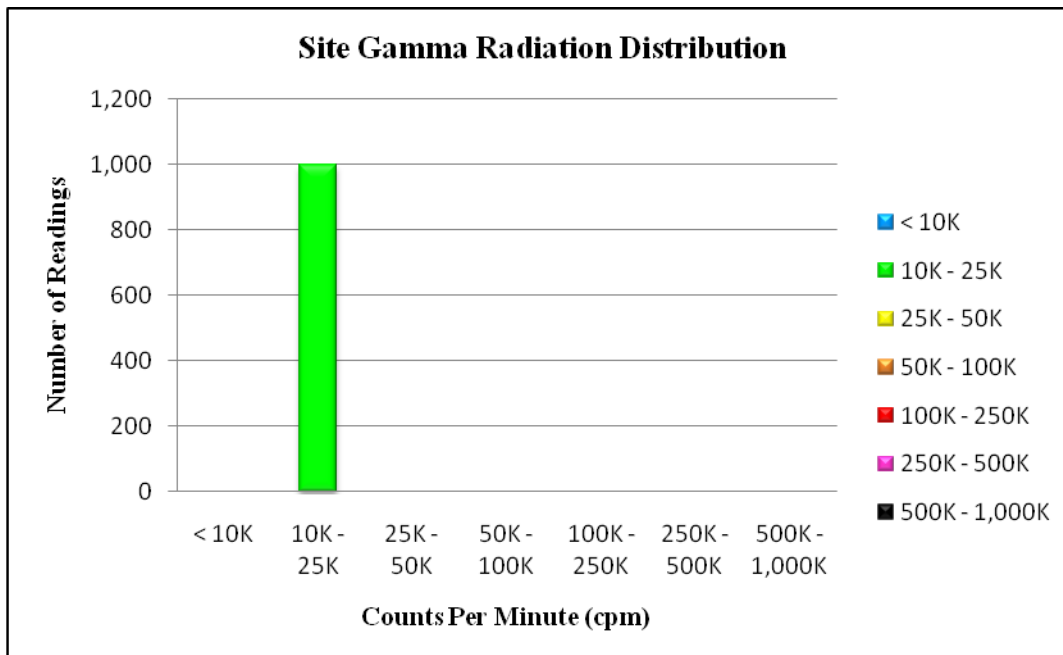
### Distribution Chart and Statistics:

A total of 998 gamma radiation measurements were collected from the mine site, ranging from 10,169 cpm to 16,818 cpm. The measurements are represented in Figures 1 and 2.

<b>Site Gamma Radiation Statistics</b>	
Number of Readings	998
Minimum (cpm)	10,169
Maximum (cpm)	16,818
Mean (cpm)	13,008
Median (cpm)	12,910
Standard Deviation	1,081

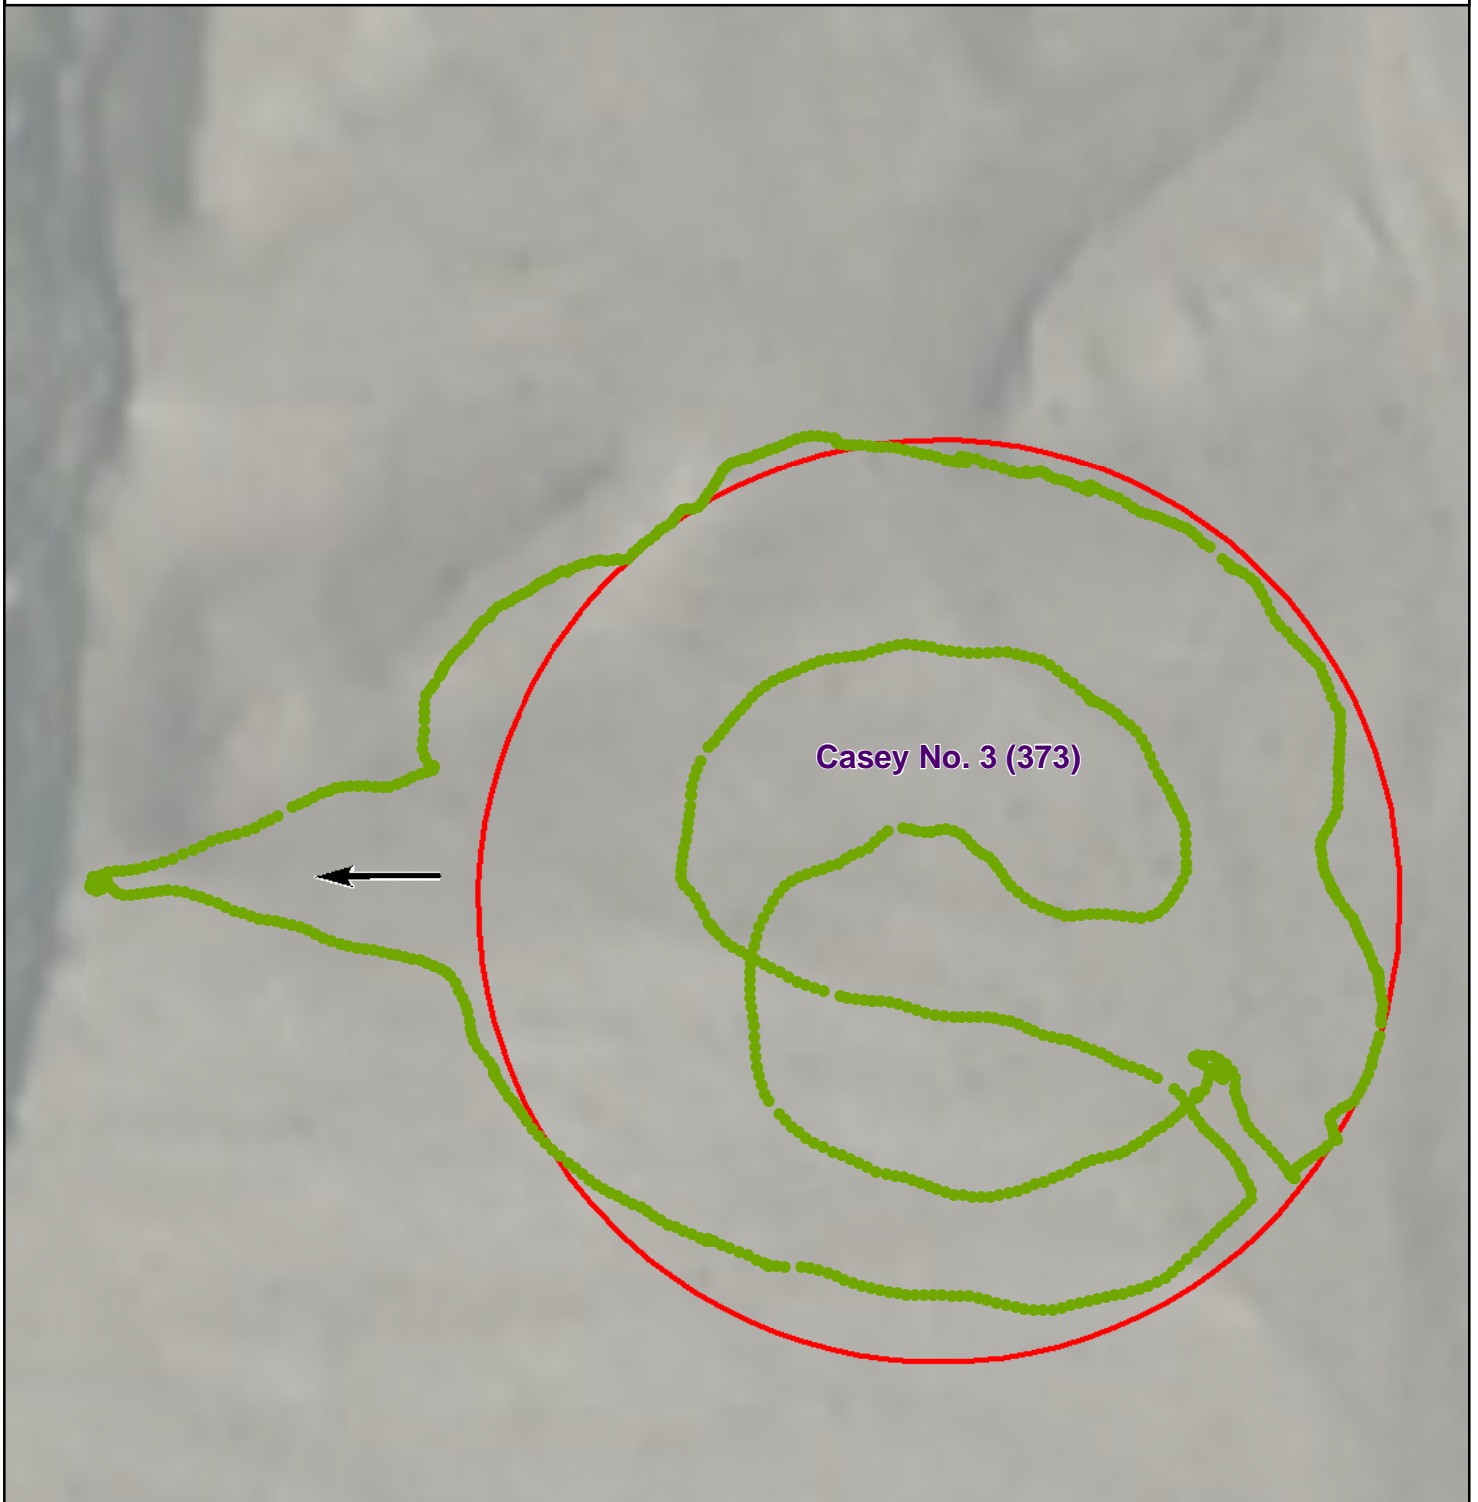
**Figure 1 - Gamma Radiation Measurements, Above Two Times Background  
Casey No. 3 (373)  
Coalmine Mesa Chapter, Navajo Nation**

**Highest gamma radiation measurement:** 16,818 counts per minute (cpm)

**Background Average:** 11,212 cpm      **Two Times Background:** 22,424 cpm
