Navajo Abandoned Uranium Mine

Site Screen Report

Mine Name: Copper Point
Mine ID: 389

April 2012

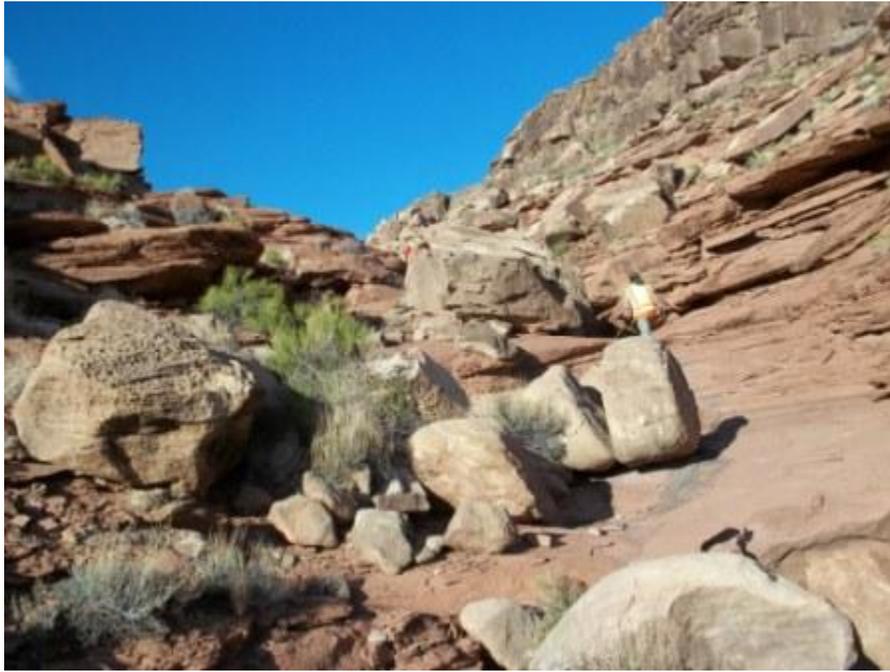
Photo 1

Mine Site #389

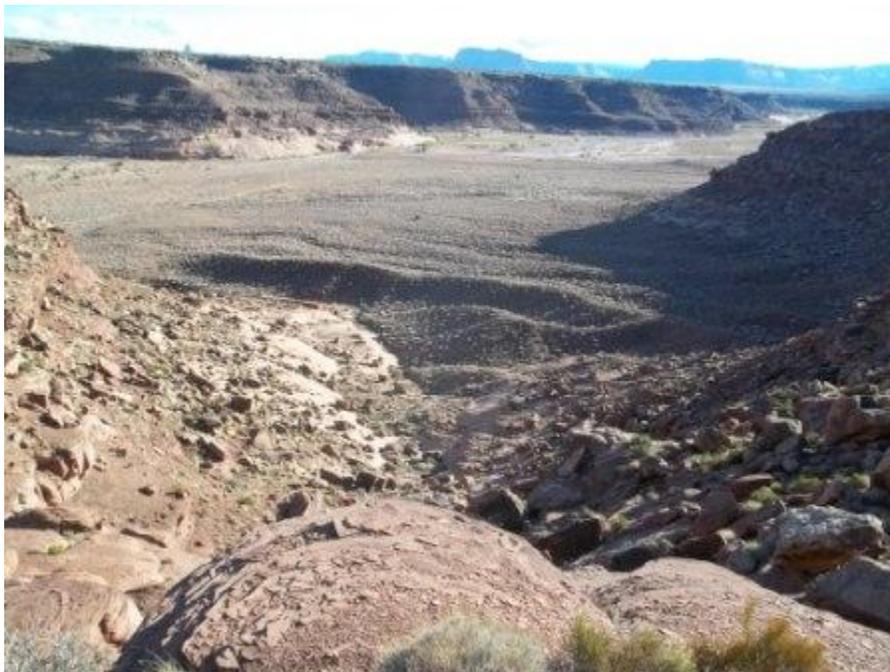
Photo 2

Mine Site #389
