# Navajo Abandoned Uranium Mine

## Site Screen Report

**Mine Name: Daylight**  
**Mine ID: 393**

**April 2012**

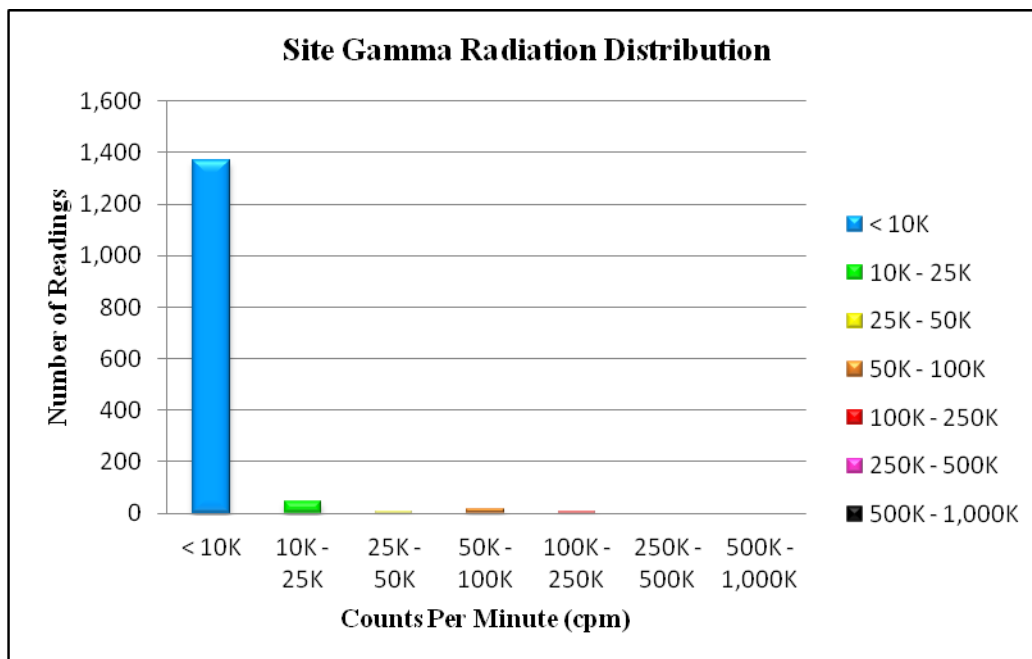
### Distribution Chart and Statistics:

A total of 1,434 gamma radiation measurements were collected from the mine site, ranging from 4,955 cpm to 113,360 cpm. The measurements are represented in Figures 1 and 2.

<b>Site Gamma Radiation Statistics</b>	
Number of Readings	1,434
Minimum (cpm)	4,955
Maximum (cpm)	113,360
Mean (cpm)	8,397
Median (cpm)	7,469
Standard Deviation	7,486

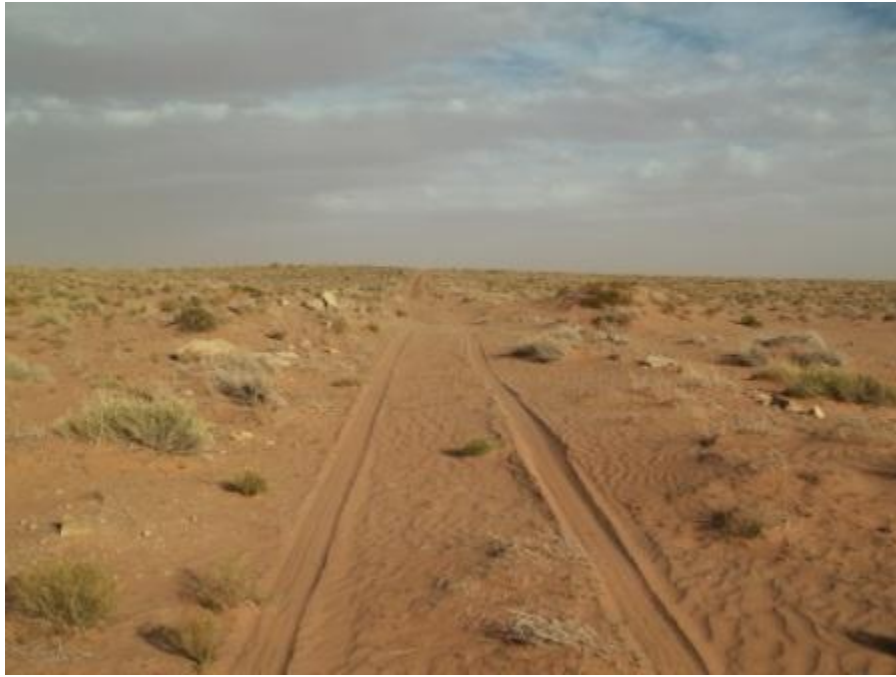
**Photo 1**

Mine Site #393

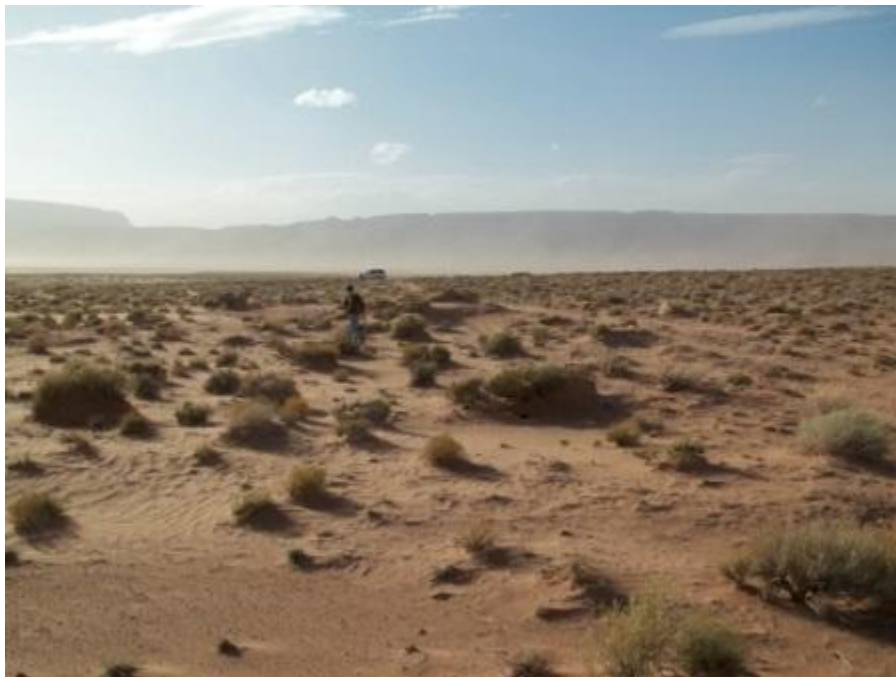
**Photo 2**

Mine Site #393

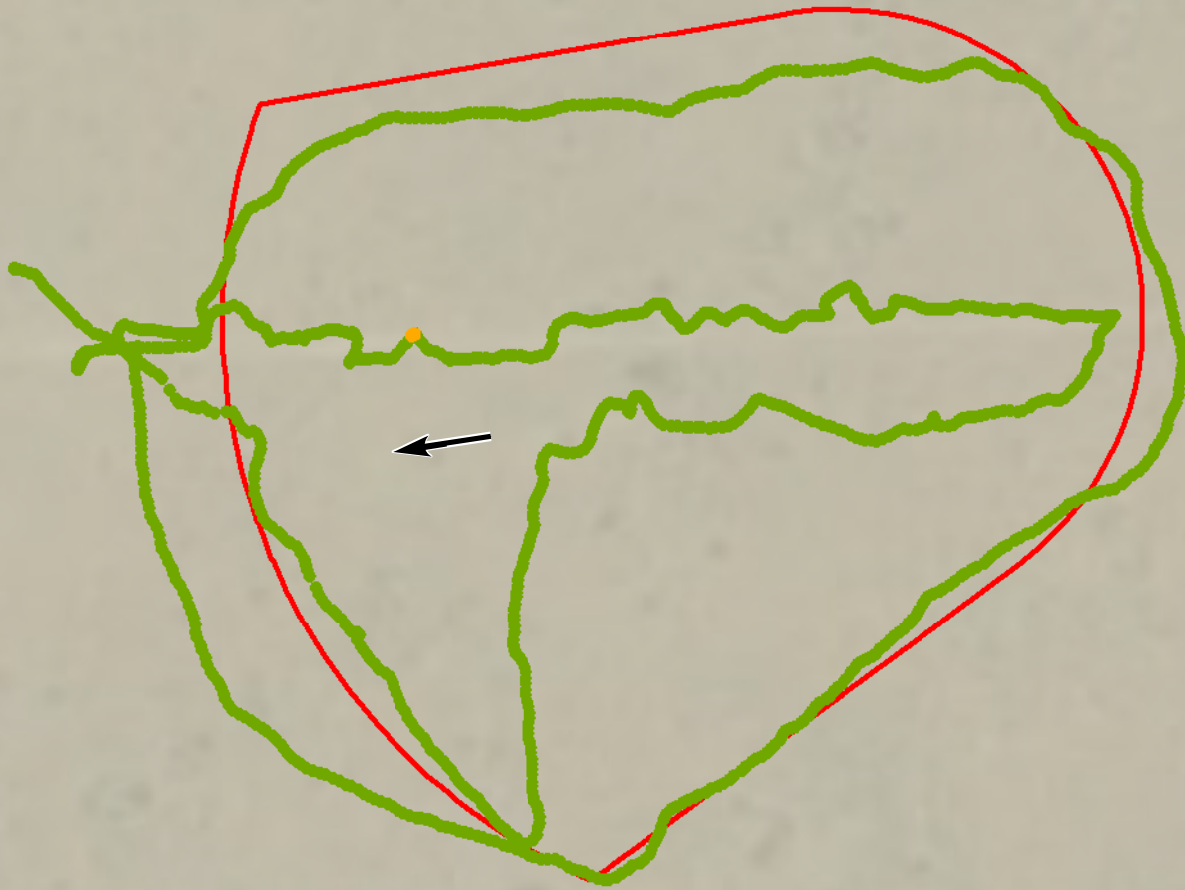
**Figure 1 - Gamma Radiation Measurements, Above Two Times Background  
Daylight (393)  
Oljato Chapter, Navajo Nation**

**Gamma Radiation Measurements**

- < 2X Background
- > 2X Background

Measured as counts per minute (cpm)

Average background 7,375 cpm

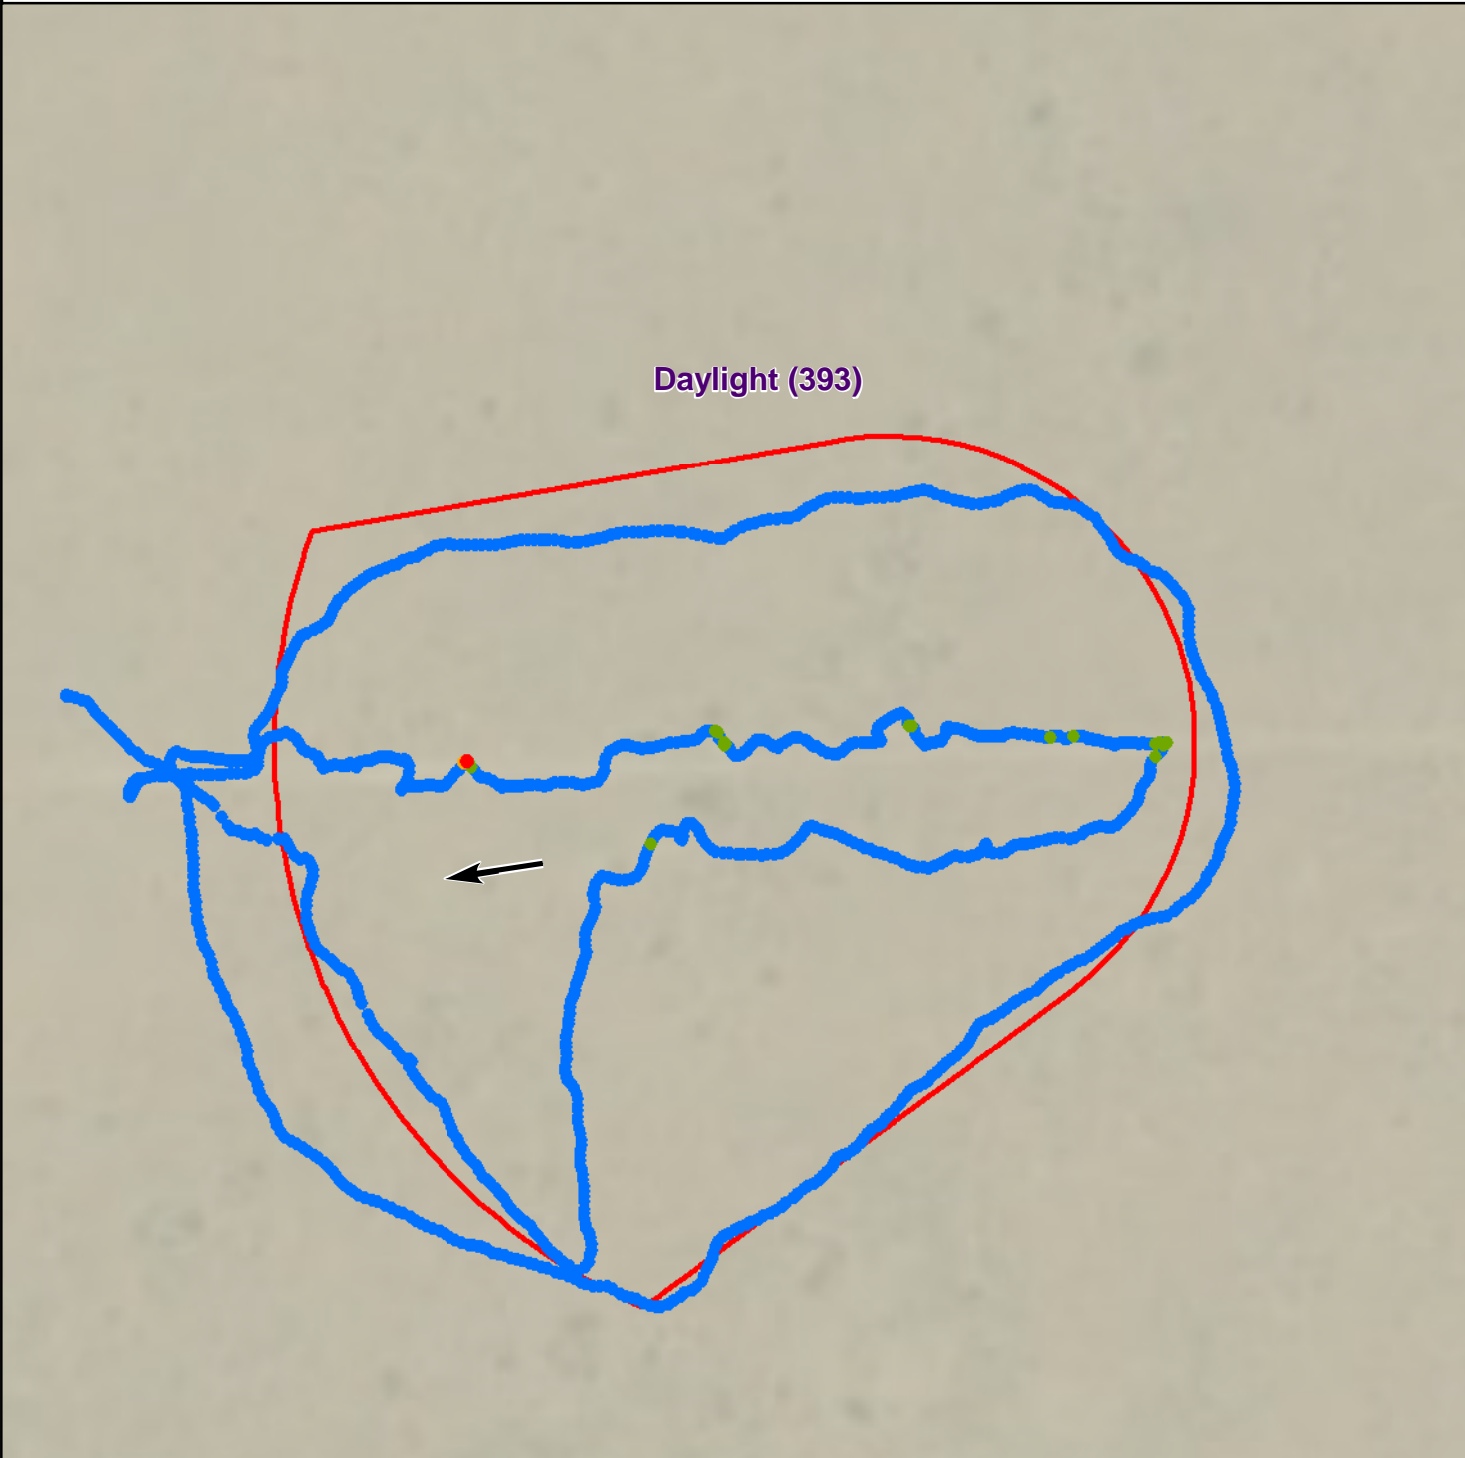
**Figure 2 - Gamma Radiation Measurements  
Daylight (393)  
Oljato Chapter, Navajo Nation**

**Gamma Radiation Measurements**

- 0 - 10,000 cpm
- 10,000 - 25,000 cpm
- 25,000 - 50,000 cpm
- 50,000 - 100,000 cpm
- 100,000 - 250,000 cpm
- 250,000 - 500,000 cpm
- 500,000 - 1,000,000 cpm

**Average background 7,375 cpm**

**Measured as counts per minute (cpm)**
