Navajo Abandoned Uranium Mine

Site Screen Report

Mine Name: Black Mountain Vase

August 2011

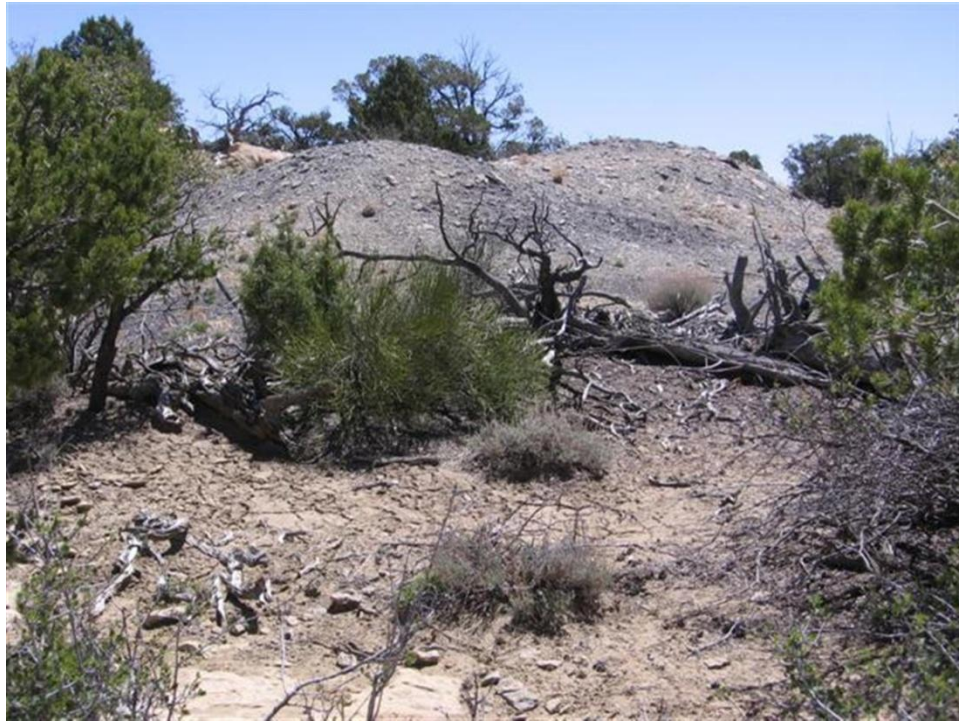
Photo 1: Mine Site #405

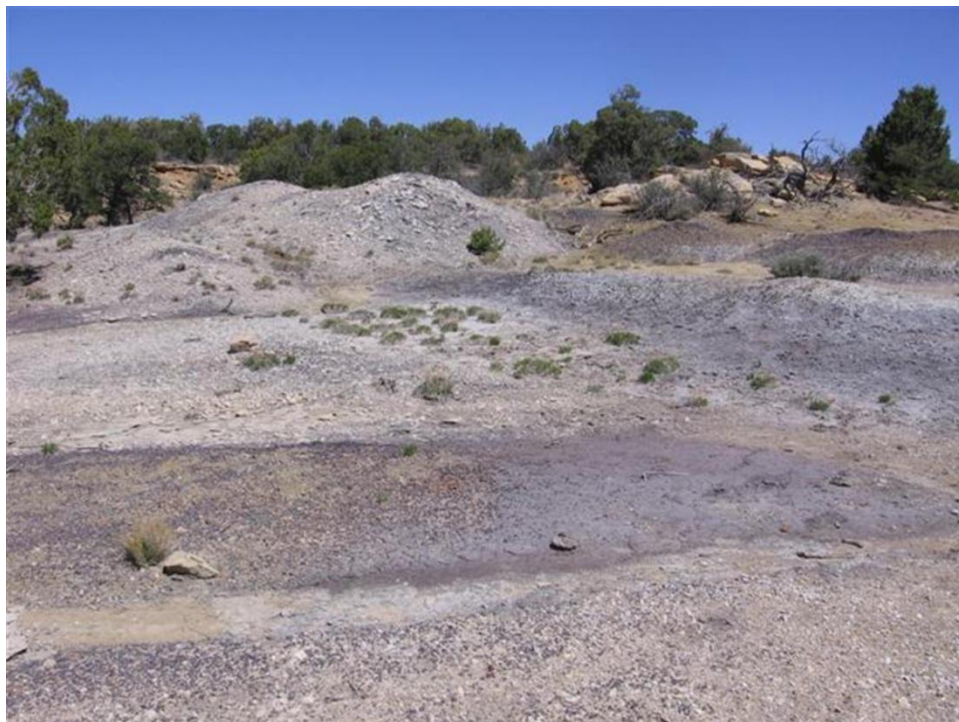
4 waste rock piles: Pile 1 - 5' h x 12' dia, gray-brown soil; Pile 2 - 10' h x 20' dia, gray-brown soil; Pile 3 - 10' h x 20' dia, gray-brown soil; Pile 4 - 30'x4'x4', gray fine soil

Photo 2: Mine Site #405; Possible waste piles

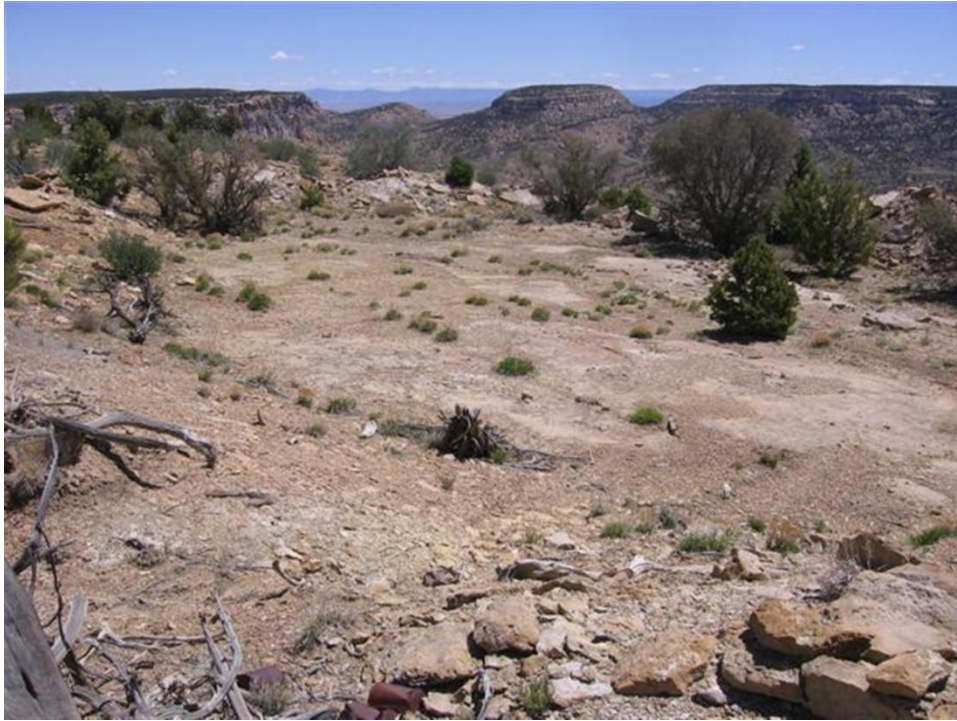
Pit area, 6' deep depression, 50'x90' oval, brown soil with mining debris (oil cans), berm surrounding depression

Photo 3: Mine Site #405; Pit / depression
