Navajo Abandoned Uranium Mine

Site Screen Report

Mine Name: Blk029

Mine ID: 406

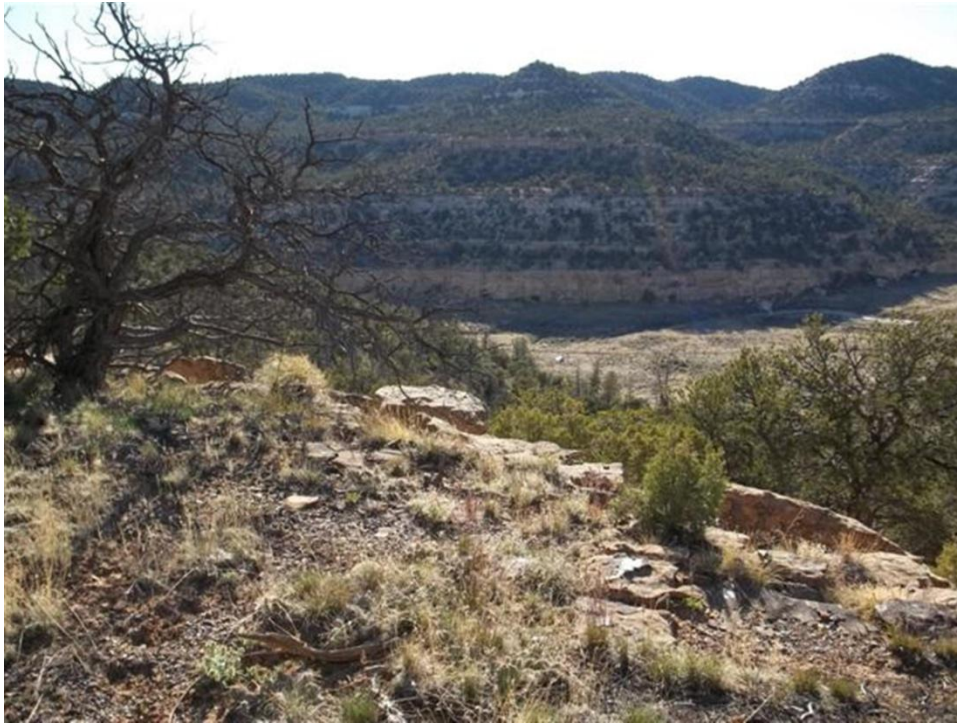
Photo 1: Mine Site #406; Valley below site

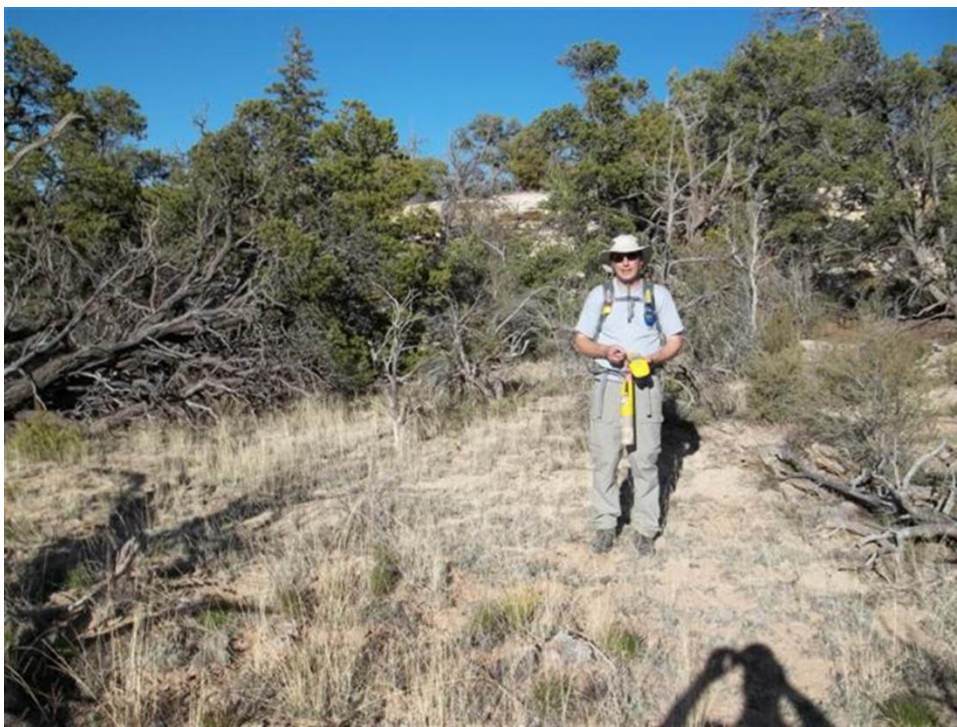
Photo 2: Mine Site #406
