Navajo Abandoned Uranium Mine

Site Screen Report

Enos Johnson 1, Enos Johnson 2 AUM Site

March 2010

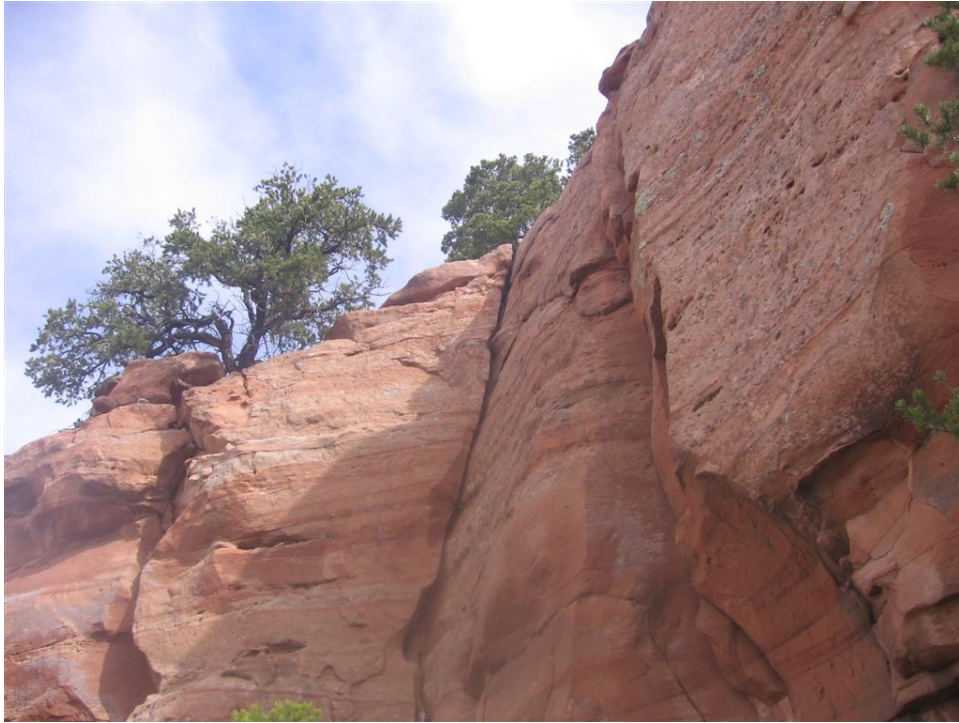
Photo 5. Cliff area

Weston was unable to access the site, due to steep grades all known paths to the site were impassible. Measurements were collected in the vicinity of the site, from a plateau approximately 50' east of the site boundary. A total of 295 gamma radiation measurements were collected near the mine site, ranging from 6,134 cpm to 11,526 cpm. The measurements are represented in Figures 1 and 2.
