Navajo Abandoned Uranium Mine

Site Screen Report

Enos Johnson AUM Site

March 2010

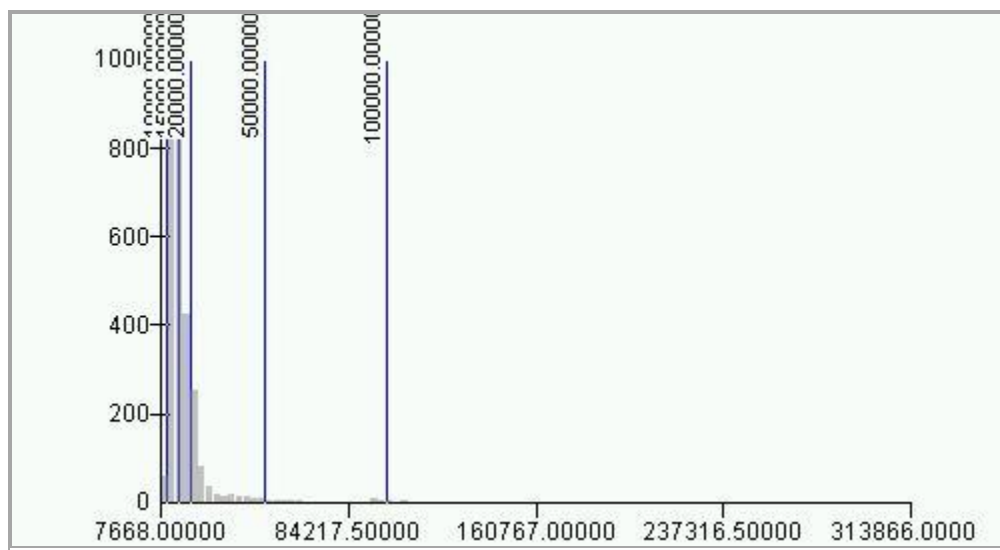
The following chart and statistics were generated by ESRI ArcGIS 9.3.1, and show the general distribution of the site gamma radiation measurements. The horizontal X axis represents the gamma radiation reading levels in cpm (lowest levels to the left). The vertical Y axis represents the frequency of each gamma radiation level.

Count:	2878
Minimum:	7668.00000
Maximum:	313866.00000
Sum:	53883985.00000
Mean:	18722.71890
Median:	15403.00000
Standard Deviation:	18147.35158

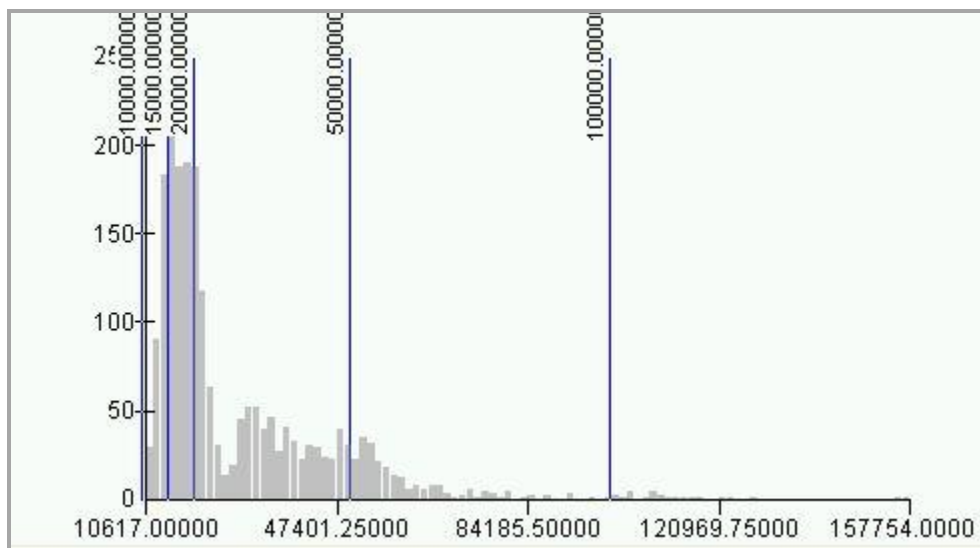
The following chart and statistics were generated by ESRI ArcGIS 9.3.1, and show the general distribution of the site gamma radiation measurements. The horizontal X axis represents the gamma radiation reading levels in cpm (lowest levels to the left). The vertical Y axis represents the frequency of each gamma radiation level.

Count:	2120
Minimum:	10617.00000
Maximum:	157754.00000
Sum:	60318896.00000
Mean:	28452.30943
Median:	20594.50000
Standard Deviation:	17673.07343

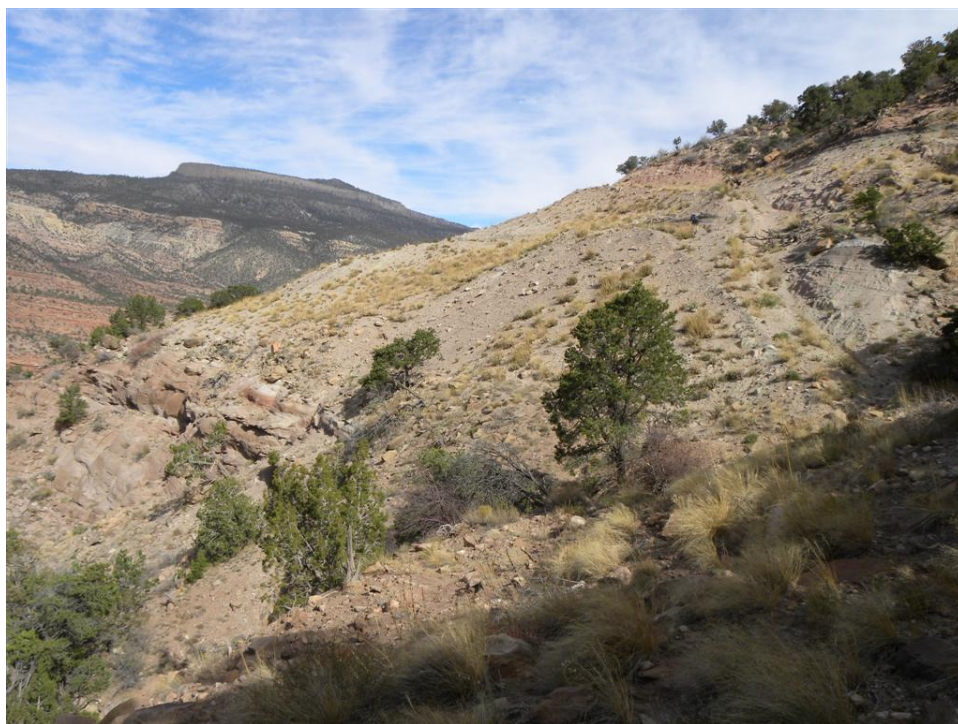
Debris slope with salt wash member, 100' x 250', with a total estimated volume of 4,630 yd³

Photo 7. Mine site #466 waste debris

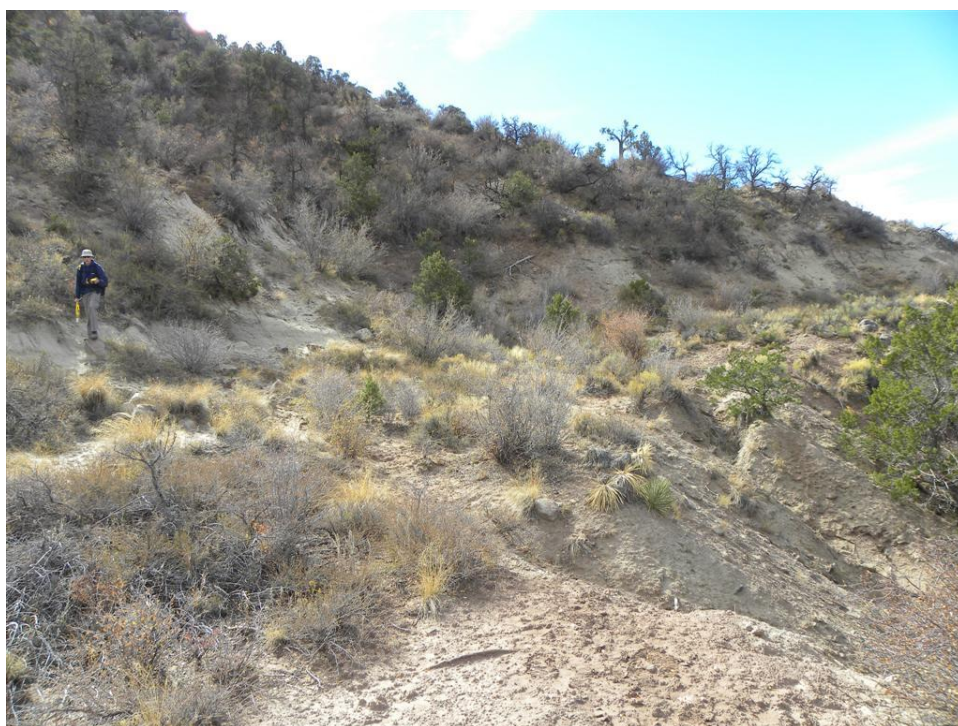
Photo 8. Mine site #466 waste debris

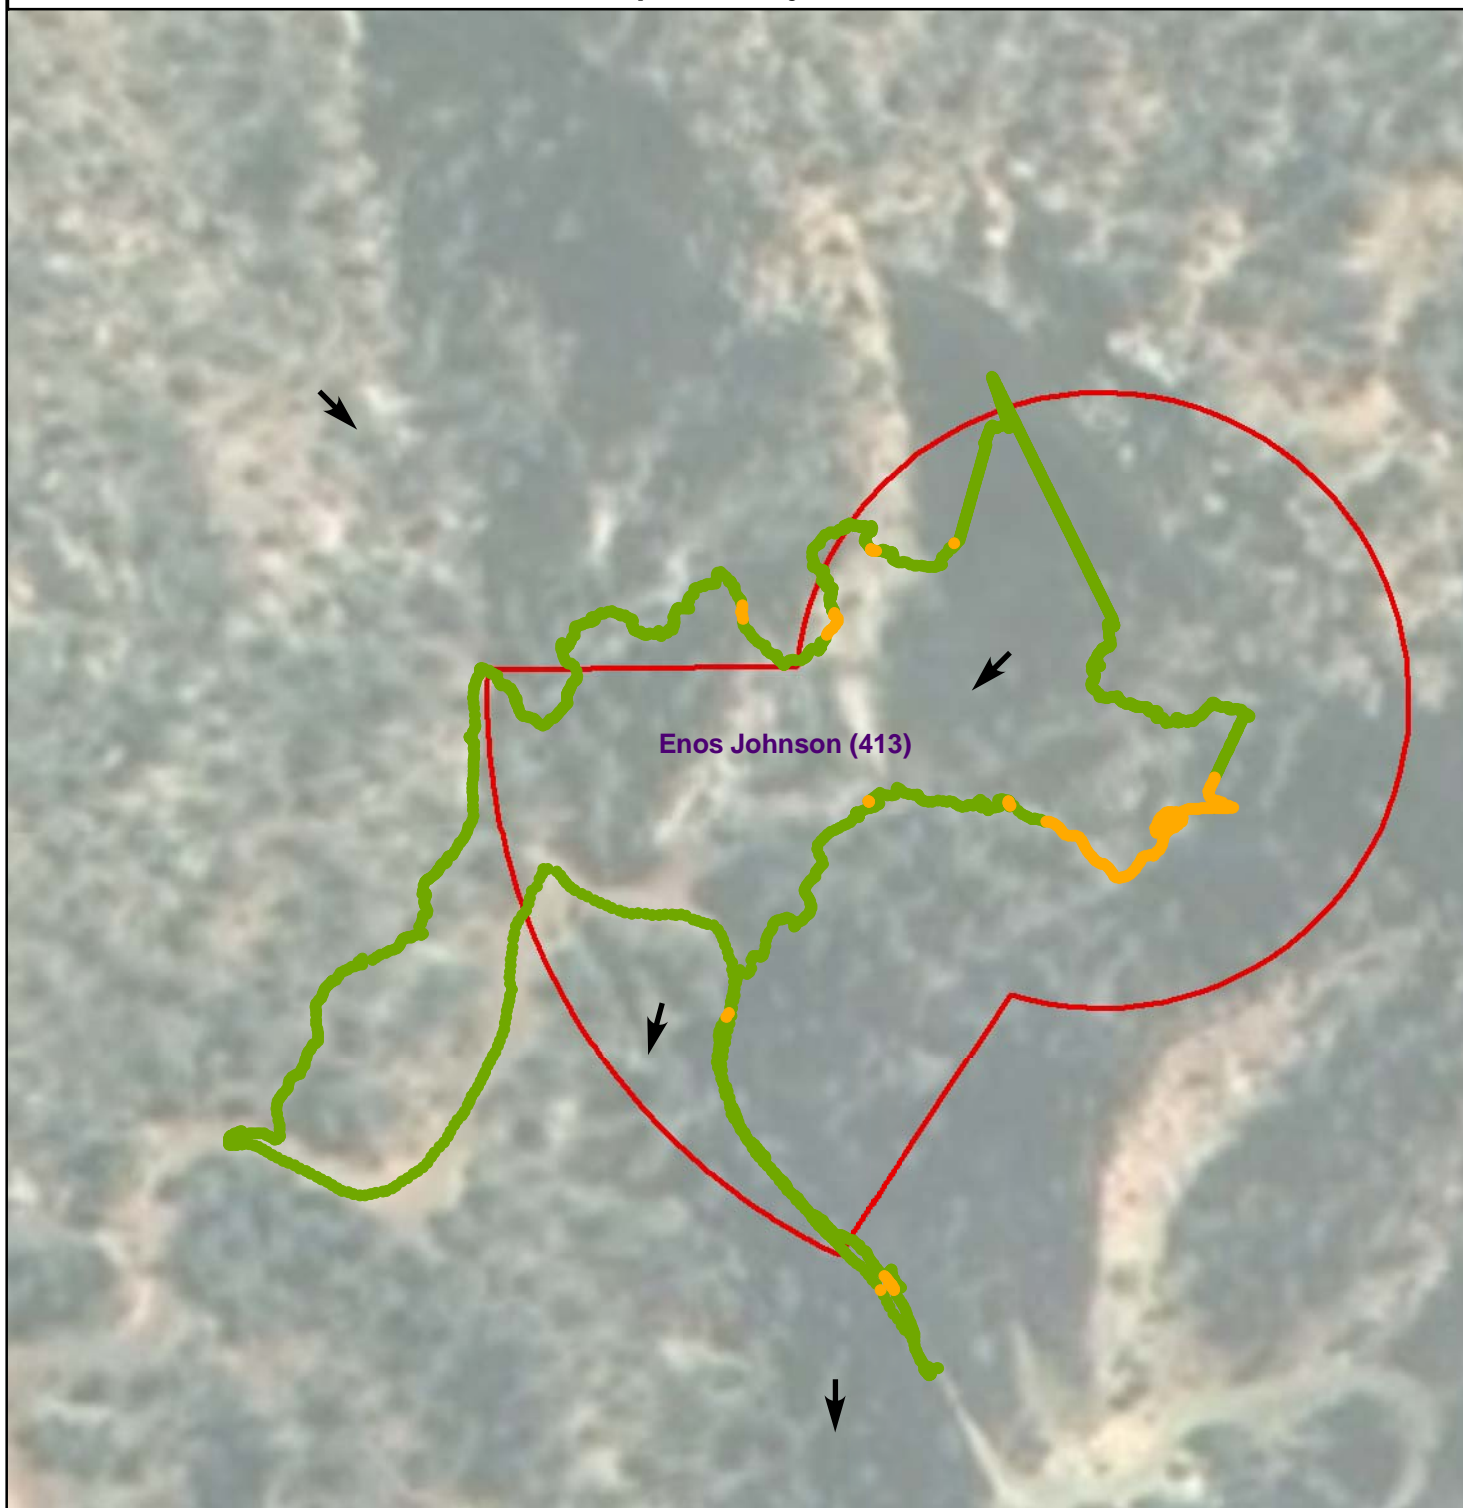
**Figure 2 - Gamma Radiation Measurements, Above Two Times Background
Enos Johnson (413)
Sanostee Chapter, Navajo Nation, Arizona**

A total of 2,878 gamma radiation measurements were collected from the mine site, ranging from 7,668 cpm to 313,866 cpm. The measurements are represented in Figures 2 and 3.

Average background = 13,037 cpm

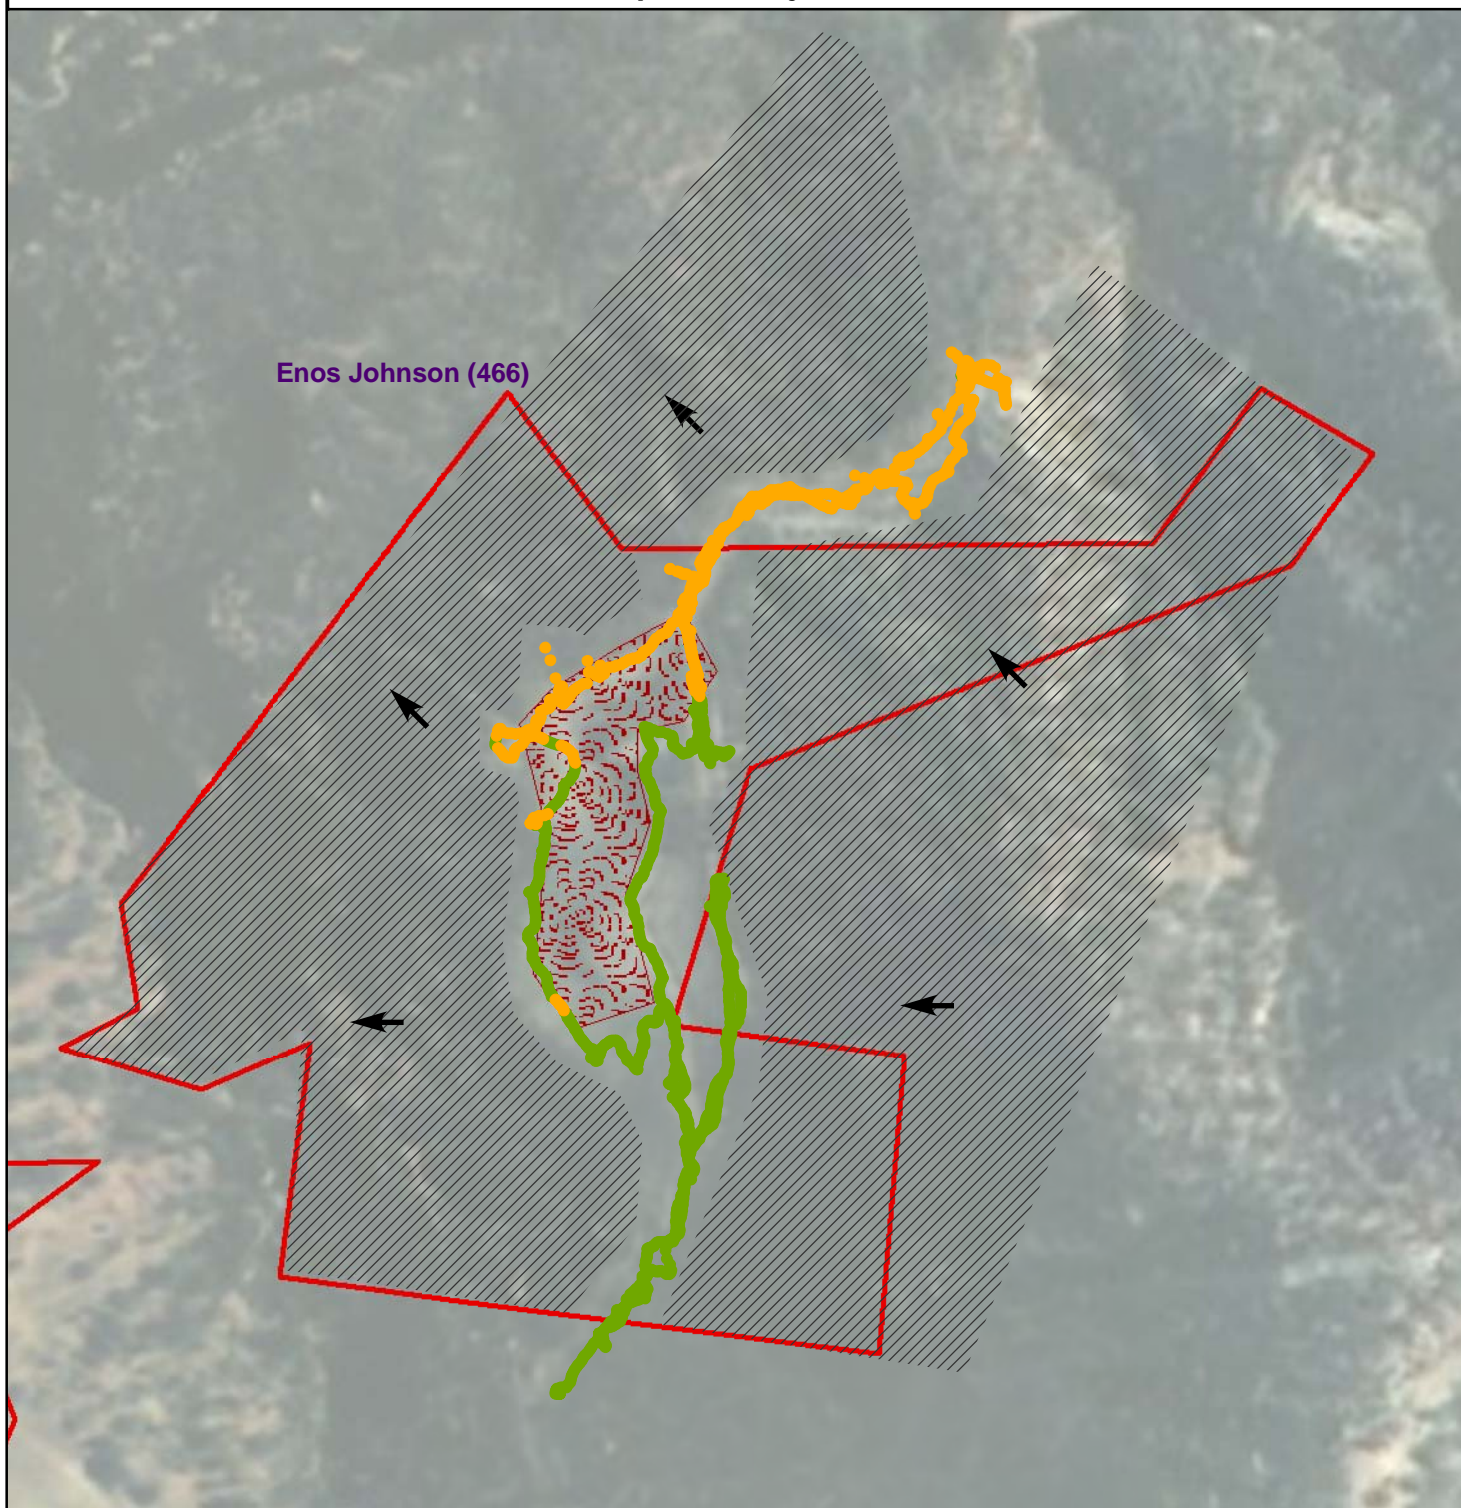
**Figure 6 - Gamma Radiation Measurements, Above Two Times Background
Enos Johnson (466)
Sanostee Chapter, Navajo Nation, Arizona**

A total of 2,120 gamma radiation measurements were collected from the mine site, ranging from 10,617 cpm to 157,754 cpm. Measurements in the vicinity of the waste debris slope were found at levels above 100,000 cpm. The measurements are represented in Figures 6 and 7.

Average background = 12,900 cpm

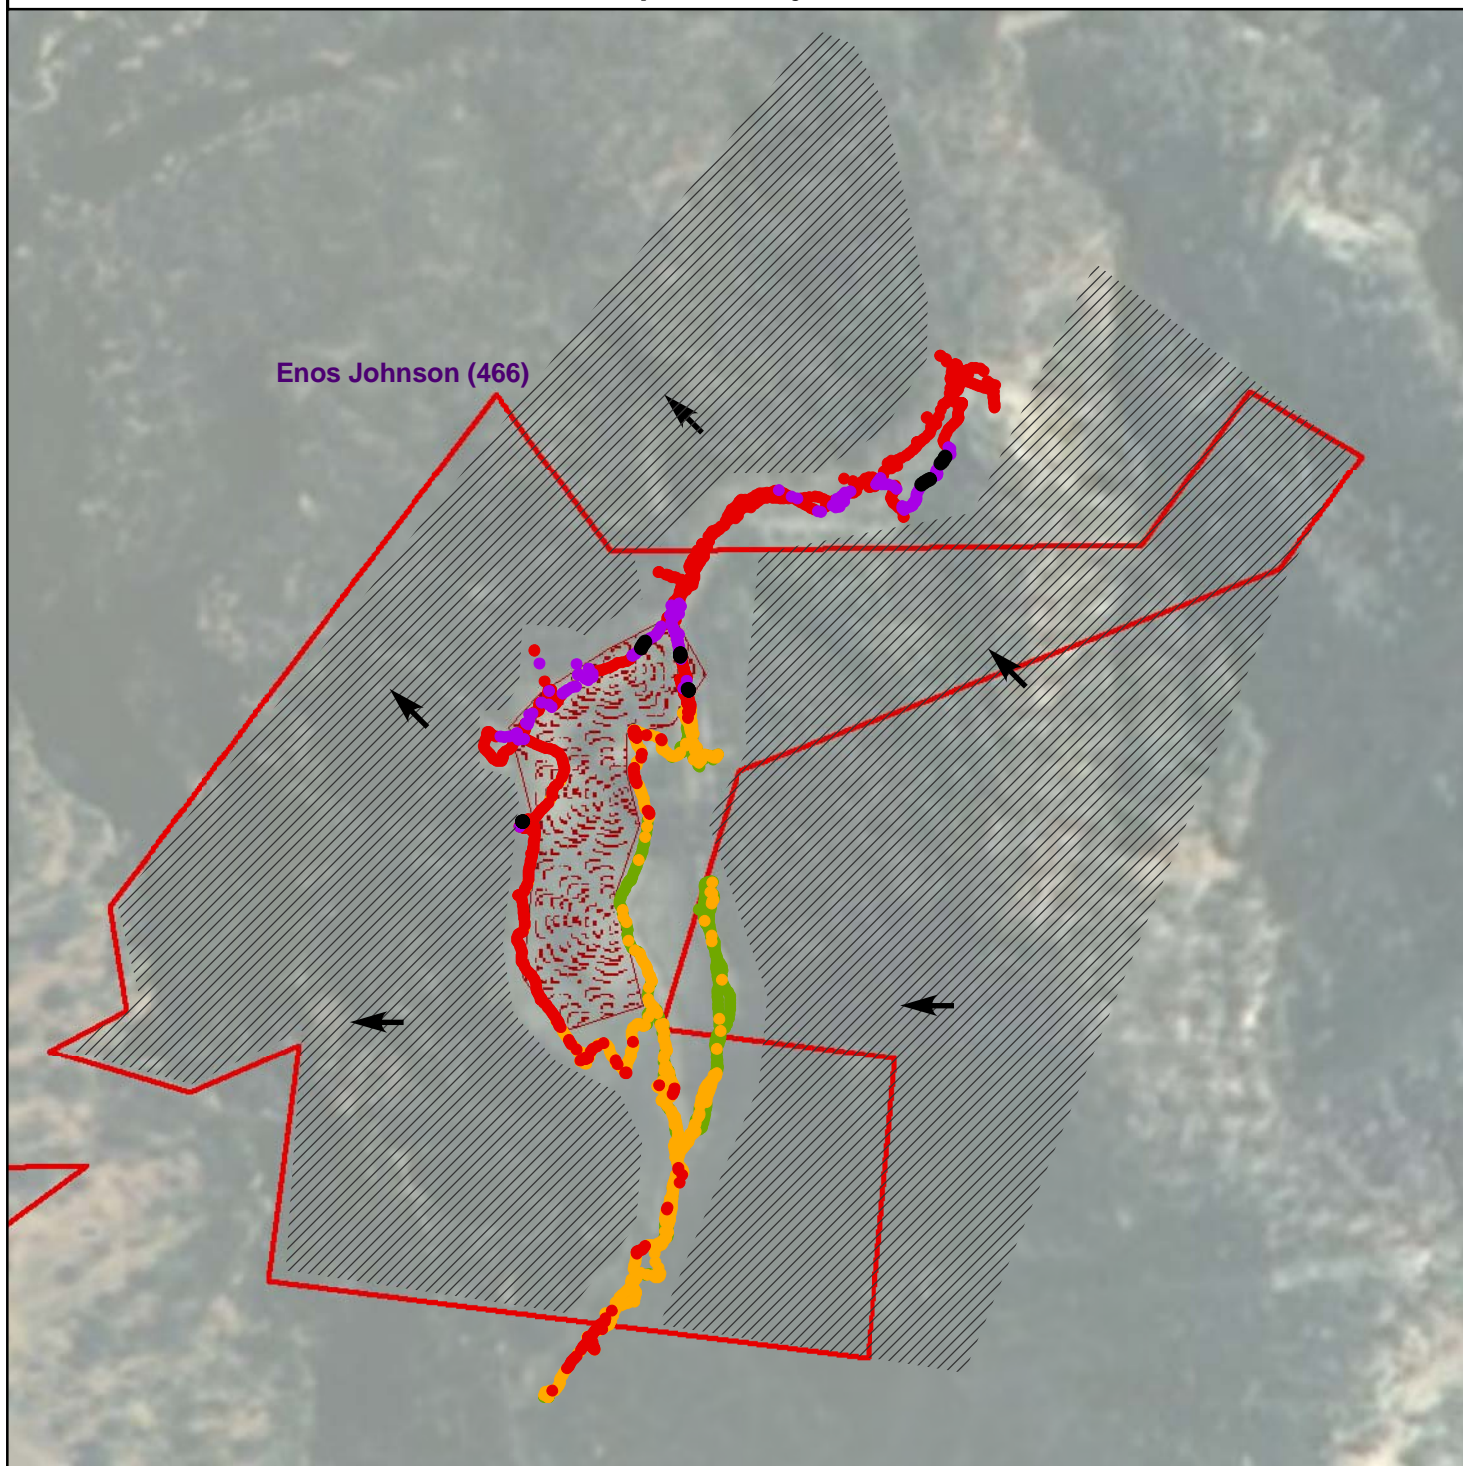
Figure 7 - Gamma Radiation Measurements
Enos Johnson (466)
Sanostee Chapter, Navajo Nation, Arizona

Average background = 12,900 cpm
