Navajo Abandoned Uranium Mine

Site Screen Report

Mesa III, West Mine AUM Site

March 2010

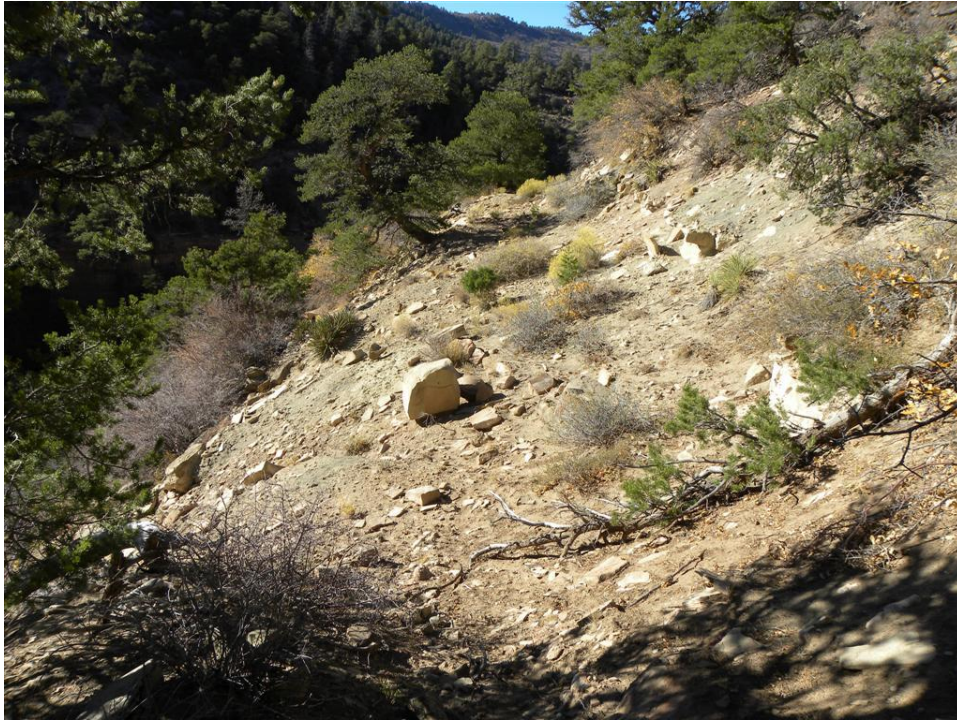
Photo 1. Waste debris sloping down to cliff

Large waste pile along edge of cliff, with a total estimated volume of 1,852 yd³

Unreclaimed waste pile

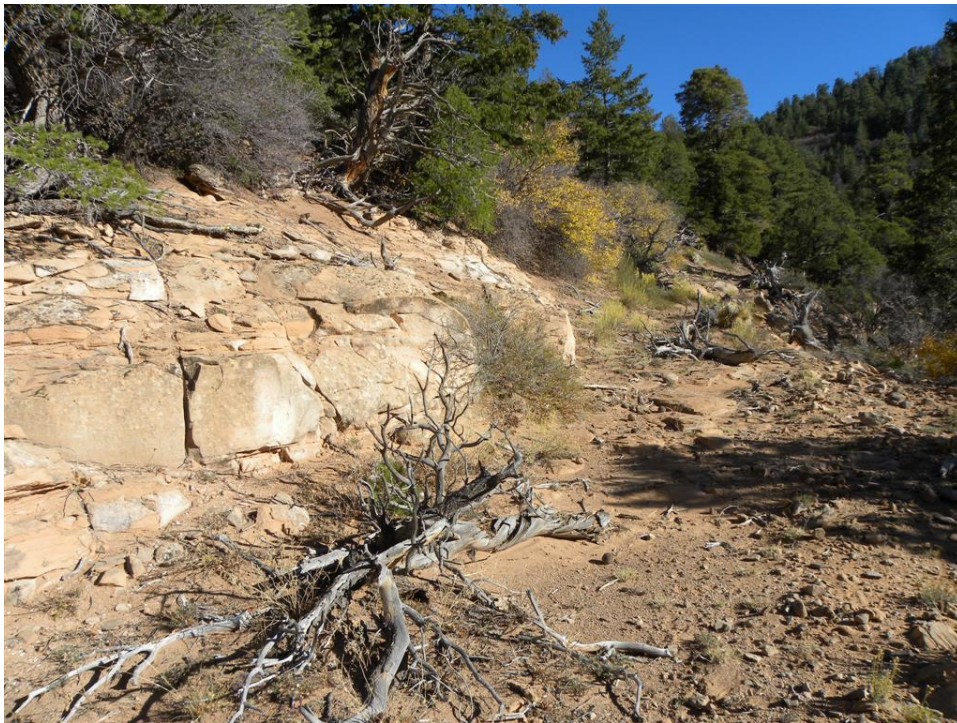
Photo 2. Mine site pathway
