# Navajo Abandoned Uranium Mine

## Site Screen Report

## Knife Edge Mesa AUM Site

**March 2010**

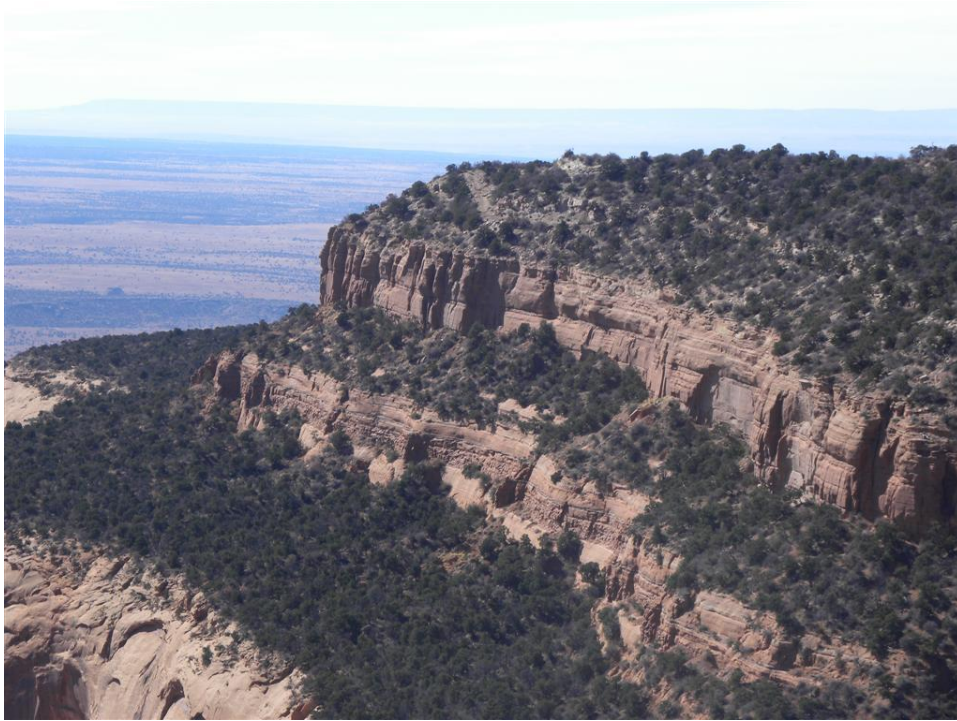
Photo 1. Mine site from a distance

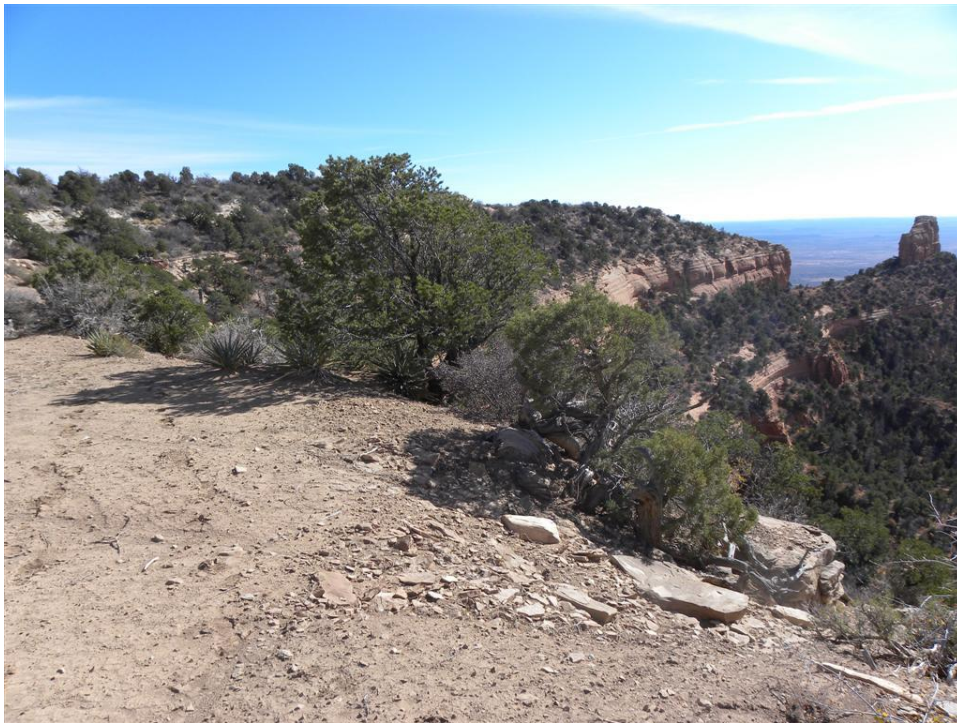
Photo 2. Edge of cliff

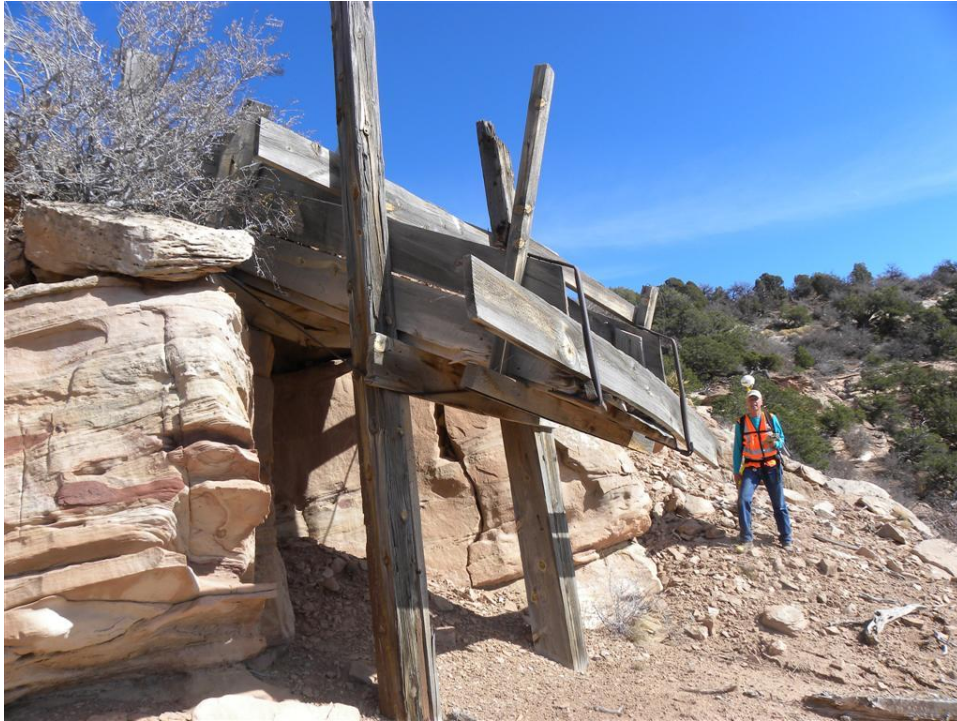
Various mining debris, pipes, wood framed chute

Photo 3. Wood framed chute

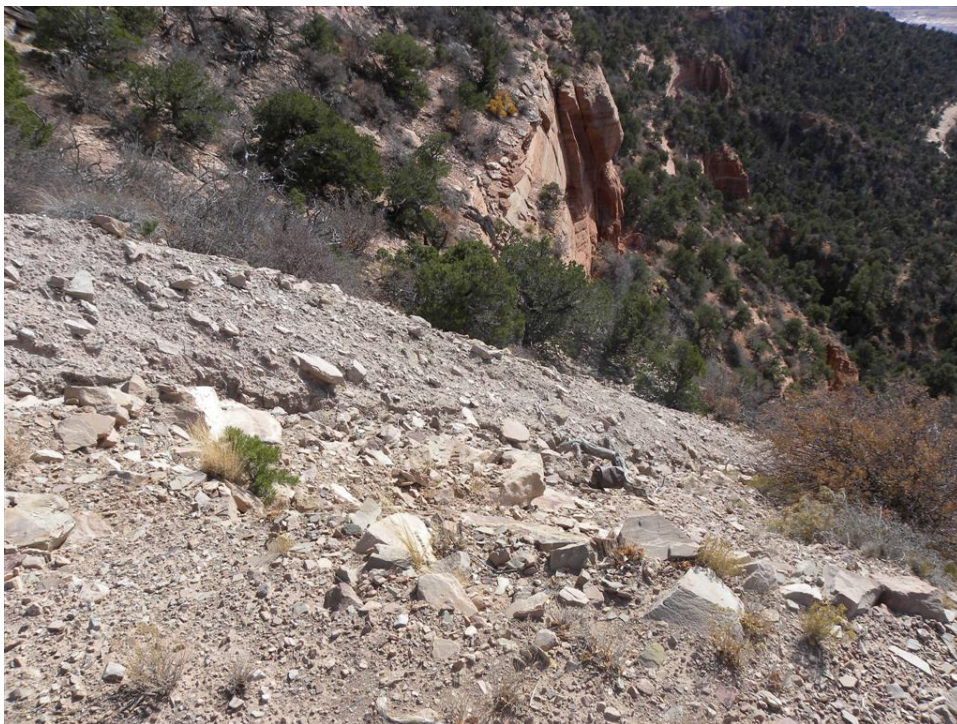
Waste debris stretching down cliff 50' x 125', with a total estimated volume of 1,157 yd<sup>3</sup>

Photo 4. Waste pile heading down slope

Unreclaimed waste pile

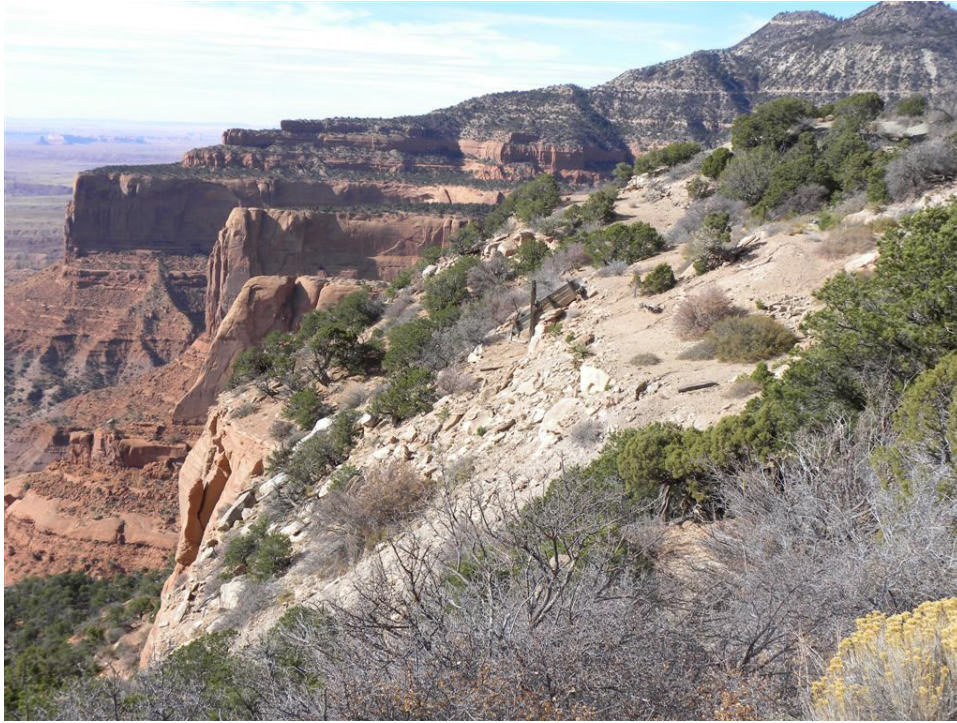
Photo 5. Waste pile heading down slope
