# Navajo Abandoned Uranium Mine

## Site Screen Report

## Rocky Spring AUM Site

### Navajo AUM Northern Region

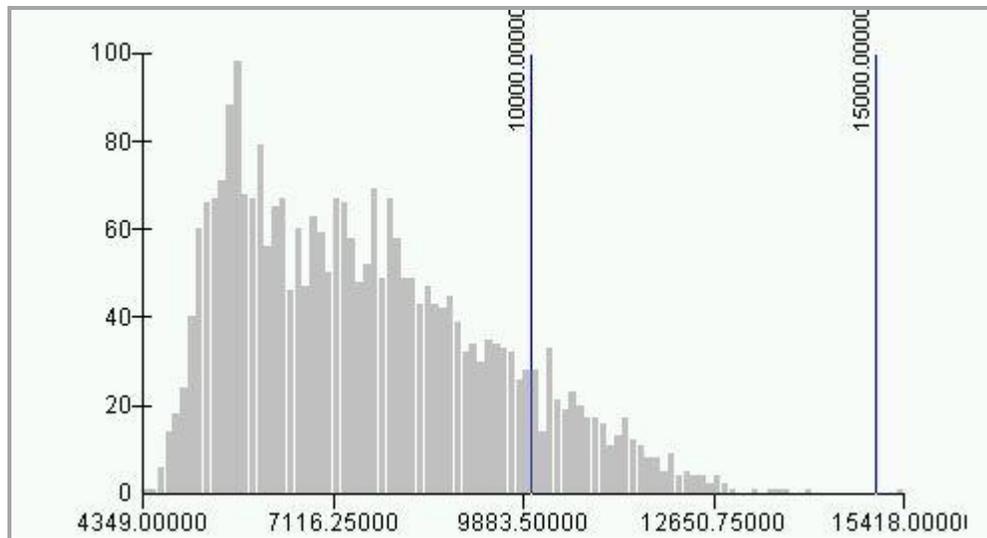
The following chart and statistics were generated by ESRI ArcGIS 9.3.1, and show the general distribution of the site gamma radiation measurements. The horizontal X axis represents the gamma radiation reading levels in cpm (lowest levels to the left). The vertical Y axis represents the frequency of each gamma radiation level.

Count:	2790
Minimum:	4349.00000
Maximum:	15418.00000
Sum:	21132671.00000
Mean:	7574.43405
Median:	7303.50000
Standard Deviation:	1835.23557

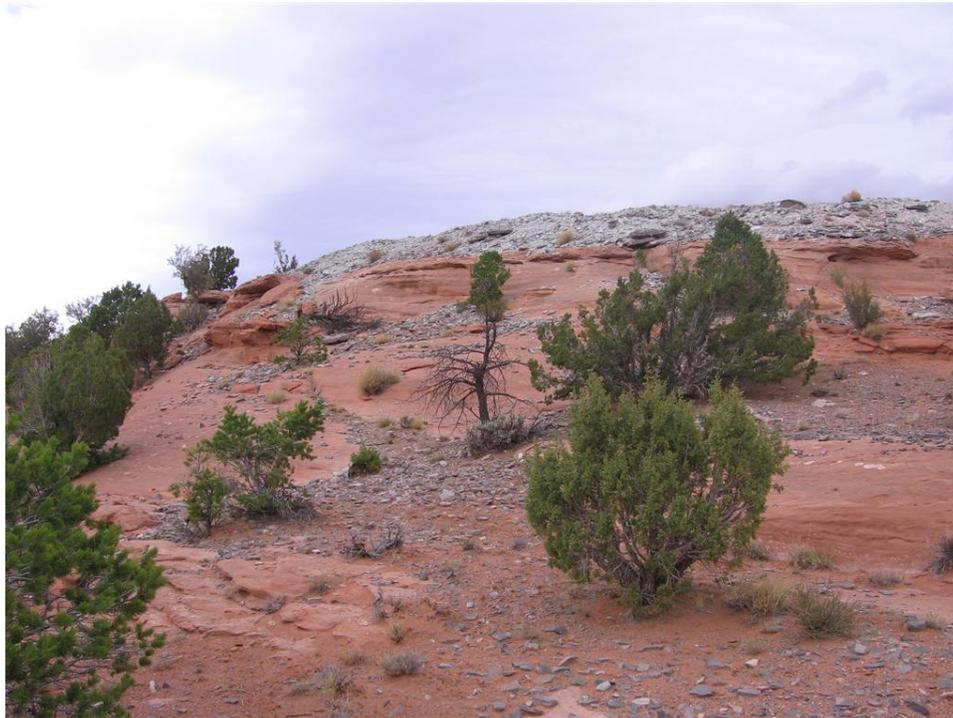
Waste piles observed east of the road on the mesa, red clay continues downslope, piles pushed as berm along road, 30' x 50', with a total estimated volume of 278 yd<sup>3</sup>

Photo 1. Waste debris

Unreclaimed waste pile; nearby homes and wells

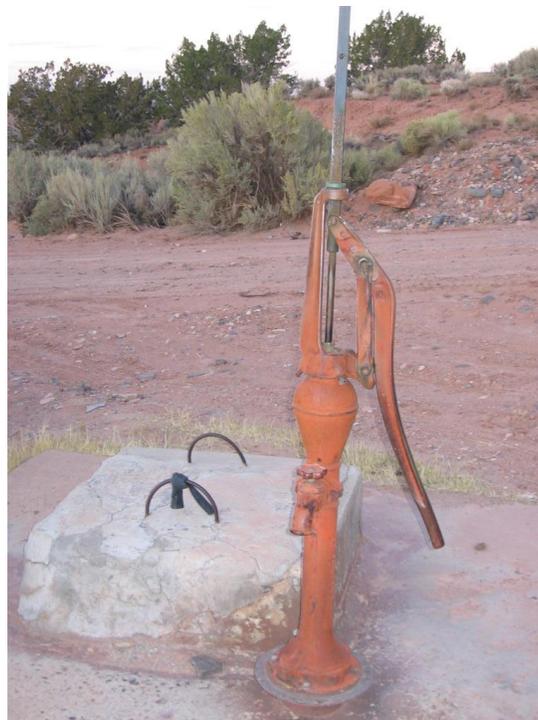
**0 to 0.25 miles:** Water well head in drainage at road (750' northeast); water lines running east-west along Navajo Road 131 (700' north); wells in front of houses to north-northeast of site (see above)  
**0.25 miles to 4 miles:** None

Photo 2. Well along road

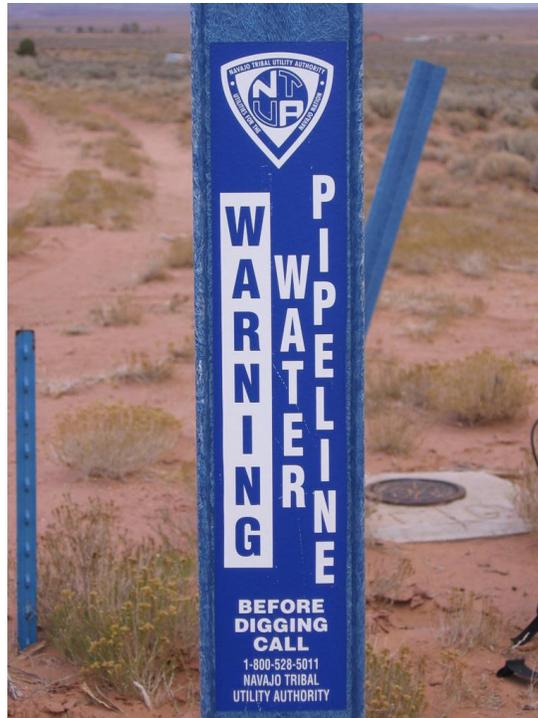
Photo 9. Water line along road

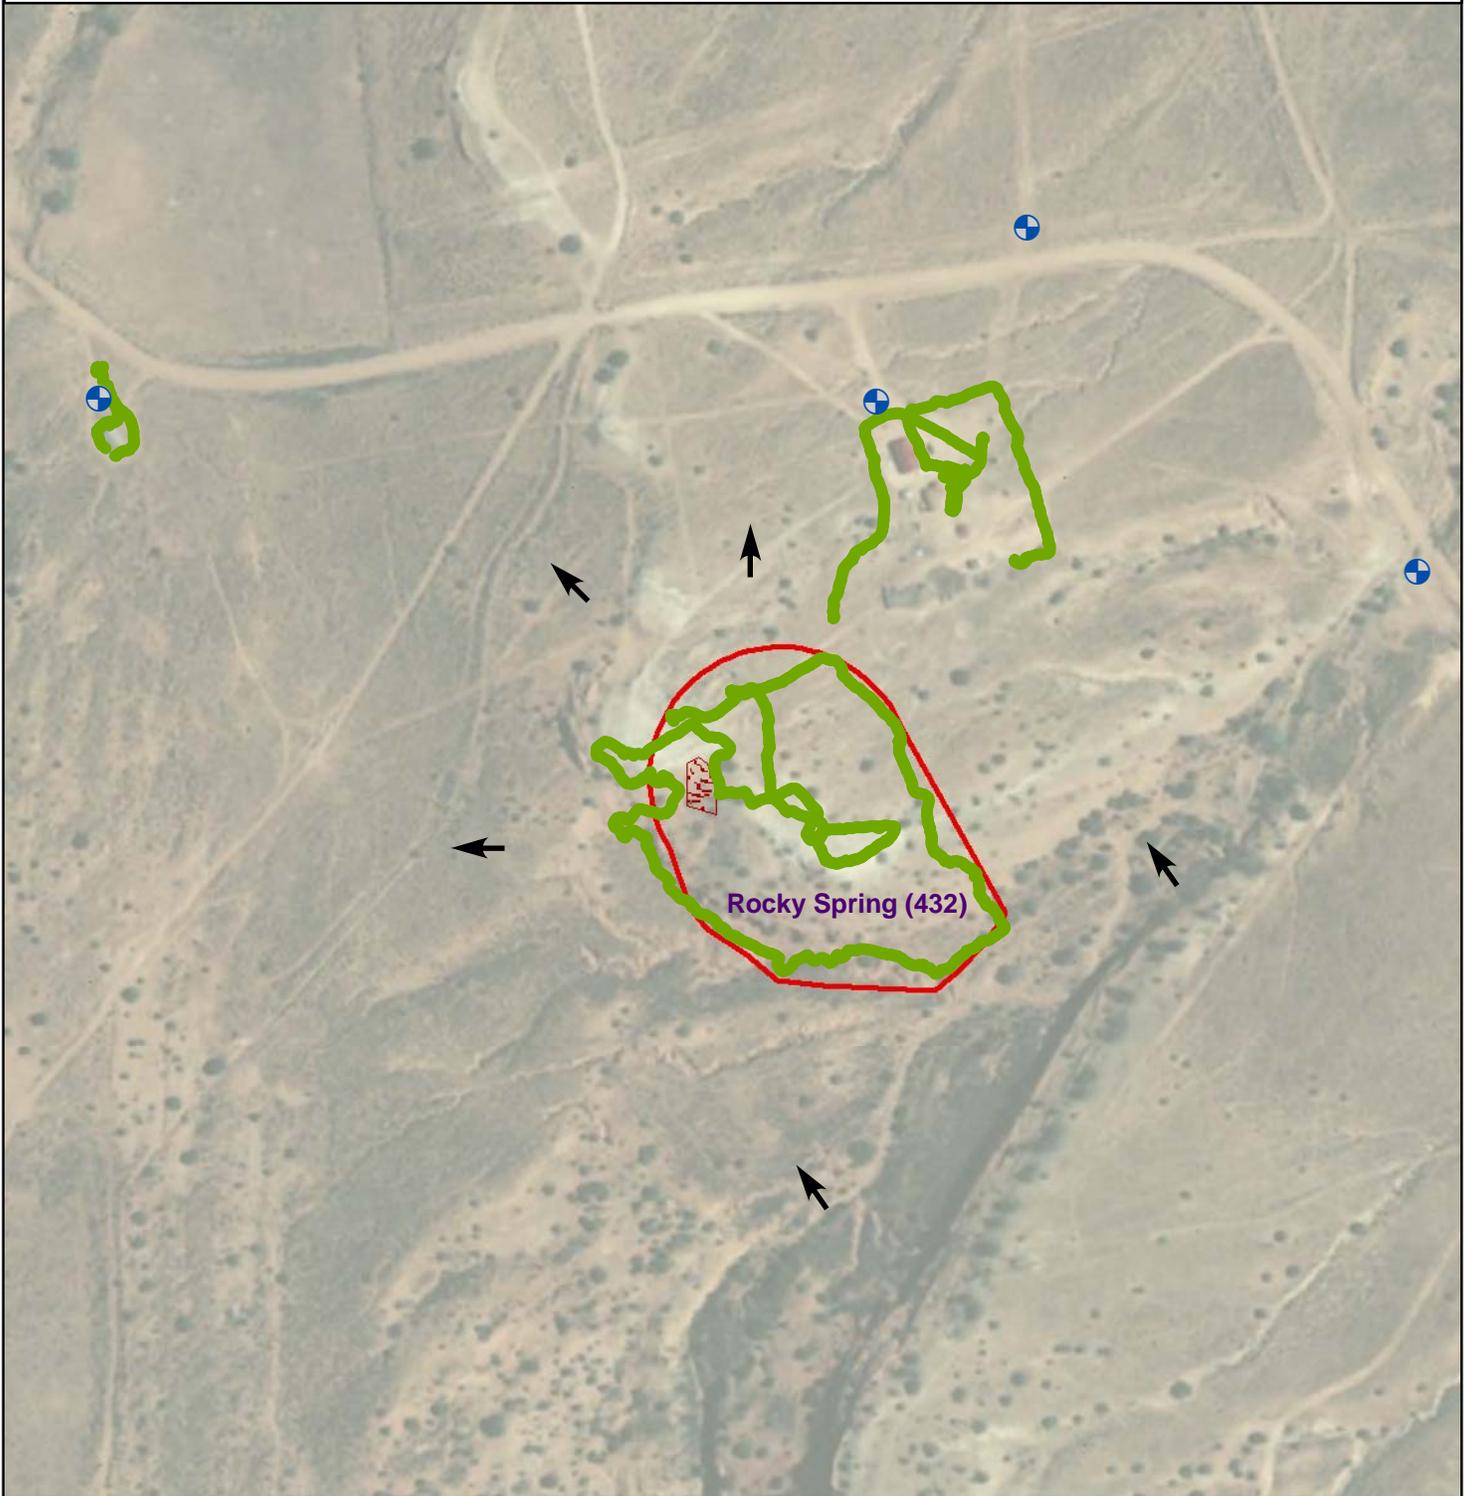
A total of 2,790 gamma radiation measurements were collected from the mine site, ranging from 4,349 cpm to 15,418 cpm. Measurements in the vicinity of the waste debris, nearby homes, and well locations were consistent with background levels, ranging from 7,000 to 12,000 cpm. The measurements are represented in Figures 1 and 2.

**Figure 1 - Gamma Radiation Measurements, Above Two Times Background  
 Rocky Spring (432)  
 Red Valley Chapter, Navajo Nation, Arizona**

Gamma survey conducted 10/2009  
 Measured as counts per minute (cpm)

Average background = 7,591 cpm

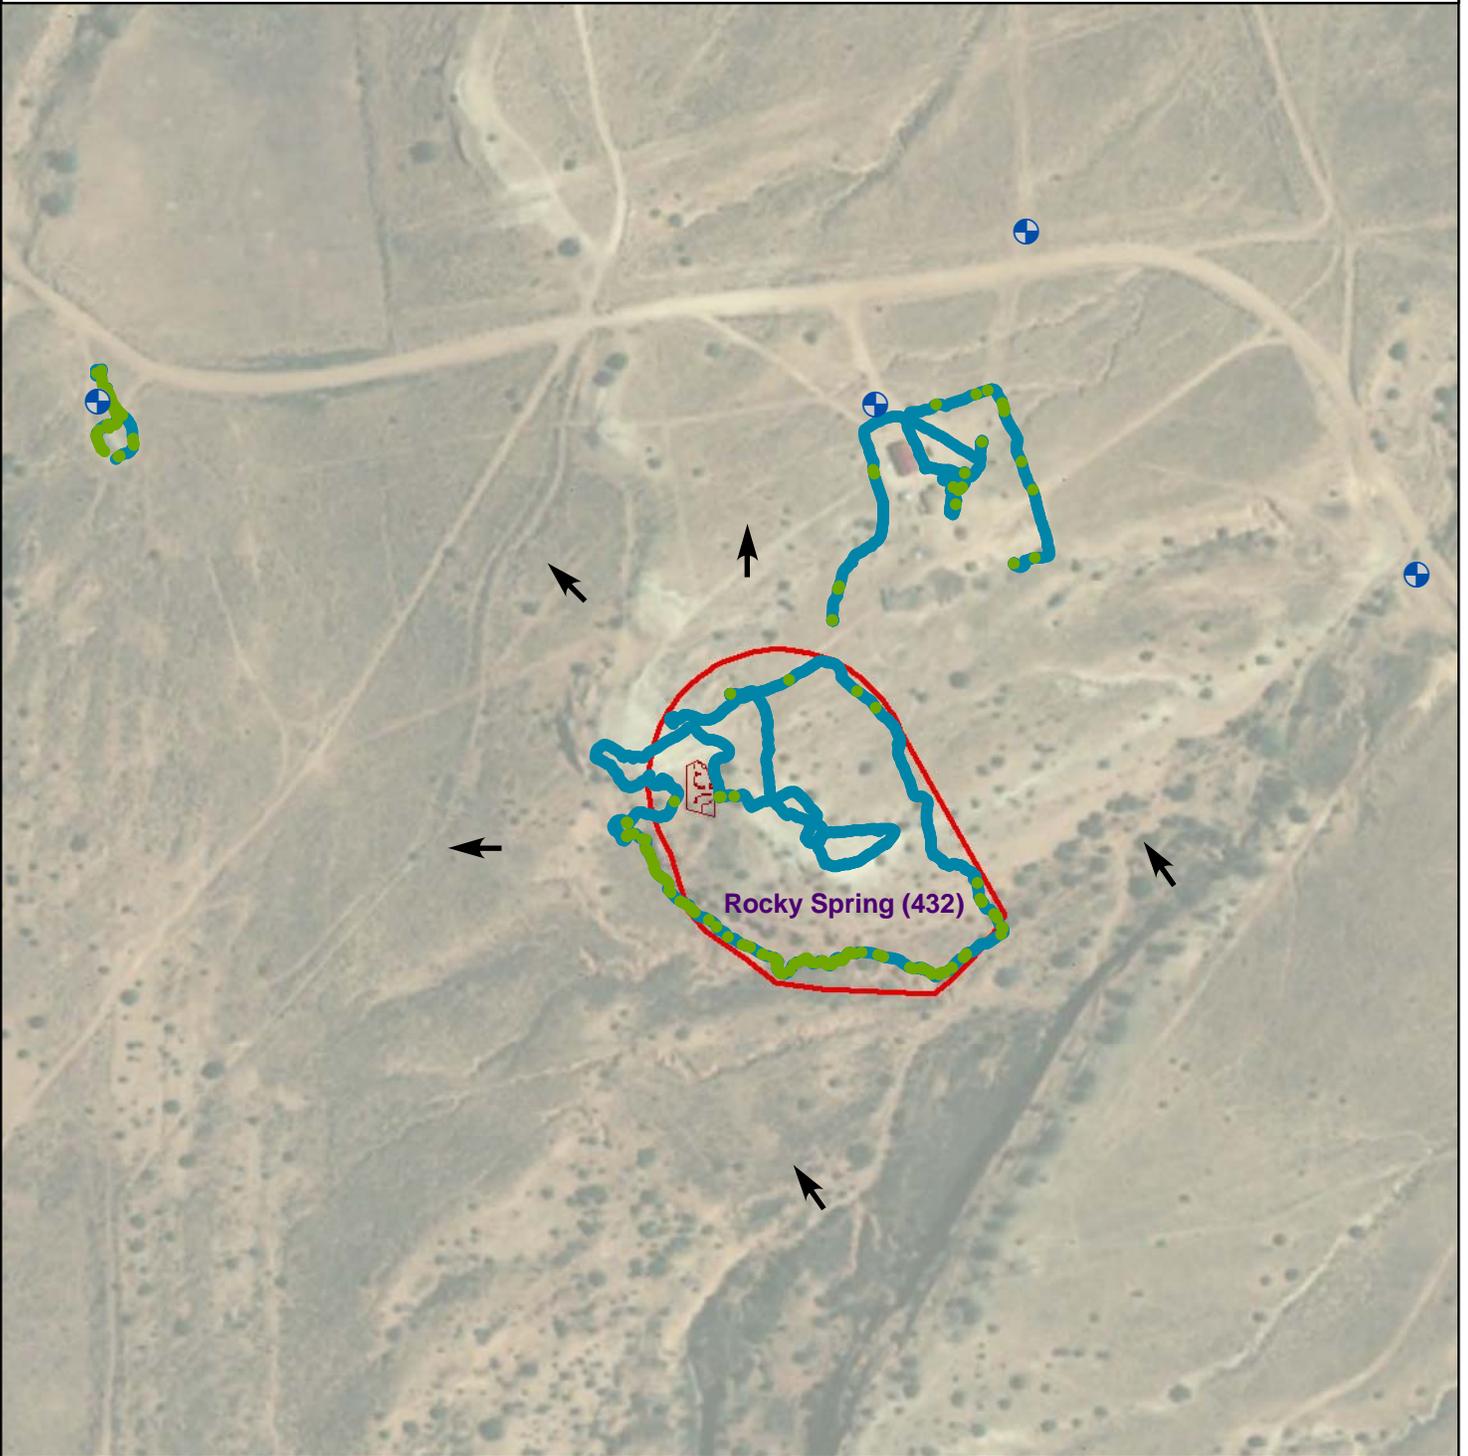
**Figure 2 - Gamma Radiation Measurements  
 Rocky Spring (432)  
 Red Valley Chapter, Navajo Nation, Arizona**

Gamma survey conducted 10/2009  
 Measured as counts per minute (cpm)

Average background = 7,591 cpm
