Navajo Abandoned Uranium Mine

Site Screen Report

Black Point-Murphy Group AUM Site

January 2011

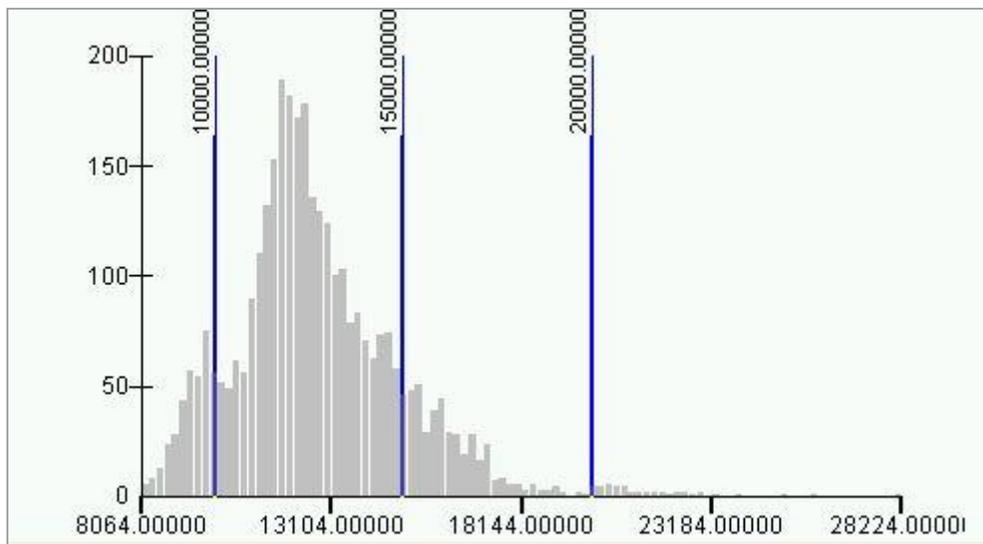
The following chart and statistics were generated by ESRI ArcGIS 9.3.1, and show the general distribution of the site gamma radiation measurements. The horizontal X axis represents the gamma radiation reading levels in cpm (lowest levels to the left). The vertical Y axis represents the frequency of each gamma radiation level.

Count:	3370
Minimum:	8064.00000
Maximum:	28224.00000
Sum:	42889246.00000
Mean:	12726.77923
Median:	12383.00000
Standard Deviation:	2244.39889

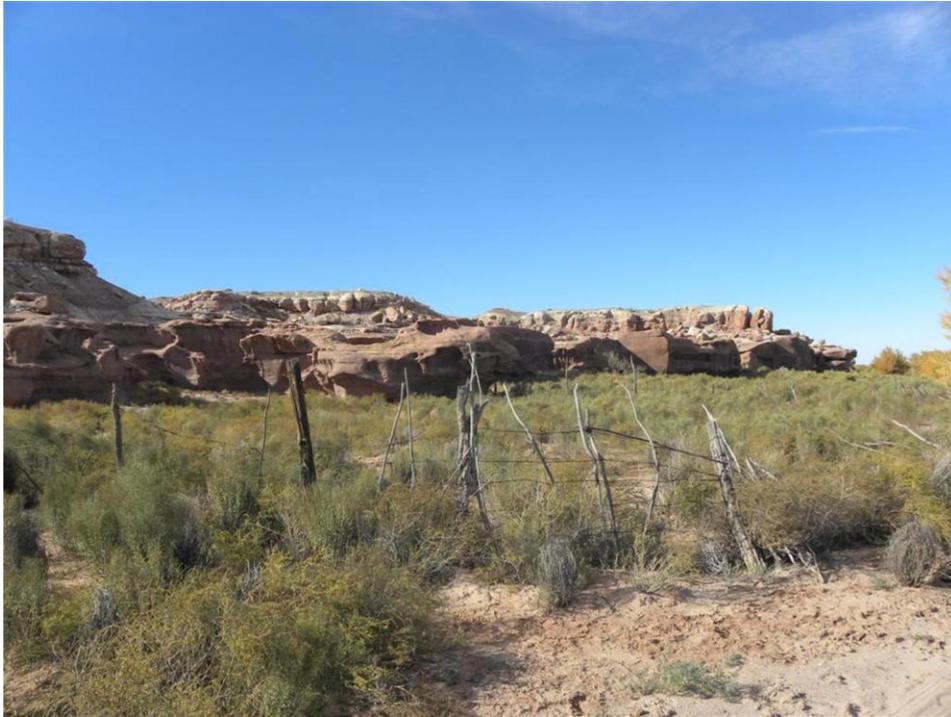
Fenced in area in NW portion of site

Unknown (there is a fenced in area in the NW portion of the site)

Photo 3. Black Point-Murphy Group mine site, fenced in area

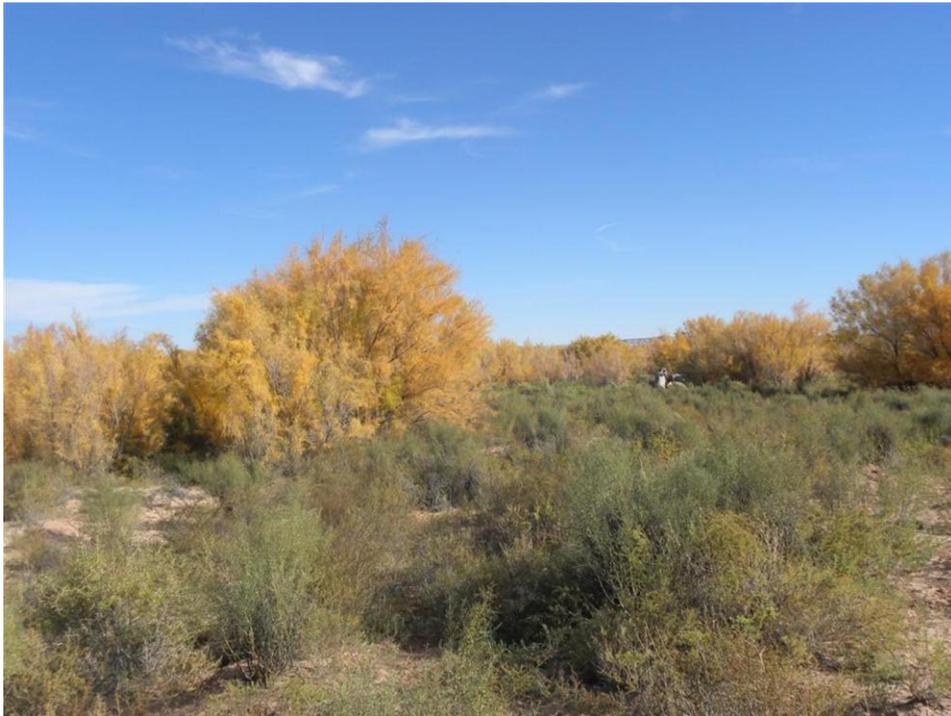
Little Colorado River Basin adjacent to the E of the site, possible wetlands

Photo 4. Black Point-Murphy Group mine site, alongside Little Colorado River Basin

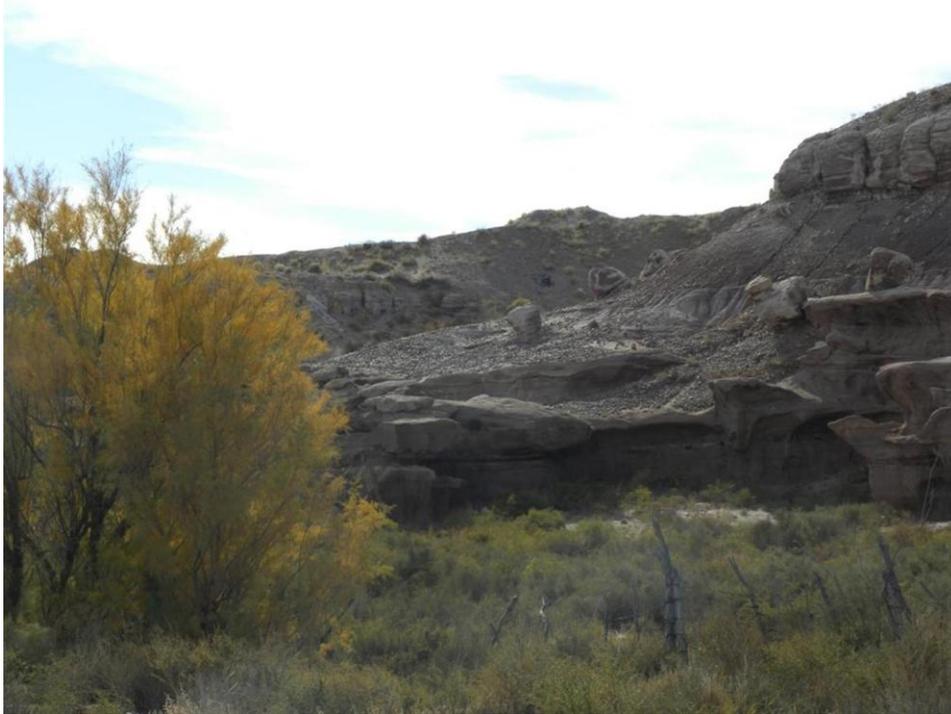
Photo 5. Black Point-Murphy Group mine site, alongside Little Colorado River Basin

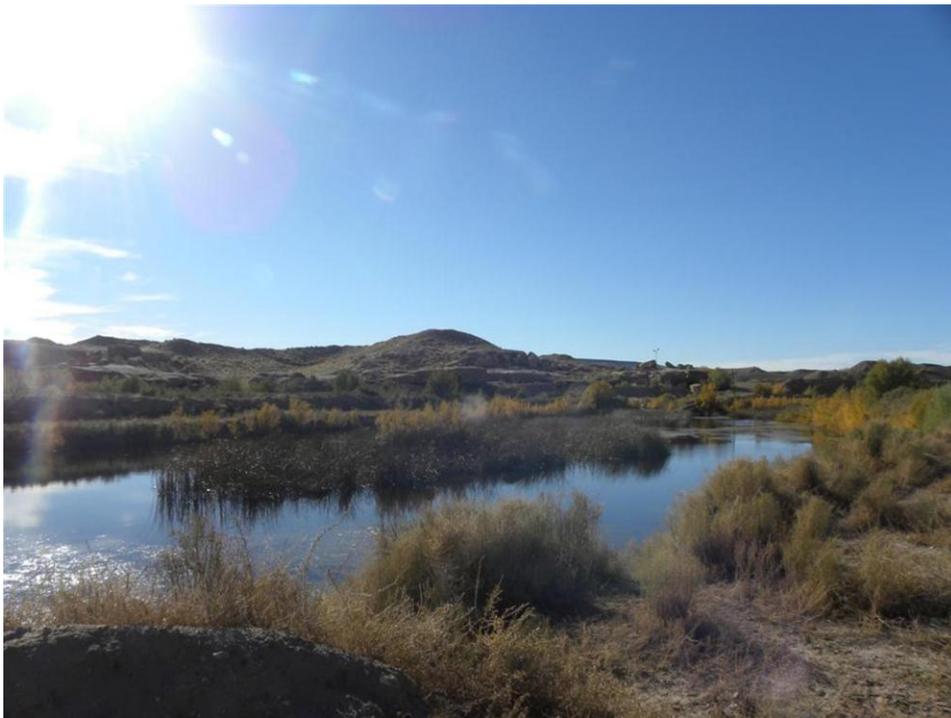
0 to 0.25 miles: Pond associated with gravel mining pit approximately 0.15 mi N of the site, all levels background; Little Colorado River Basin adjacent to the E of the site

Photo 6. Black Point-Murphy Group, pond associated with gravel mine 0.15 mi north of site

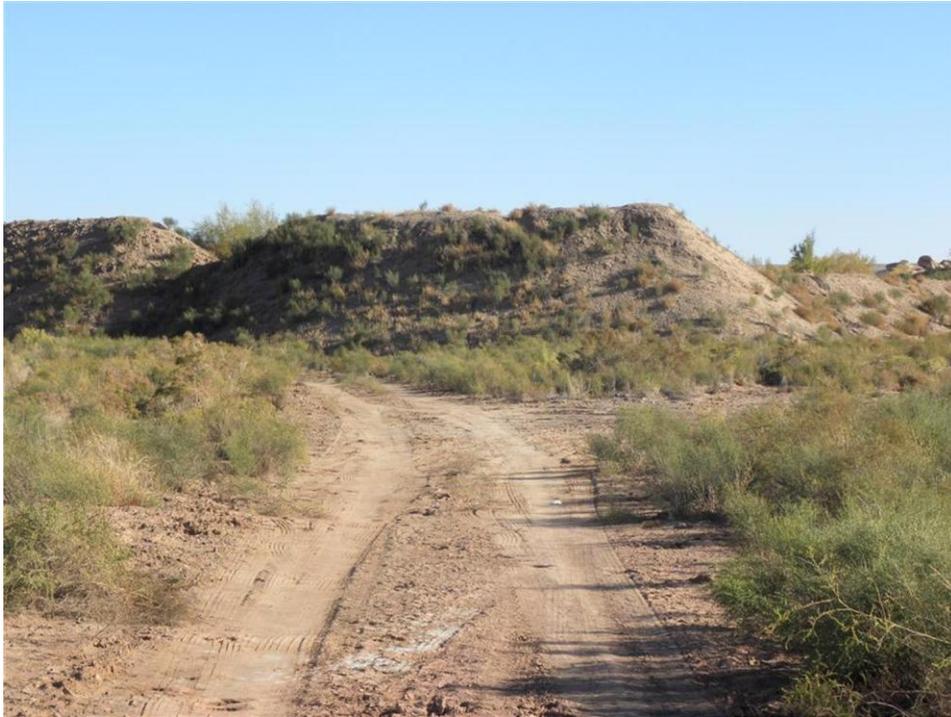
Background levels near gravel mine and pond, road 0.25 mi N of gravel mine had a small section up to 50,000 cpm

Photo 7. Black Point-Murphy Group, road with elevated gamma readings, 0.4 mi north of site

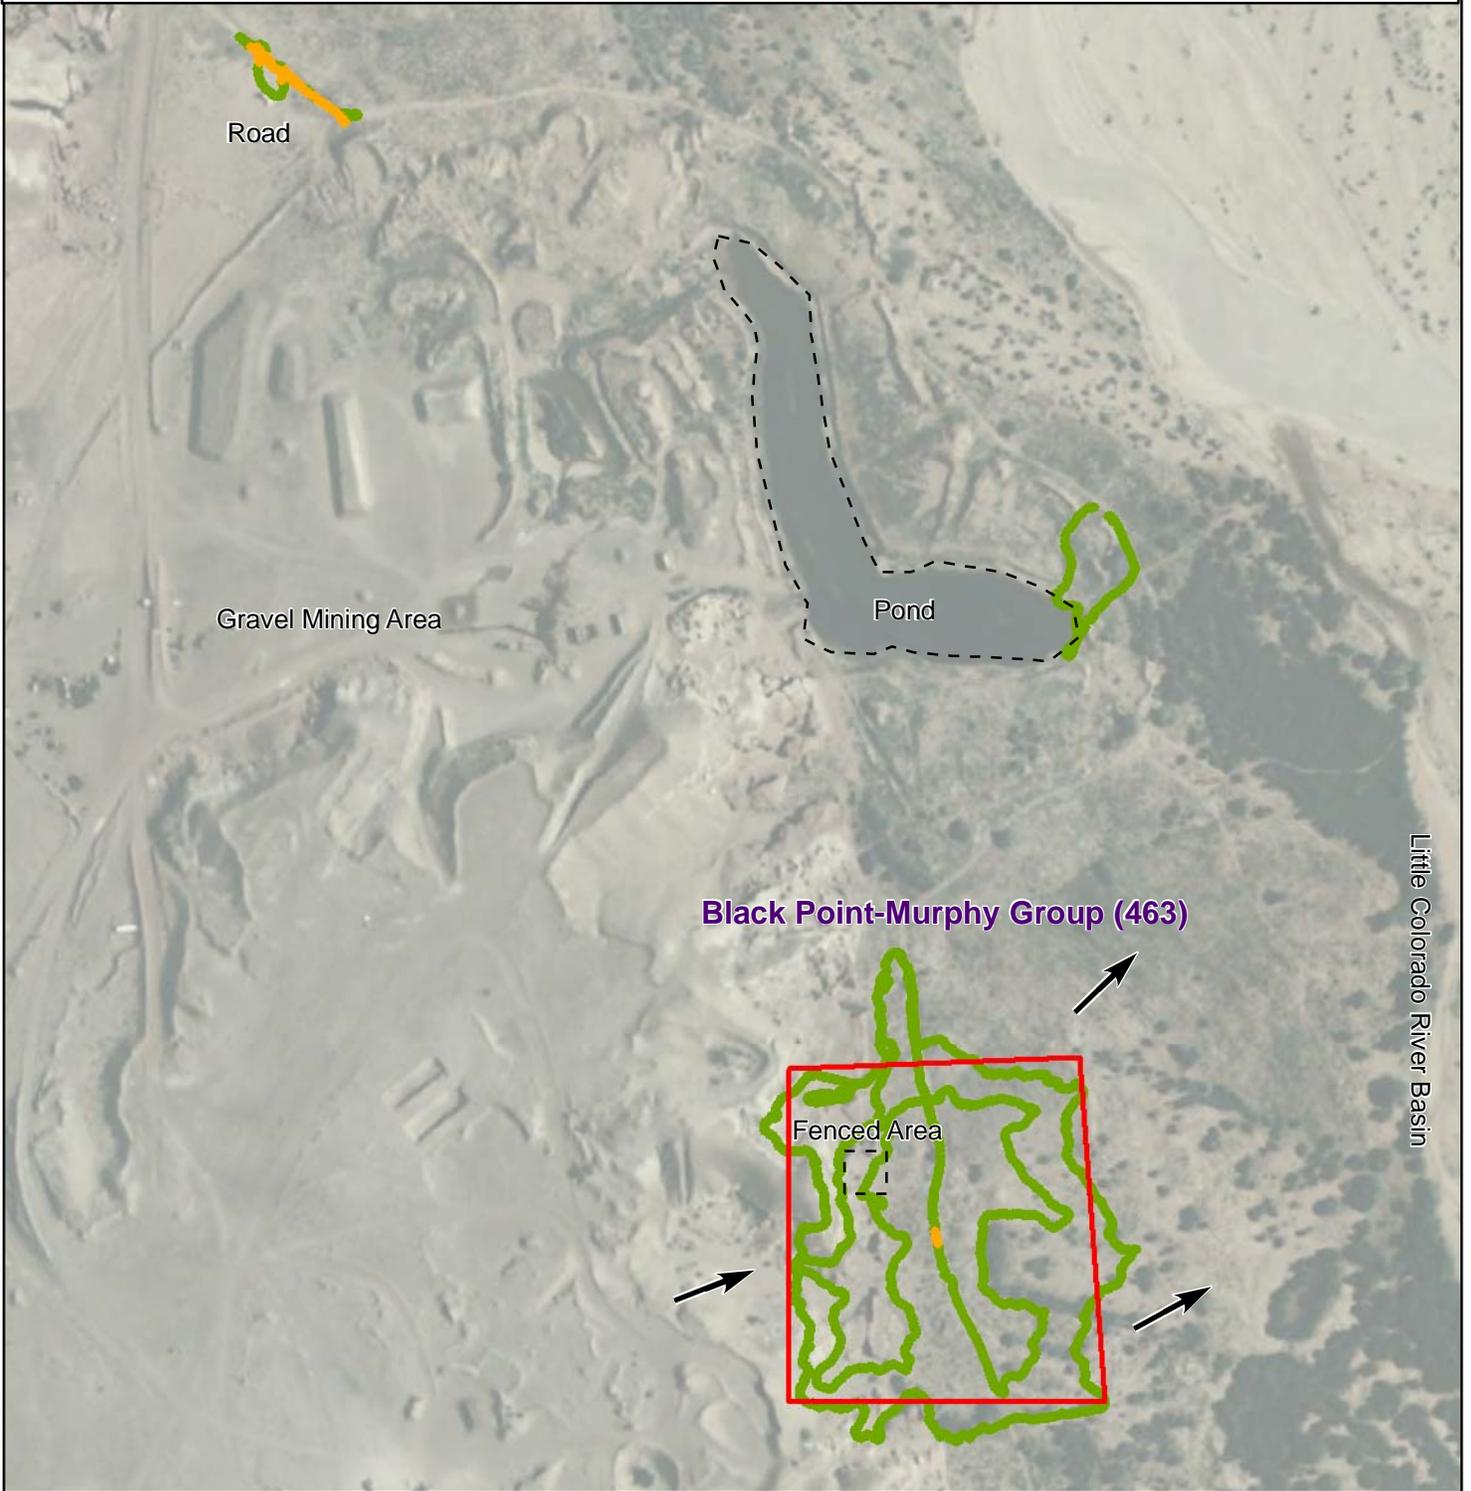
**Figure 1 - Gamma Radiation Measurements, Above Two Times Background
Black Point-Murphy Group (463)
Coconino County, Arizona**

A total of 3,370 gamma radiation measurements were collected from the mine site, ranging from 8,064 cpm to 28,224 cpm. The measurements collected at the site and pond 0.15 mi north of the site were found at background levels, but measurements collected from an isolated hot spot along the road 0.4 miles north of the site were found at a maximum level of 50,000 cpm. The measurements are represented in Figures 1 and 2.

Gamma survey conducted 11/2010
Measured as counts per minute (cpm)

Average background 11,605 cpm

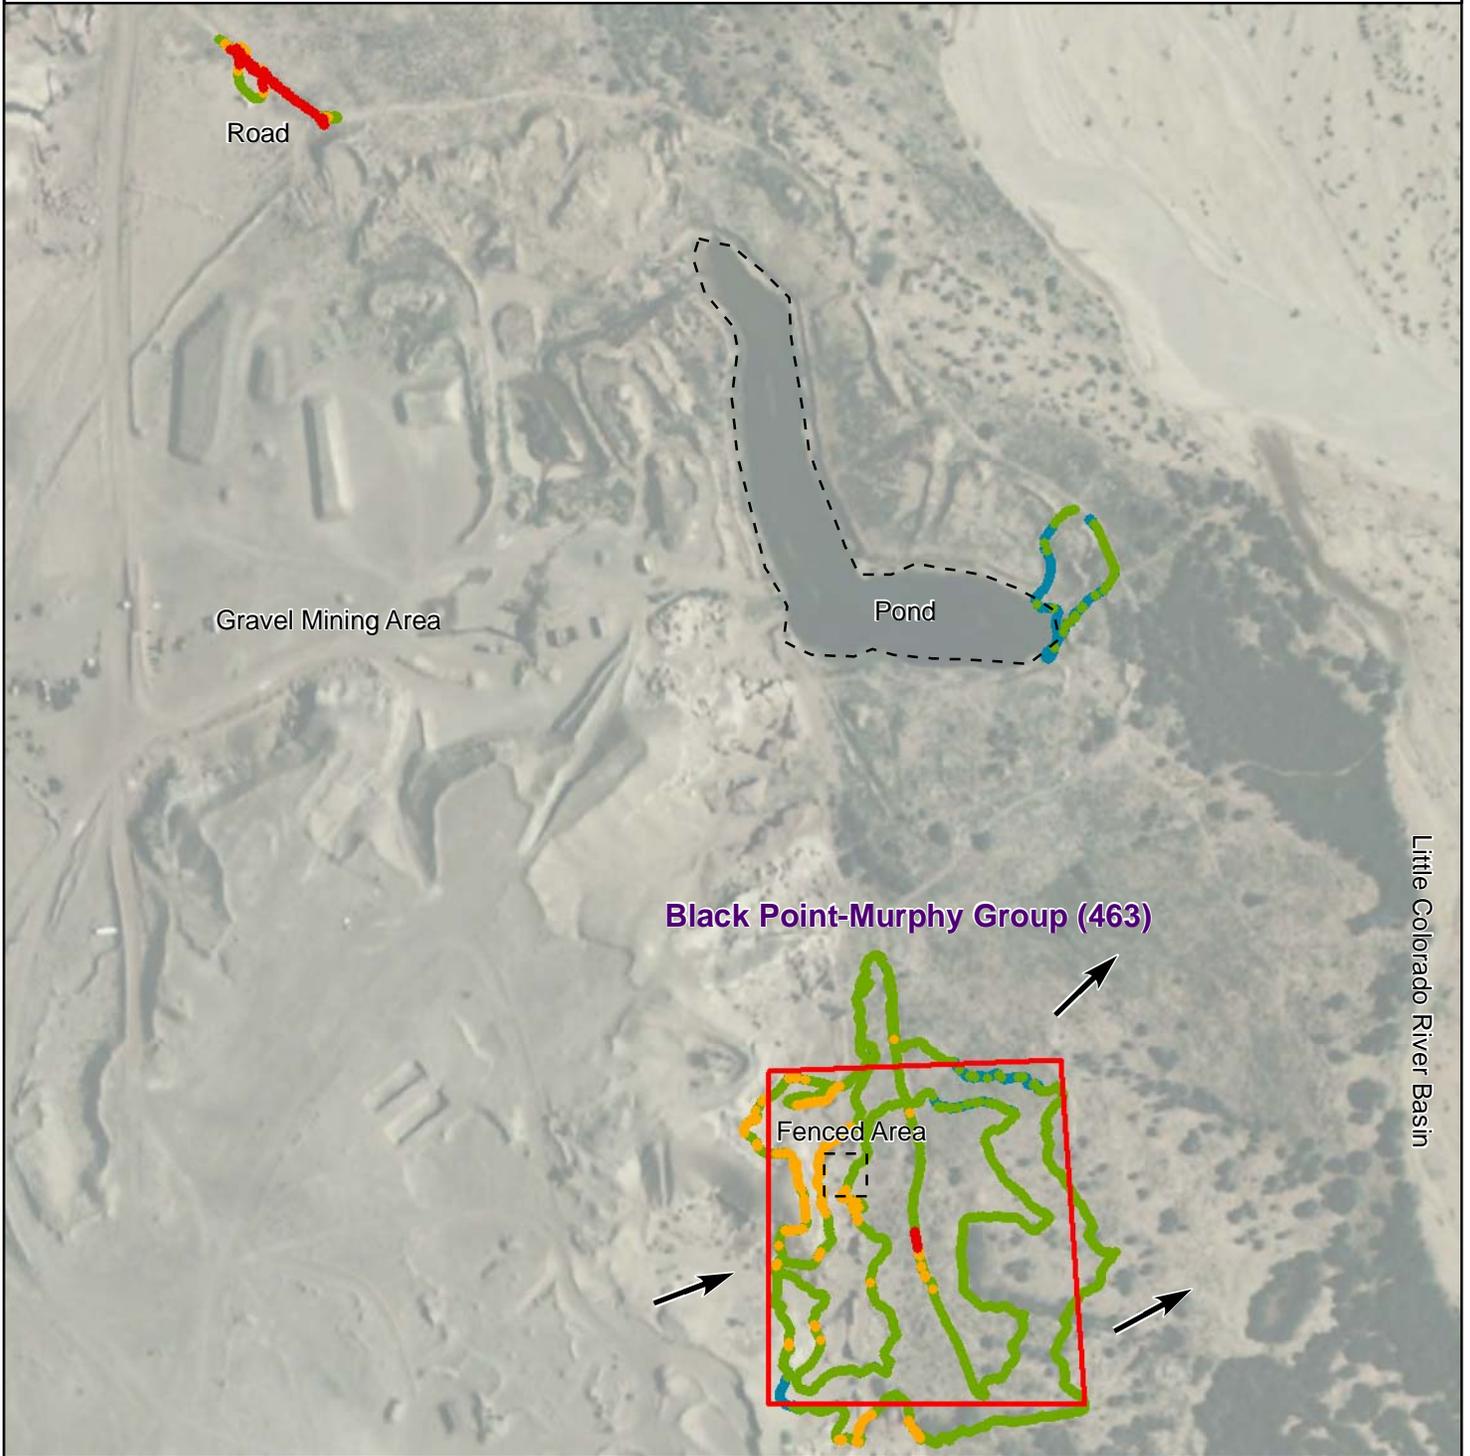
**Figure 2 - Gamma Radiation Measurements
Black Point-Murphy Group (463)
Coconino County, Arizona**

**Gamma survey conducted 11/2010
Measured as counts per minute (cpm)**

Average background 11,605 cpm
