Navajo Abandoned Uranium Mine

Site Screen Report

Kings 6 AUM Site

March 2010

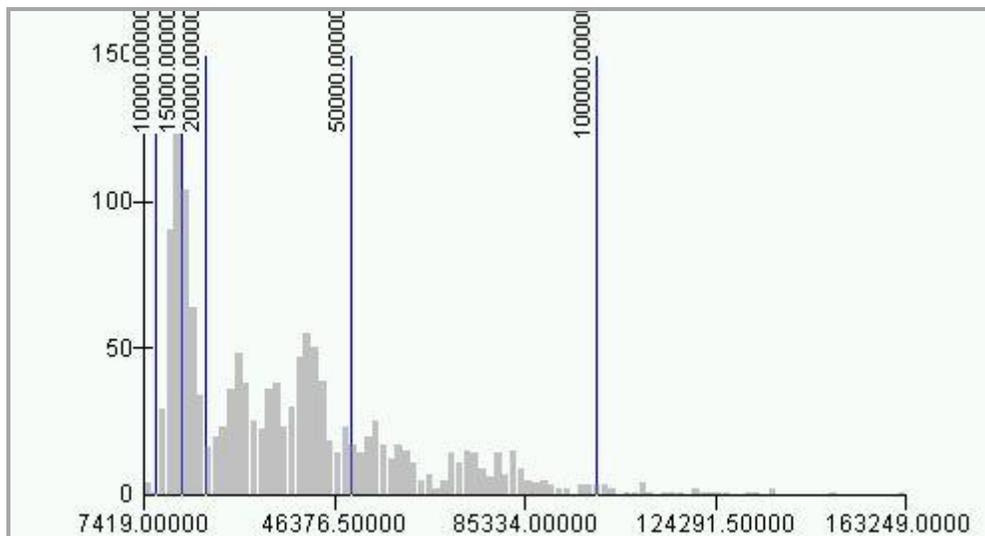
The following chart and statistics were generated by ESRI ArcGIS 9.3.1, and show the general distribution of the site gamma radiation measurements. The horizontal X axis represents the gamma radiation reading levels in cpm (lowest levels to the left). The vertical Y axis represents the frequency of each gamma radiation level.

Count:	1410
Minimum:	7419.00000
Maximum:	163249.00000
Sum:	52506933.00000
Mean:	37238.95957
Median:	32765.00000
Standard Deviation:	23902.95480

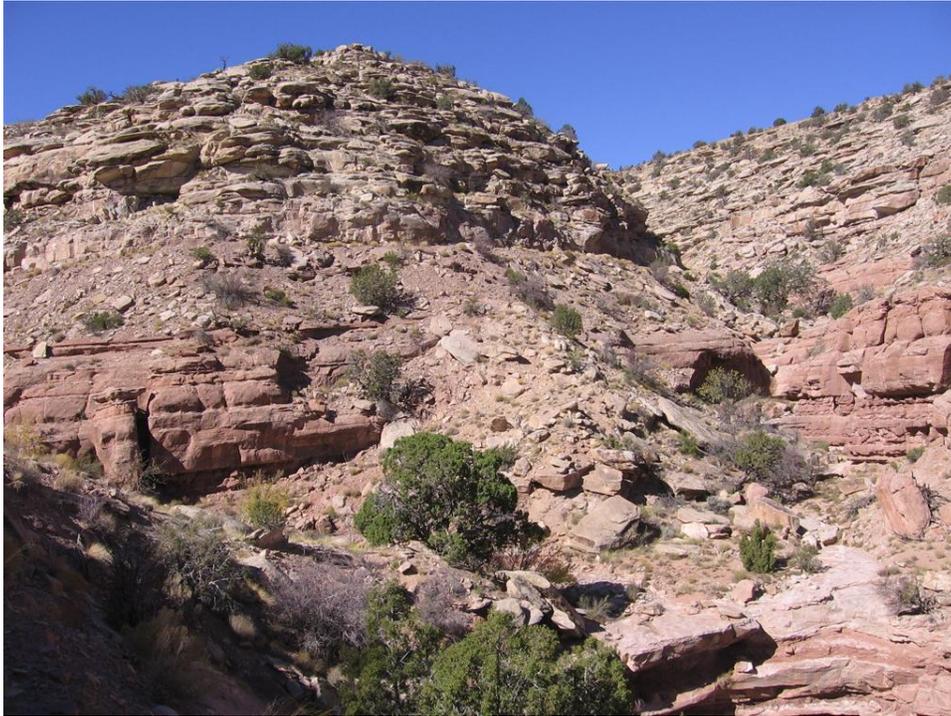
Waste pile sloughing off down road beneath adit, 100'x75', with a total estimated volume of 1,389 yd³

Photo 1. Cliff side below adits, with waste rock

Unreclaimed waste pile; 2 sealed adits

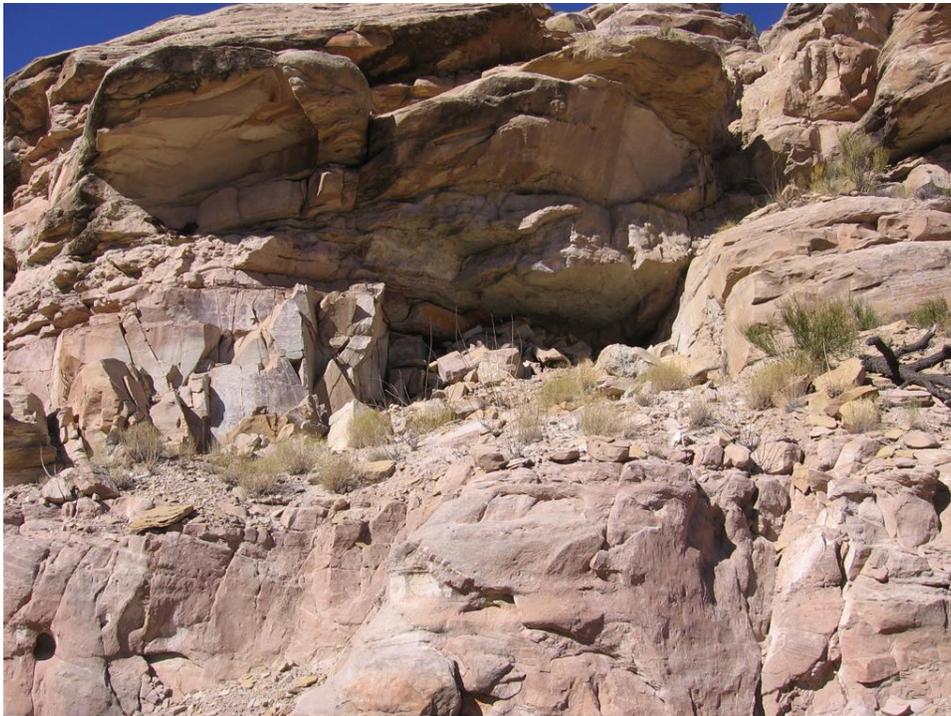
2 adits, approximately 6' x 8', reclaimed with stone and poly-foam

Photo 2. Sealed adit

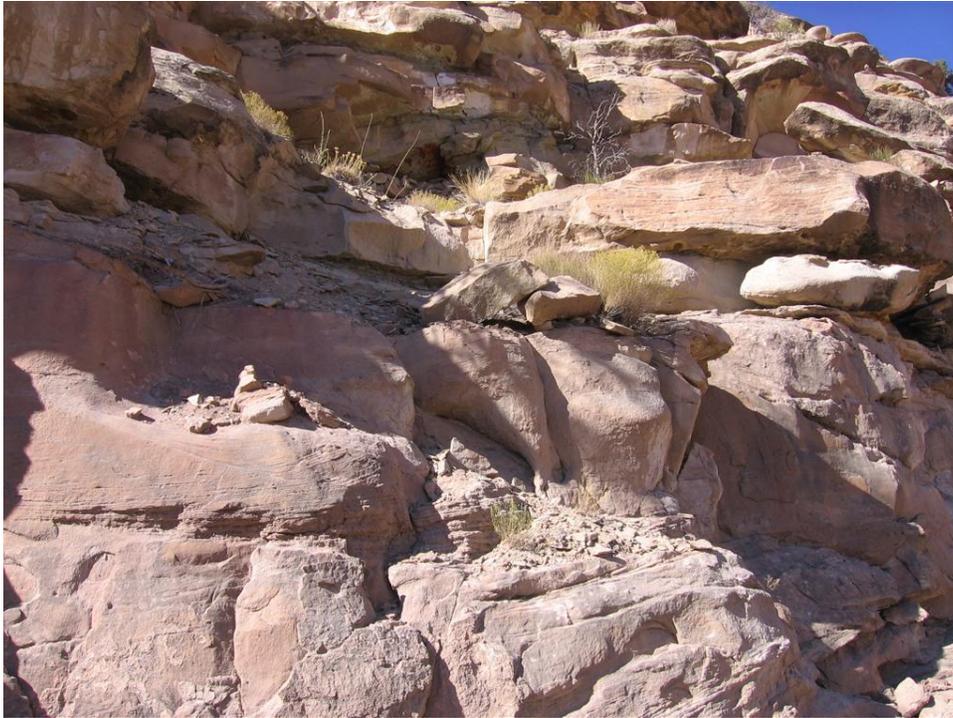
Photo 3. Waste rock below adit

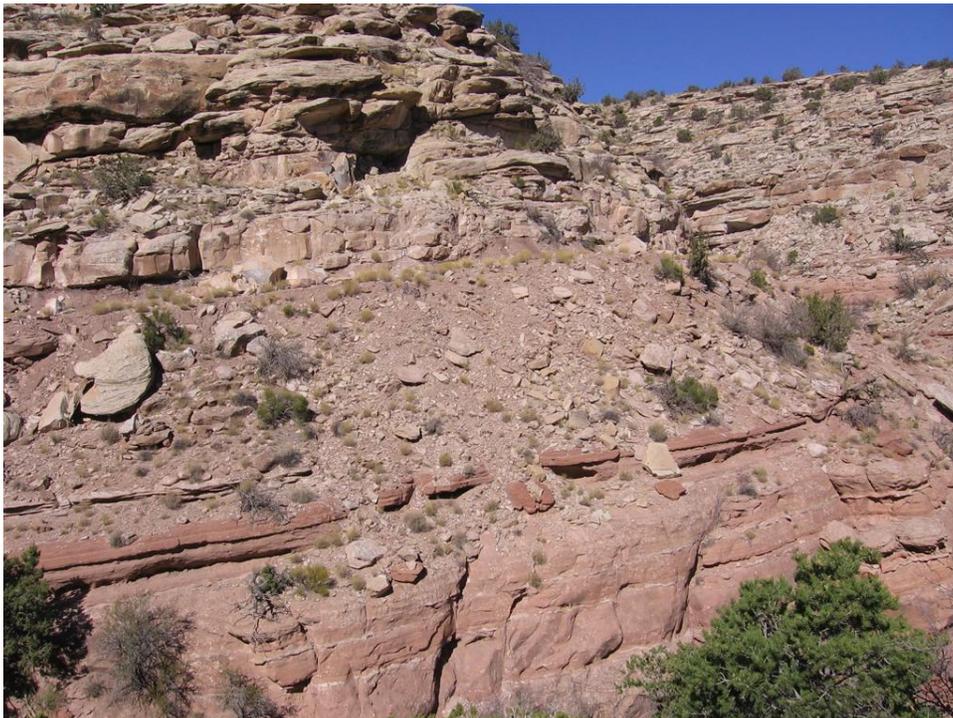
Photo 4. Cliff side below adits, with waste rock

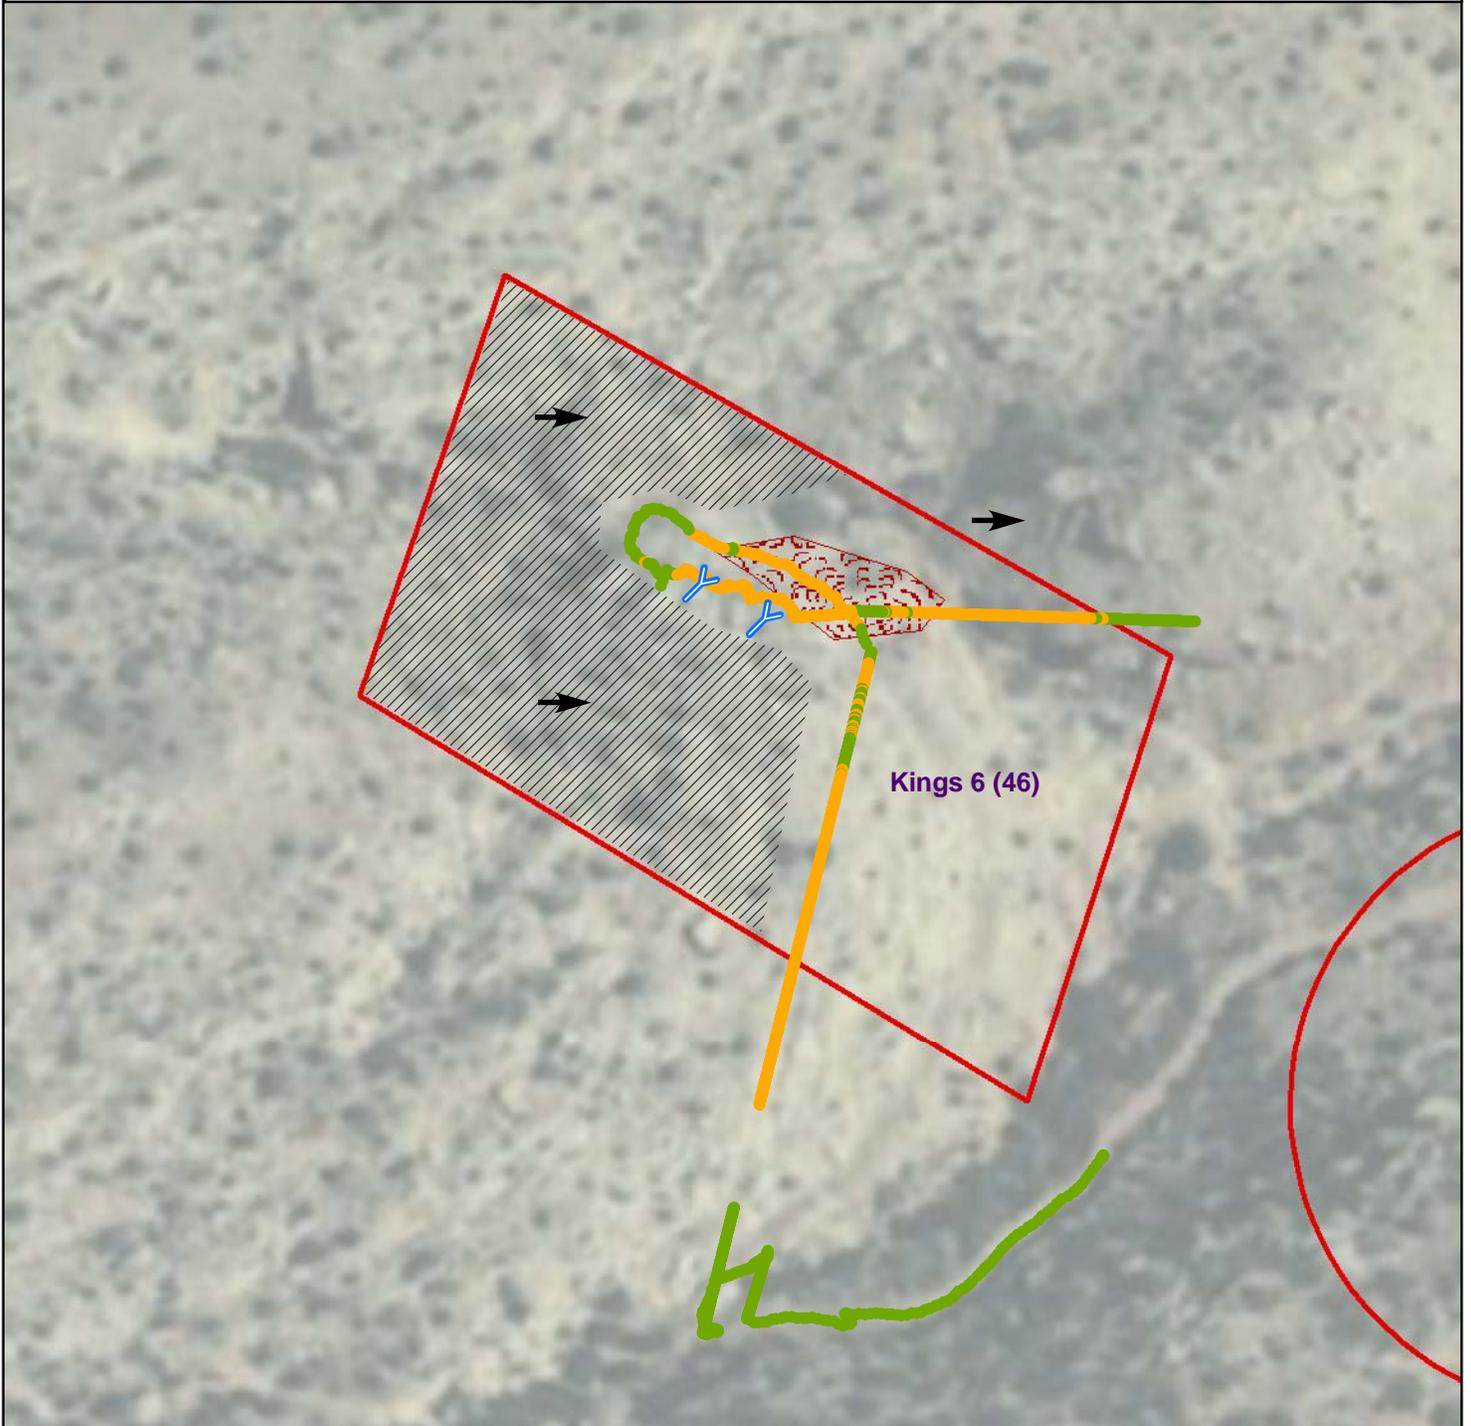
A total of 1,410 gamma radiation measurements were collected from the mine site, ranging from 7,419 cpm to 163,249 cpm. Measurements in the vicinity of the waste debris were found at levels of approximately 80,000 cpm, and in the vicinity of the 2 adits at approximately 17,000 cpm, and 80,000 cpm. The measurements are represented in Figures 1 and 2.

**Figure 1 - Gamma Radiation Measurements, Above Two Times Background
Kings 6 (46)
Beclabito Chapter, Navajo Nation, Arizona**

Note: A portion of the path was estimated by the GPS unit, due to poor satellite coverage encountered during the site visit.

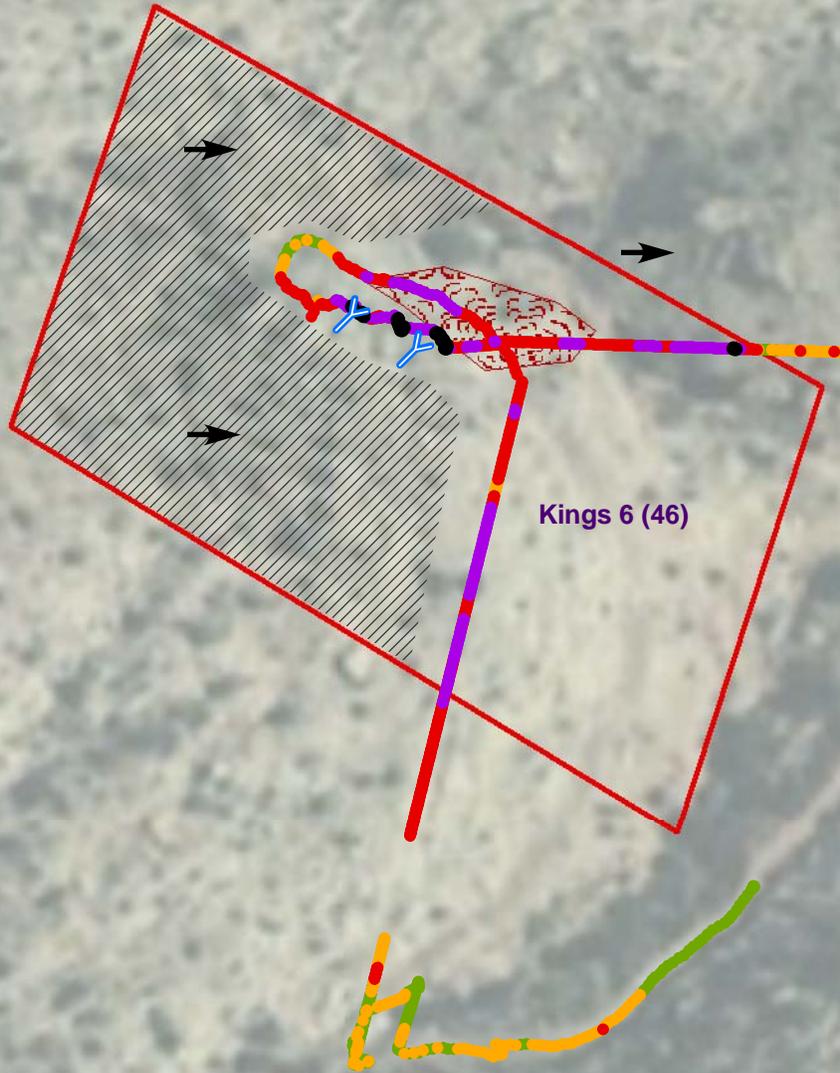
**Figure 2 - Gamma Radiation Measurements
Kings 6 (46)
Beclabito Chapter, Navajo Nation, Arizona**

Note: A portion of the path was estimated by the GPS unit, due to poor satellite coverage encountered during the site visit.
