Navajo Abandoned Uranium Mine

Site Screen Report

East Portal, Frank No. 1 Mine AUM Site

Weston Solutions, Inc.

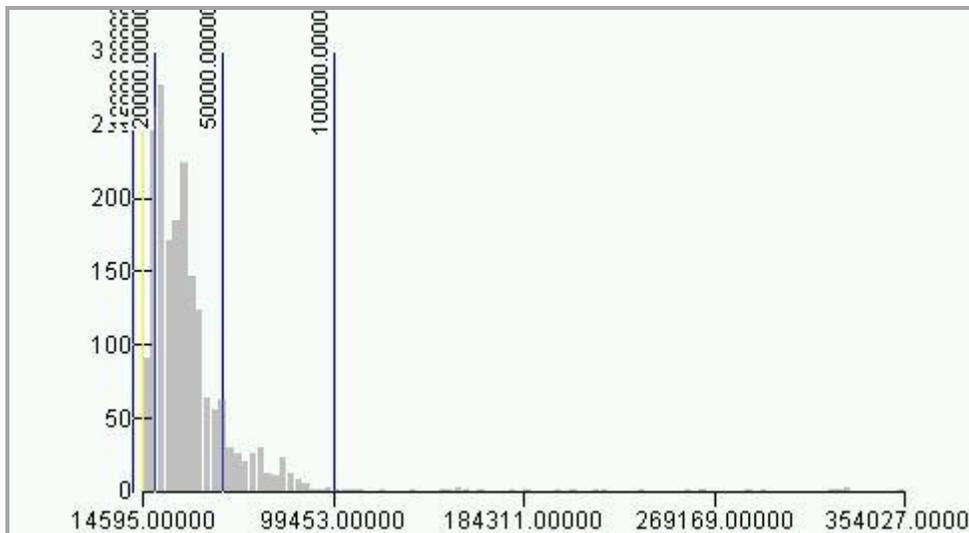
The following chart and statistics were generated by ESRI ArcGIS 9.3.1, and show the general distribution of the site gamma radiation measurements. The horizontal X axis represents the gamma radiation reading levels in cpm (lowest levels to the left). The vertical Y axis represents the frequency of each gamma radiation level.

Count:	1899
Minimum:	14595.00000
Maximum:	354027.00000
Sum:	70322039.00000
Mean:	37031.08952
Median:	31160.00000
Standard Deviation:	29595.91186

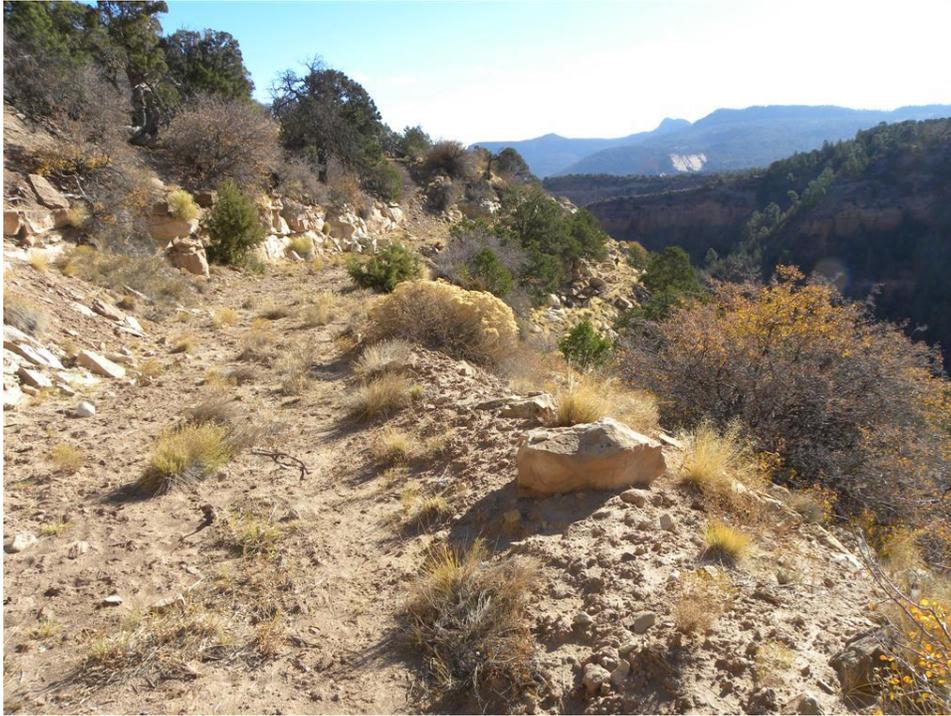
Photo 1. Down slope edge

Scattered waste debris along roads throughout site; waste pile along cliff, 500' x 50'; with a total estimated volume of 4,630 yd³

Unreclaimed waste pile

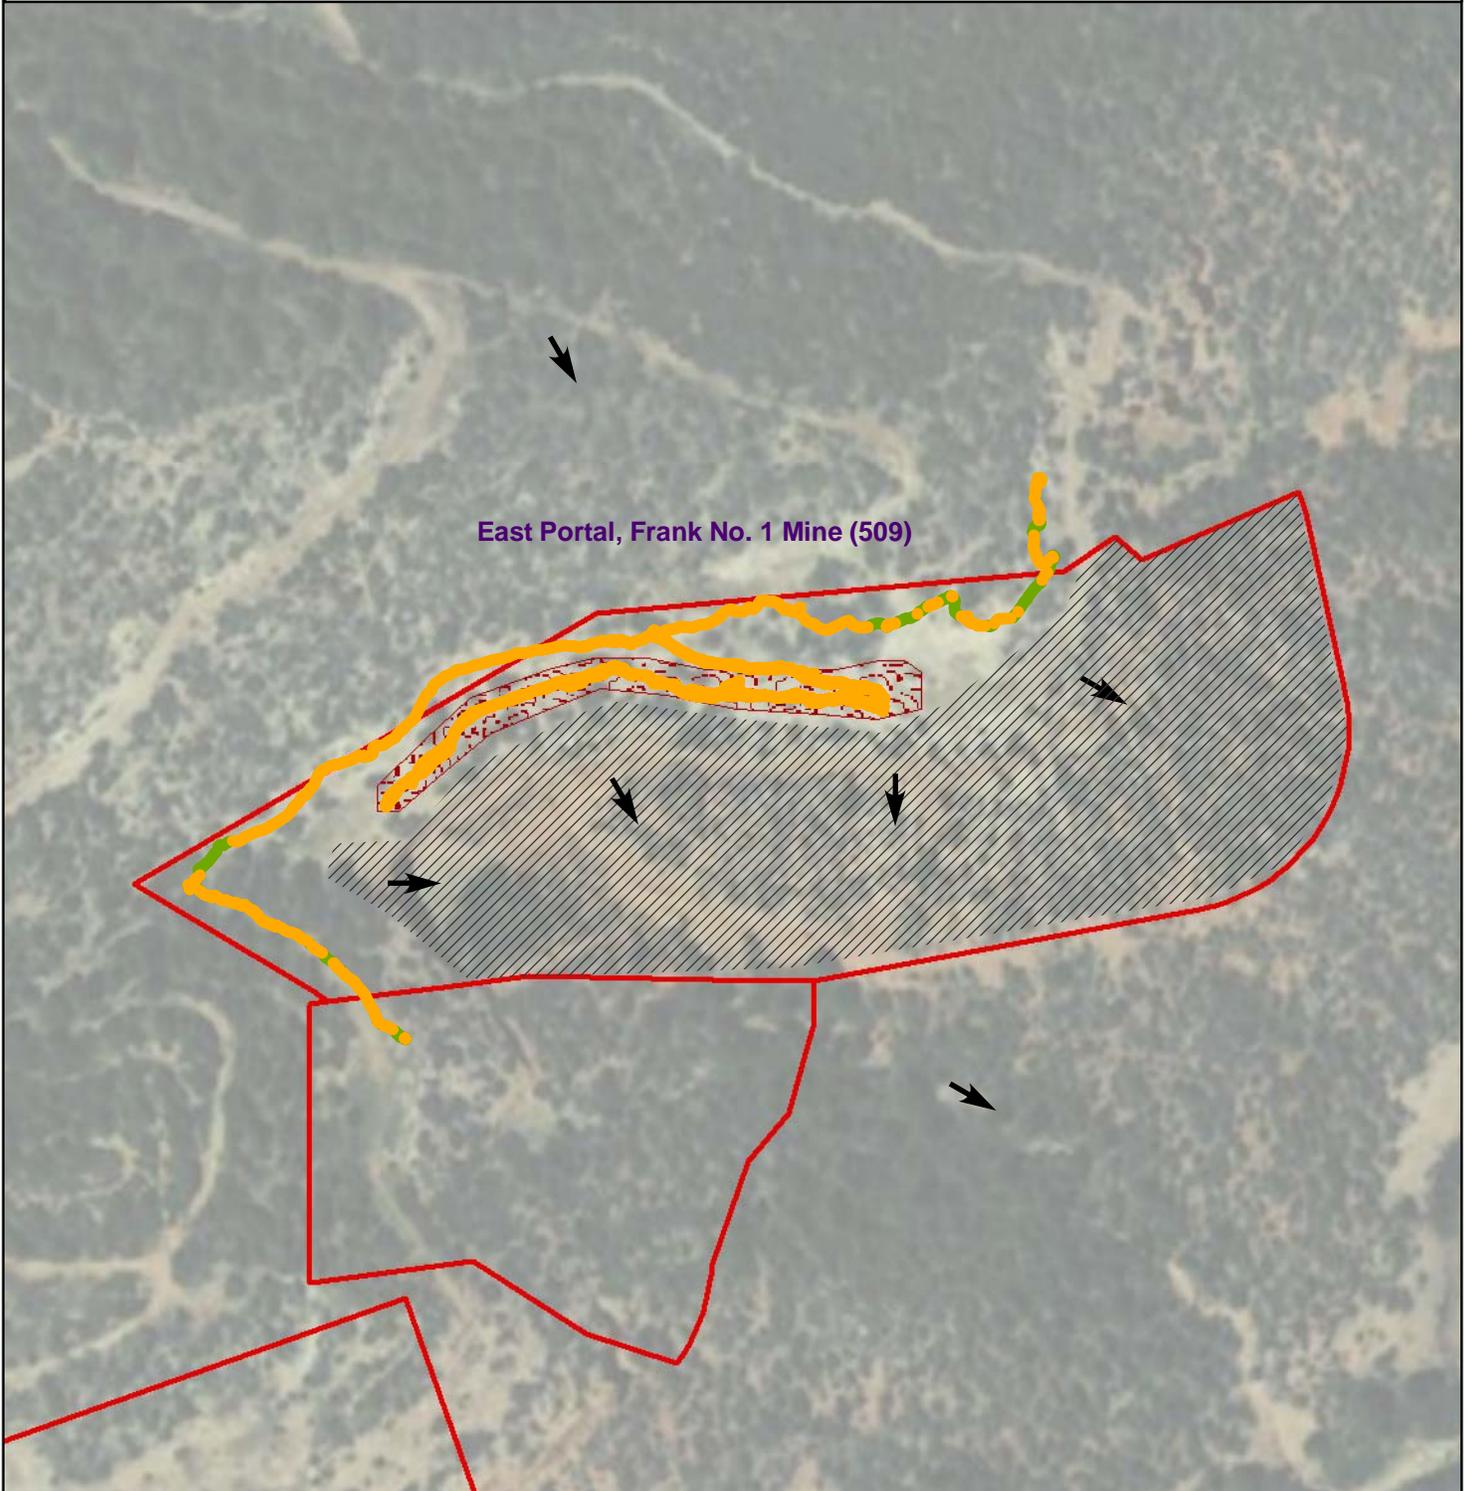
**Figure 1 - Gamma Radiation Measurements, Above Two Times Background
 East Portal, Frank No. 1 Mine (509)
 Cove Chapter, Navajo Nation, Arizona**

A total of 1,899 gamma radiation measurements were collected from the mine site, ranging from 14,595 cpm to 354,027 cpm. Measurements in the vicinity of the waste debris were found at levels ranging from 40,000 - 60,000 cpm, elevated readings in northern cliff face of 400,000 cpm. The measurements are represented in Figures 1 and 2.

Gamma survey conducted 10/2009
 Measured as counts per minute (cpm)

Average background = 9,717 cpm

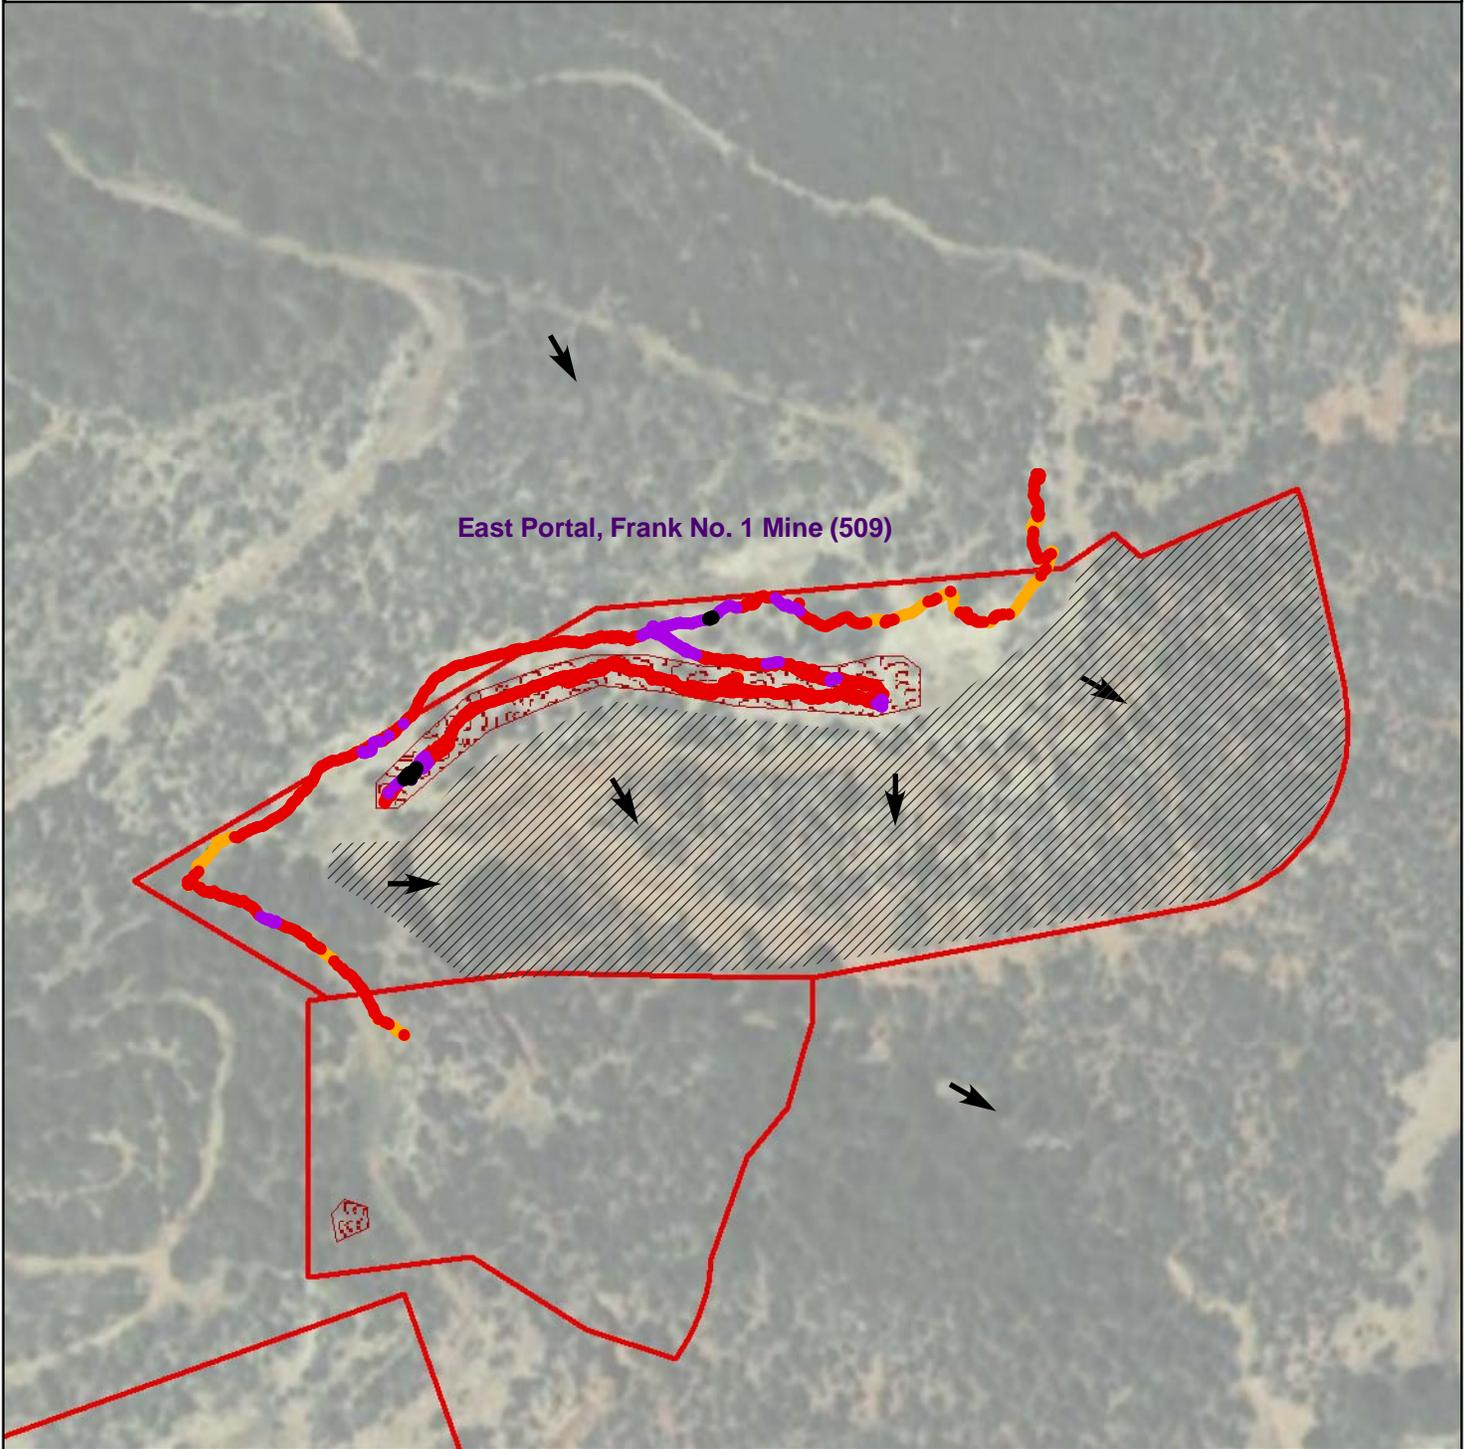
**Figure 2 - Gamma Radiation Measurements
 East Portal, Frank No. 1 Mine (509)
 Cove Chapter, Navajo Nation, Arizona**

**Gamma survey conducted 10/2009
 Measured as counts per minute (cpm)**

Average background = 9,717 cpm
