Navajo Abandoned Uranium Mine

Site Screen Report

Mine Name: Martin Johnson No. 4
Mine ID: 540

August 2011

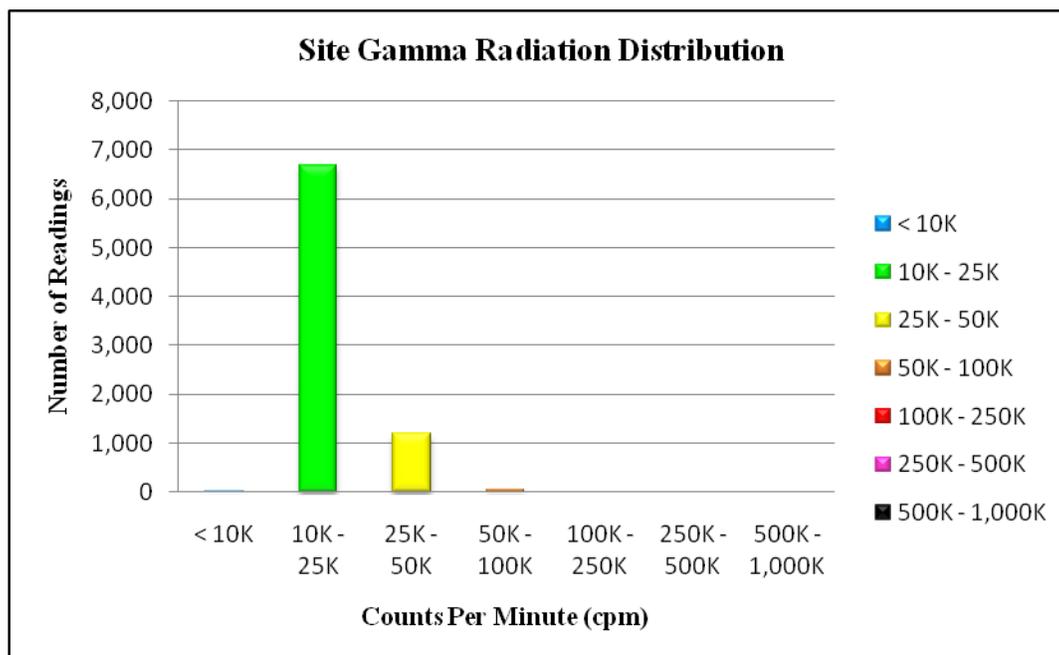
Distribution Chart and Statistics:

Site Gamma Radiation Statistics	
Number of Readings	7,915
Minimum (cpm)	9,986
Maximum (cpm)	80,663
Mean (cpm)	18,787
Median (cpm)	16,197
Standard Deviation	7,243

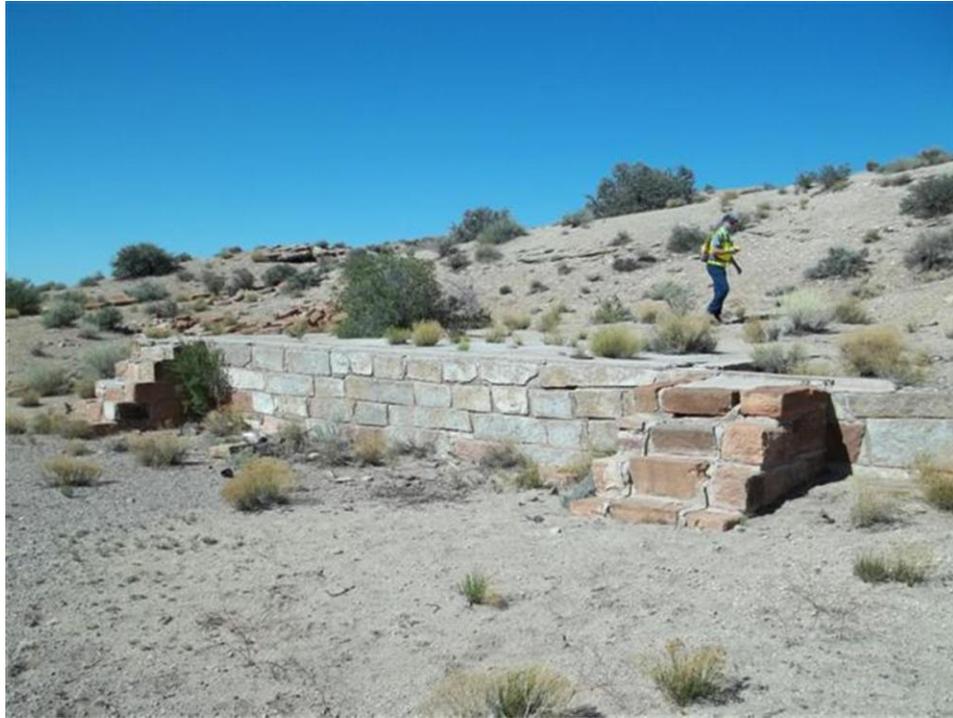
Photo 3: Mine Site #540; Stone foundation onsite

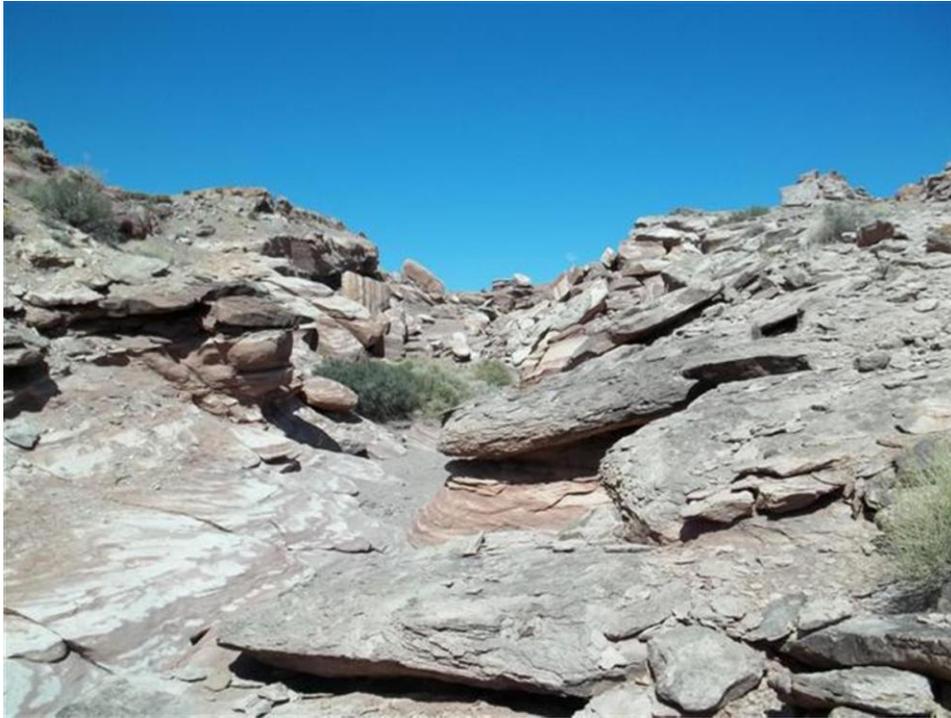
Photo 5: Mine Site #540; Onsite drainage

The site is located within a wash area which may contain seasonal tributaries to the Little Colorado River

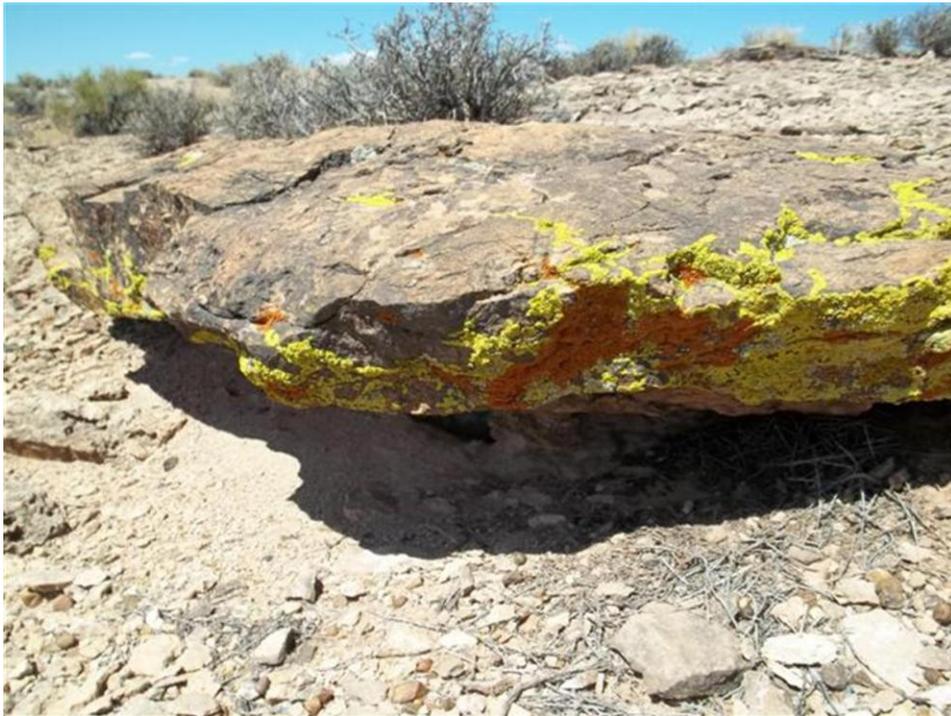
Photo 6: Mine Site #540; Onsite rocks

A total of 7,915 gamma radiation measurements were collected from the mine site, ranging from 9,986 cpm to 80,663 cpm. Measurements collected in the vicinity of the scattered loose rock were found at a maximum level of approximately 80,000 cpm. The measurements are represented in Figures 1 and 2.

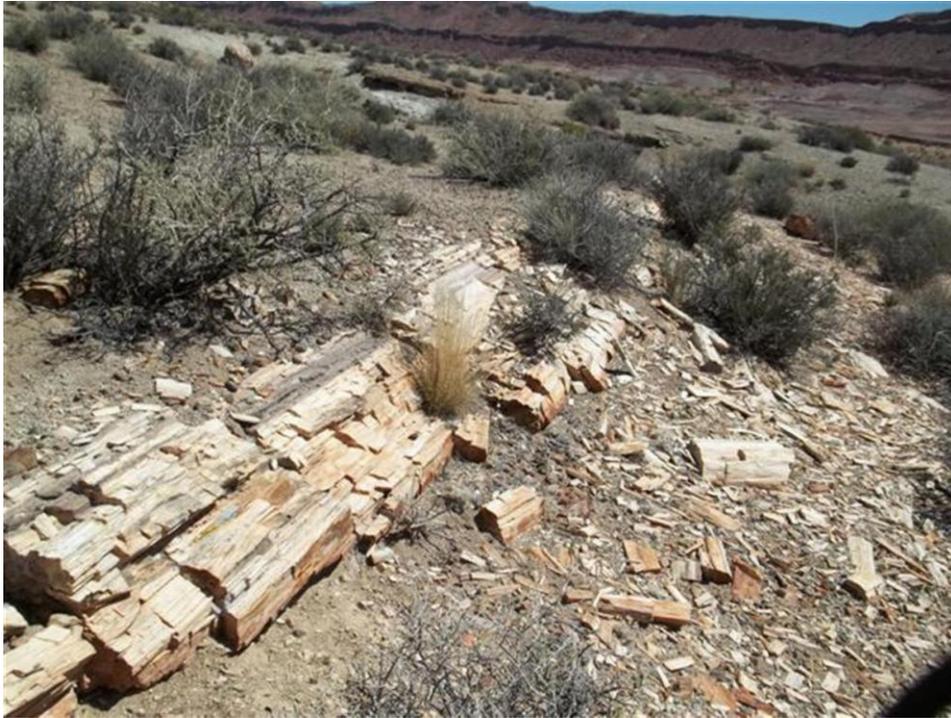
Photo 7: Mine Site #540; Petrified wood pile

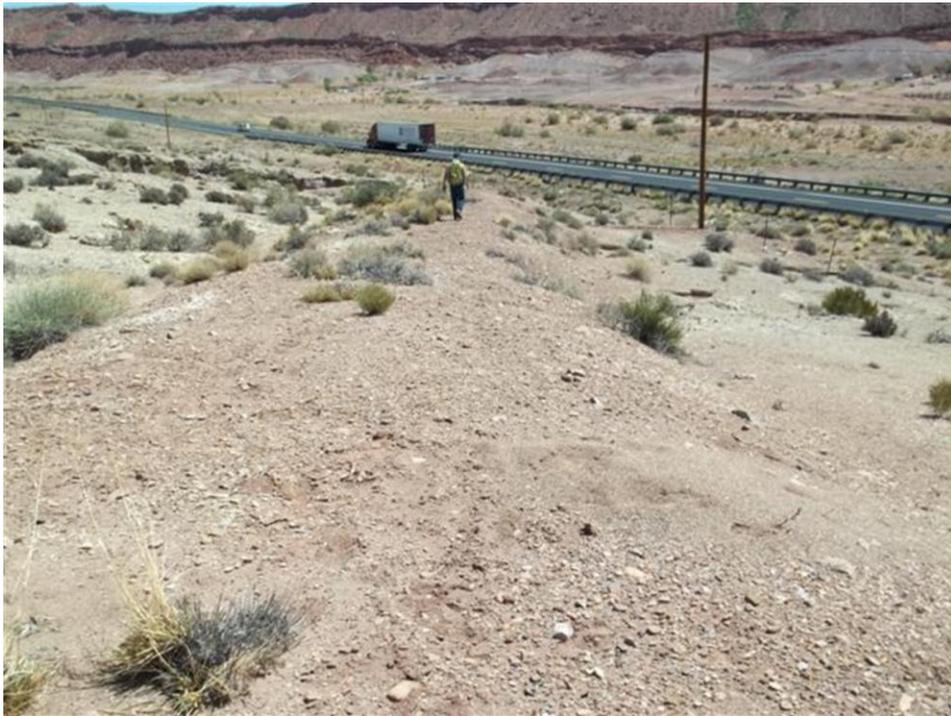
Photo 8: Mine Site #540; Berm

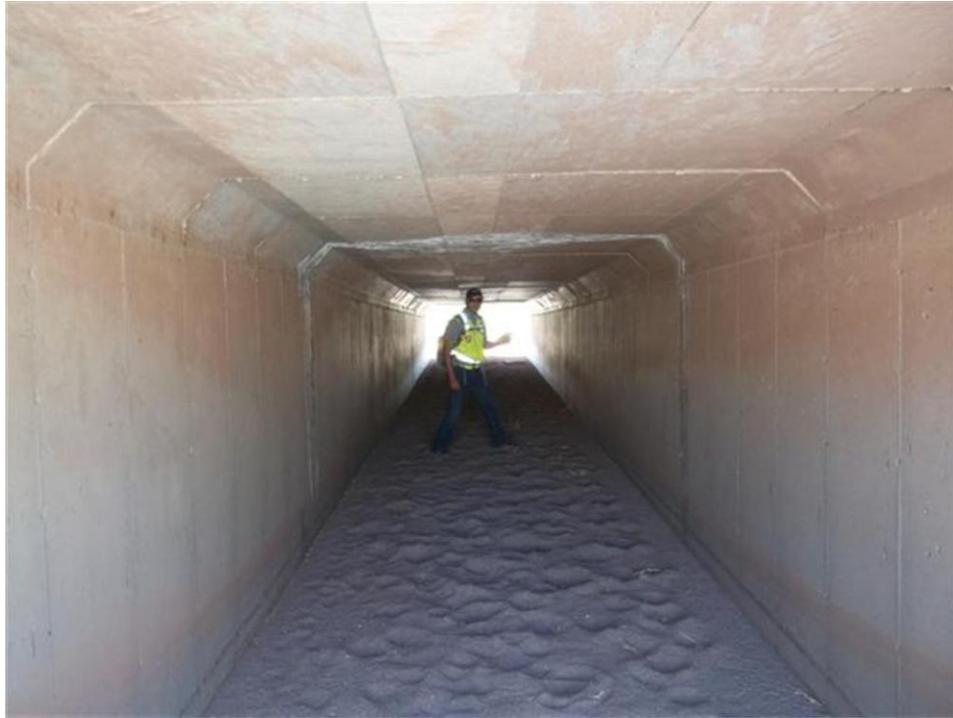
Photo 11: Mine Site #540; Culvert below Hwy 89

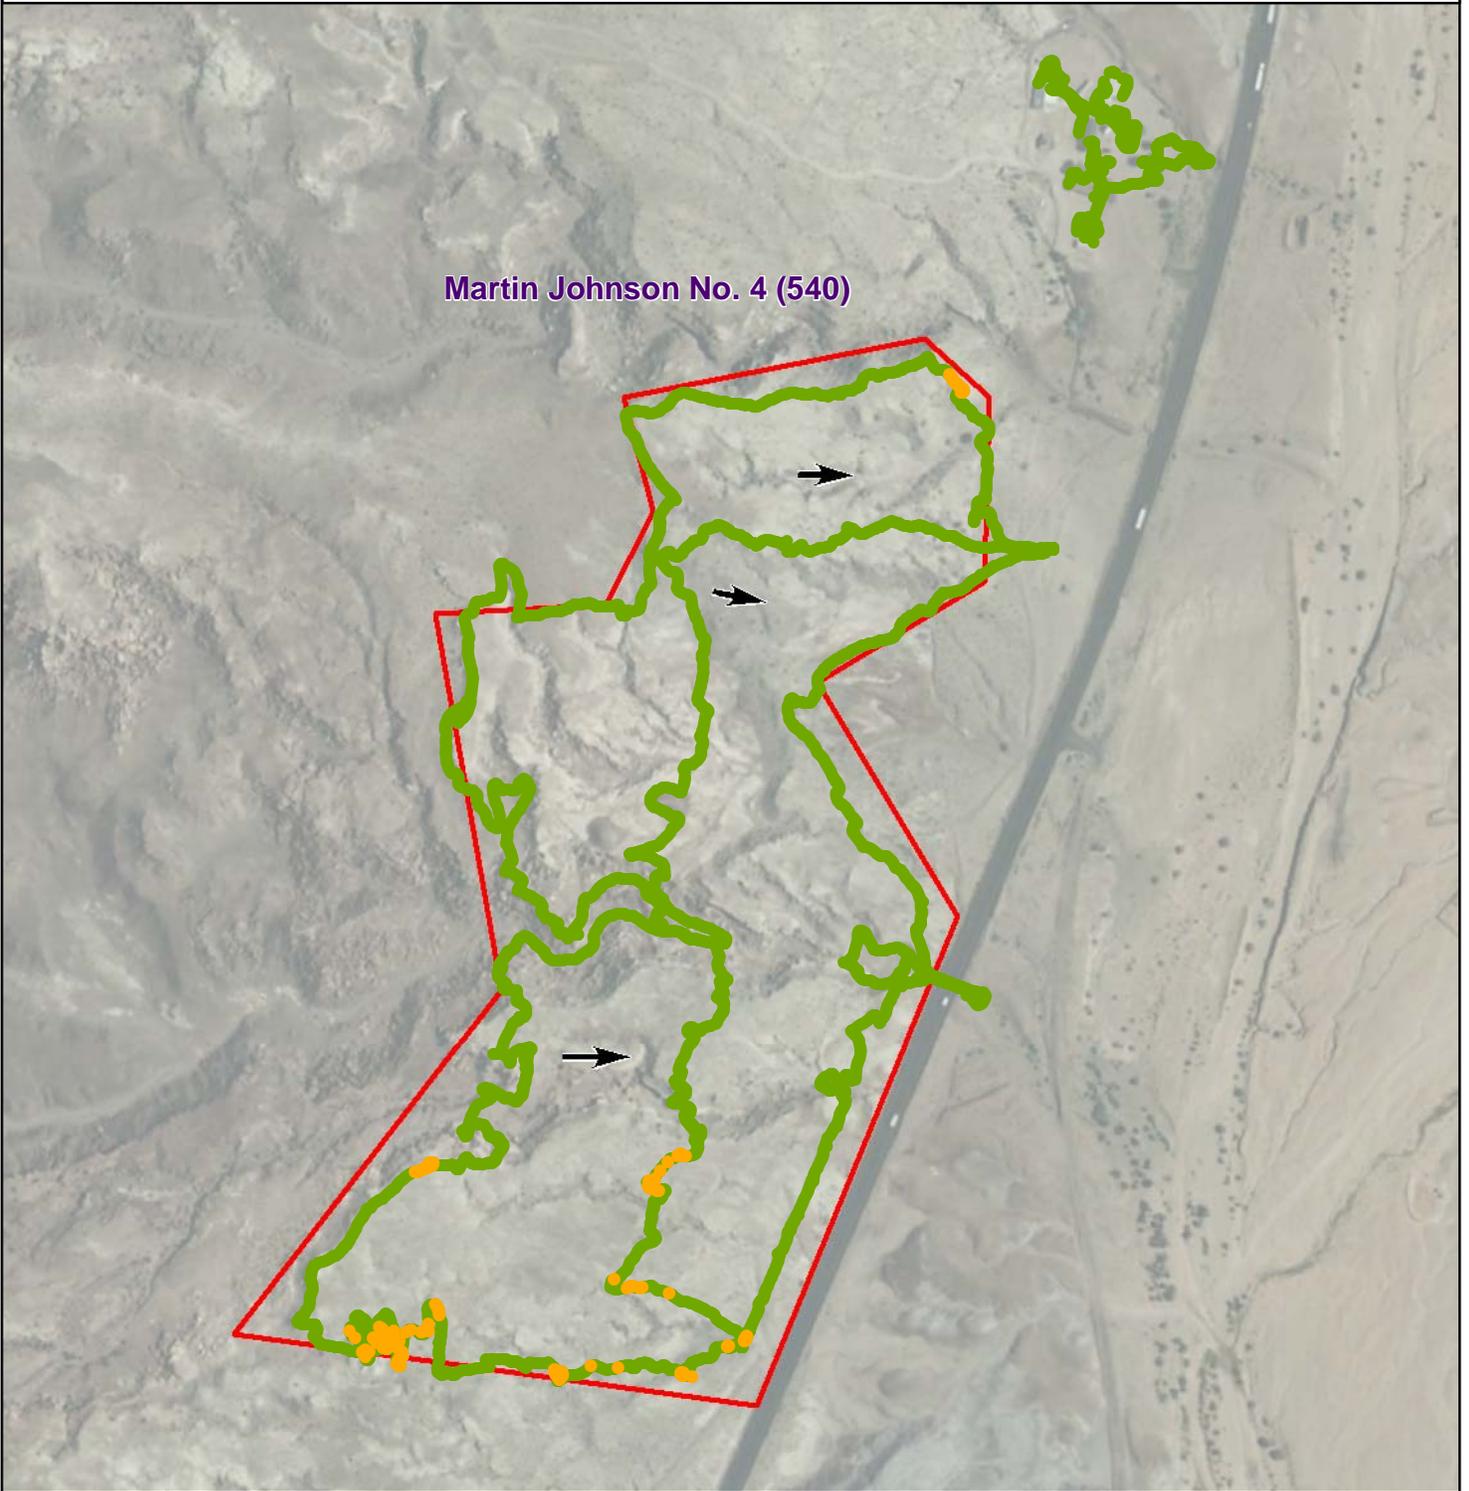
**Figure 1 - Gamma Radiation Measurements, Above Two Times Background
 Martin Johnson No. 4 (540)
 Bodaway / Gap Chapter, Navajo Nation**

Average background 14,864 cpm

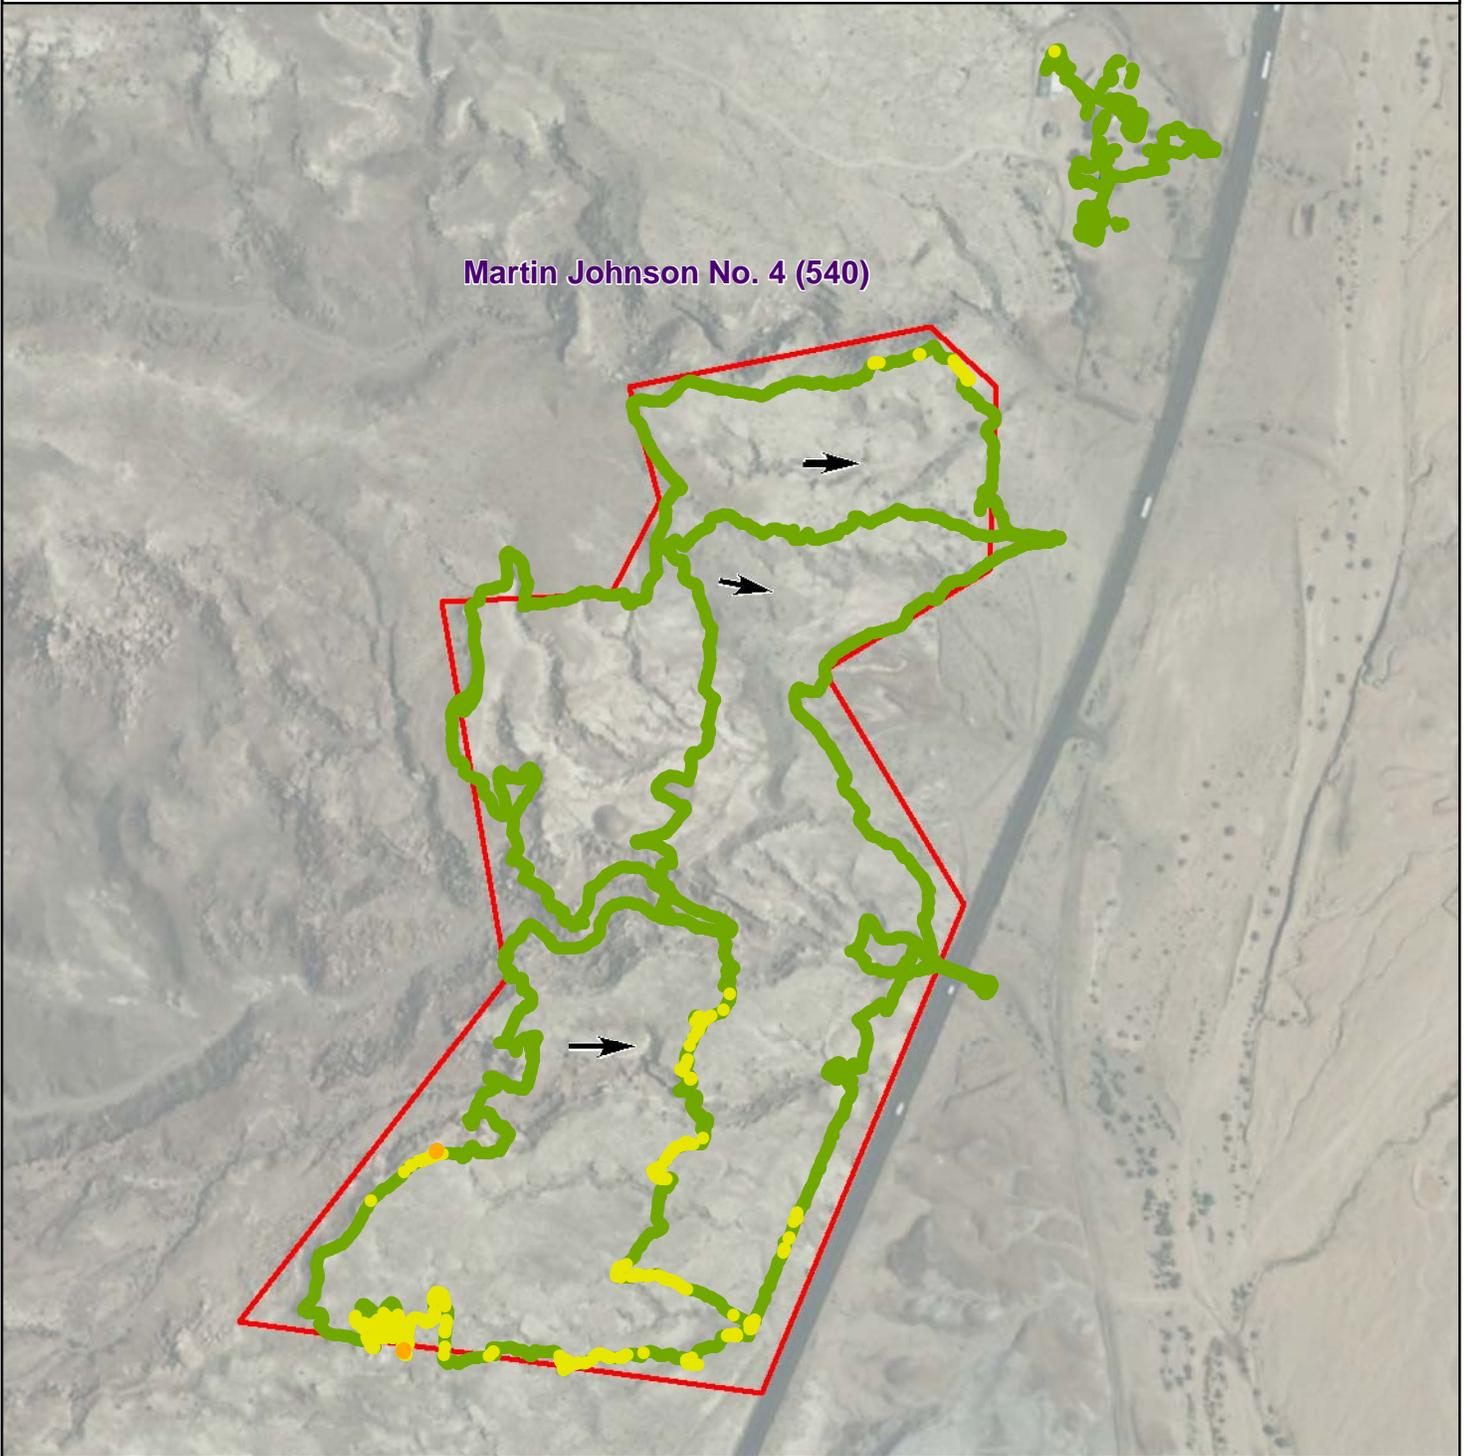
**Figure 2 - Gamma Radiation Measurements
 Martin Johnson No. 4 (540)
 Bodaway / Gap Chapter, Navajo Nation**

Measured as counts per minute (cpm) Average background 14,864 cpm
