Navajo Abandoned Uranium Mine

Site Screen Report

Emmett Lee No. 3 AUM Site

January 2011

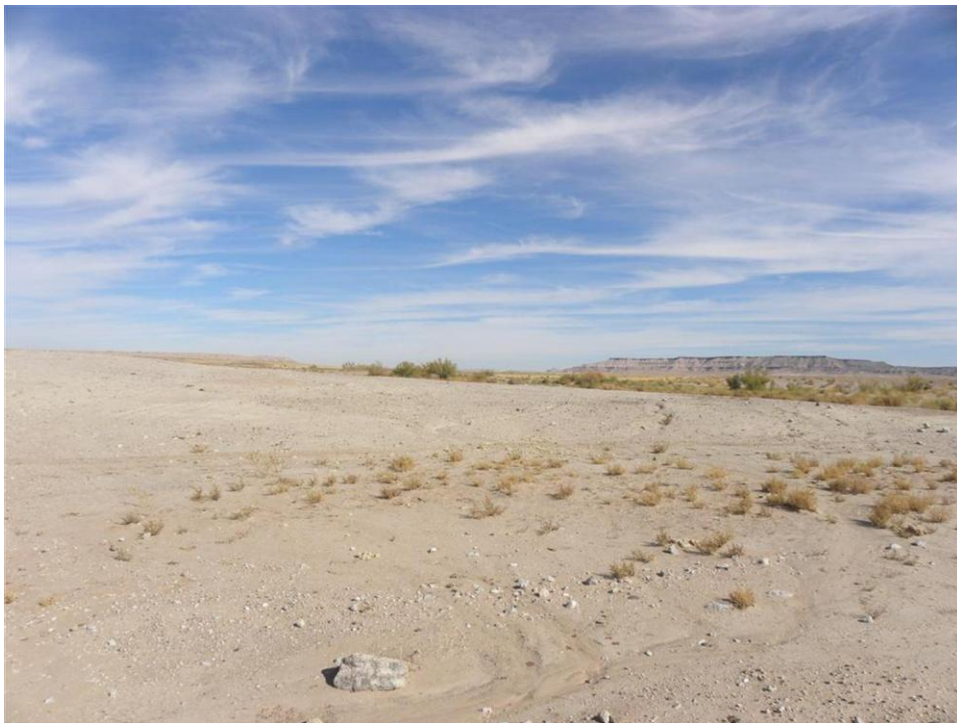
2 reclamation caps, shared with site #154: western cap 1000' x 300'; eastern cap 400' x 100', both made of grey material

Photo 2. Emmett Lee No. 3 mine site, reclamation cap

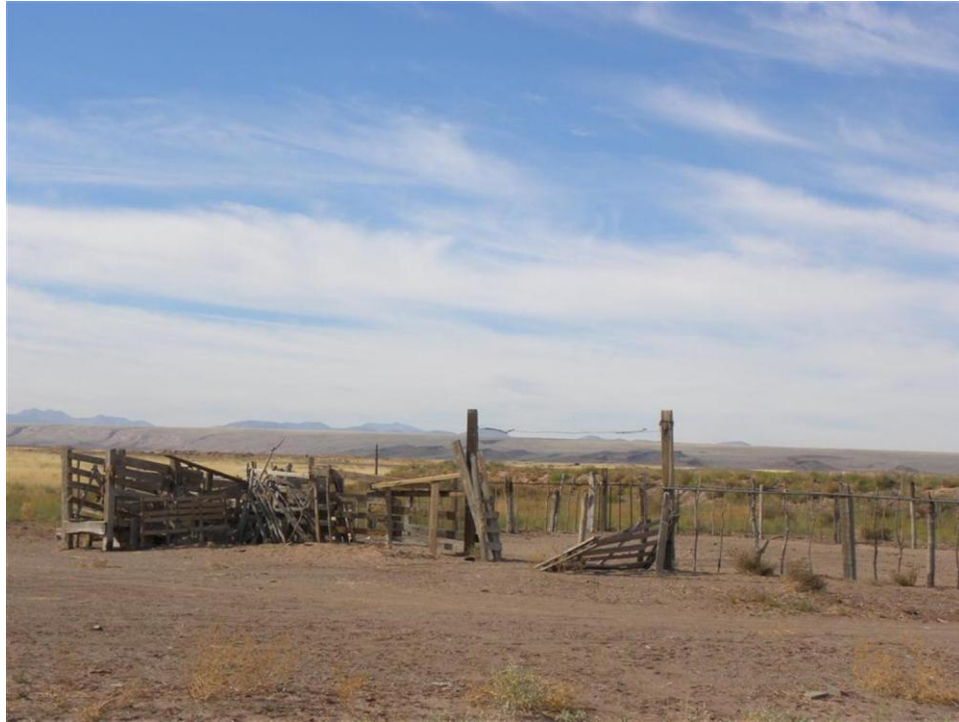
200 feet to 0.25 mile: Livestock corral used for cattle, approximately 250' W of site

Photo 3. Emmett Lee No. 3, livestock corral 250' west of site

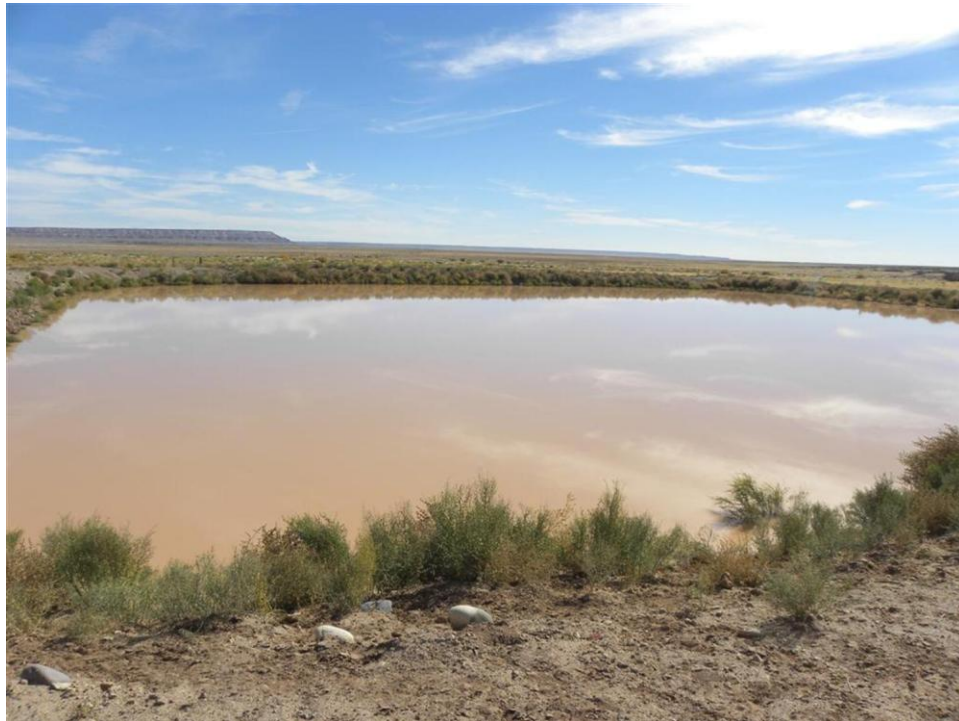
0 to 0.25 miles: Pond area behind livestock corral, approximately 500' E of the site

Photo 4. Emmett Lee No. 3, livestock corral pond 500' west of site
