# Navajo Abandoned Uranium Mine

## Site Screen Report

### Julius Chee No. 3 AUM Site

**January 2011**

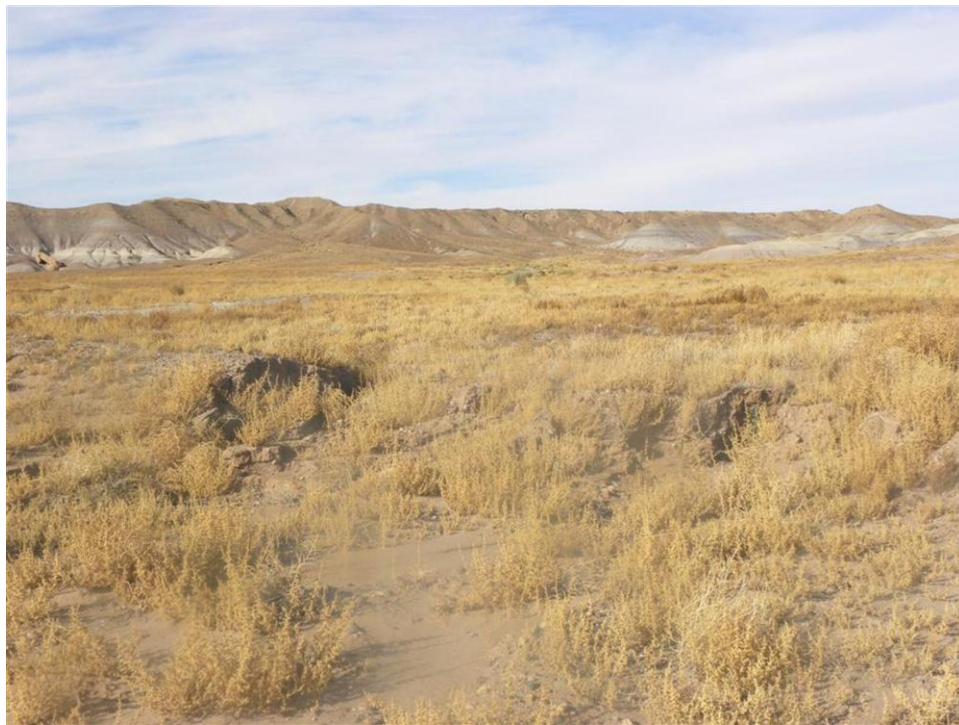
Series of reclamation berms, over area identified on old topo maps as "tailings", berms cover the corner area between sites 159, 549, 550, and 1041, breached in the southwest

Photo 2. Julius Chee No. 3 mine site, berm area

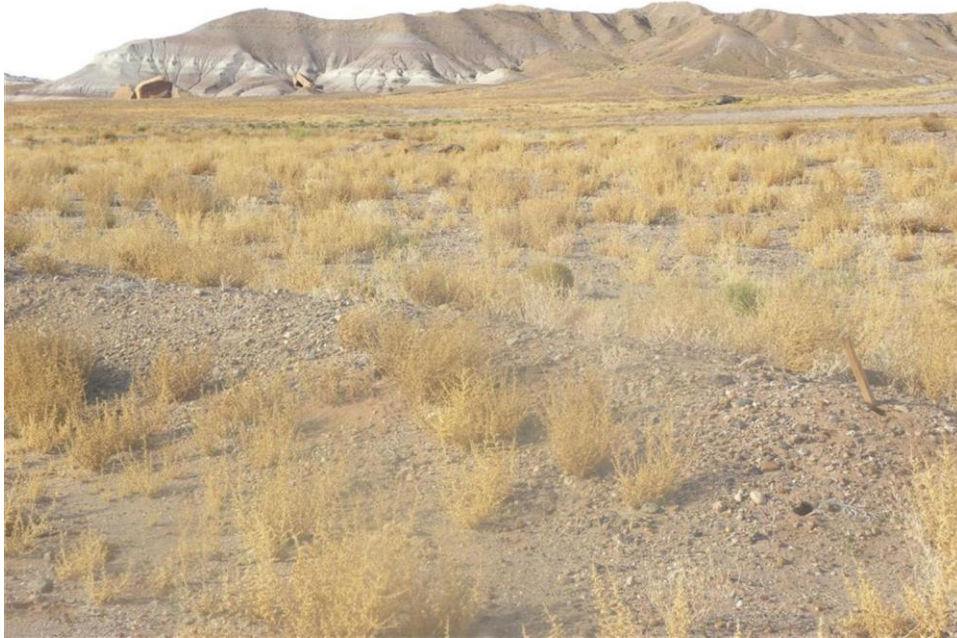
Photo 3. Julius Chee No. 3 mine site, berm area
