Navajo Abandoned Uranium Mine

Site Screen Report

Mesa II, Mine No. 1, P-150 AUM Site

March 2010

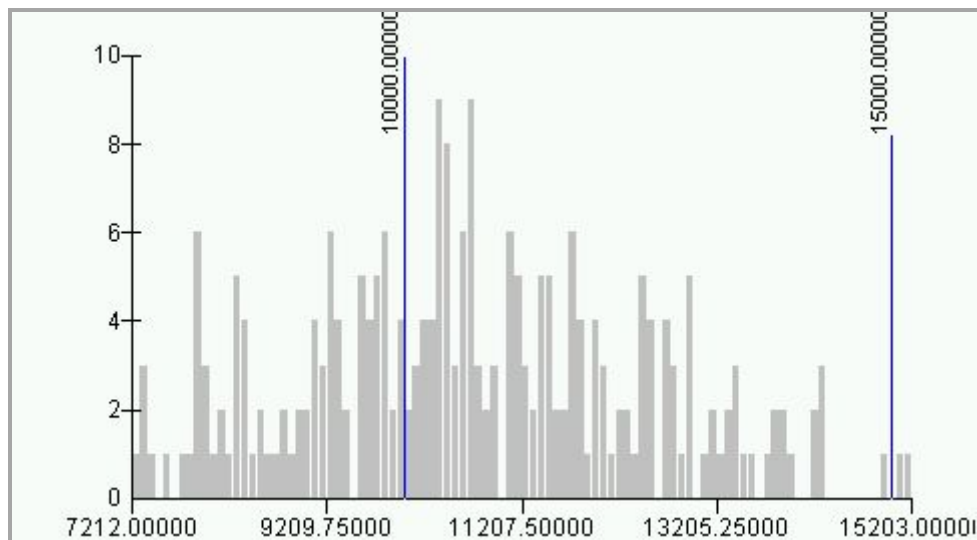
The following chart and statistics were generated by ESRI ArcGIS 9.3.1, and show the general distribution of the site gamma radiation measurements. The horizontal X axis represents the gamma radiation reading levels in cpm (lowest levels to the left). The vertical Y axis represents the frequency of each gamma radiation level.

Count:	244
Minimum:	7212.00000
Maximum:	15203.00000
Sum:	2612209.00000
Mean:	10705.77459
Median:	10592.00000
Standard Deviation:	1740.28277

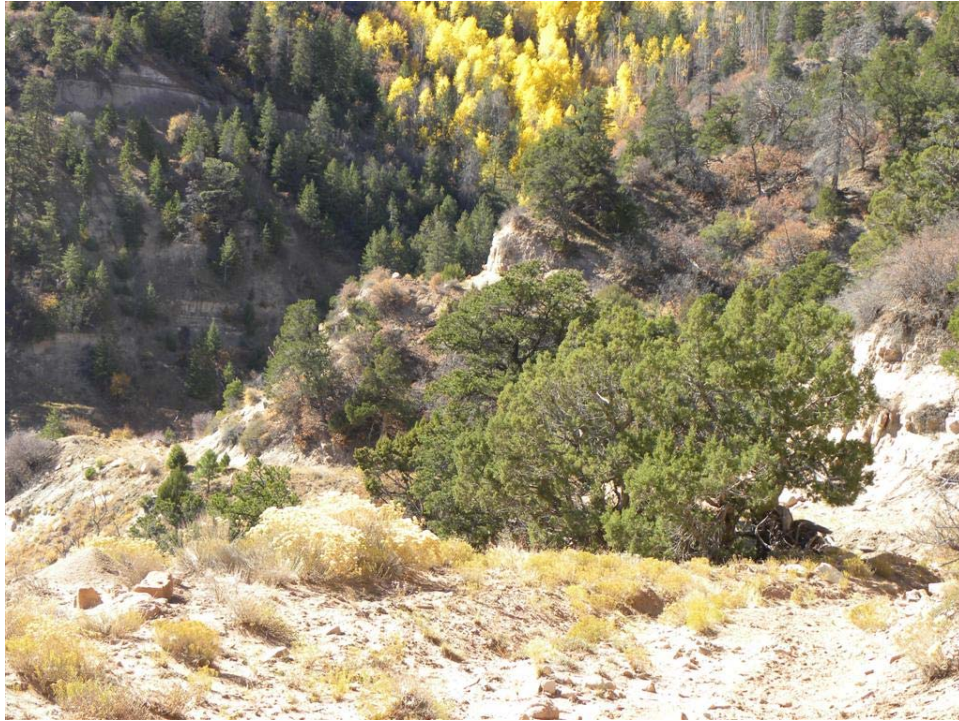
Cliff face waste, 50' x 50', with a total estimated volume of 463 yd³.

Photo 1. Looking down on mine site

Unreclaimed waste pile

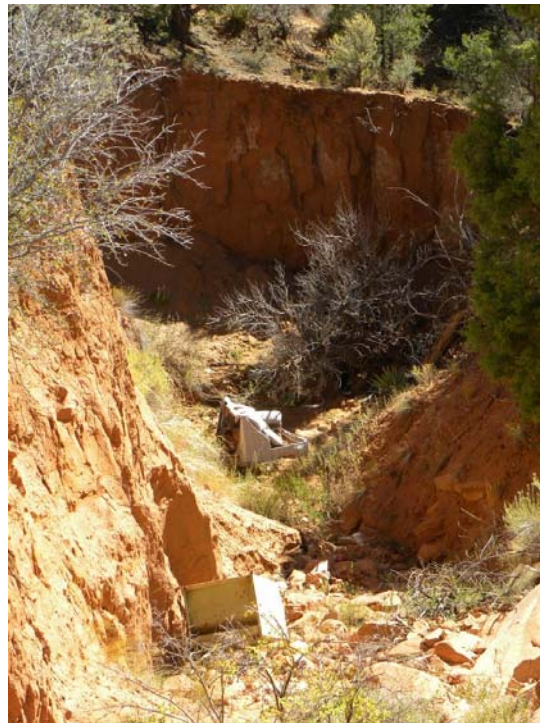
Photo 2. Looking down into mine site

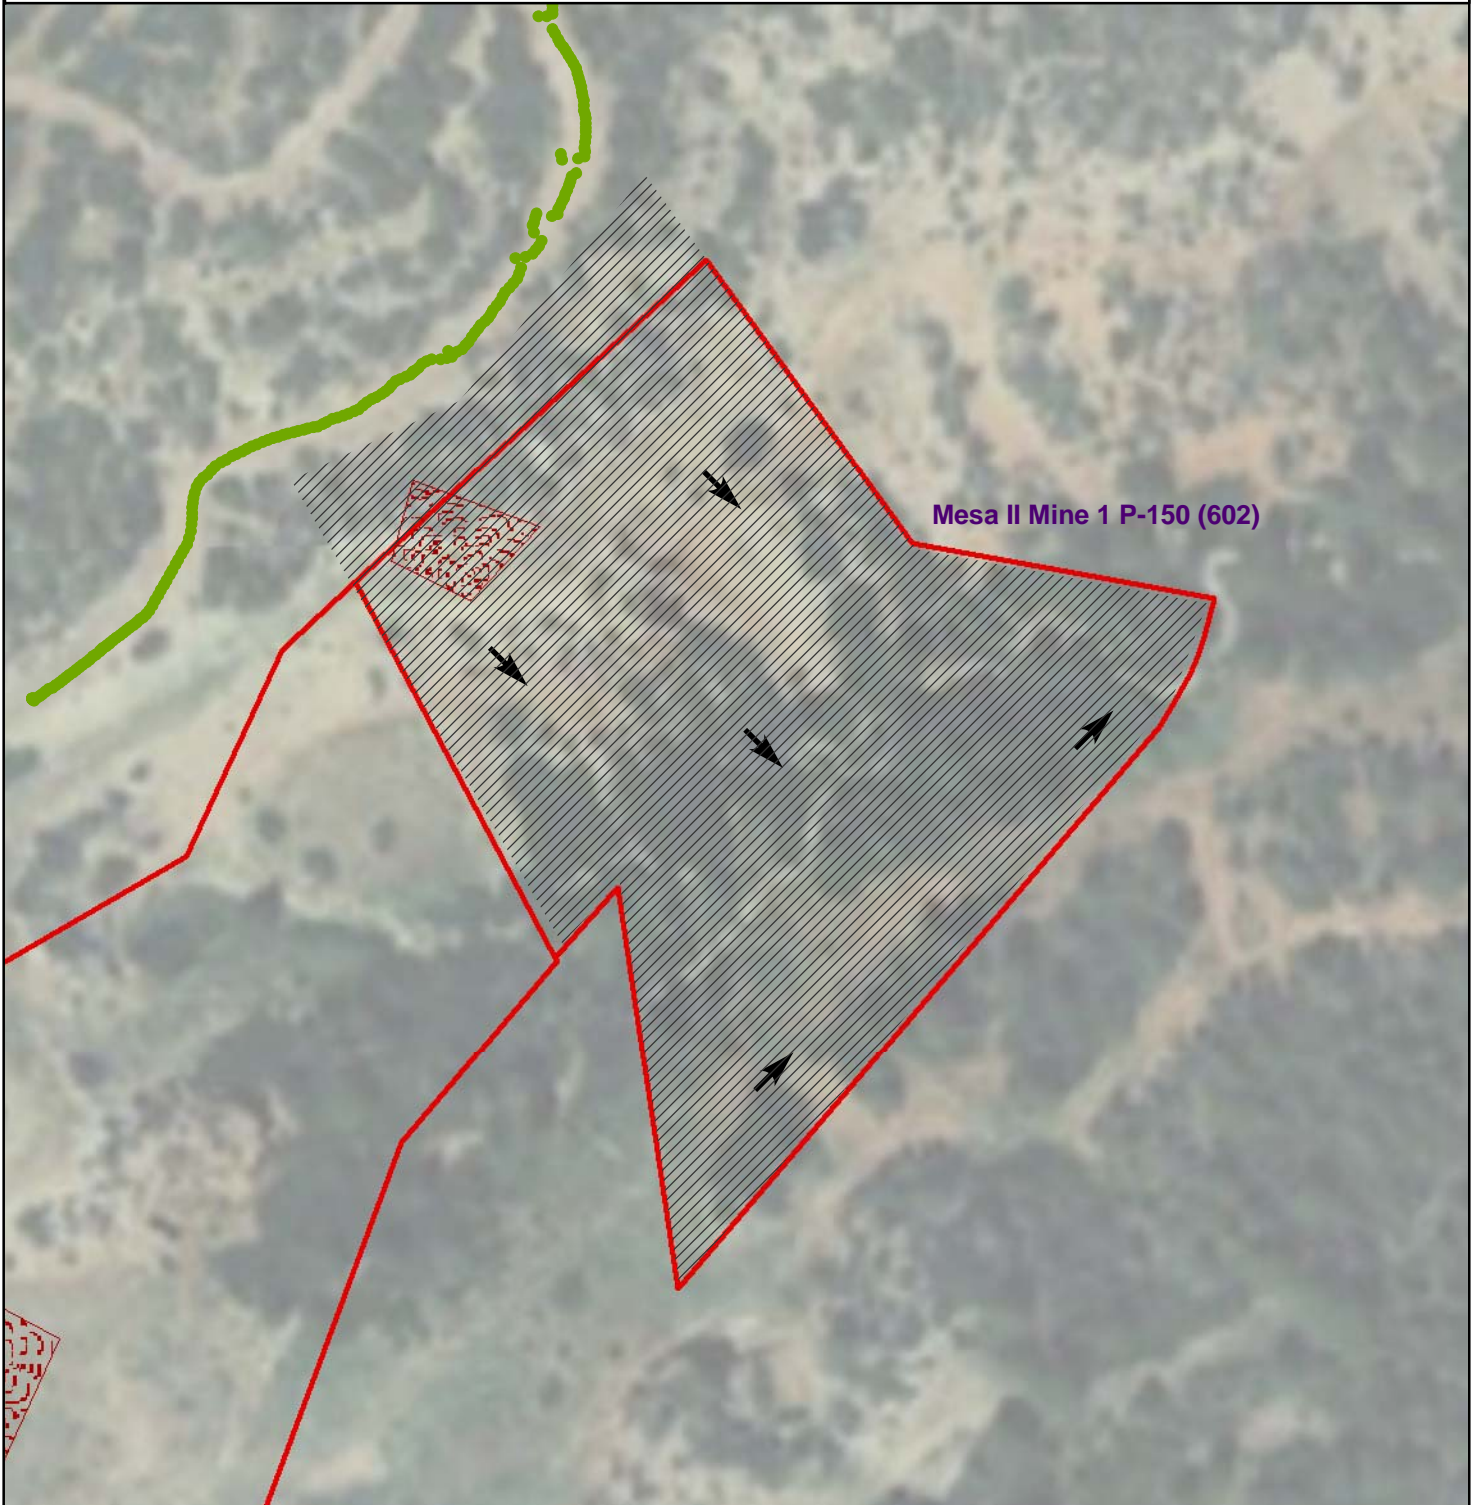
**Figure 1 - Gamma Radiation Measurements, Above Two Times Background
Mesa II Mine 1 P-150 (602)
Cove Chapter, Navajo Nation, Arizona**

Weston was unable to access the site, due to steep grades. Measurements were collected in the vicinity of the, at approximately 75' north of the site boundary A total of 244 gamma radiation measurements were collected near mine site, ranging from 7,212 cpm to 15,203 cpm. . The measurements are represented in Figures 1 and 2.

Gamma survey conducted 10/2009
Measured as counts per minute (cpm)

Average background = 7,906 cpm

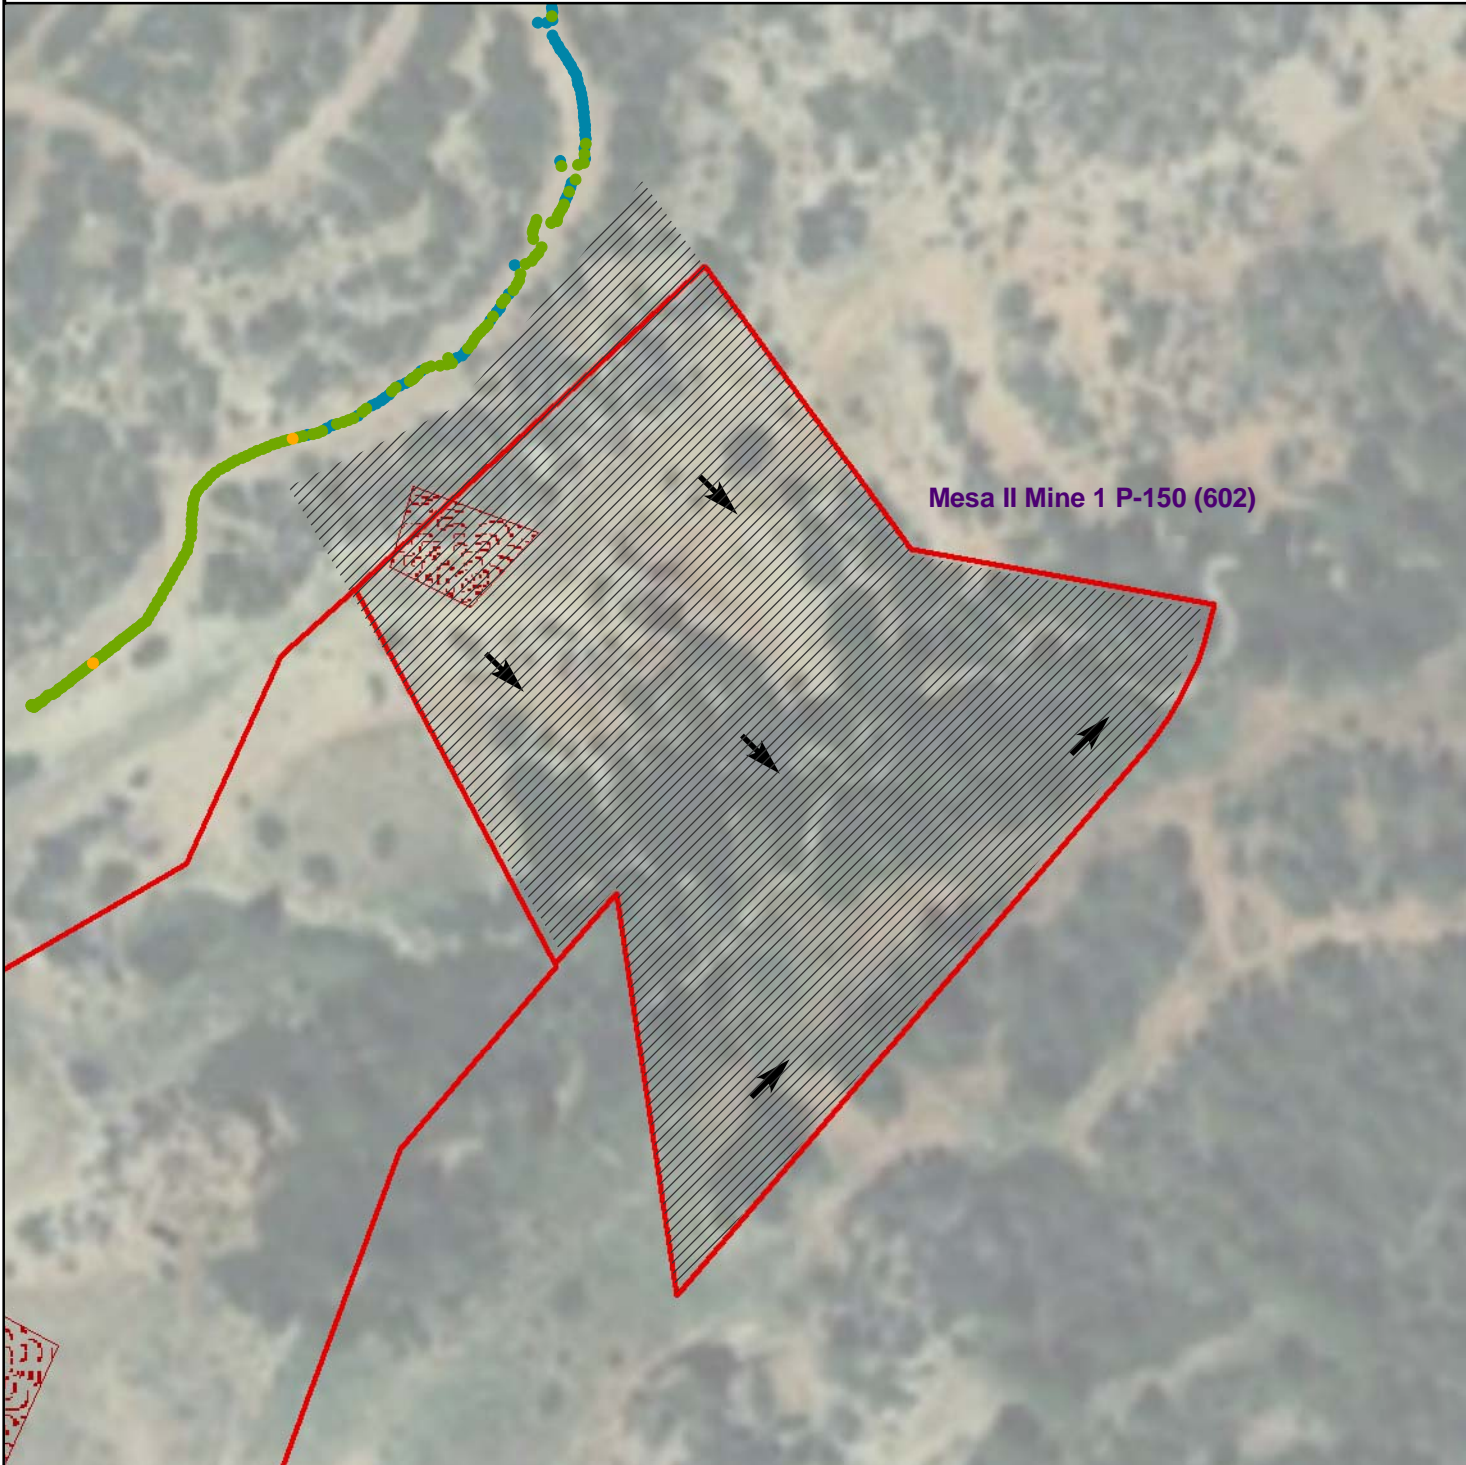
**Figure 2 - Gamma Radiation Measurements
Mesa II Mine 1 P-150 (602)
Cove Chapter, Navajo Nation, Arizona**

**Gamma survey conducted 10/2009
Measured as counts per minute (cpm)**

Average background = 7,906 cpm
