# Navajo Abandoned Uranium Mine

## Site Screen Report

### **Deneh Nezz 3 AUM Site**

**March 2010**

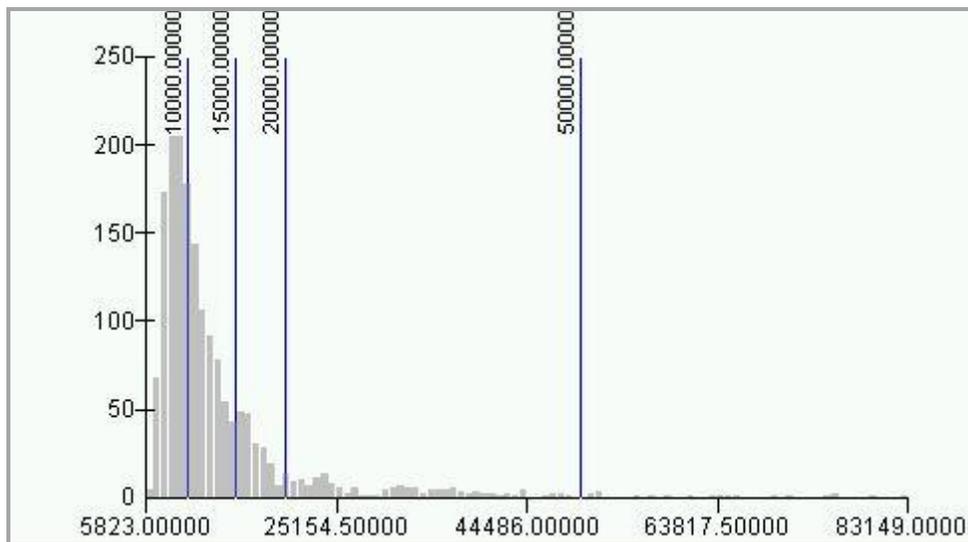
The following chart and statistics were generated by ESRI ArcGIS 9.3.1, and show the general distribution of the site gamma radiation measurements. The horizontal X axis represents the gamma radiation reading levels in cpm (lowest levels to the left). The vertical Y axis represents the frequency of each gamma radiation level.

Count:	1737
Minimum:	5823.00000
Maximum:	83149.00000
Sum:	22926514.00000
Mean:	13198.91422
Median:	10531.00000
Standard Deviation:	8546.89045

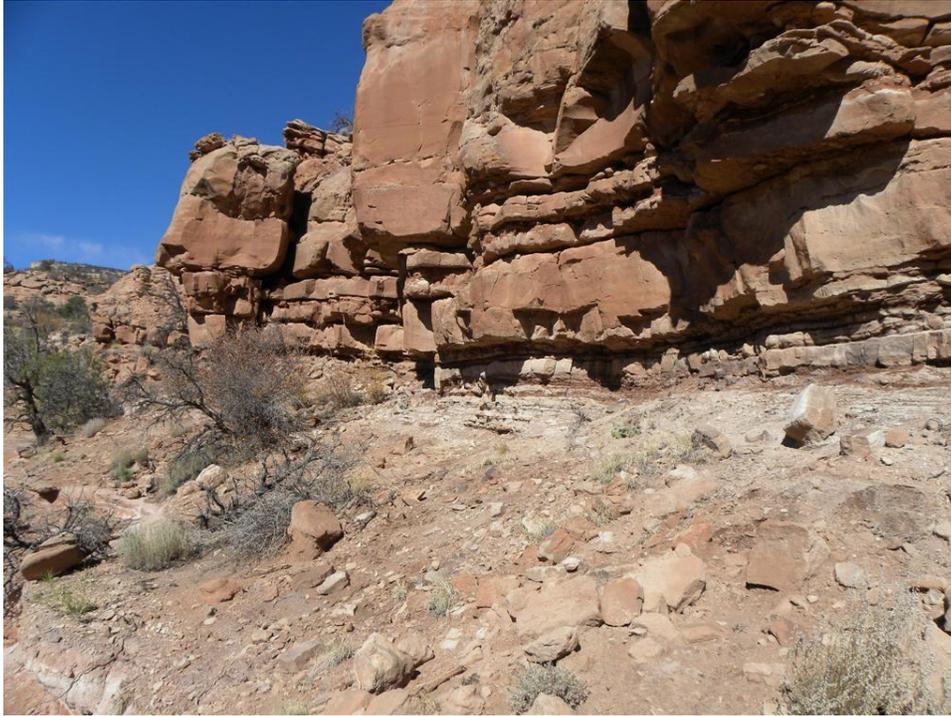
Photo 1. Waste pile

Small waste pile in front of possible adit/rim strip operation, 20' x 20', with a total estimated volume of 74 yd<sup>3</sup>

Possible adit or rim strip cut into rock face; unreclaimed waste pile

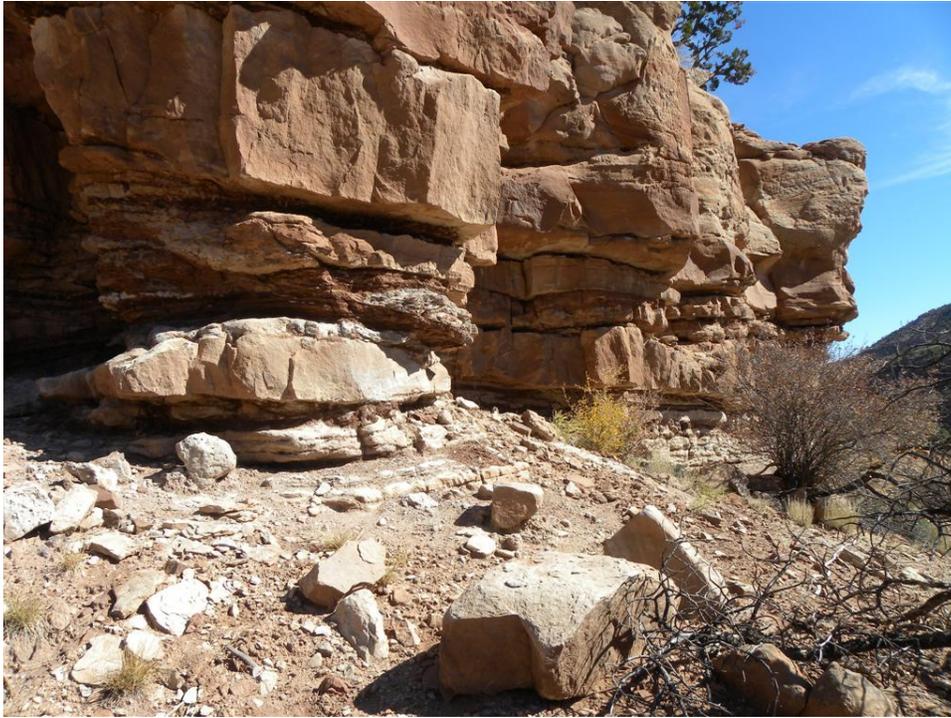
Photo 3. Possible adit or rim strip cut into rock face

A total of 1,737 gamma radiation measurements were collected from the mine site, ranging from 5,823 cpm to 83,149 cpm. Measurements in the vicinity of the waste debris were found at levels up to 80,000 cpm, and at the possible adit or rim strip cut into rock face from 9,000 cpm (bottom) to 22,000 cpm (top). The measurements are represented in Figures 1 and 2.

Possible adit or rim strip cut into rock face

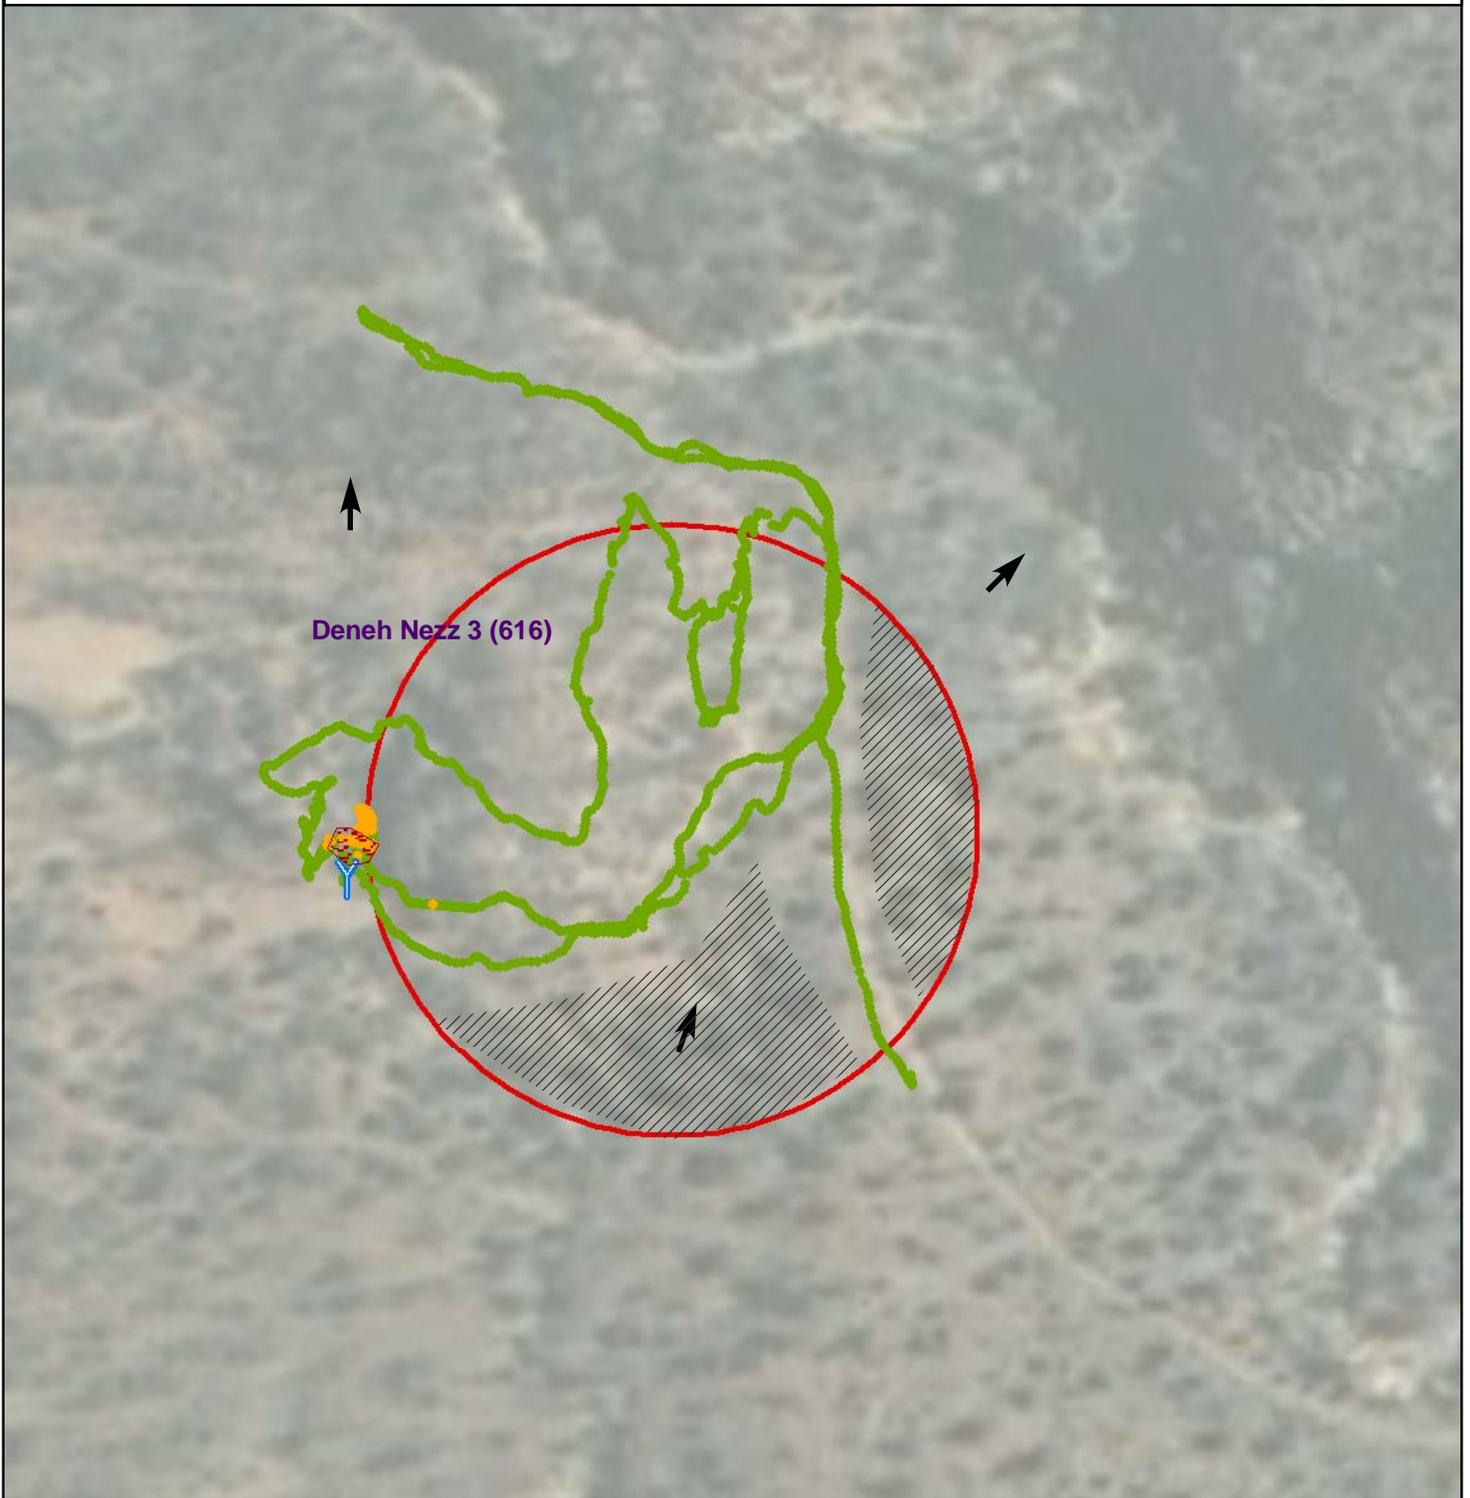
**Figure 1 - Gamma Radiation Measurements, Above Two Times Background  
Deneh Nezz 3 (616)  
Sanostee Chapter, Navajo Nation, Arizona**

Gamma survey conducted 10/2009  
Measured as counts per minute (cpm)

Average background = 10,121 cpm

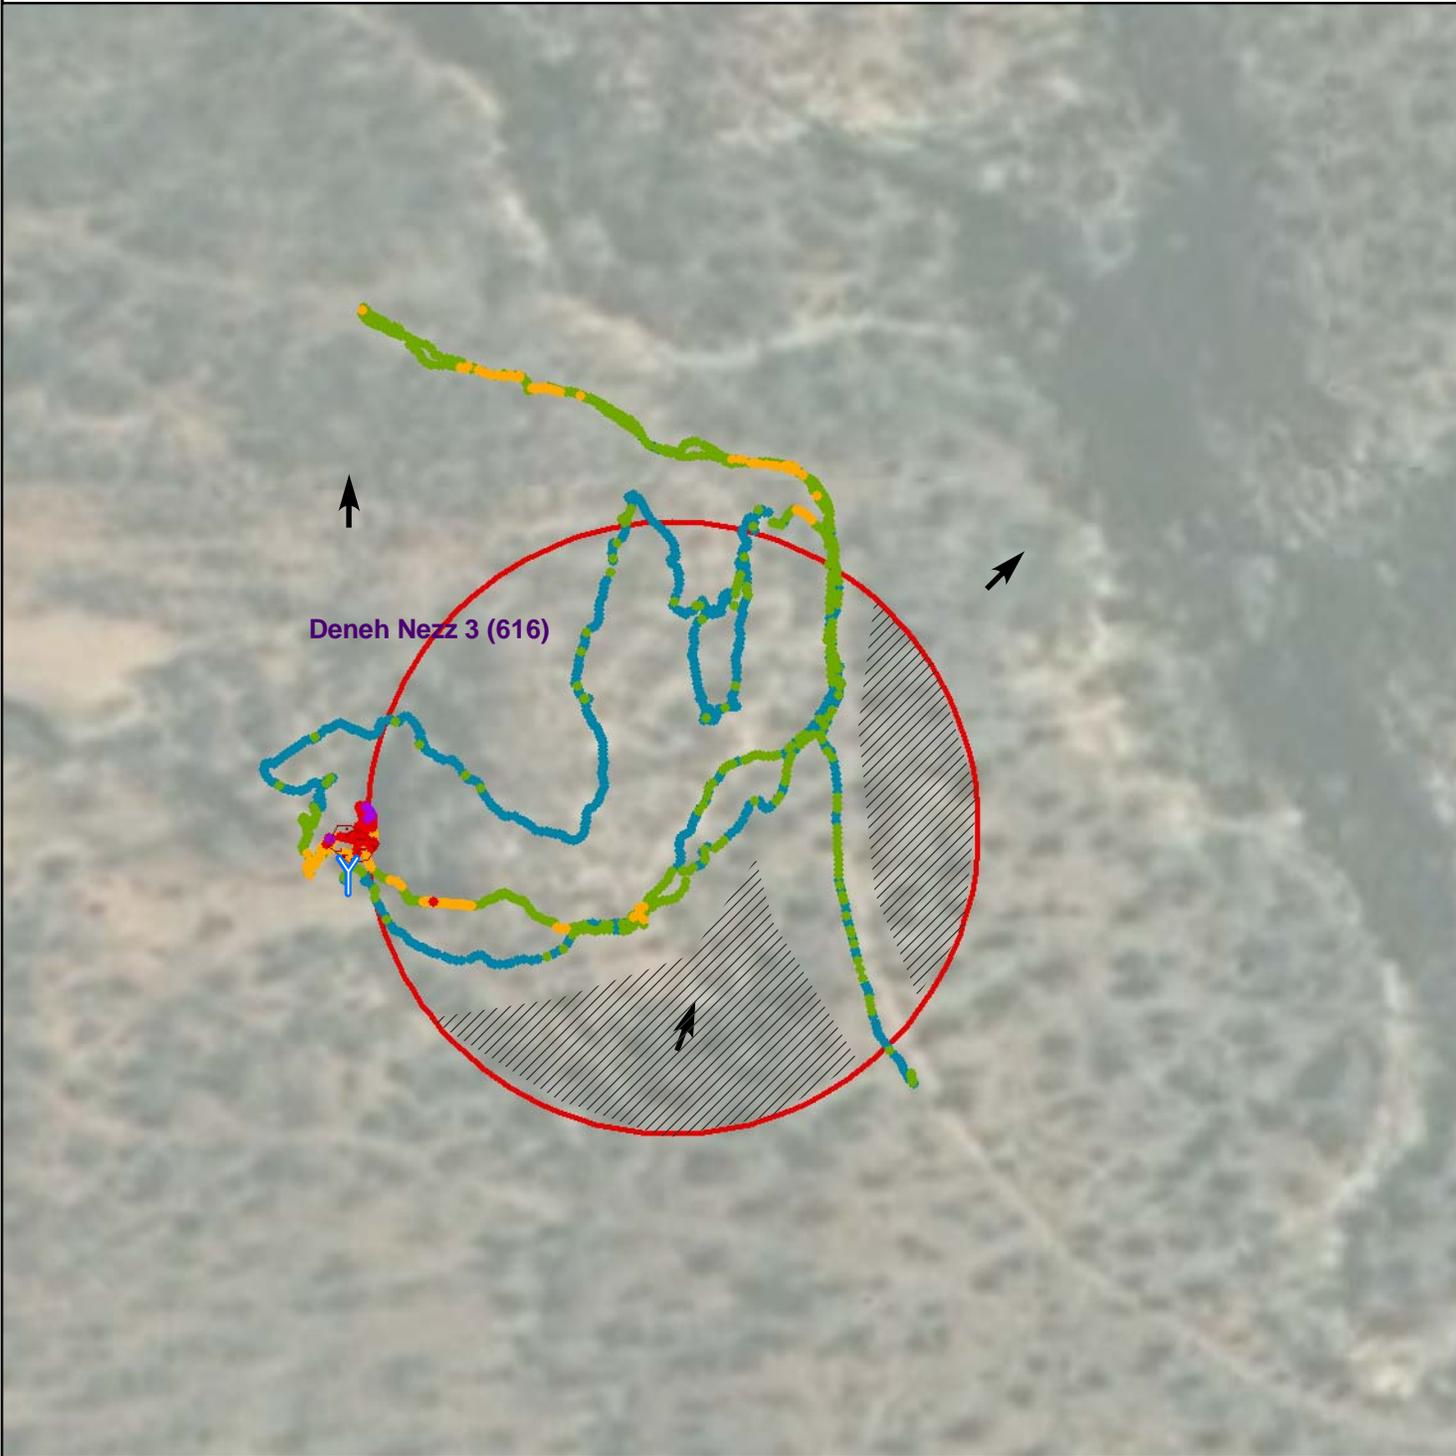
**Figure 2 - Gamma Radiation Measurements  
Deneh Nezz 3 (616)  
Sanostee Chapter, Navajo Nation, Arizona**

**Gamma survey conducted 10/2009  
Measured as counts per minute (cpm)**

**Average background = 10,121 cpm**
