Navajo Abandoned Uranium Mine

Site Screen Report

Silentman 1 AUM Site

August 2010

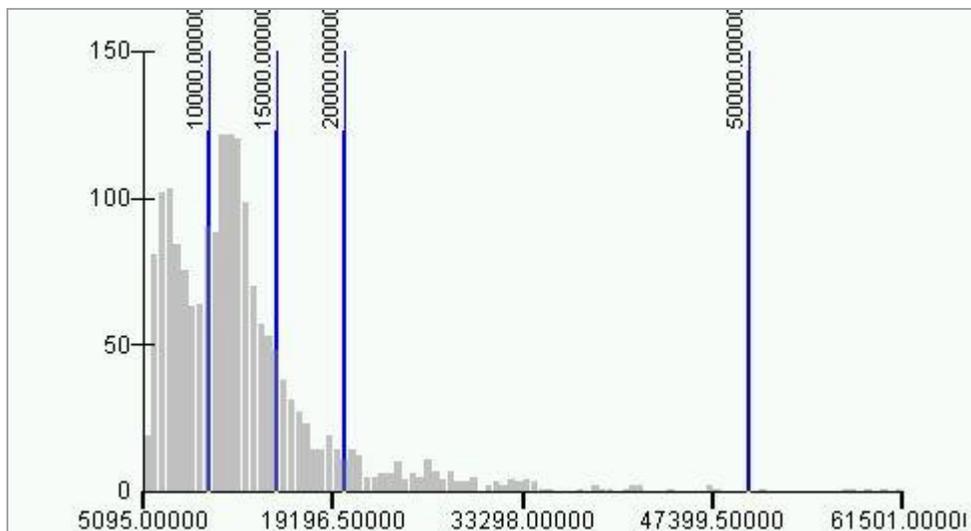
The following chart and statistics were generated by ESRI ArcGIS 9.3.1, and show the general distribution of the site gamma radiation measurements. The horizontal X axis represents the gamma radiation reading levels in cpm (lowest levels to the left). The vertical Y axis represents the frequency of each gamma radiation level.

| Count: | 1804 |
| Minimum: | 5095.00000 |
| Maximum: | 61501.00000 |
| Mean: | 12521.54102 |
| Median: | 11362.00000 |
| Standard Deviation: | 6400.43160 |

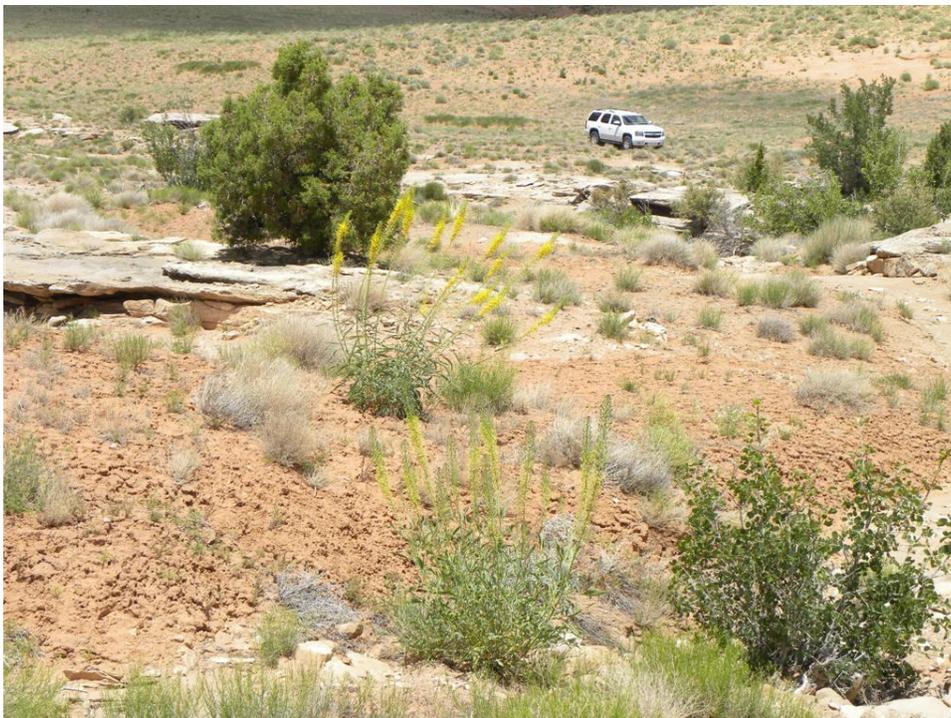
Photo 2. Silentman 1 site, reclamation cap

2 reclamation caps: 50' x 20' x 2'; 15' x 10' x 0.5'

Is the cap/seal functionally intact? Yes

Is the cap/seal sufficiently degraded to create a concern about releases? No

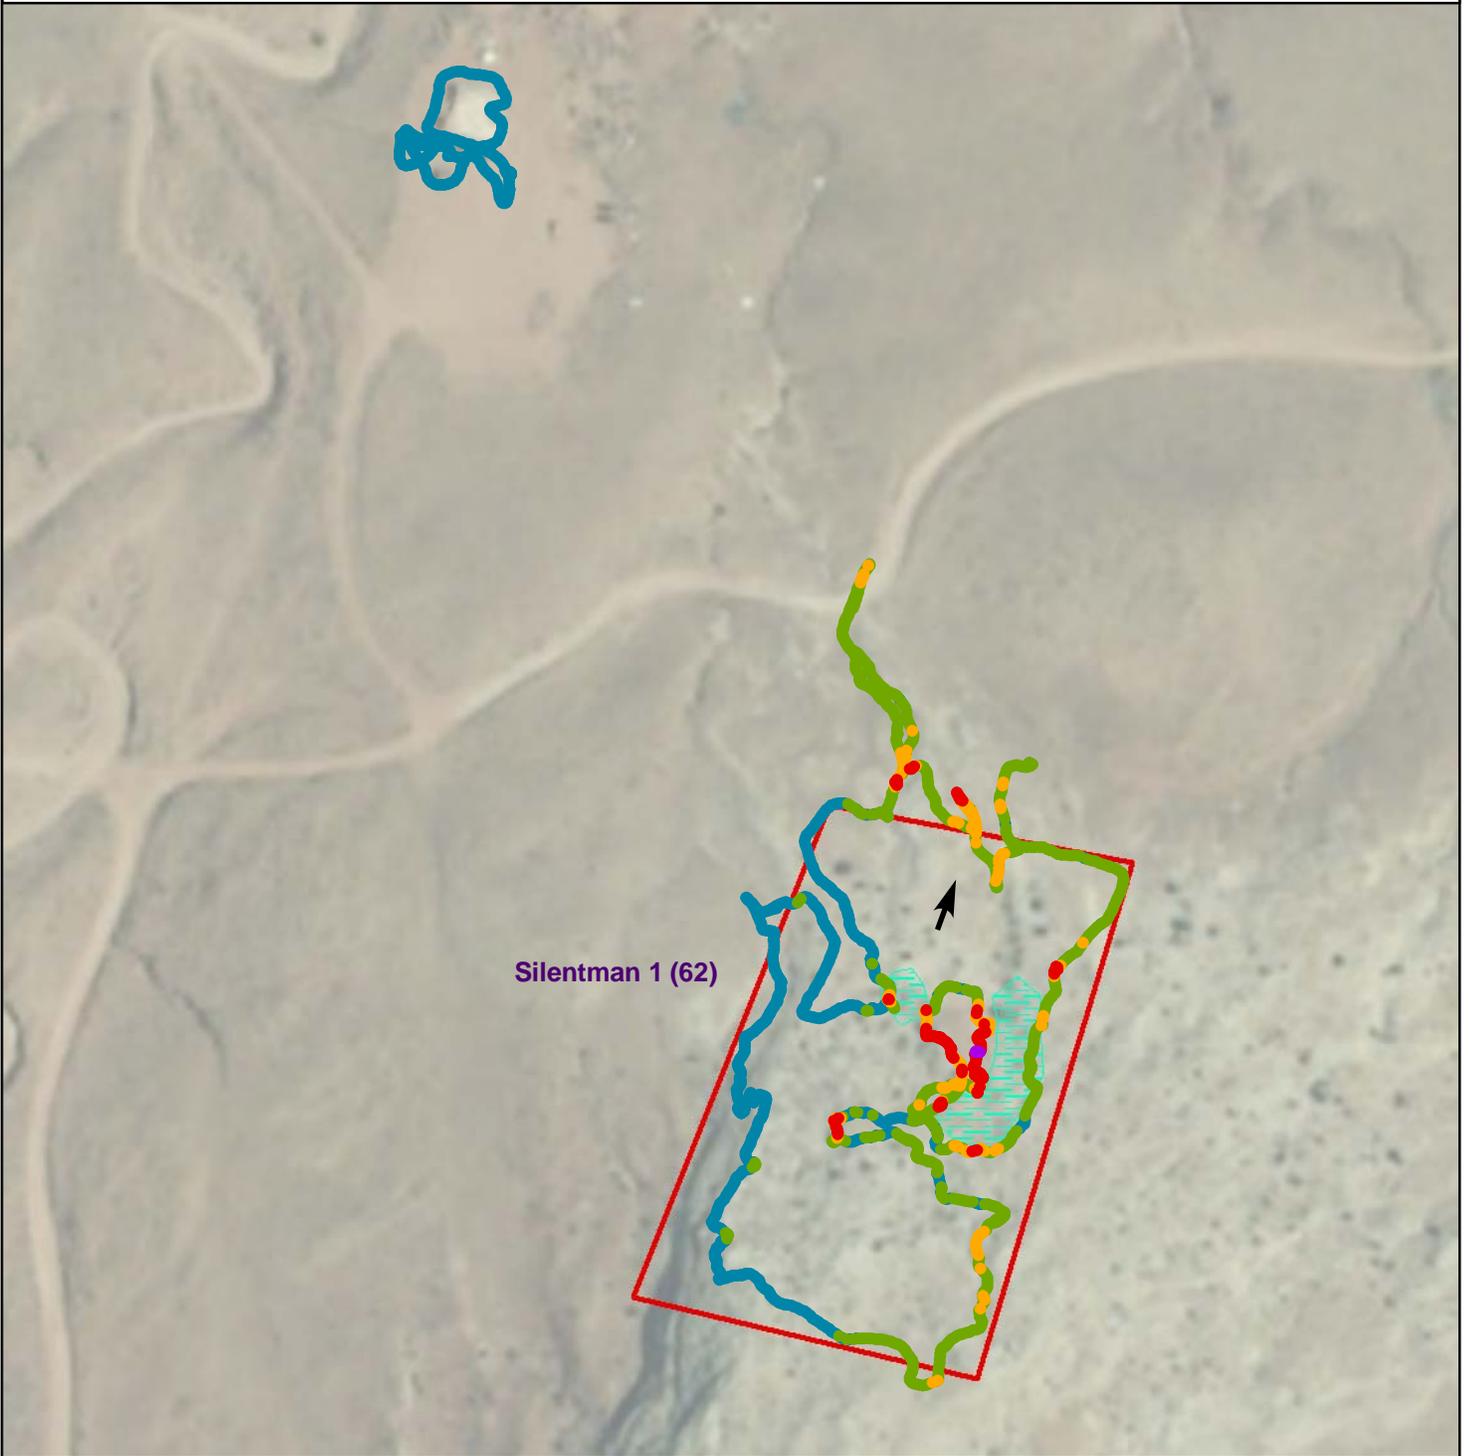
**Figure 2 - Gamma Radiation Measurements
 Silentman 1 (62)
 Teec Nos Pos Chapter, Navajo Nation**

A total of 1,804 gamma radiation measurements were collected from the mine site, ranging from 5,095 cpm to 61,501 cpm. Measurements collected in the vicinity of the reclamation caps were found at levels ranging from approximately 20,000 cpm to 60,000 cpm. The measurements are represented in Figures 1 and 2.

**Gamma survey conducted 06/2010
 Measured as counts per minute (cpm)**

Average background 11,042 cpm
