Navajo Abandoned Uranium Mine

Site Screen Report

Mine Name: South Sunlight
Mine ID: 702

Weston Solutions, Inc.

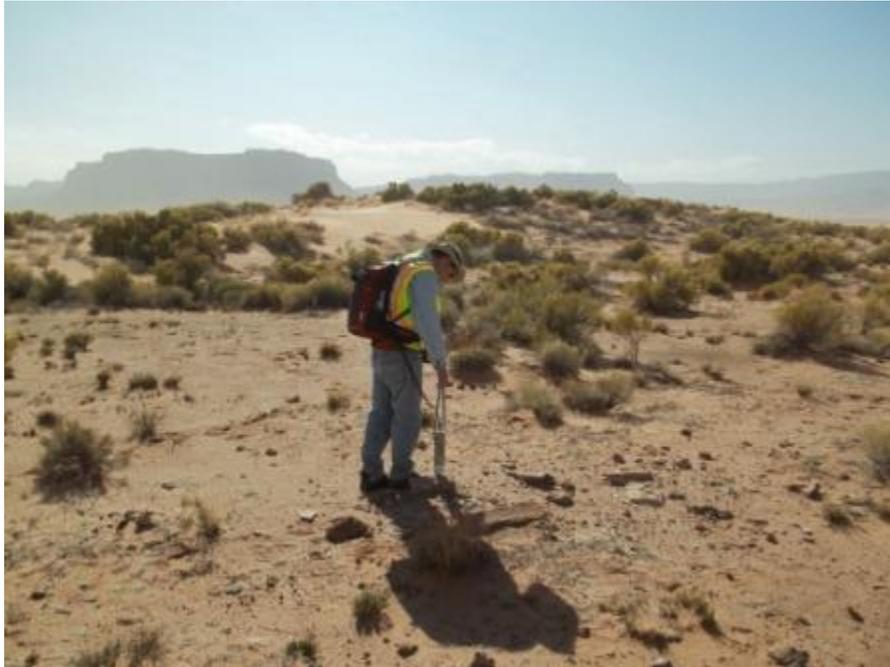
Photo 3

Mine Site #702 – Waste Rock

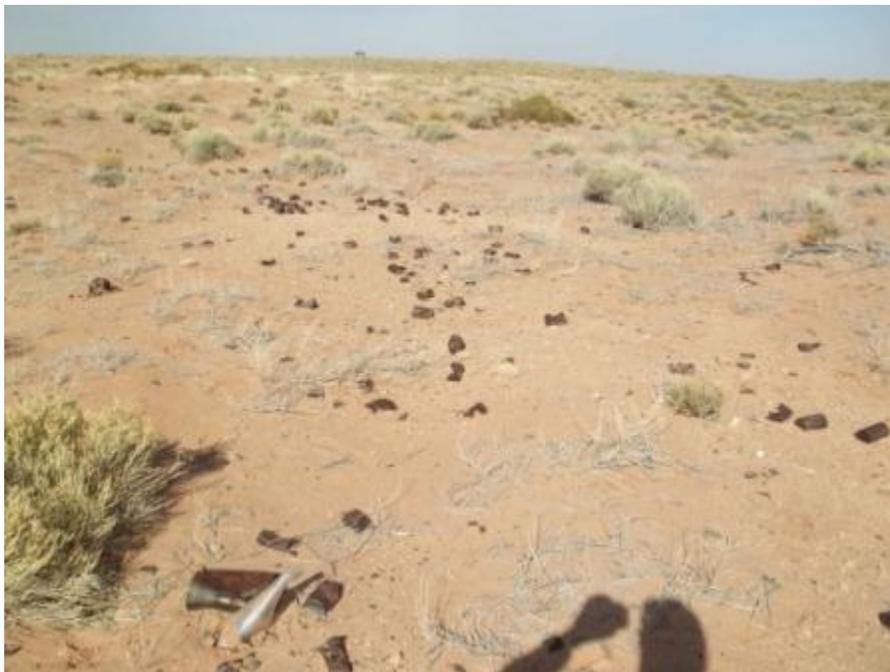
Photo 4

Mining camp waste (cans, bottles with a few waste piles and debris) found in central area near the road and in southwest corner of the site

Mine Site #702 – Mining debris

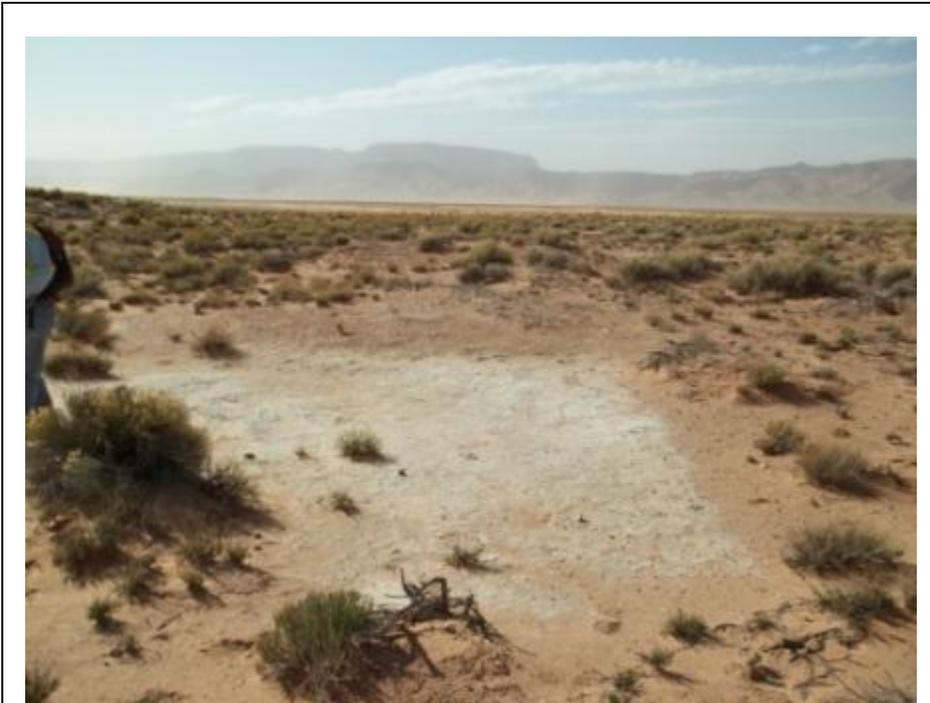
Photo 5	Mine Site #702 – Waste rock
----------------	-----------------------------

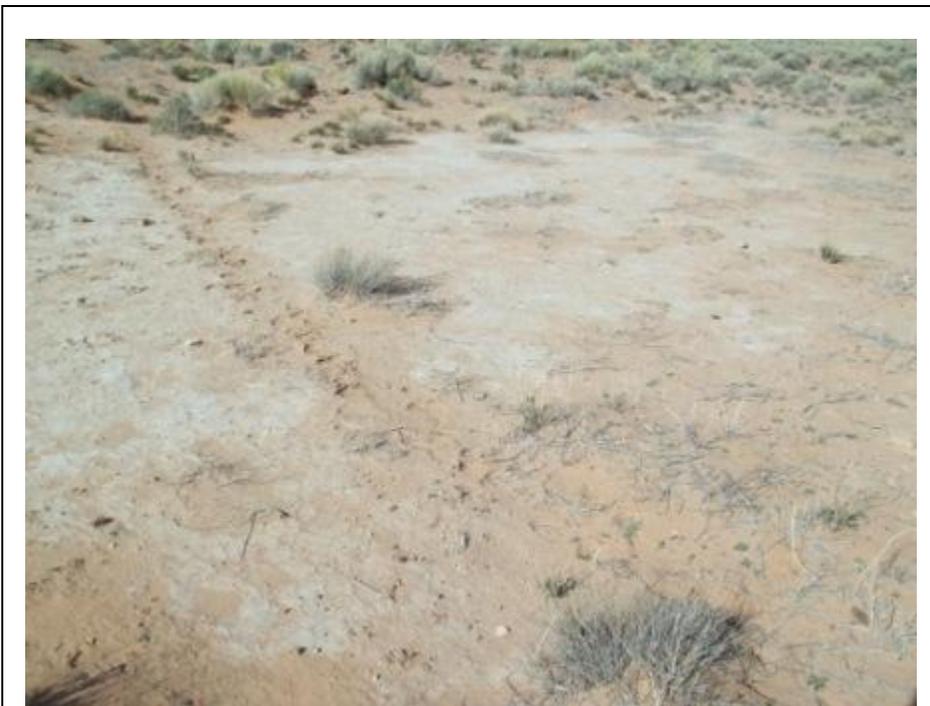
Photo 6	Mine Site #702 – Waste rock
----------------	-----------------------------

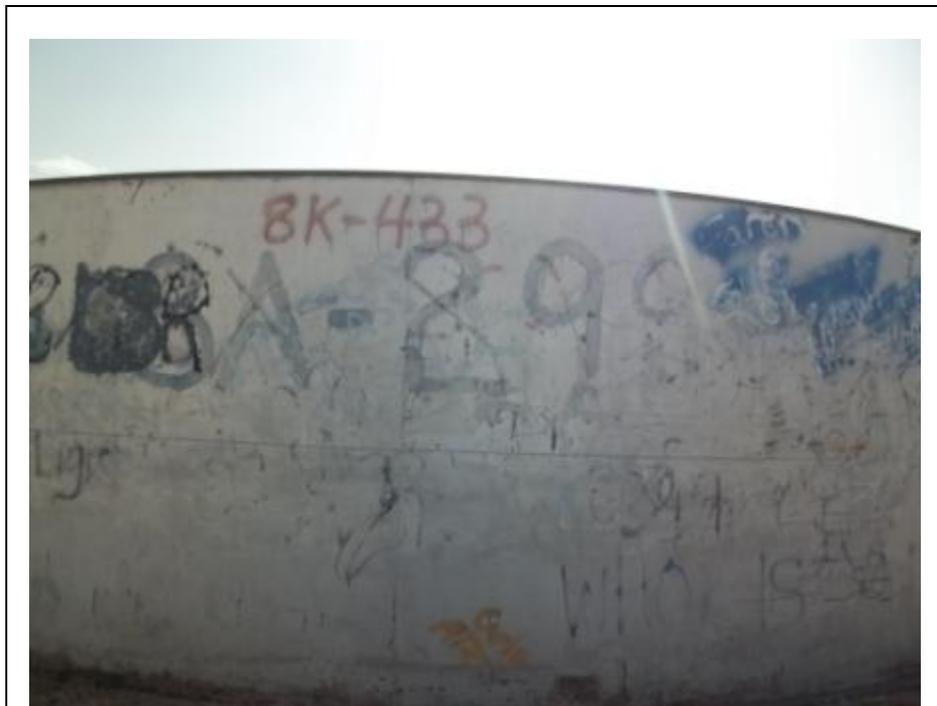
Photo 8

0 to 0.25 miles: 750 ft NW - Water Well 8K-433

Mine Site #702 – Well 8K-433
